***Cimarron Watershed-Based Plan***

***Prepared by***

***Joanne Hilton, P.G. in cooperation with  
the Cimarron Watershed Alliance  
and the Quivira Coalition***

***First Revision Completed December 2017***

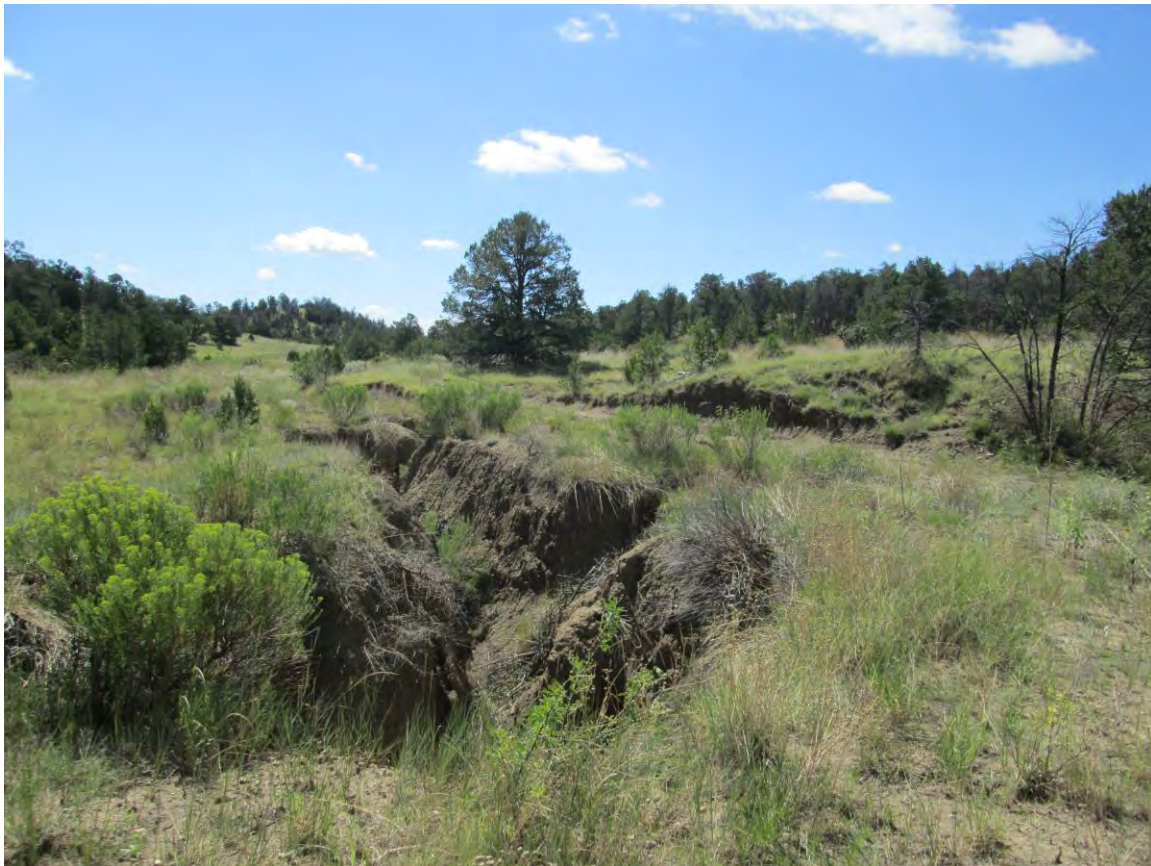
Example of erosional gully resulting from poor road drainage

- The Chase Ranch also has numerous low water crossings on the Ponil Creek. These low water crossings are in poor condition and should be upgraded to current design standards by stabilizing and armoring the stream channel and banks with locally sourced rock and cobble.

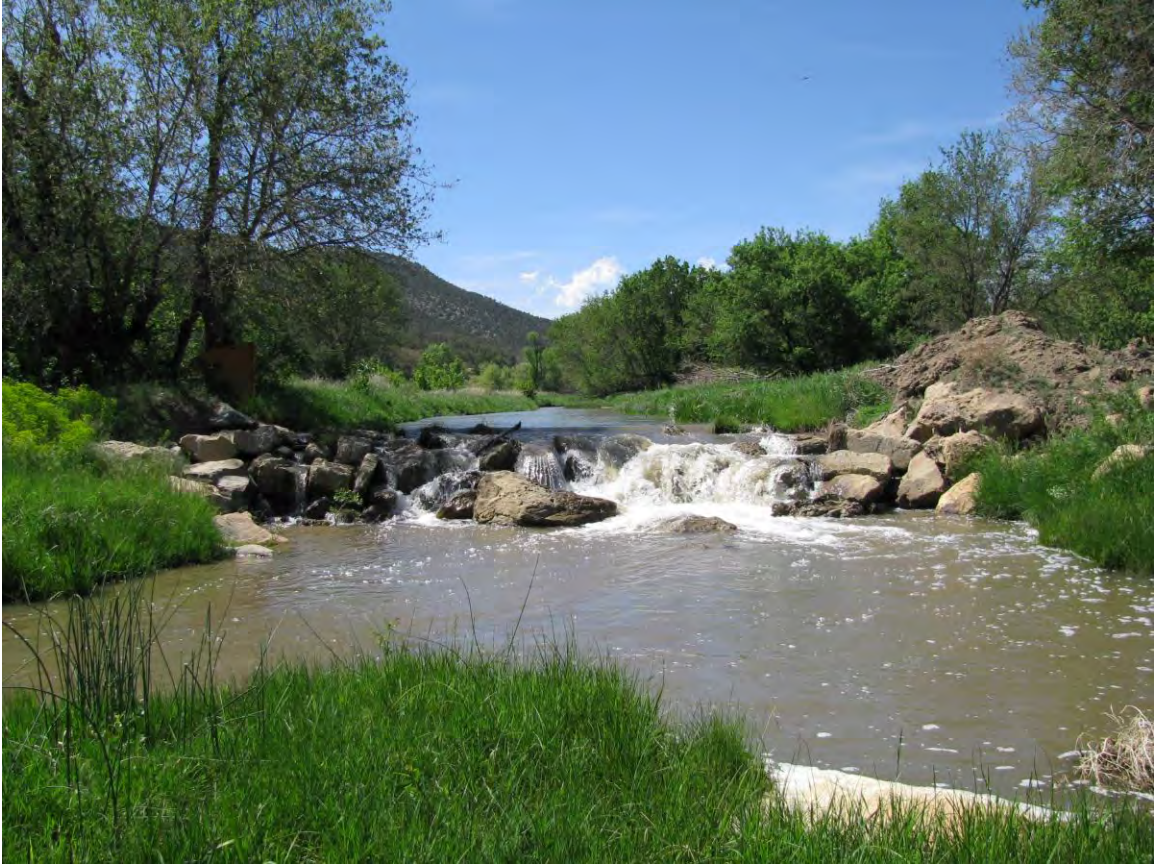
Second Irrigation Diversion on the Chase Ranch

- There is a third irrigation diversion just above US Hwy 64 that needs major repairs to the headgates and inlets.
  - Many of the irrigation ditches on the Chase Ranch are in need of maintenance. Many of these ditches are full of sediment, frequently leak, and contain conifer trees that reduce their efficiency. A great deal of maintenance work was completed on these ditches during 2017, but more work is needed. Upgrades to the irrigation diversions would reduce the sedimentation in the ditches.

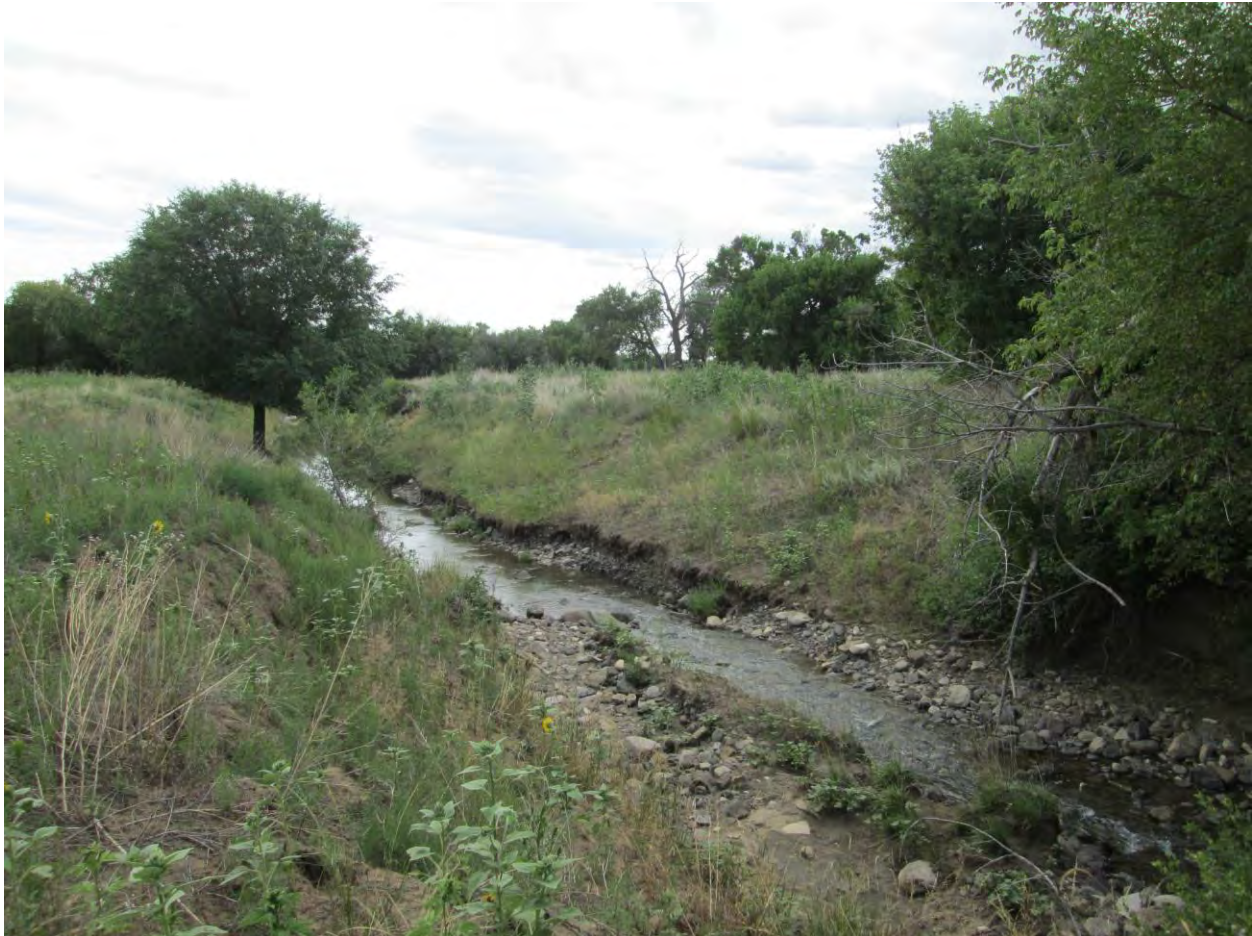
Entrenched section of Ponil Creek that was intentionally straightened and is continuing to downcut

- Stream Channel Restoration
  - The assessment team observed a number of locations in which the stream channel was actively down cutting. These areas could to be treated with grade control structures to stabilize the elevation of the channel. Other treatments could include boulder and tree rootwad bank protection to reduce stream bank erosion and induced meandering to improve channel length, create grade control, and establish a functional meander pattern.
  - There is one location that is about a half mile long where the channel could be placed back into the original valley bottom and a new channel system constructed. The relocated channel would eliminate having to treat the existing degraded channel system that parallels this location.

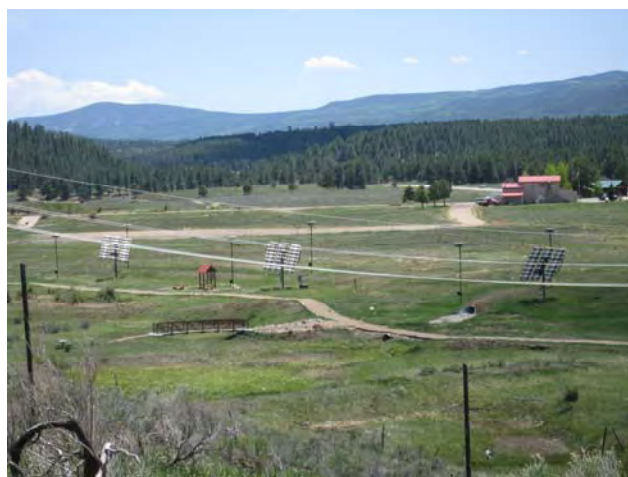
These photos are looking at the stream from Halo Pines terrace looking east

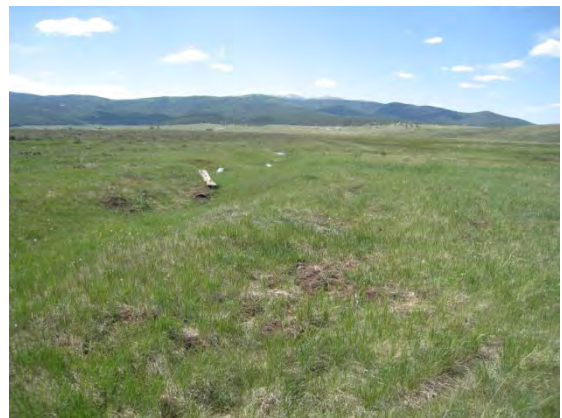
At waypoint 64, N36.42305 W10528458 there is an old road crossing that needs to be removed. The stream is cleaner and less silty with a more stable bottom. This photo shows old meander.

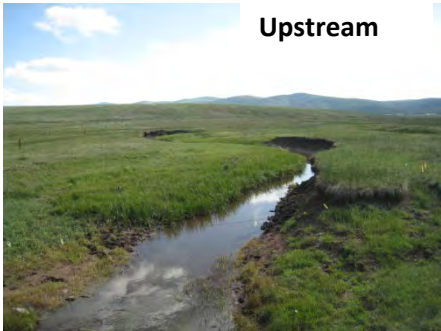
**Upstream**

5-30 Waypoint 65, N36.44013 W105.27456, is located downstream of the airport going toward

eagle nest on the main road; then on the 1<sup>st</sup> road to the right just past security building. There is a 3ft culvert at the road crossing.

There are extreme-moderate banks downstream and moderate banks upstream and an electric fence on both

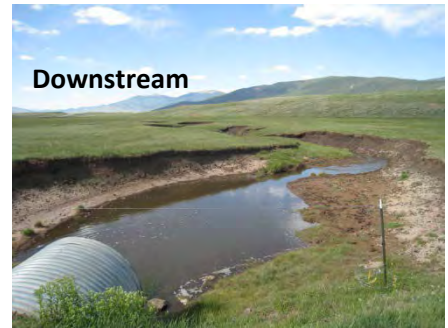
**Downstream**

sides of the road.

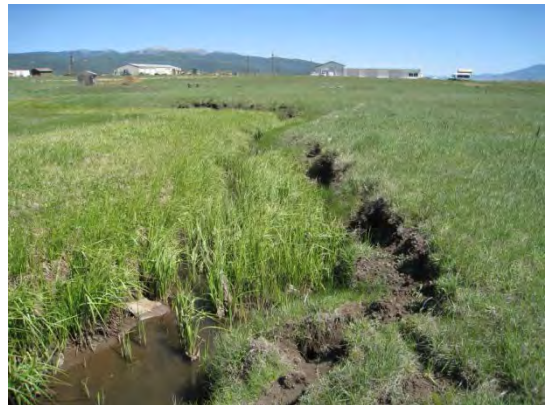
4. There is a large pond with a very silty stream bottom located 50ft downstream of Halo Pines Terrace road crossing/culvert. There is a lot of trash in the stream, and another moderate bank 340ft downstream of the road. All along the stream there is tall grass sometimes growing in the stream slowing down the current. 130ft farther downstream there is a fence going across the stream. 34ft downstream of the fence there is a moderate bank and grass in the stream. 3 inch and smaller fish were observed 30ft farther downstream there is another moderate bank with a grass bench below.

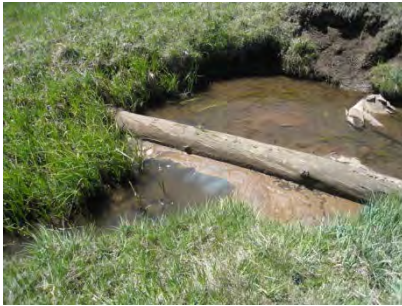
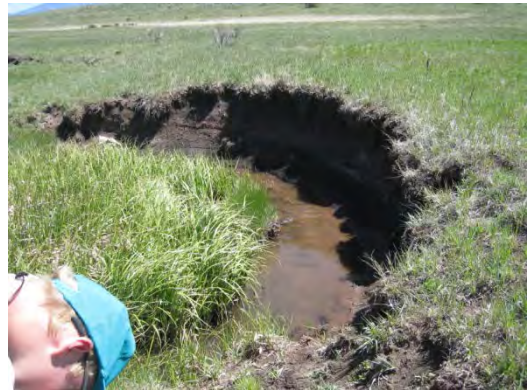
6. Waypoint 59 is 320ft farther downstream. Vegetation is protecting the bank when the flow is moderate, however, at high flows it is completely exposed. The BEHI index is 35, giving it a high rating. 150ft beyond Waypoint 59 there is a 10ft long undercut bank that is between high and

very high on

the BEHI. 60ft farther there is an almost identical bank. Another 130ft downstream there is an outside meander, and very high on the BEHI. The flow is better and less obstructed by trash and vegetation in the stream

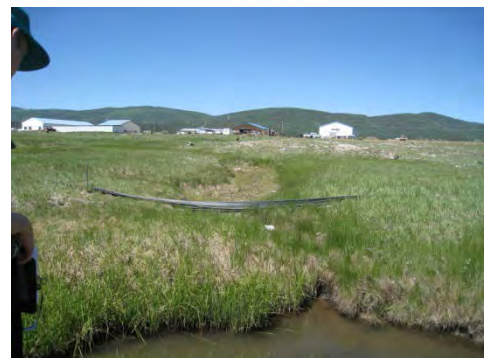
7. Another 230ft downstream there is a small silt fence below an industrial site, located about 500ft away from the stream. There was a small gray rat observed. There are moderate BEHI banks throughout this reach. 230 feet beyond the fence there is a moderate bank with a bench below. 90 feet past that there is a silt fence coming in to the stream.

90ft farther downstream there is a blue drum and garbage in the stream.

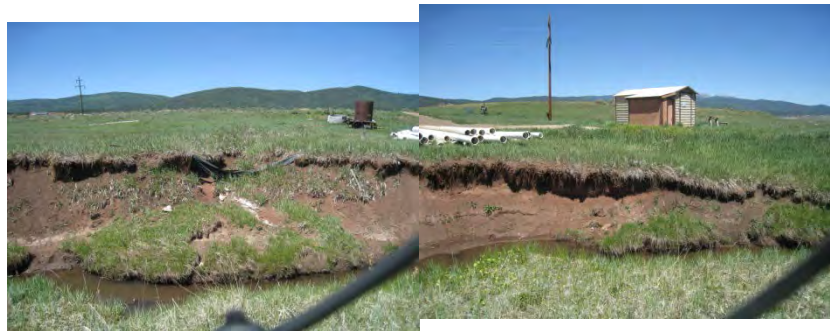
8. Located at N36.40395 and W105.28350 there is 80ft of exposed bank with a BEHI of high to very high. There is a drainage coming in close to the road.

600ft farther down there is a high BEHI bank.

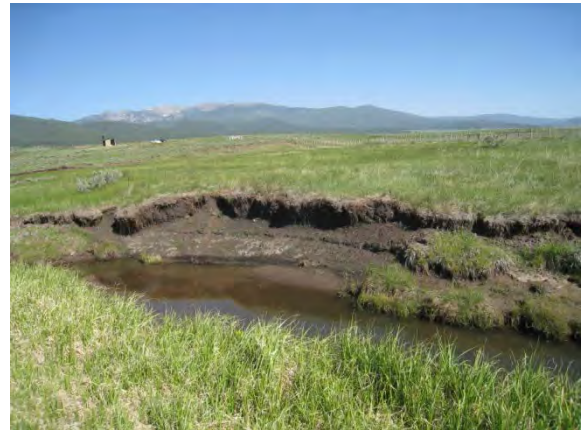
5-31 Waypoint 68, N36.47555 W105.26464, is located off of the first road south of Eagle Nest Lake. Along the Cieneguilla there are a series of exclosures. Upstream there is a fence that has a no trespassing sign. It is south 300ft downstream of the gauging station. The stream is very silty with extreme meanders. Most of the banks are very high to moderate BEHI in both the upstream and downstream direction.

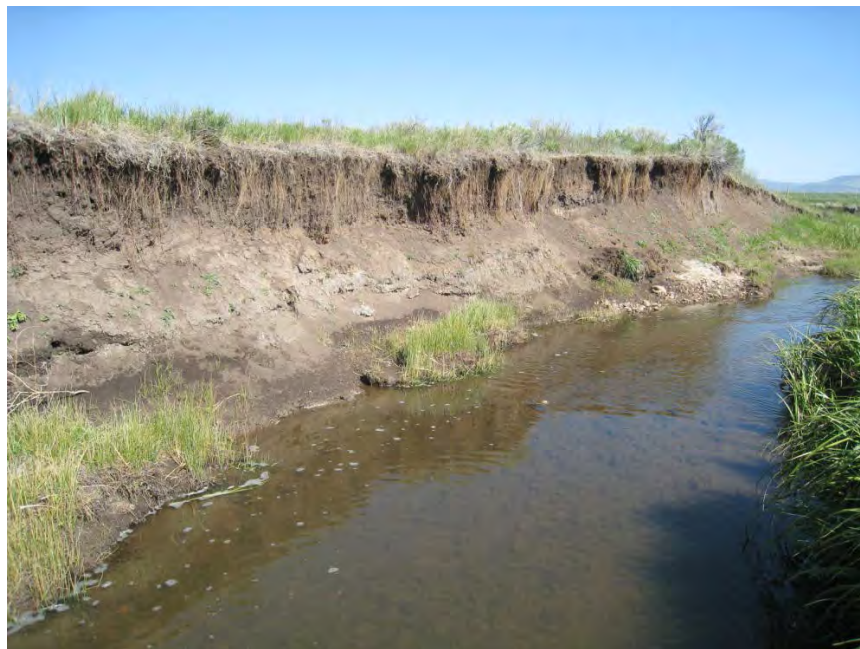
5-31 At Waypoint 69, N36.48659 W105.28814, there is a 100ft long 6ft high bank just North East of the parking lot at the end of the road. That bank has a BEHI of 41: very high erosion potential. 150ft downstream on the Cieneguilla there is a bank with high BEHI, about 100ft long, directly east of the restroom and it borders the exclusion fence.

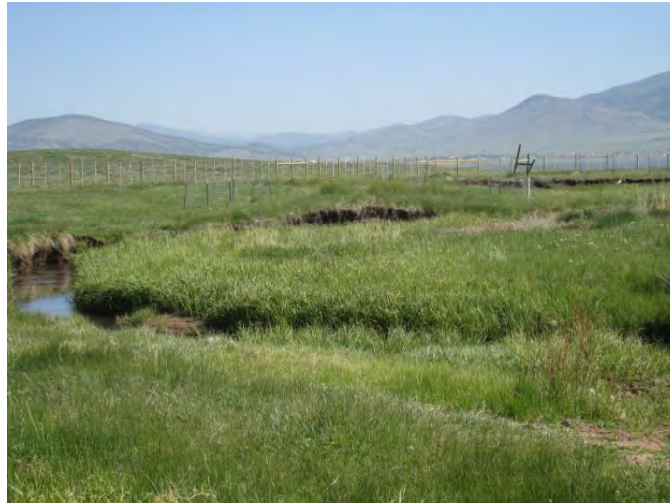
Looking downstream into the exclosure, there are moderate cut banks with some smaller fencing inside as well as small recently planted vegetation.

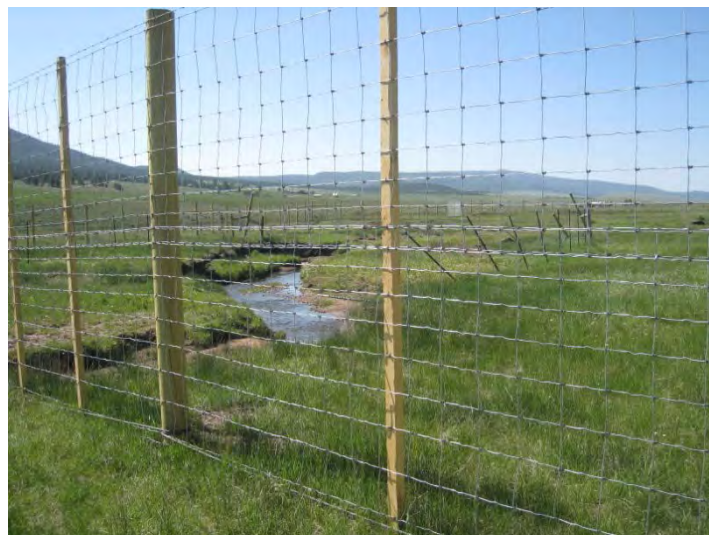
It is possible to walk into the exclosure from the north end. Downstream toward Eagle Nest Lake there are moderate to high banks.

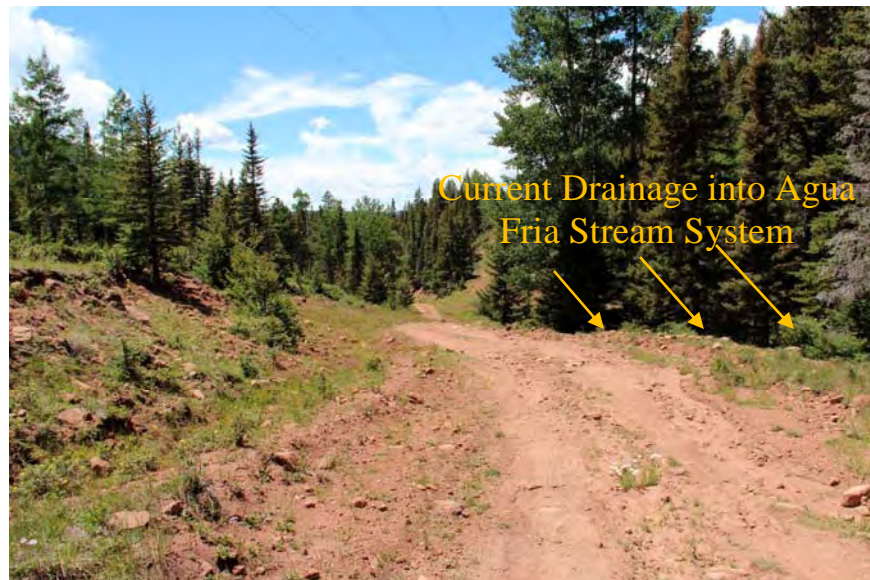
The existing road system crosses West Agua Fria Creek from the north side of the creek over to the south side along the 245 KV powerline right of way and runs east crossing over the creek again and then turns north. Both creek crossings currently have culverts in them. This section of road is approximately 1,600 feet in length.

The west section of this road, +/- 750 feet is at a slope of +/- 12% currently drains directly into the creek. The east end of the road, +/- 750 feet also drains directly into the creek at the location of the upper culvert. The soils in this area are fine red clay. This road could be cross drained, however; it is very close to the creek and there are limited buffer areas to filter the runoff water before it enters the stream system.

The proposal to stop the direct sediment contribution into West Agua Fria Creek is to close and drain this section of road and reopen an existing road that is on the north side of the creek.

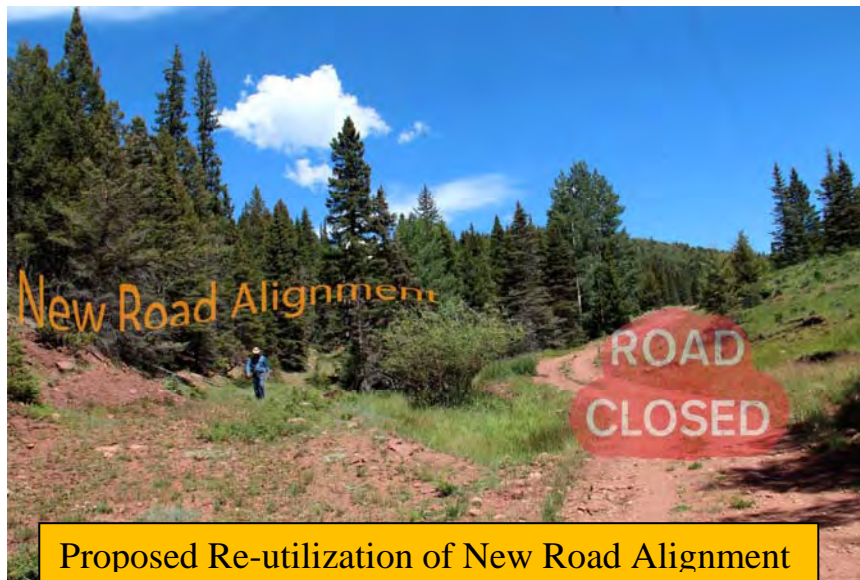
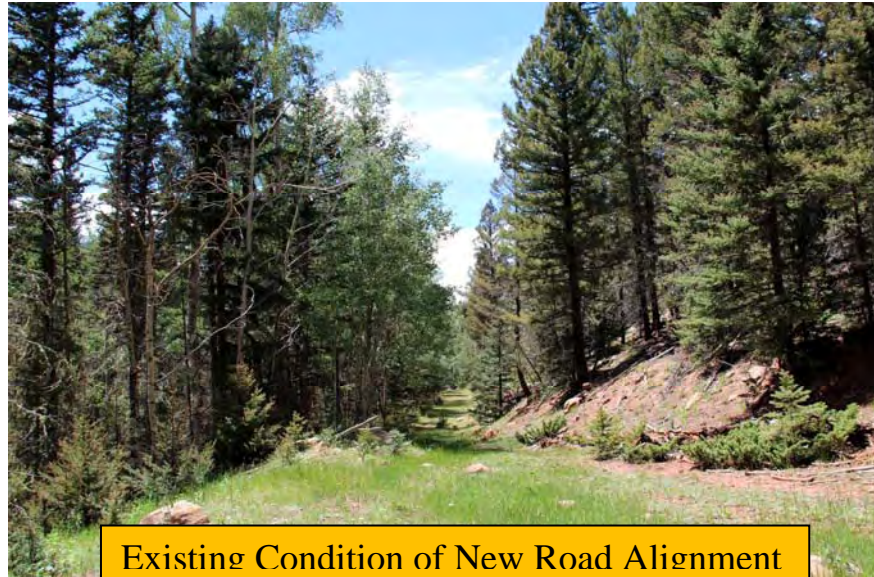
The new road alignment, approximately 1,450 feet long, would be on an abandoned road on the north side of the creek. This new alignment is not as steep as the old road and provides better buffer areas to sequester road drainage sediment. The road would require +/- ten Rolling Dip Road Surface Cross drains as well as +/- 5 drains on an abandoned road that enters the new alignment from the north. The new alignment crosses over a spring fed sloped wetlands. To cross these wetlands a permeable fill crossing would be installed at this location. The preamble fill area is approximately 100 feet long x 15 feet wide x 2 feet deep.

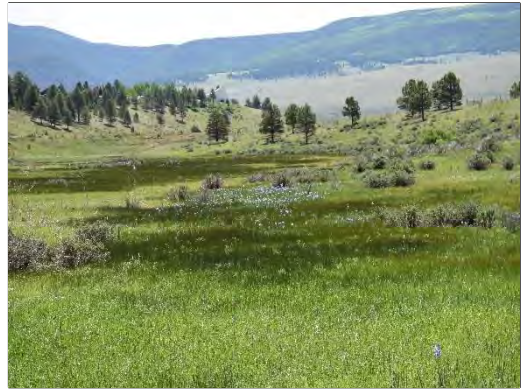
*--Slope wetlands upstream of pond*

**Slope wetlands** are normally found where there is a discharge of groundwater to the surface of the land. Elevation gradients may range from steep hillsides to gentle slopes. Principal water sources are usually from the return flow of groundwater, interflow from surrounding uplands, and precipitation. If groundwater discharge is a dominant water source, slope wetlands can occur in nearly flat landscapes.

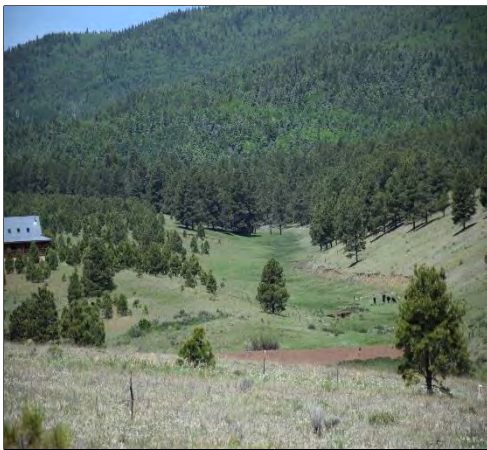
*--Slope wetlands with headcut*

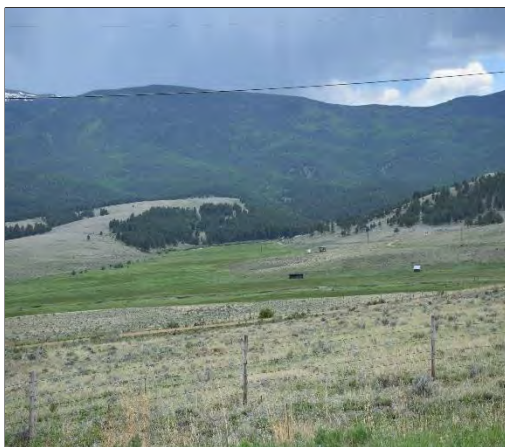
*--Slope wetlands along a tributary to Moreno Creek*

Slope wetlands lose water primarily by saturation of the subsurface, through surface flows, and by evaporation. Springs are an example of slope wetlands in New Mexico. Slope wetlands are the most prevalent wetlands in the Moreno Valley.

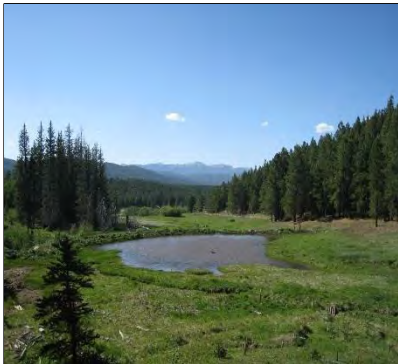
*--Palustrine fringe on perimeter of pond*

**Palustrine fringe wetlands** are adjacent to ponds where the water elevation of the pond maintains the water table in the wetland.

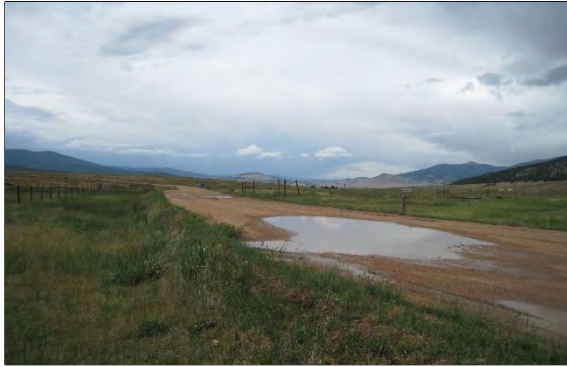
*--Moreno Valley road*

sedimentation. This assessment indicated that road conditions were extremely poor due to the clay-base soil type, poor original design, a road width that is wider than necessary, poor maintenance and management practices, plugged culverts, and system overloading from driveway runoff and steep grades (Rangeland Hands, 2009).

In addition, this road system is hydraulically connected in numerous locations via wheel tracks, ruts, and improperly maintained road ditches, culverts, and driveways as well as old roads. In these locations, water is trapped on the road surface for hundreds of consecutive feet. Similar road drainage issues may be affecting wetlands elsewhere in the Moreno Valley.

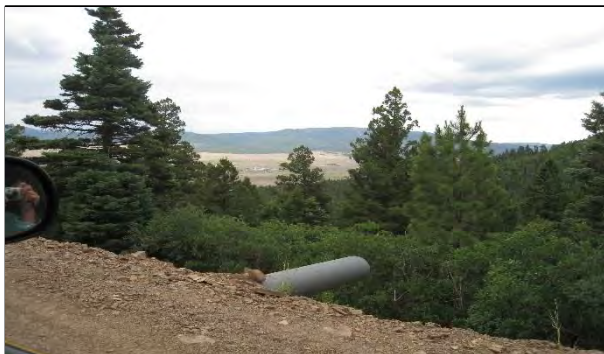
*--Poorly placed culverts can accelerate erosion*

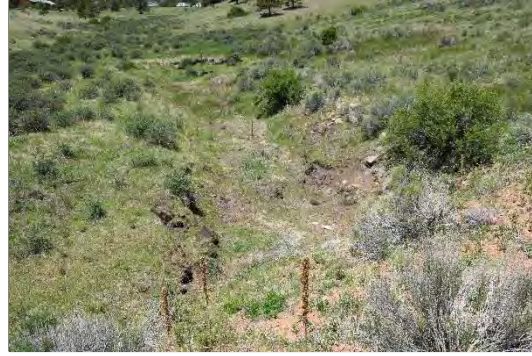
*--Presence of shrubby cinquefoil is an indicator of slope wetlands drying below road and culvert*

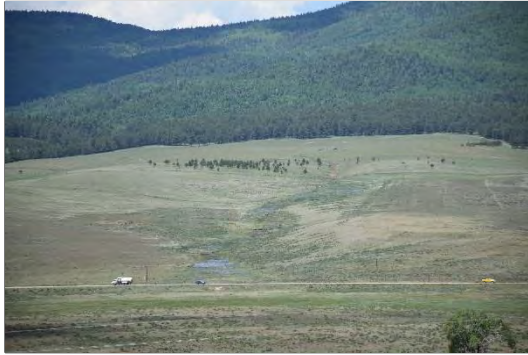
*--Slope wetlands dewatered from extensive headcuts*

Poorly designed roads or drainage, poorly managed grazing, diversion ditches, and/or stock tanks, wildfires or other upland land disturbances, or any combination of these impairments can lead to headcuts, channelized flow (disconnection from the floodplain), and sediment loading. Restoration measures may include in-channel measures, such as post vanes, baffles, one rock dams, media lunas, willow planting or other measures to improve bank stability, slow and redistribute flows, and reconnect channels with floodplains to prevent erosion and sedimentation in wetland areas (Zeedyk and Clothier, 2009).

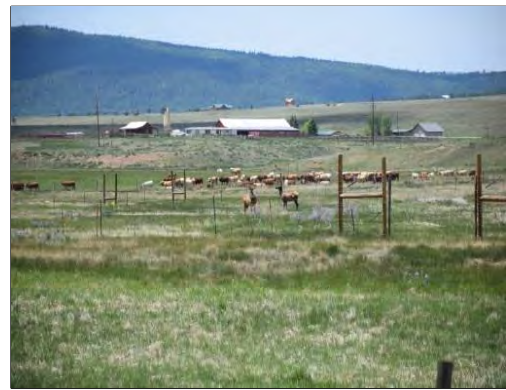
*--Elk and cattle in slope wetland along Cieneguilla Creek*

**Grazing.** Large Elk herds and other wildlife may impact wetlands by disturbing soil and overgrazing in riparian areas. Wetlands may also be affected by livestock grazing. Overgrazing reduces wetlands vegetation and initiates or exacerbates erosion.

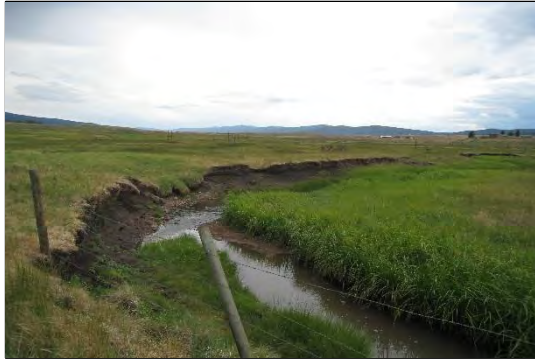
--Bank erosion along Cieneguilla Creek

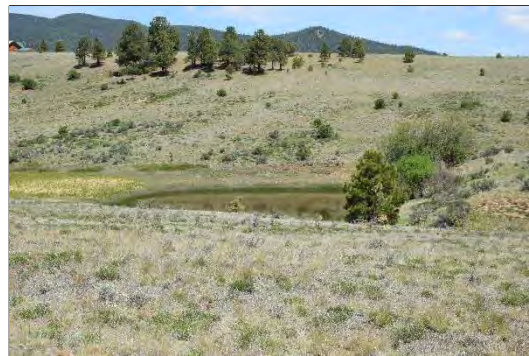
--Stock pond built on slope wetlands
