# The Plug and Pond Treatment: Restoring Sheetflow to High Elevation Slope Wetlands in New Mexico

*A Restoration Project in the Valle Seco of the  
Valles Caldera National Preserve, Jemez Mountains*

**November 2017**

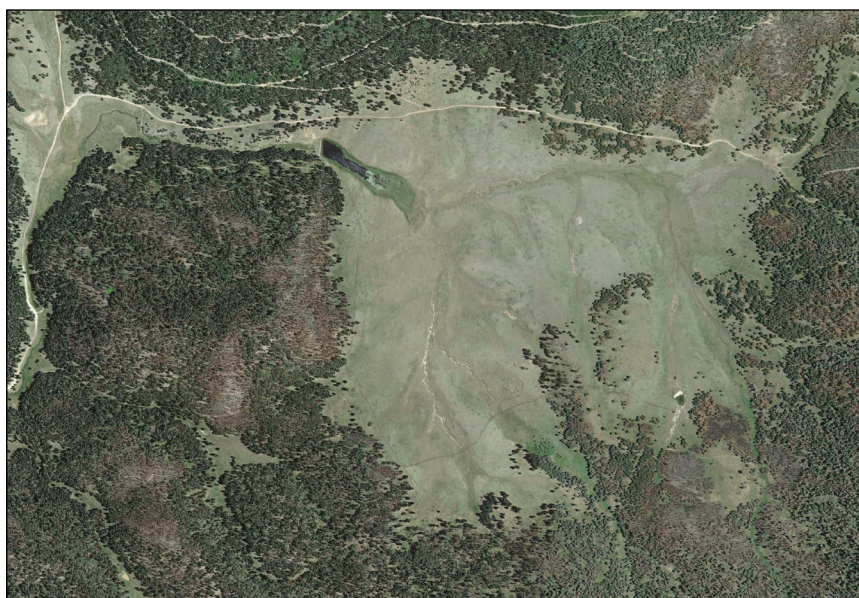
Figure 2. Valle Seco. (©Google™ earth, Keystone Restoration Ecology, LLC)

Restoration treatments were applied within the Valle Seco, a bowl shaped historic lake bed (now a valley or valle) between two volcanic domes (Goff 2009), situated within the west-central portion of the Valles Caldera National Preserve (Figures 1, 2 and 3). The Valle Seco is approximately 500 acres in size, lies within the Sulphur Creek Watershed and is a principal watershed tributary

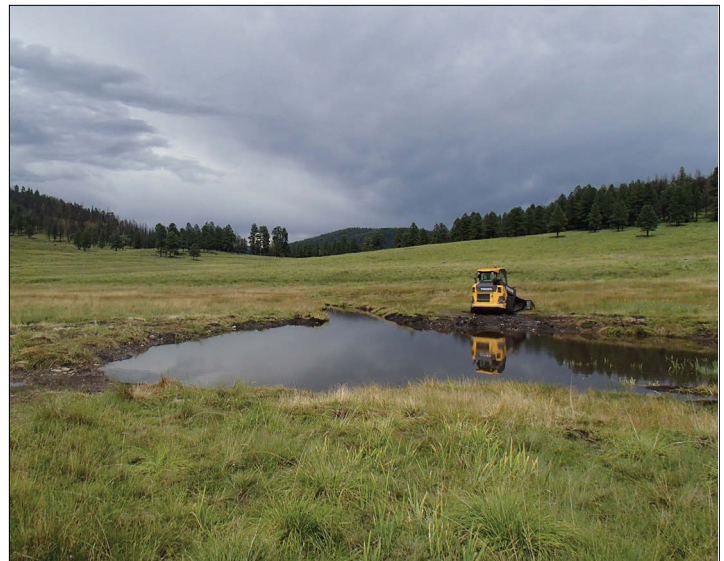
Figure 4. Site 21, August 7, 2016. A plug and pond on a perennial channel fills soon after construction. (©S. Vrooman)

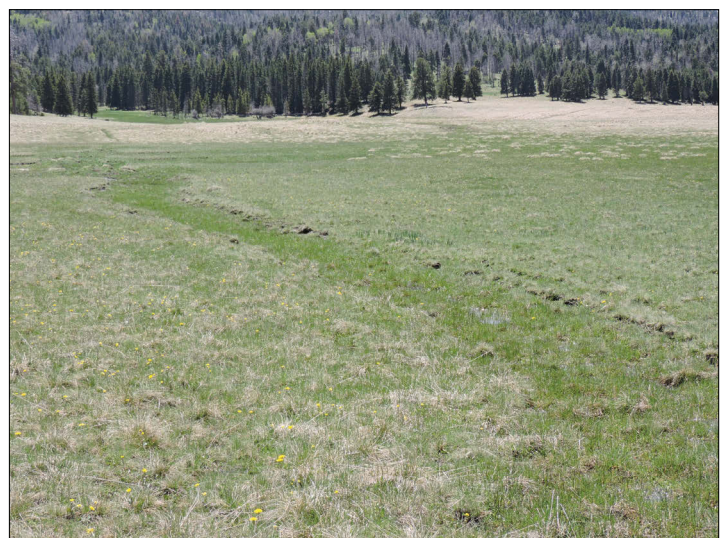
Figure 5. Site 42-44 complex, May 11, 2017. Incision due to cattle trailing in Tributary 3 wet meadow. View looking upvalley. (©W.D. Zeedyk)

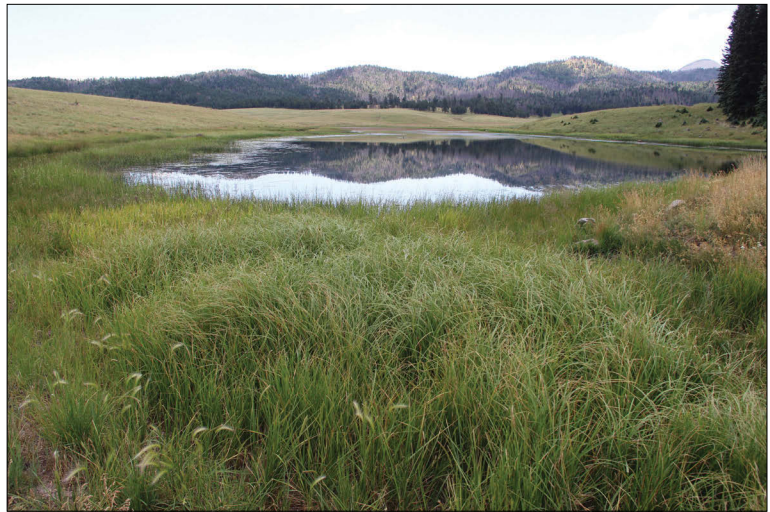
Figure 8. July 6, 2017. Key wetland species, *Carex sp.*, surrounding a stock pond. (©T.E. Gadzia)

Reading the landscape is an art— the art of perceiving and understanding the origin of a landform and the processes sustaining, modifying or destroying it. In the case of wet meadow restoration, reading the landscape is the art of recognizing landforms that were shaped by slow-moving surface waters that both flattened the land surface and deposited successive layers of fine grained sediments, aided by the presence and distribution of wetland dependent species adapted to soil and water features. The ability to recognize representative landscape features and relate such features to the presence or absence of key wetland indicator plant species (Figure 8) is

important, though not essential. For example, the presence of a typical species of sedge, e.g., Nebraska sedge, would indicate that the site in question is likely a wetland. A similar site, based on landform and soils, but seasonally lacking surface waters and dominated by such species as Kentucky bluegrass or dandelions, might indicate the presence of a former wetland no longer benefiting from seasonal surface flows due to channel incision. A closer examination might indicate the presence of an abandoned sinuous channel no longer subject to flooding. Similarly, a formerly active alluvial fan, as apparent from its typical triangular shape and gently sloping surface, might be longitudinally bisected by an eroding trail and no longer saturated by snow melt runoff. Rather than being dominated by sedges and Arctic rush, that same fan surface, deprived of dispersed surface flow, might currently be dominated by Arizona fescue or invading ponderosa pine trees. Scanning the landscape to internalize and interpret the subtle implications of various geologic, hydrologic and ecologic processes, as impacted by human activities, helps planners to read the landscape and to identify restoration opportunities. After reading the landscape, geomorphic features are used to guide the location of treatments and to quantify the number of treatments.

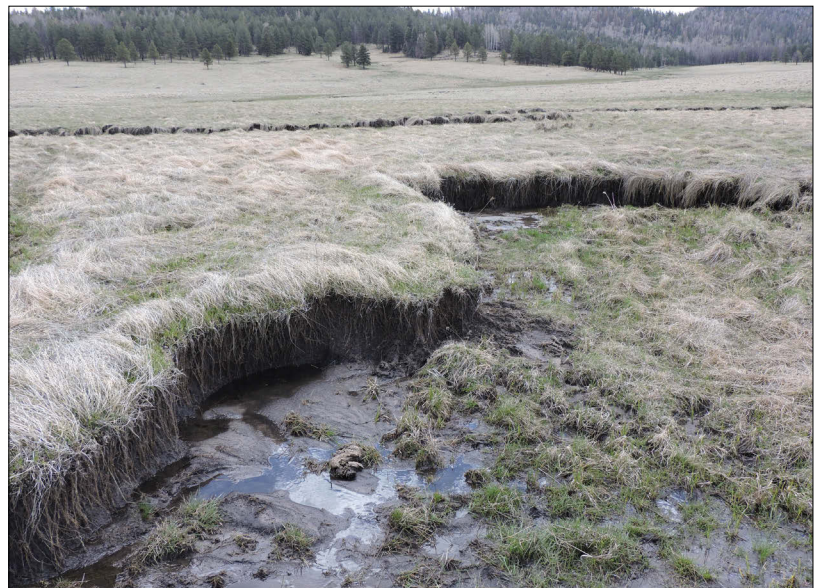
Figure 10. Site 23, May 11, 2016. Sulphur Creek headcut. (©W.D. Zeedyk)

Most slope wetlands have been damaged by roads or trails that have intercepted, consolidated and accelerated surface sheetflow into channelized flow resulting in channel incision or headcutting (Figures 10 and 11). Dispersed sheetflow has little erosional force but channelized flow is highly erosive and results in headcutting and further incision. Incision usually cuts down to the underlying boulder or cobble layer and then gradually widens, leaving the residual surface soils isolated from periodic flooding and subject to drying over time.

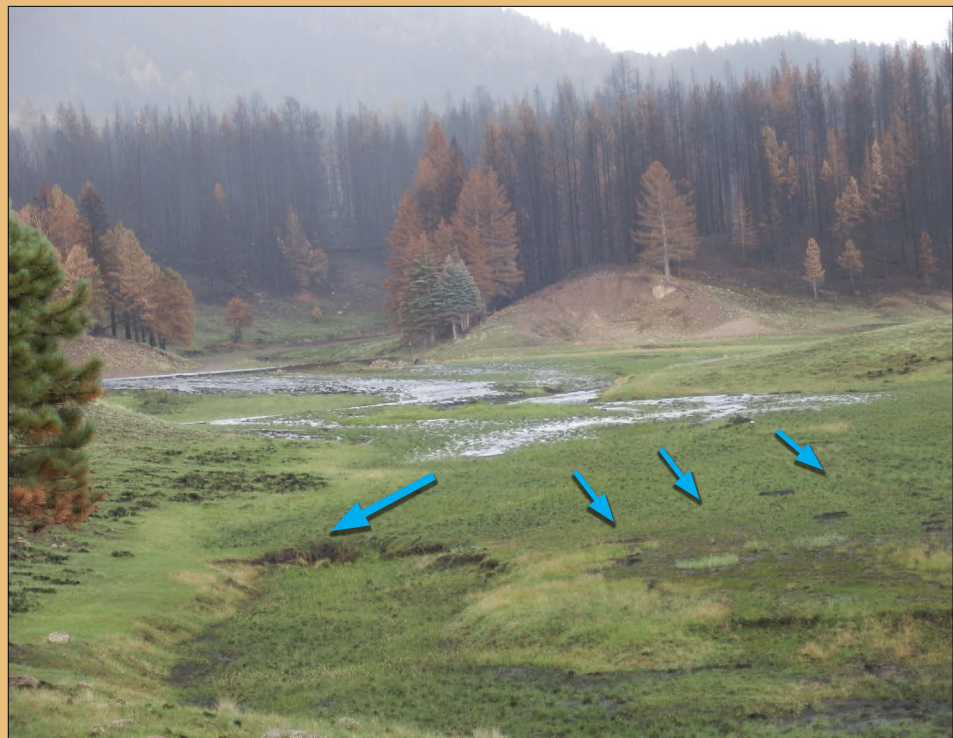
Figure 14. Santa Rosa Creek, Los Conchas Fire, Valles Caldera National Preserve, August 4, 2011. Sediment-laden flash flood waters spreading valley wide. (©S. Vrooman)

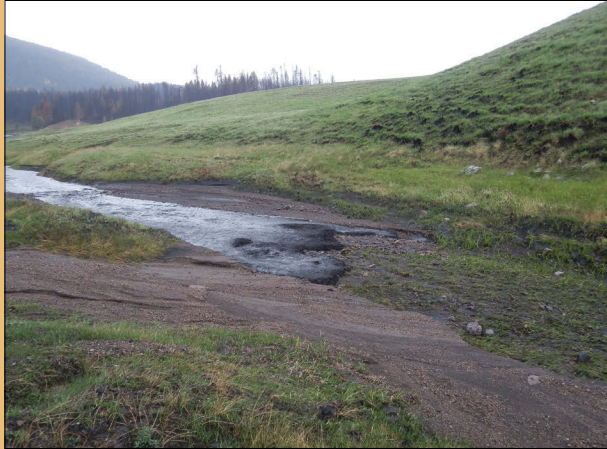
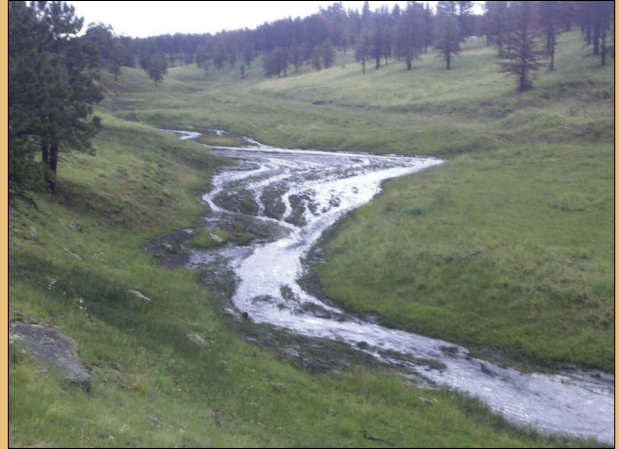
Figure 15. August 4, 2011. First monsoon season after the fire, sediments are already being deposited in Santa Rosa gullies. (©S. Vrooman)

burn (Figures 15-17). It is recommended that management respond accordingly and install treatments which might enhance wetland response outside the burned area and not limit erosion control efforts to sites within the burned area boundary. Opportunities to use sediment discharged from a burned area for positive benefit should be identified and inventoried in conjunction with the planning of treatments within the burned area. In addition, adjustments to livestock management practices, including use, timing and intensity of grazing, are critical to restoration success (Briggs 1996, Bellows 2003).

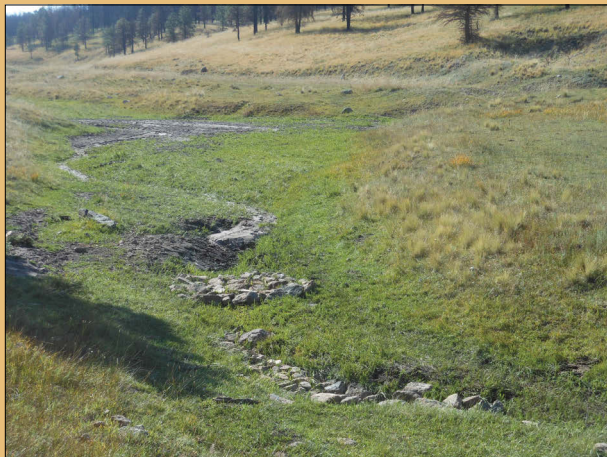
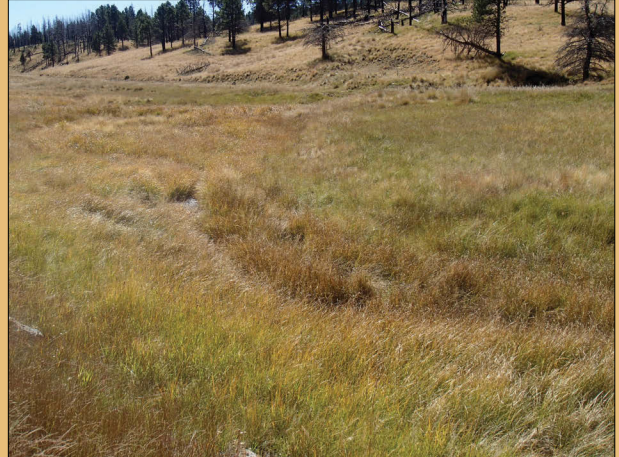
Figure 16. Left, small rock grade control structures, September 22, 2012. Right, same site now occupied by wet meadow vegetation, October 2, 2017. (©S. Vrooman)

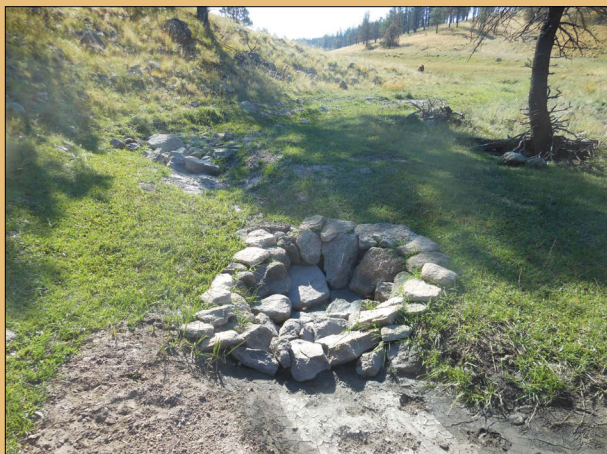
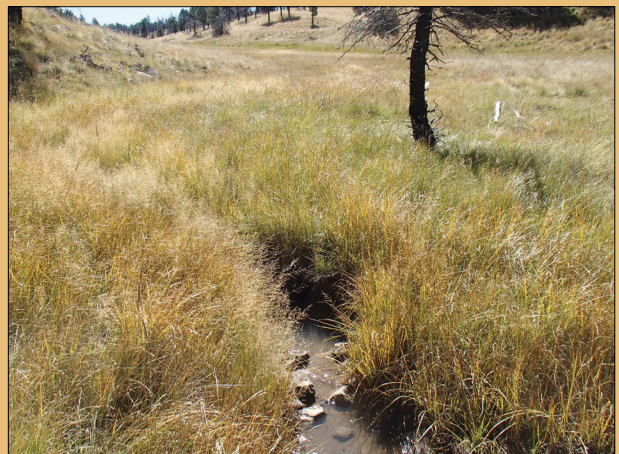
Figure 17. Left, rock headcut control structures, September 21, 2012. Right, same site now occupied by wet meadow vegetation October 2, 2017. (©S. Vrooman)

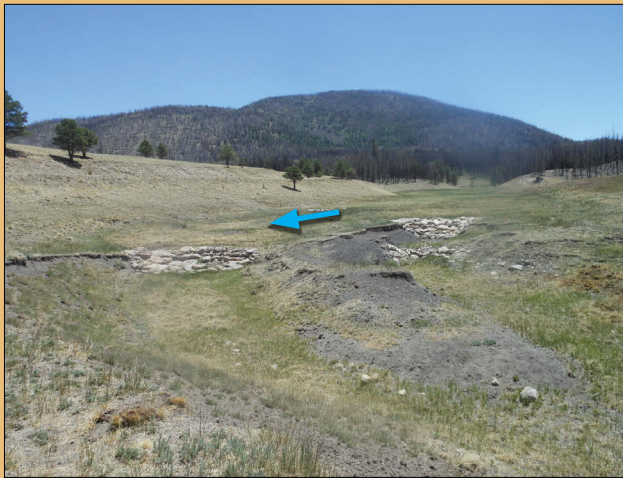
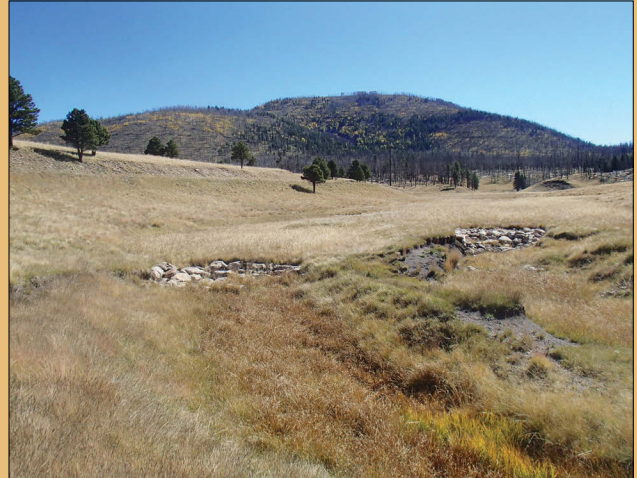
Figure 18. Looking upvalley. Left, June 24, 2012. Right, October 2, 2017. (©S. Vrooman)

Figures 18-19 below display upstream and downstream, before and after views of adjacent wet meadow headcuts that were treated, prior to the Los Conchas Fire, by installing three large-rock headcut control structures (Zuni bowls). Fortunately, these structures not only successfully withstood the erosive force of subsequent fire-induced floods but also enabled sediment deposition within the gullied landform both upstream and downstream of the structures.

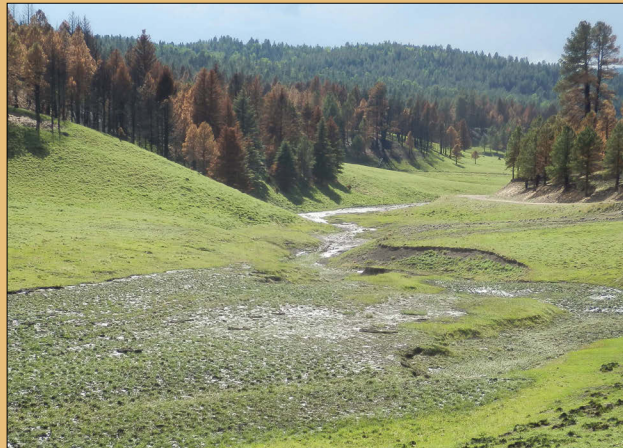
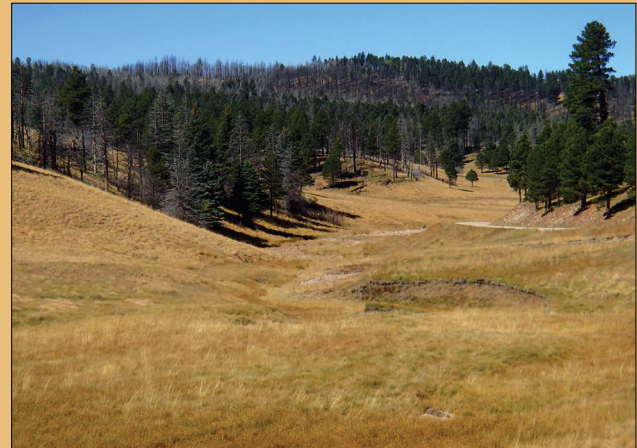
Figure 19. Looking downvalley. Left, August 4, 2011. Right, October 2, 2017. (©S. Vrooman)

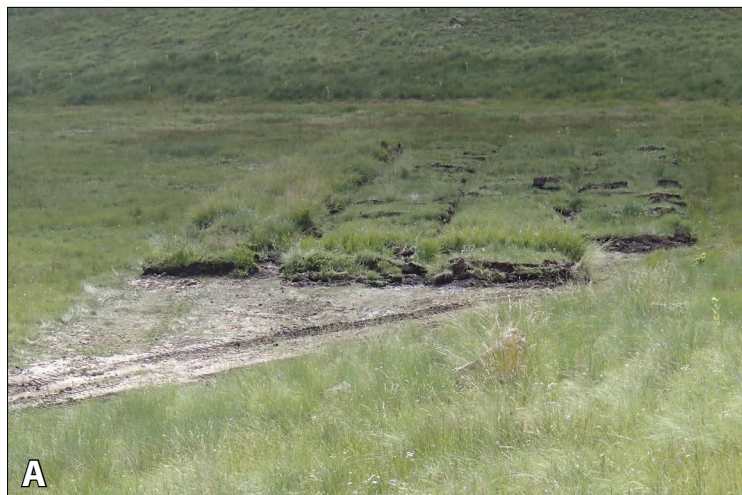
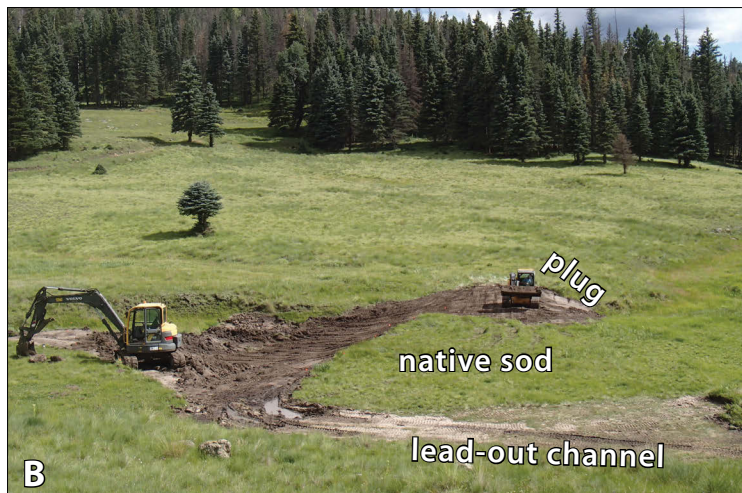
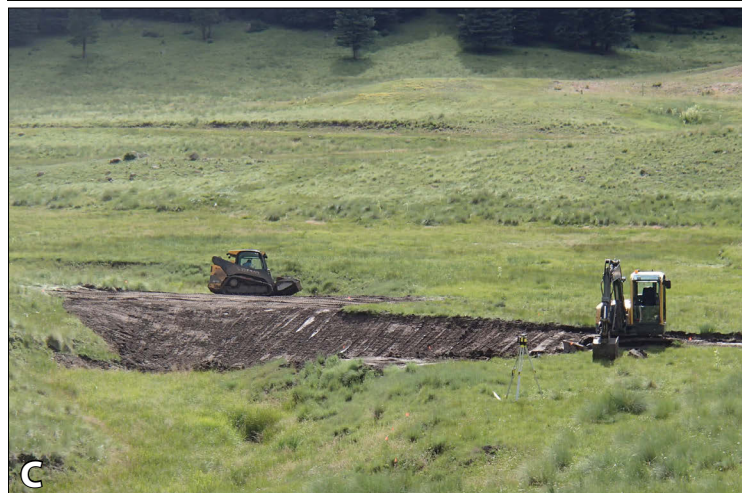
Figure 22. Site 52, August 3, 2016. **A:** Stockpiled sod. **B:** Excavator borrowing soil from pond. Skid loader is building and compacting the plug. Outlet in the foreground. **C:** Adding stockpiled sod to the surface of the plug. (©S. Vrooman)

Excavate a clean sod-free surface along the bank at the site of the plug before adding fill to create the plug. Place fill where needed to build the plug as staked. Compact the plug using either the bucket or tracks of the excavator or skid loader. Add fill until the height of the plug is equal to or slightly less than the bank height. As a general rule, the plug should be at least as long (channel length) as the channel width at that point. Taller plugs may require tapered slopes on the upstream and downstream sides. Once the plug is compacted, sod mats from the stock pile and lead-out channel are added to the surface of the plug, preferably using the skid loader to place the mats (Figure 22C). Sod mats should be placed neatly so that their edges interlock. The plug may be damaged by over-topping flows

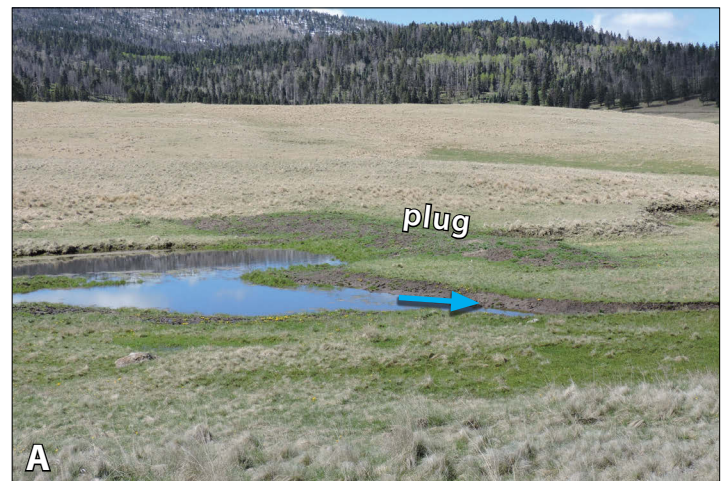
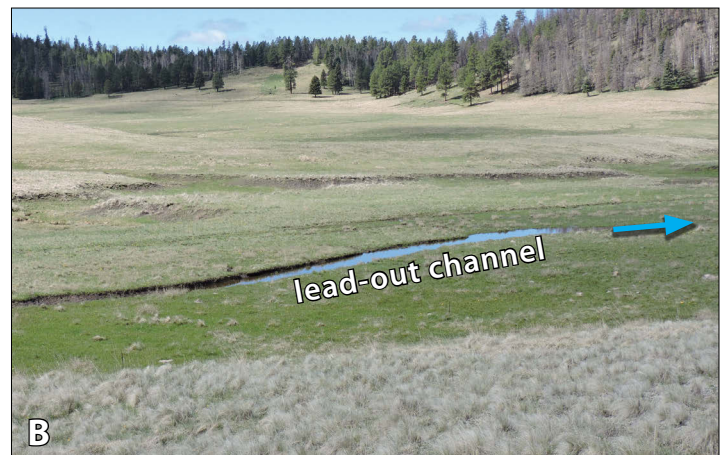
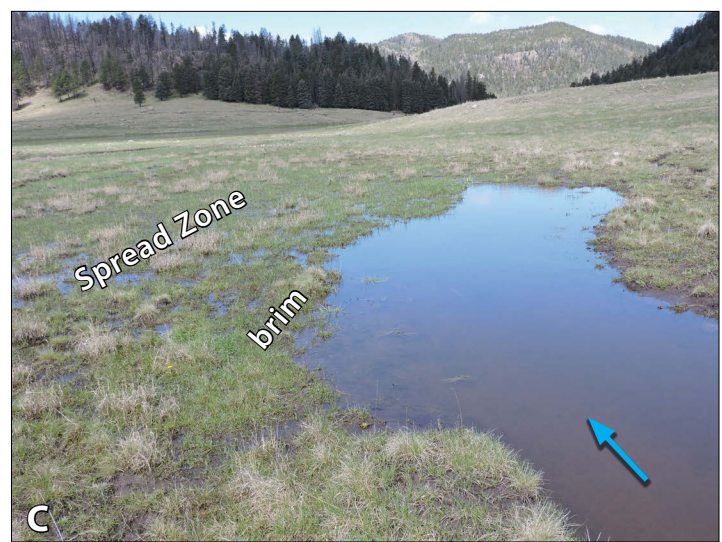
Figure 23. Site 28, May 11, 2017. **A:** the plug, **B:** the lead-out channel, and **C:** the brim and spread zone at the end of lead-out channel. (©W.D. Zeedyk)

- 4. Ensure that deflected flows are routed effectively toward the surface to be rewetted by constructing a lead-out channel on either or both sides of the plug with sufficient capacity to accommodate the maximum expected flows and prevent erosion of the plug** (Figure 23). A lead-out channel or channels diverting water around the plug and onto the surface of the wetland to be rewetted is built last and should be so oriented as to maximize the area wetted. Water may be routed to either or both sides of the plug depending on the location of the area(s) to be wetted, presence of former wetland soils, and the presence of remnant wetland vegetation along either or both sides of the newly plugged channel. A plug capped by vigorous sod or “sod tiles,” once well established, can resist erosion by over-topping flood flows, but it is best to minimize the depth of such flows by increasing the width of the lead-out channel. Health and vigor of the sod on the plug is sustained by capillary flow seeping through the plug more than by surface flow spilling over the plug. The lead-out channel should terminate where the bypassed flows will spill onto the reconnected meadow surface most effectively. Ideally, the downstream end, or brim, of the lead-out channel will be shaped so as to maximize the spread of water on the receiving surface. Once a flow event has occurred, the spread zone can

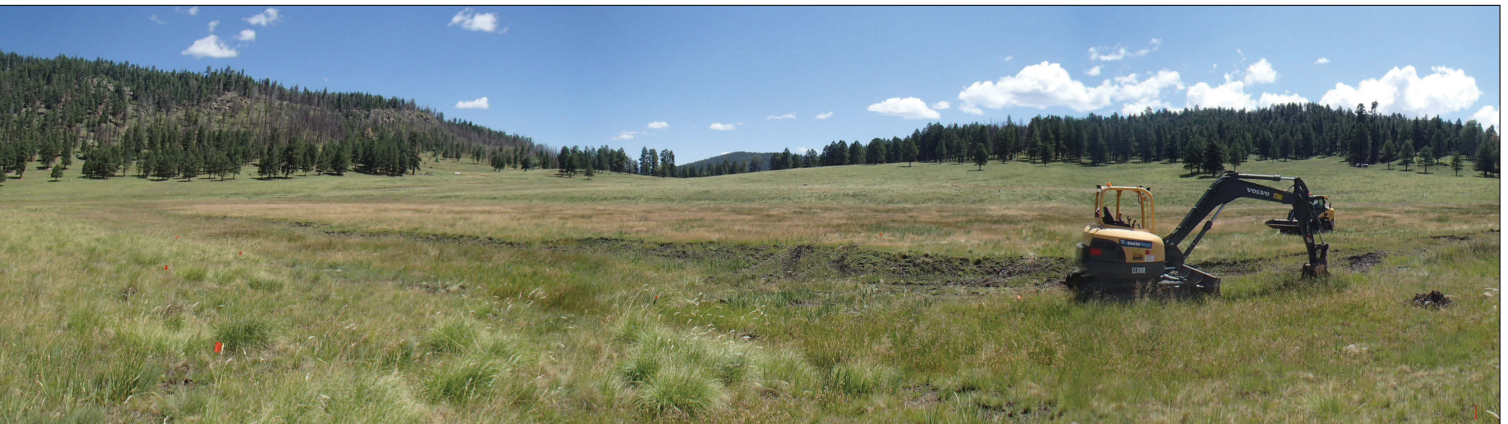
Figure 26. Beginning construction of the pond by borrowing fill for the plug. (©S. Vrooman)

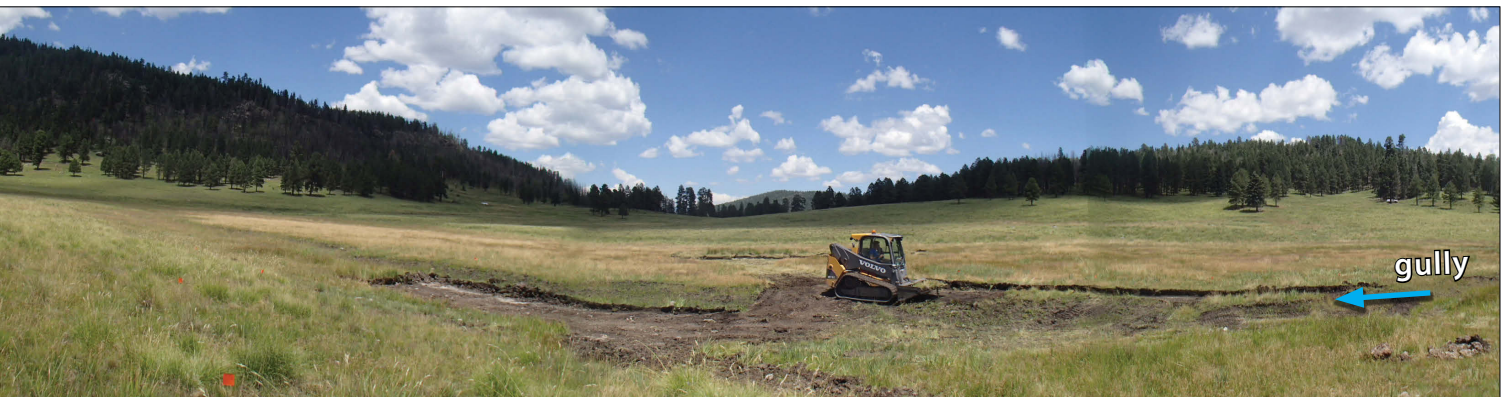
Figure 27. Excavator is removing sod from the surface of the area to be ponded and stockpiling it for surfacing the plug. (©S. Vrooman)

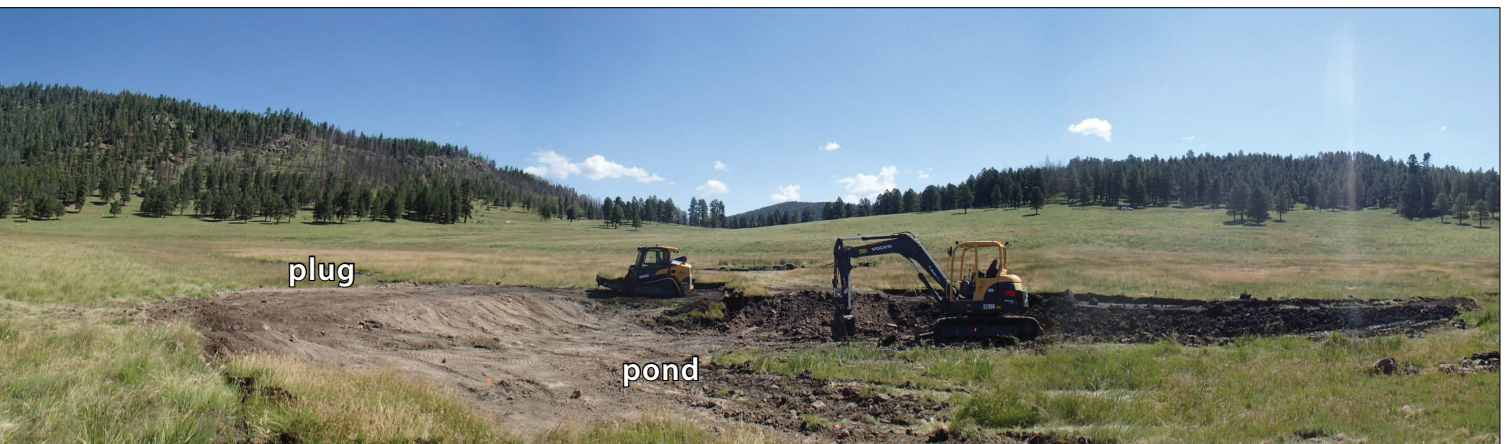
Figure 28. Constructing and compacting the plug. (©S. Vrooman)

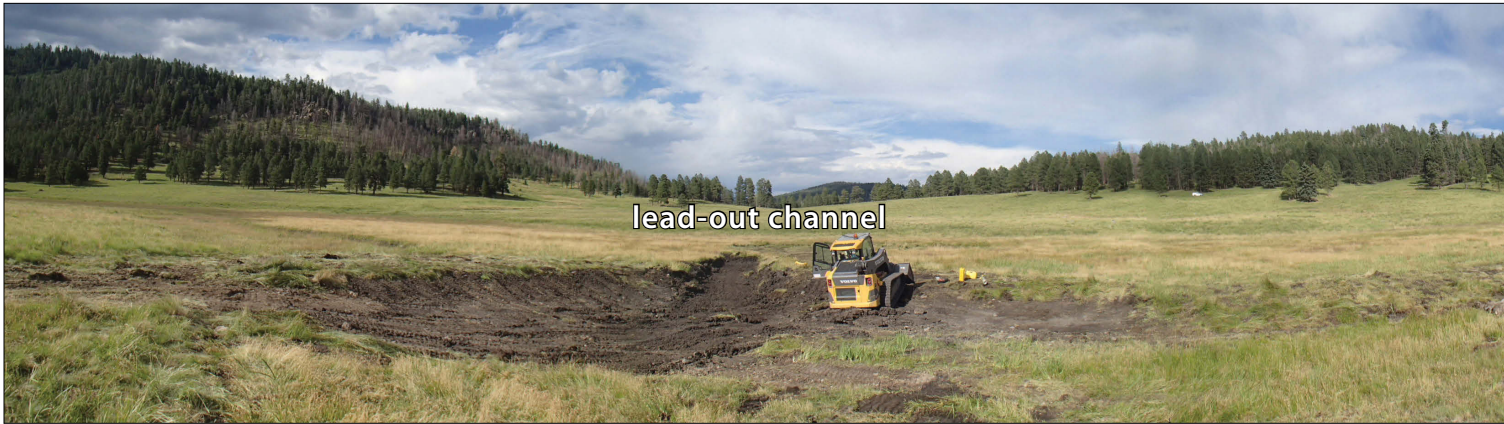
Figure 29. Sod has been added to cap the plug. Skid loader is constructing lead-out channel. (©S. Vrooman)

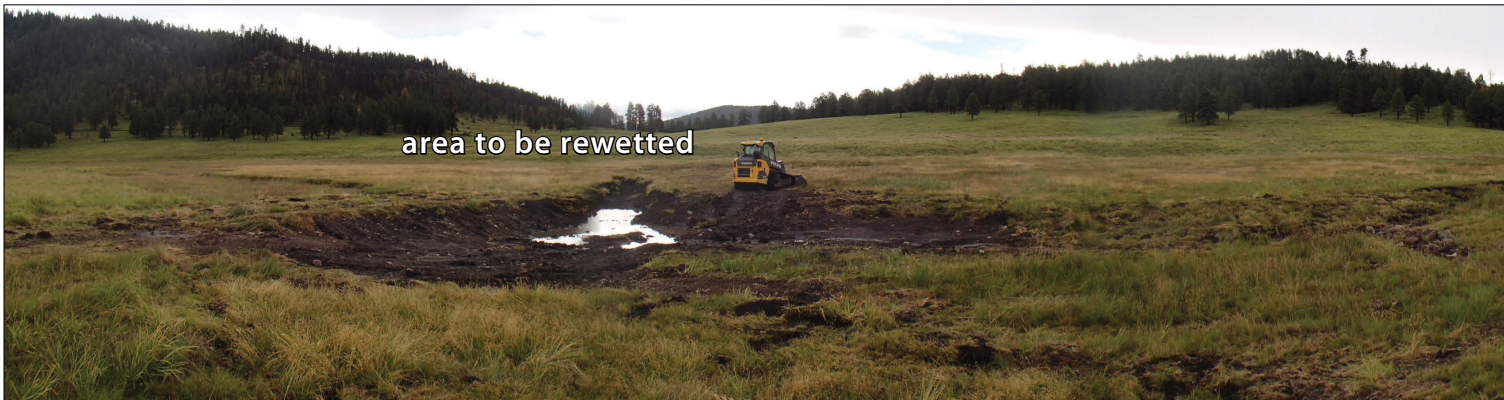
Figure 30. Pond beginning to fill as construction continues. Area to be rewetted is beyond the end of the lead-out channel. (©S. Vrooman)

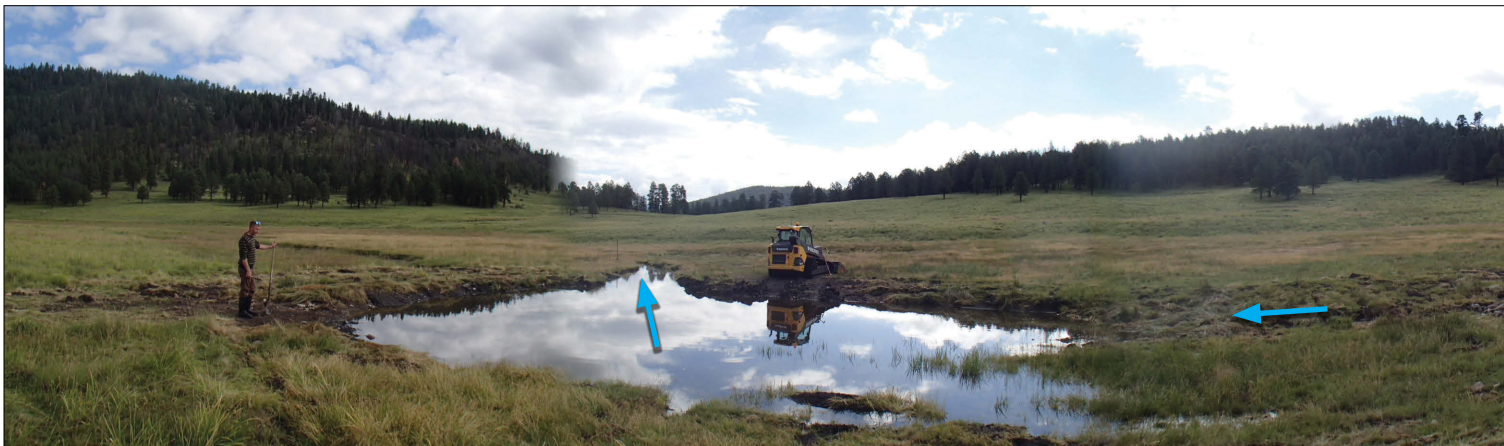
Figure 31. Construction completed and water from lead-out channel is spilling onto reconnected wetland surface. (©S. Vrooman)

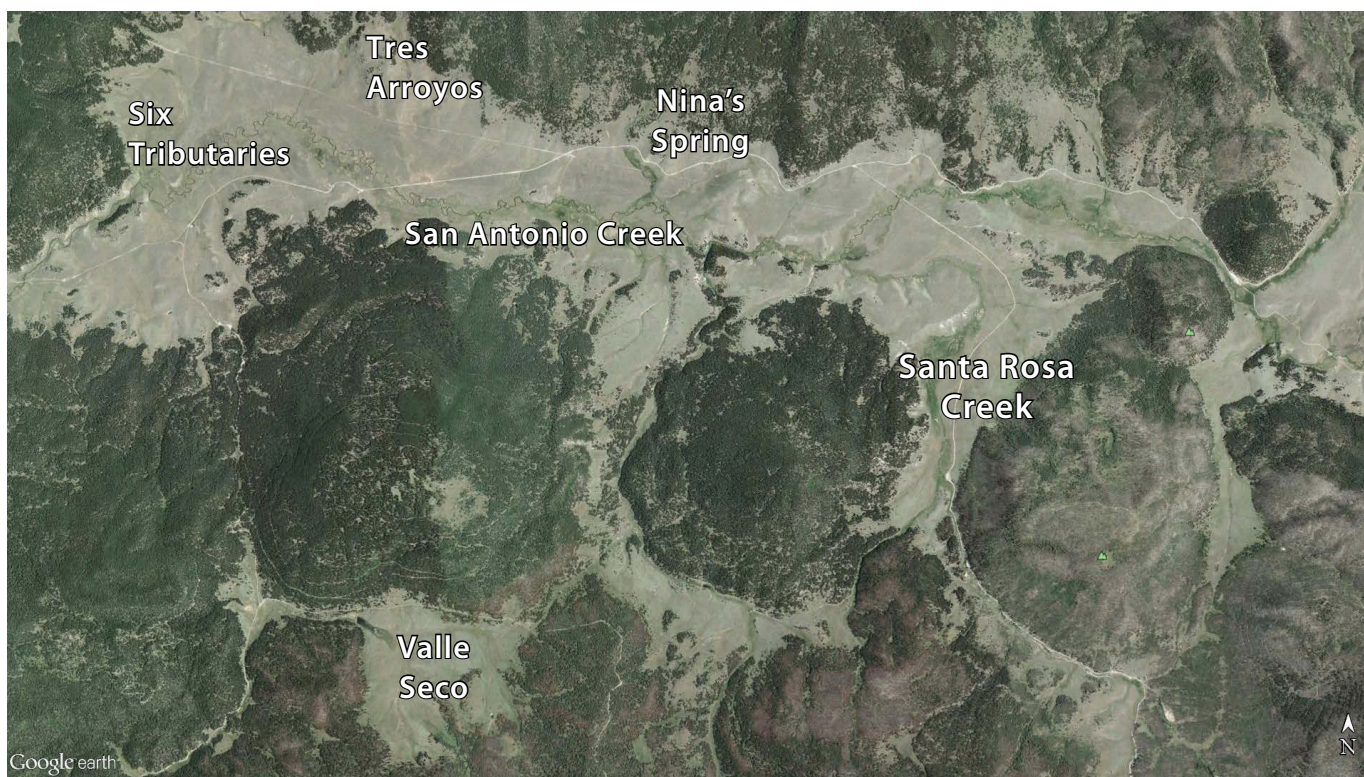
Figure 32. Partial map of wetland restoration projects within the Valles Caldera National Preserve that used the plug and pond treatment. Jaramillo Creek and Rito de los Indios are not shown. (©Google™earth, imagery date 6/25/2014)

The Valle Seco project (2013-2017) is the most recent and most complex of several plug and pond projects installed within the Valles Caldera National Preserve. Earlier projects included Nina's Spring (2011-2013), Tres Arroyos (2012), Six Tributaries of San Antonio Creek (2013-2016), Jaramillo Creek (2011-2015), and Rito de los Indios (2016-2017) (Figure 32). There are currently 129 plug and pond structures working to restore and expand wetlands on the Valles Caldera National Preserve: Nina's Spring (9), Tres Arroyos (5), Six Tributaries of San Antonio Creek (40), Jaramillo Creek (16), Rito de los Indios (35) and Valle Seco (24). The variety of treatments used has increased in number and broadened in complexity with each additional project. Nina's Spring and Tres Arroyos are described below.

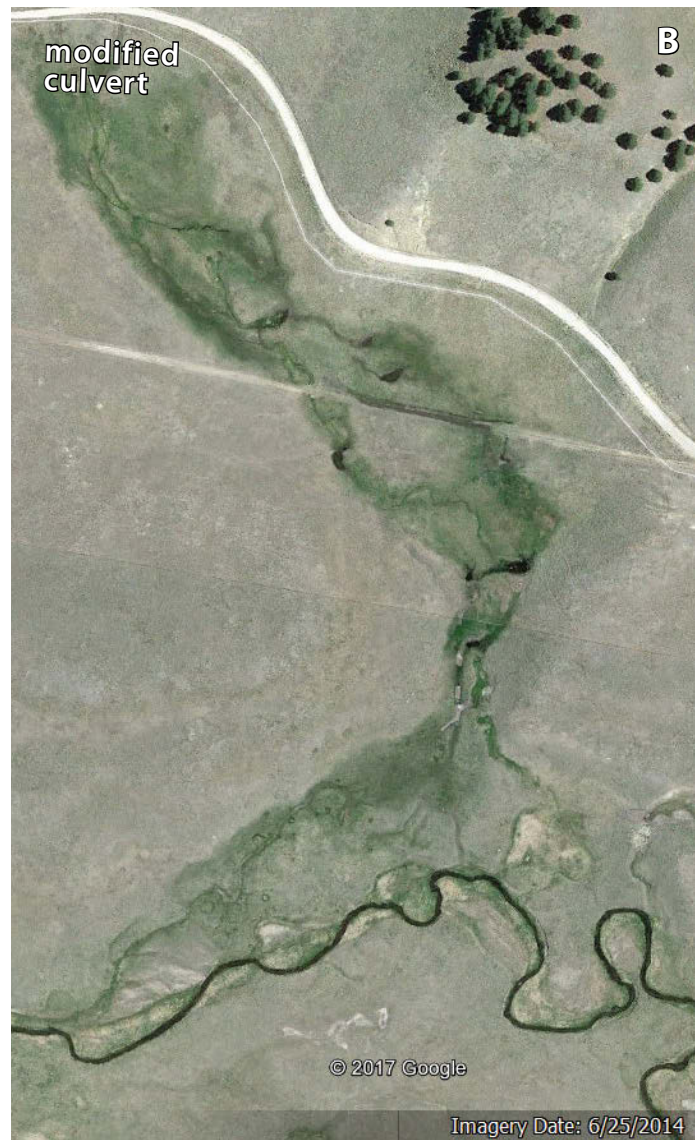
Figure 34B. 2014 Nina's Spring wetland response map. (©Google™ earth)

Principal gullies were formed by headcuts originating from: 1) the pipeline road, 2) an abandoned wagon road on the north side of San Antonio Creek, and 3) a more recent headcut related to the main road (VC08).

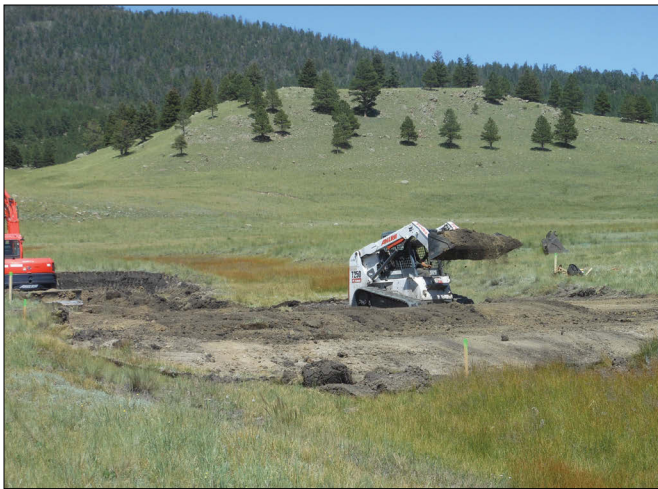
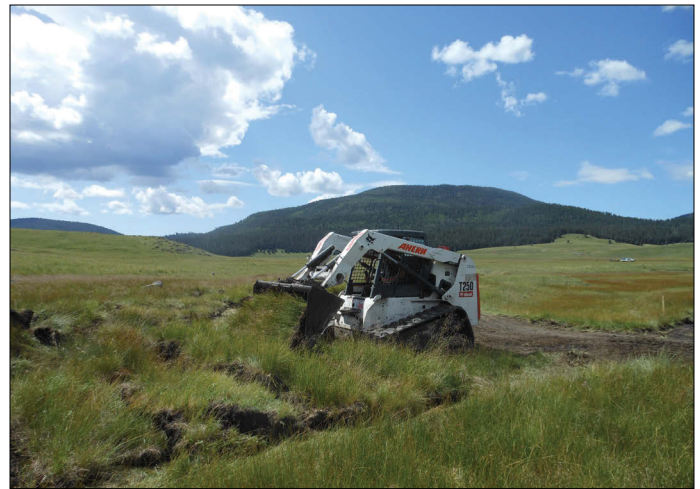
Figure 36. Tres Arroyos, August 2012. Left, skid loader adds fill dirt excavated from the pond to the surface of the plug. Right, sod tiles stockpiled prior to constructing the plug are placed on the completed plug. (©S. Vrooman)

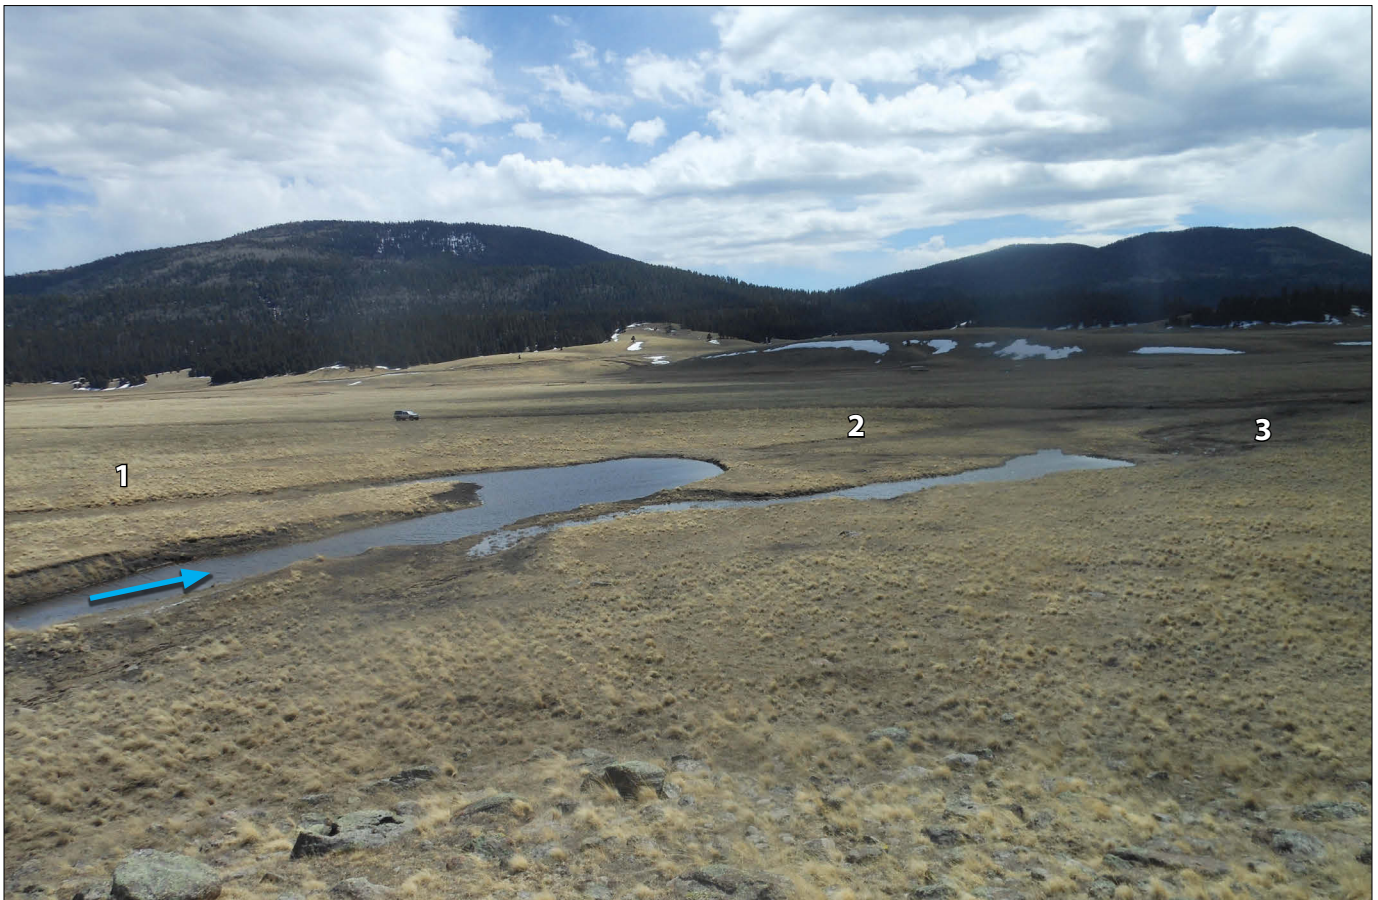
Figure 37. Tres Arroyos, April 2013. Two plugs created ponds impounding three adjacent erosion gullies and reconnecting multiple wet meadow surfaces. (©S. Vrooman)

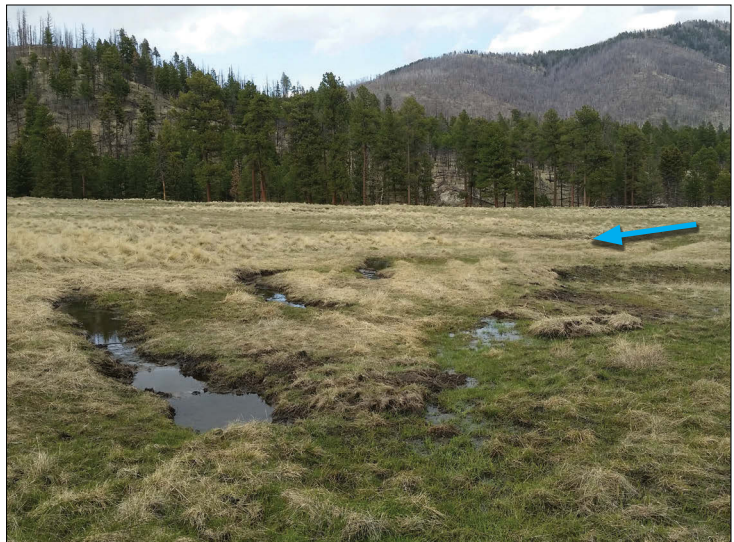
Figure 44. Site 31, April 20, 2017. Upper swale, left, diverts flow around a headcut and directs it to two spreader swales, valley left. (©S. Vrooman)

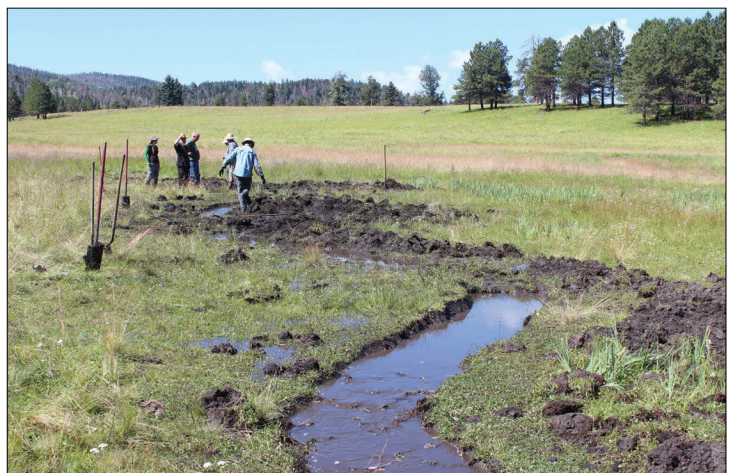
Figure 45. Site 20, July 2015. Worm ditch hand-dug by volunteers. Here water spills as sheetflow to the left. (©K. Menetrey, NMED)

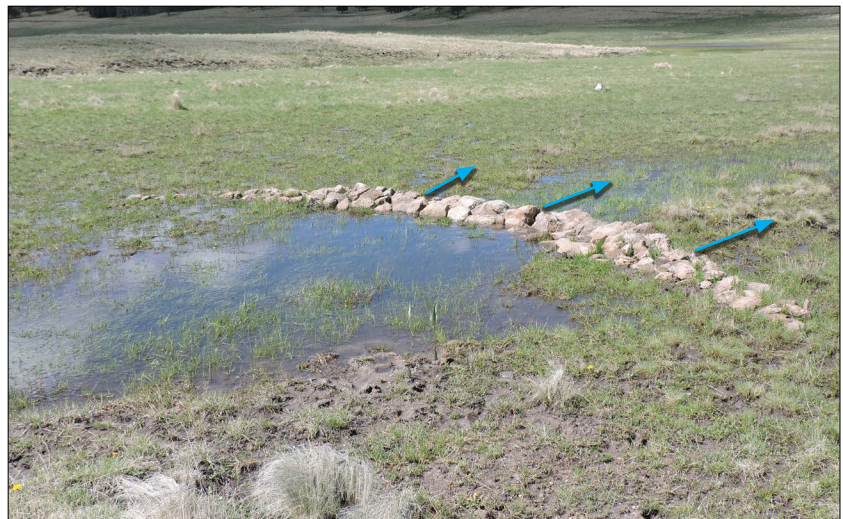
Figure 47. Complex Site 28, May 11, 2017. Media luna spreading water downvalley from plug and pond. (©W. D. Zeedyk)

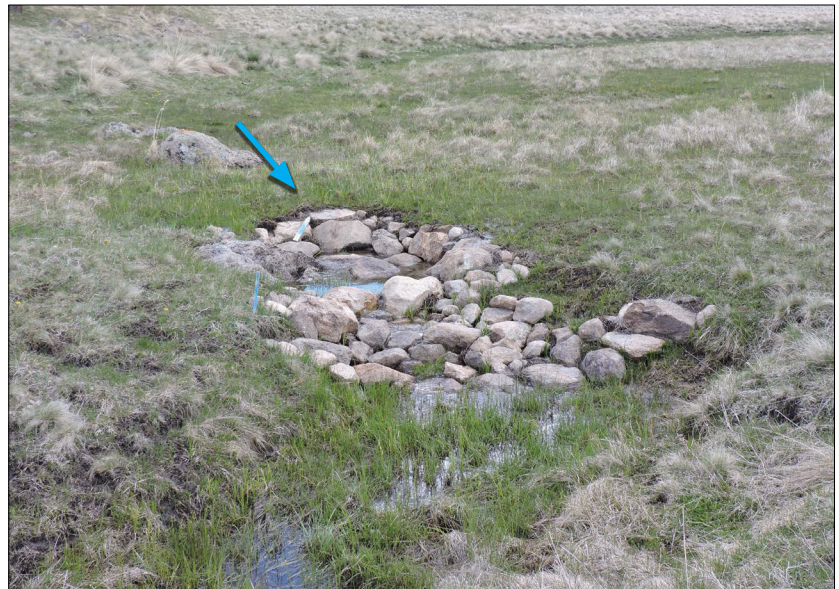
Figure 48. Site 24, May 11, 2016. Rock Zuni bowl. (©W.D. Zeedyk)

**ROCK.** “A Zuni bowl up to 3 feet in height with a single bowl can be built by hand using 10 to 50 pound rocks. Zuni bowls larger than this must be built with heavy equipment. Angular rocks are preferred and care should be taken to properly place them so that they will key into each other. Construction begins with shaping the base and walls of the headcut to remove loose material, rocks, roots, etc. The sides and back wall are laid back on an approximately 2:1 slope and a footer trench is dug. Flatter rocks are placed in the trench as an apron to dissipate the force of water pouring out of the bowl.”

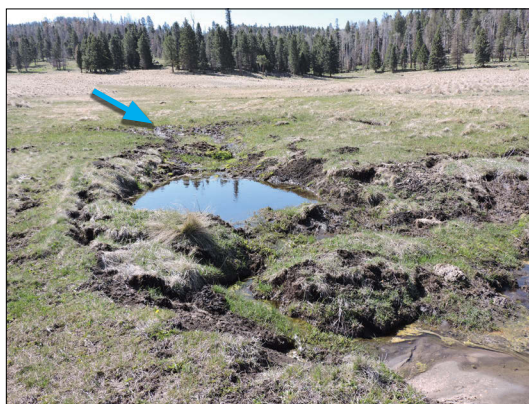
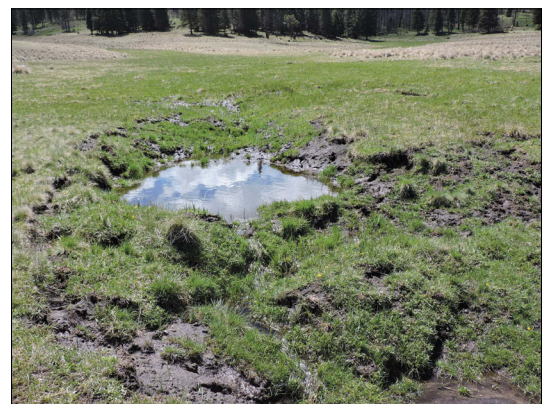
Figure 50. Site 38, left, sod Zuni bowl after construction, May 13, 2016 and right, one year later, May 11, 2017. (©W.D. Zeedyk)

**SOD.** Sod Zuni bowls can be used to stabilize headcuts bypassed by a worm ditch or diversion swale. Several sod Zuni bowls were constructed at Valle Seco (Figure 50, page 32). Sod harvested from swales was used to build the bowls. Sod Zuni bowls were first used at Tres Arroyos at the Valles Caldera National Preserve by Stream Dynamics, Inc. in 2012.

The bowl is constructed using successive layers of sod placed on a 3:1 slope either by hand or by use of an excavator bucket. Unlike when building a rock-lined Zuni bowl, the back shape of the sod bowl is not reshaped to create a tapered slope. Every effort is made to retain all existing well-rooted sod clumps in order to strengthen the structure against erosion and retain moisture. Shaping the bowl would make the soil more erodible.

Once the bowl is built, the sod is moistened by groundwater seeping from the banks or by very shallow, well-dispersed sheetflow spilling over the lip of the headcut. Because the surface flow has been deflected by the bypass structure, the volume, velocity and force of water falling onto the sod bowl is much reduced. This keeps the bowl from being damaged or washed away. With time, the sod grows stronger and becomes more resistant to erosion (Figure 50).

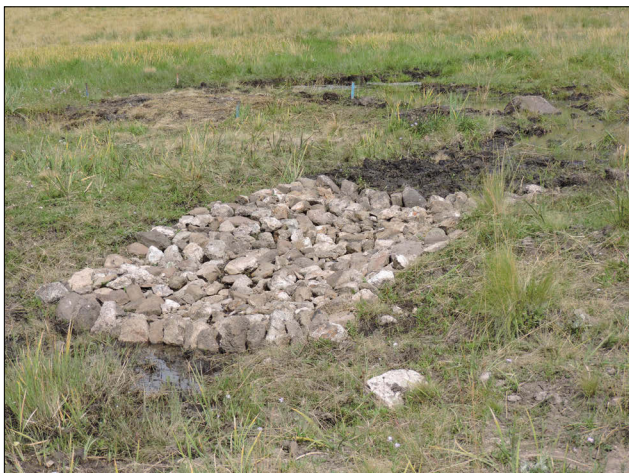
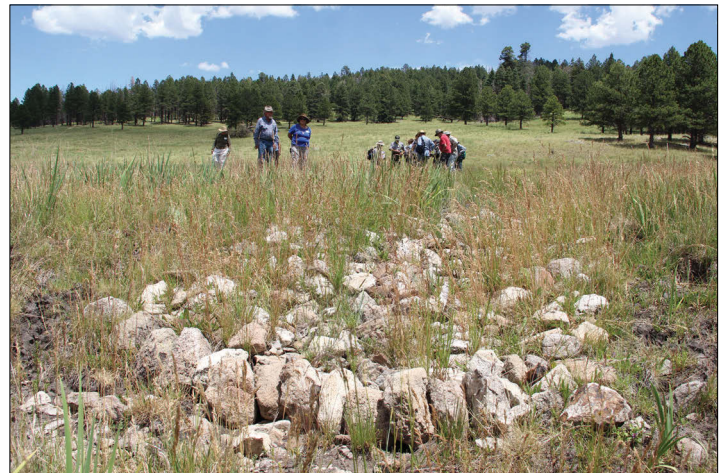
Figure 51. Site 19. Left, rock rundown after construction, August 25, 2015. (©W.D. Zeedyk) Right, two years later, July 6, 2017. (©T.E. Gadzia)

“Low energy headcuts in small watercourses and arroyos can be repaired by laying back the channel at a shallow gradient and building a rock rundown to stabilize the slope, allowing grasses and sedges to colonize the slope (Figure 51). Several structures of different types applied in sequence are often required to stabilize a headcut. For instance, since headcuts often advance in waves of three drops of different heights, a rock rundown might be used to control the upper, more shallow drop, a Zuni bowl to control the middle or taller drop and a one rock dam to control the third drop. Adding a one rock dam or weir beneath the central structure is always an effective way to reduce the depth of scour, while also creating a more permanent scour pool as a water source for livestock or wildlife.” (Zeedyk and Clothier 2009) A hand-built rock rundown was installed at Site 53 to stabilize the plug and pond outlet for Site 52.

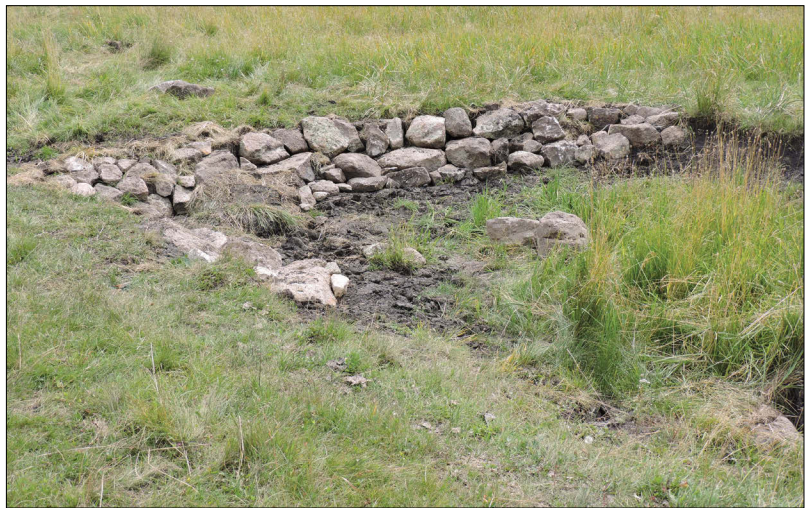
Figure 52. Site 11, August 25, 2015. Rock layback after construction. (©W.D. Zeedyk)

A rock layback is used to armor a long, low vertical headcut subject to erosion by shallow, well-dispersed, slow moving sheetflow events. This is in contrast with narrow, taller “V” shaped headcuts caused by higher velocity concentrated flows having greater erosive force normally treated by use of a Zuni bowl or rock rundown. A rock layback, rather than a Zuni bowl, is used to minimize the volume of rock needed to treat a headcut (Figures 52 and 53).
