# The Plug and Pond Treatment: Restoring Sheetflow to High Elevation Slope Wetlands in New Mexico

*A Restoration Project in the Valle Seco of the  
Valles Caldera National Preserve, Jemez Mountains*

**November 2017**

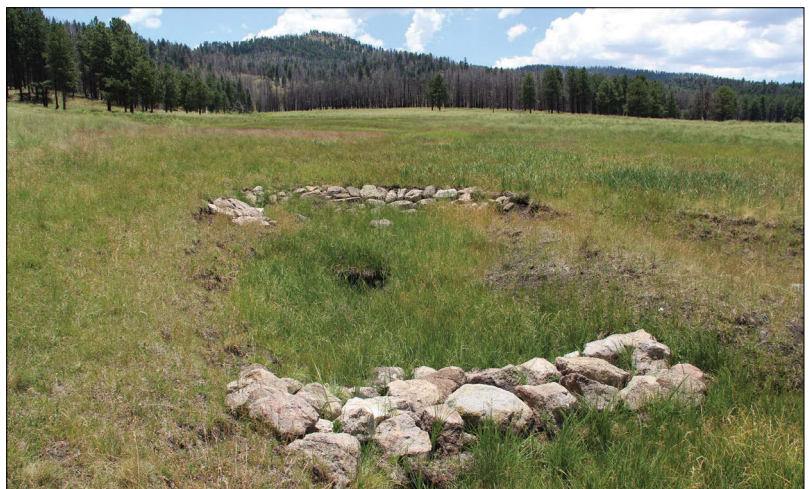
Figure 53. Site 11, July 6, 2017. Paired rock layback and one rock dam as revegetated two years later. (©T.E. Gadzia)

A rock layback is used to armor a long, low vertical headcut subject to erosion by shallow, well-dispersed, slow moving sheetflow events. This is in contrast with narrow, taller “V” shaped headcuts caused by higher velocity concentrated flows having greater erosive force normally treated by use of a Zuni bowl or rock rundown. A rock layback, rather than a Zuni bowl, is used to minimize the volume of rock needed to treat a headcut (Figures 52 and 53).

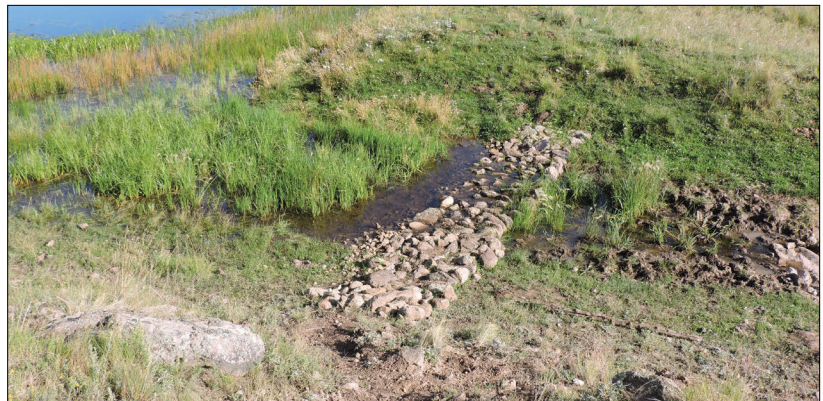
Figure 54. Site 50, August 11, 2015. One rock dam at stock pond outlet. (©W.D. Zeedyk)

A one rock dam (ORD) “is a low grade control structure built with a single layer of rock on the bed of the channel (Figure 54). ORDs stabilize the bed of the channel by slowing the flow of water, increasing roughness, recruiting vegetation, capturing sediment, and gradually raising the bed level over time. ORDs are also passive water harvesting structures. The single layer of rock is an effective rock mulch that increases soil moisture, infiltration and plant growth. Original concept developed by Bill Zeedyk.” (Sponholtz and Anderson 2010).

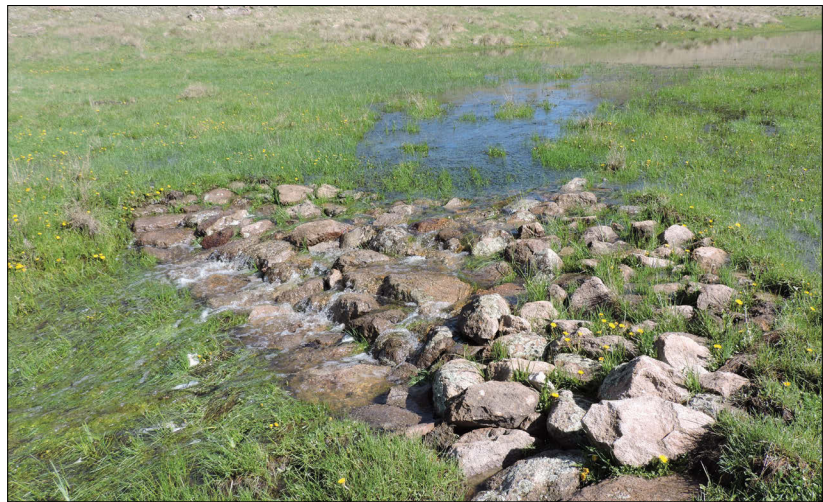
Figure 55. Site 53, May 11, 2017. Rock rundown constructed by volunteers as a stable return site for plug and pond at Site 52. (©W.D. Zeedyk)

“Low energy headcuts in small watercourses and arroyos can be repaired by laying back the channel at a shallow gradient and building a rock rundown to stabilize the slope, allowing grasses and sedges to colonize the slope (Figure 51). Several structures of different types applied in sequence are often required to stabilize a headcut. For instance, since headcuts often advance in waves of three drops of different heights, a rock rundown might be used to control the upper, more shallow drop, a Zuni bowl to control the middle or taller drop and a one rock dam to control the third drop. Adding a one rock dam or weir beneath the central structure is always an effective way to reduce the depth of scour, while also creating a more permanent scour pool as a water source for livestock or wildlife.” (Zeedyk and Clothier 2009) A hand-built rock rundown was installed at Site 53 to stabilize the plug and pond outlet for Site 52.

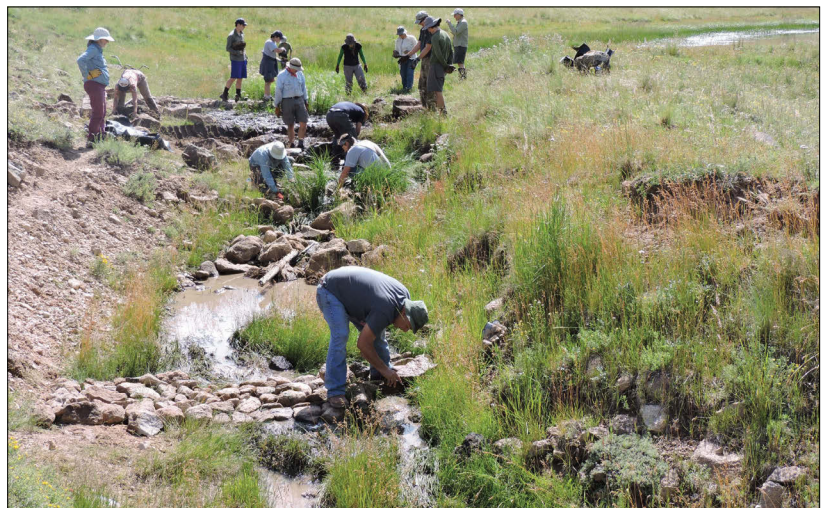
Figure 56. Site 50 and 51, July 18, 2015. Volunteers build grade control rock structures at stock pond outlet. (©W.D. Zeedyk)

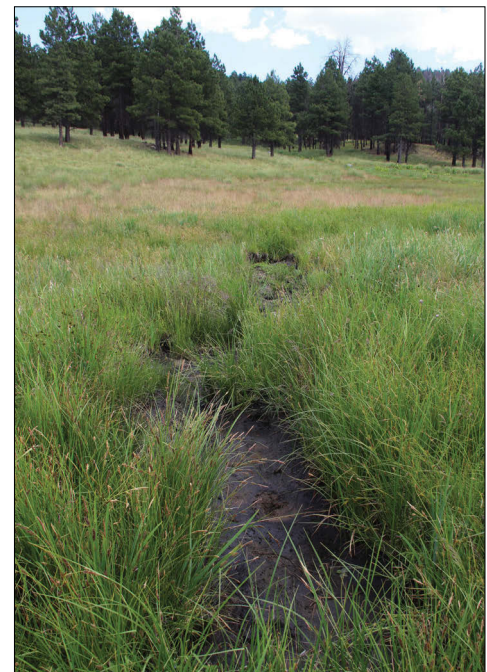
Figure 59. Site 23, July 6, 2017. Ditch.  
(©T.E. Gadzia)

headcut (Page 8, Figure 10). These two ditches overlapped so that the upper ditch captured and routed sheetflow from valley left and toward valley right and in the direction of the lower ditch. The lower ditch captured and routed these flows further toward valley right, the relict channel of Sulphur Creek itself. The downvalley edges of the two ditches were lined with berms built of sod wads dug from the ditches by an excavator. The sod wads were loosely stacked and compacted on the surface of the natural sod. This treatment was not fully successful because some waters trapped by the ditch leaked through cracks between the loosely placed sod wads. While most of the flow was successfully rerouted around the headcut and into the historic channel, sufficient sheetflow remains on the surface to maintain active headcutting in part. The error was in not compacting the sod berm sufficiently to prevent leakage. In retrospect, diversion swales, as described on pages 28-29, might have proven more effective. In August of 2017, the sod berms were repaired by volunteers but have yet to be subjected to spring runoff events and remain untested.

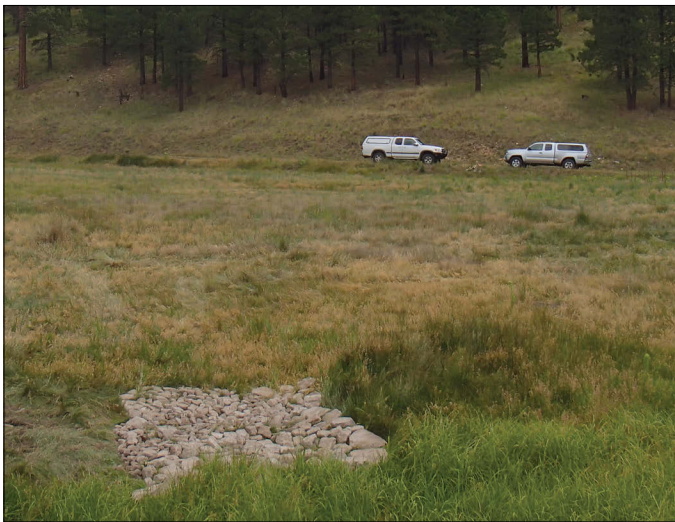
Figure 60. July 14, 2017, *Poa pratensis* and *Juncus balticus*. (©S. Vrooman)

Year 1: *Poa pratensis* (Kentucky bluegrass) and *Juncus articus* (Arctic rush) respond with increased and vigorous growth (Figure 60). Almost all *Poa pratensis* goes to seed across the re-wetted area in year 1. In late summer, the small grass *Agrostis scabra* (rough bentgrass) also goes to seed (Figure 61). This normally three-inch tall bunch grass has tall pink stalks in mid-August under re-wetted conditions.

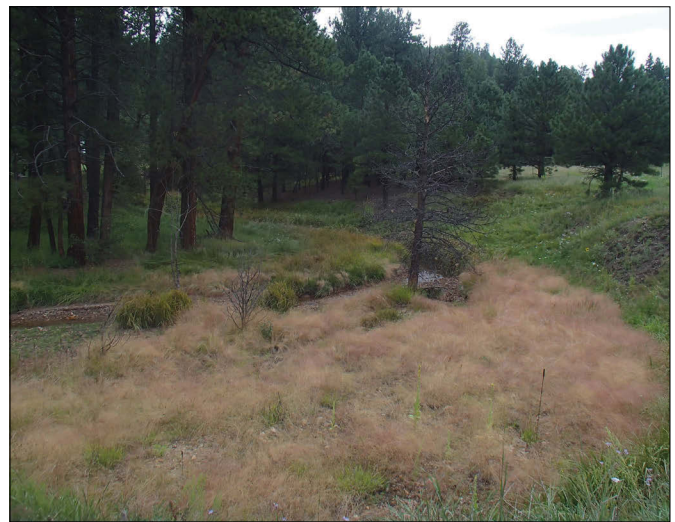
Figure 61. August 23, 2017, *Agrostis scabra* (rough bentgrass) (©S. Vrooman)

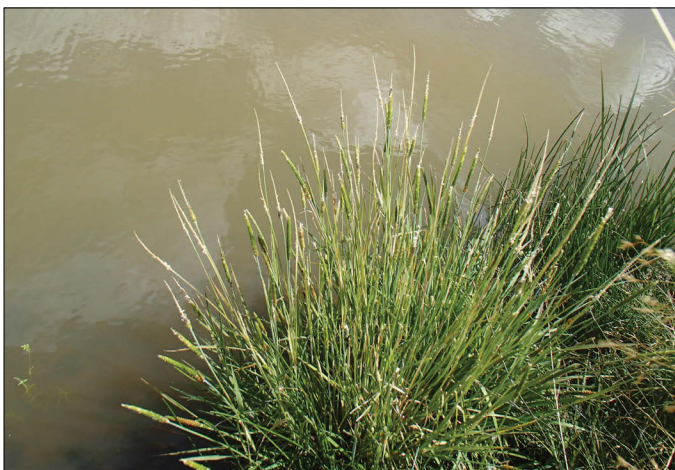
Figure 62. September 16, 2017, *Alopecurus* sp. (©S. Vrooman)
