**Final Report  
November 2014  
Restoring and Protecting Wetlands in Cebolla Canyon Closed Basin  
Assistance Agreement No. CD-966857-01-0C (FY2008)**

(This project is Part C of a larger 2008 grant award to NMED Wetlands Program entitled “NMED 2008 Wetlands Awards Project.”)

Restoring and Protecting Wetlands in Cebolla Canyon Closed Basin  
June 2014

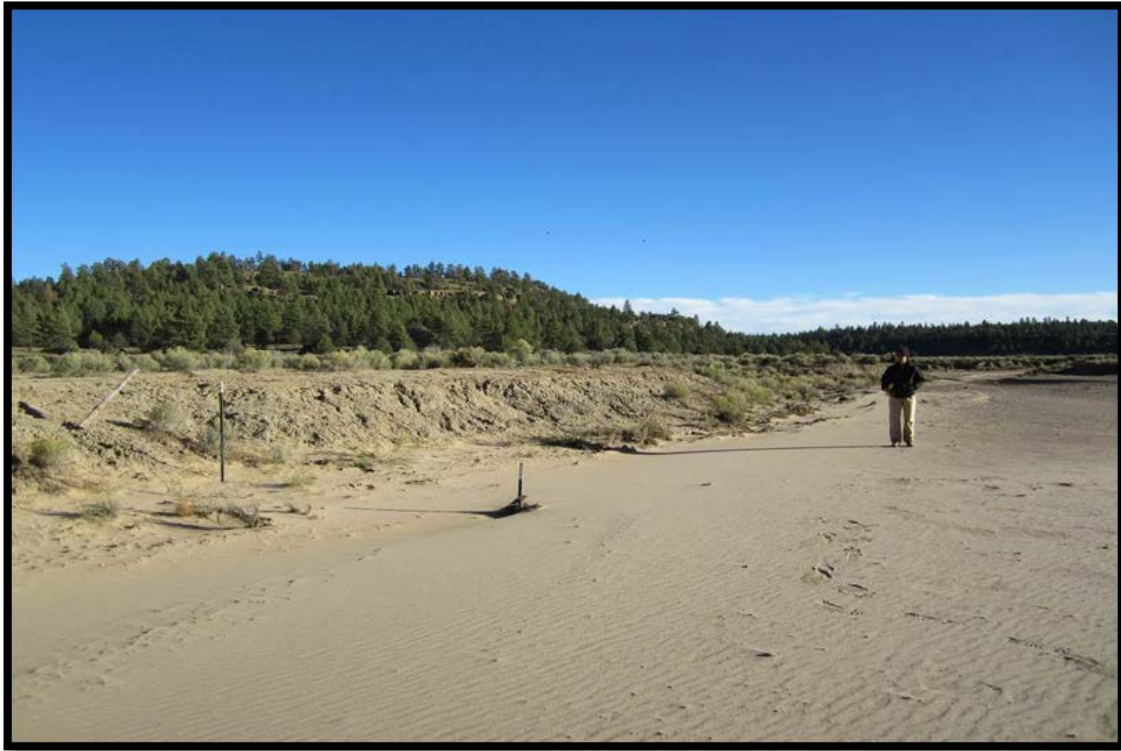
Figure 2. Buried enclosure fence in reach by a major storm in September 2013 (photo in late fall 2013). This channel is now only 4 feet from the former wide wetland surface of the valley (called “Lake Cebolla”) and is expected to fill and vegetate with no additional treatment creating an additional 10-20 acres of wetland. The fences were also repaired in 2014.

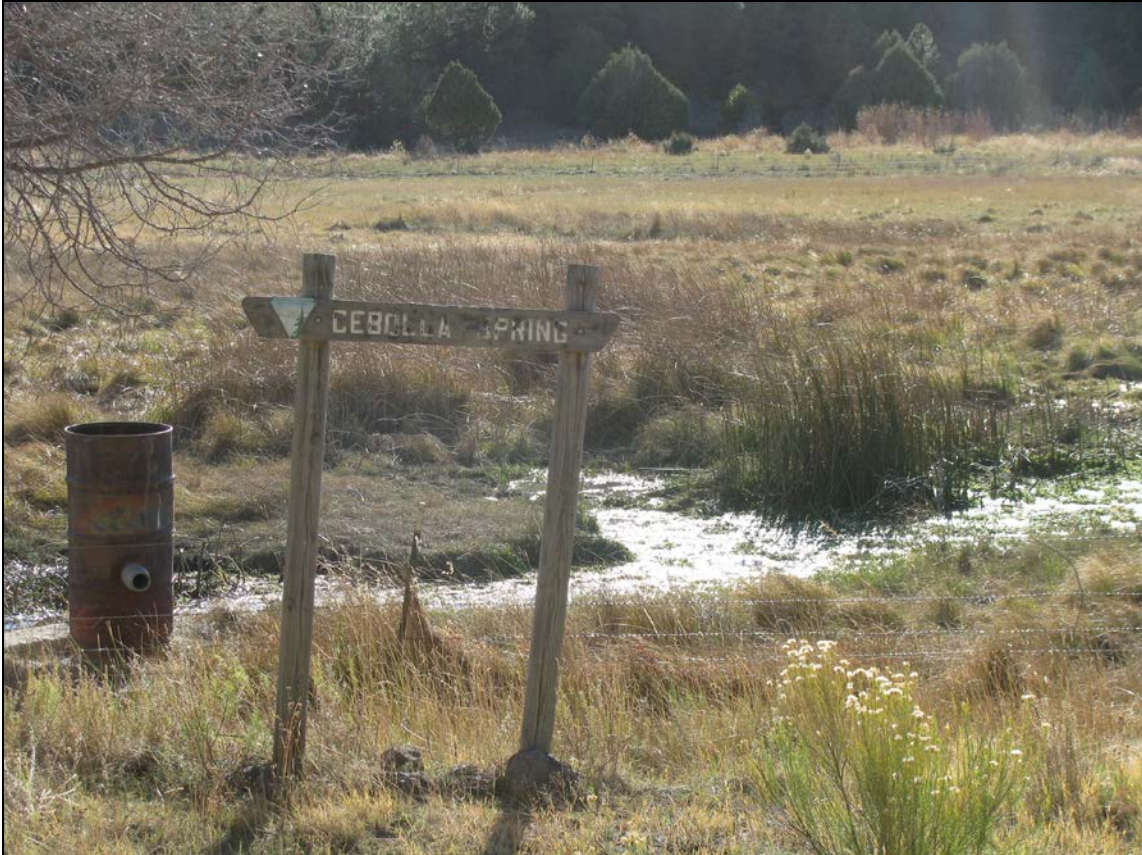
Figure 3. Cebolla Spring pre-project (2008).

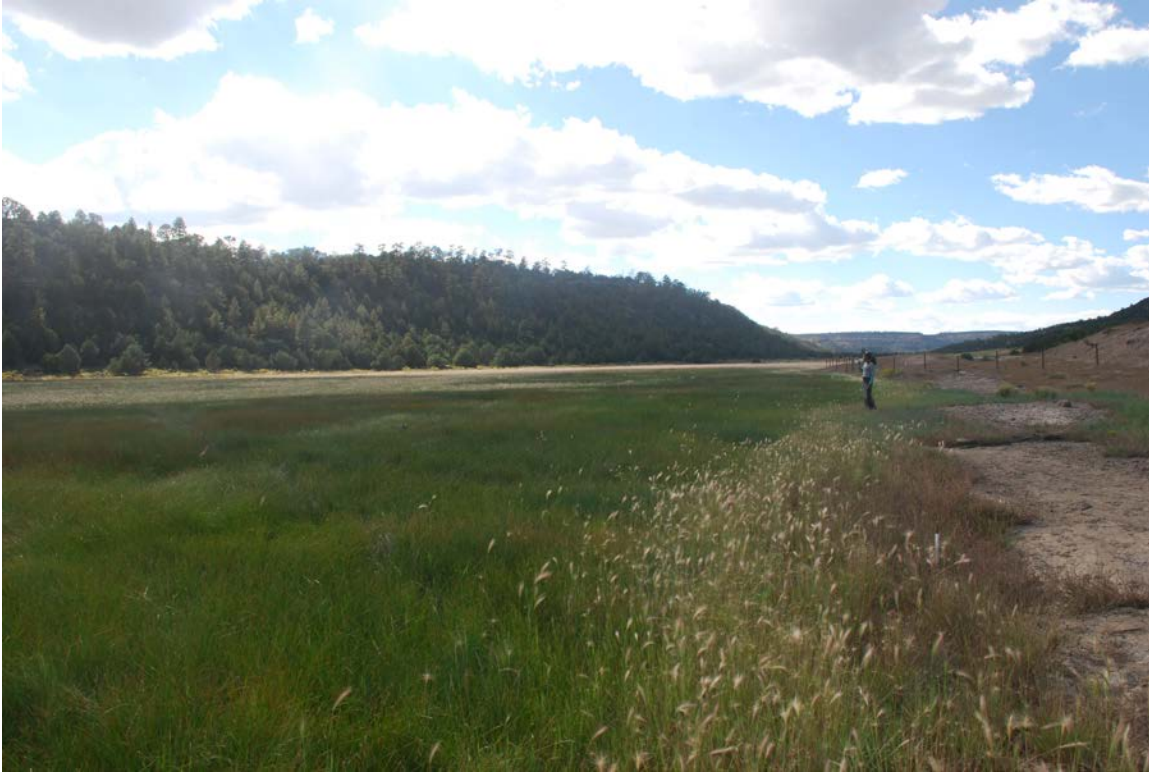
Figure 4. Current view (September 2014) of the Cebolla Canyon Wetlands after implementation of project restoration structures, grazing cattle removed from the area, and the 2014 monsoon season.

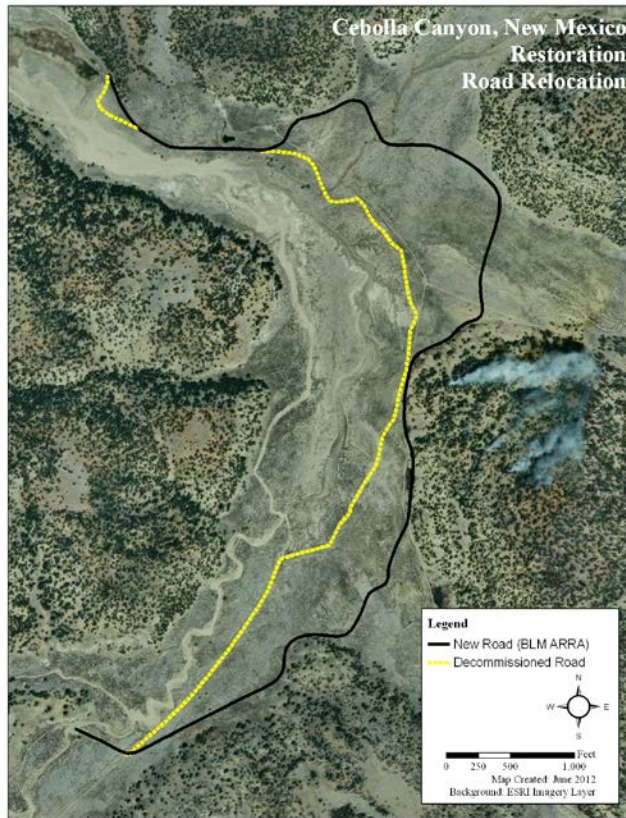
Figure 7. ARRA Road project to take the existing road out of the Cebolla Floodplain.

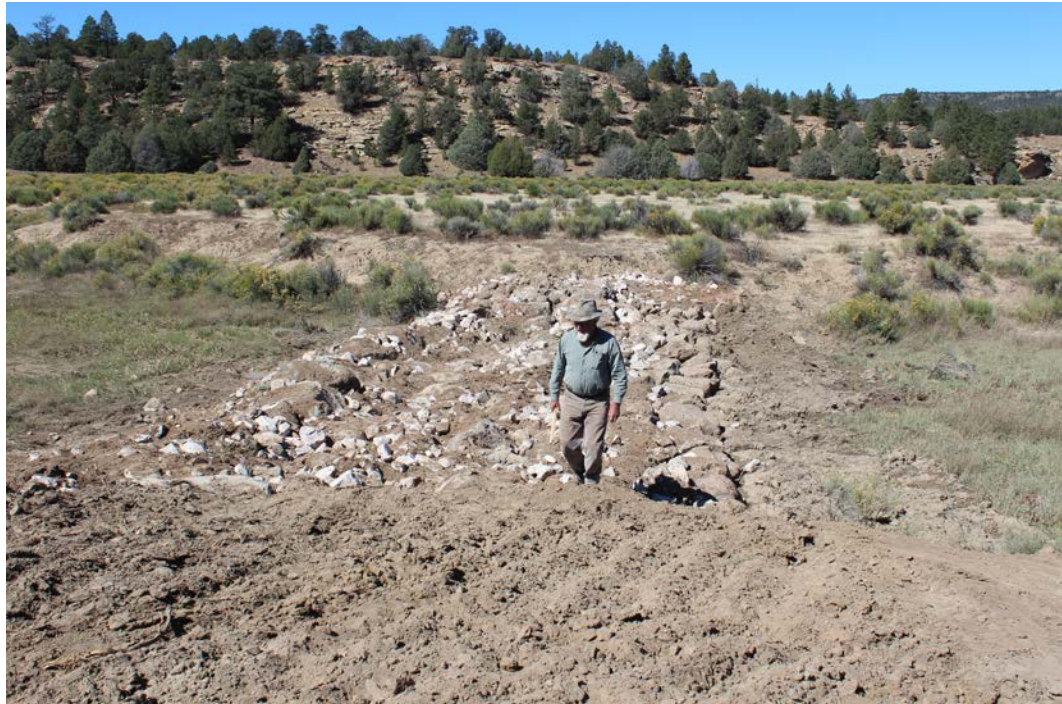
Figure 11. Dam breached and outlet created with heavy equipment to convey flow to center of valley. Larger materials were used on the upstream and downstream edge of the constructed filter dam. Bill Zeedyk (design Contractor) inspects the design and construction results.

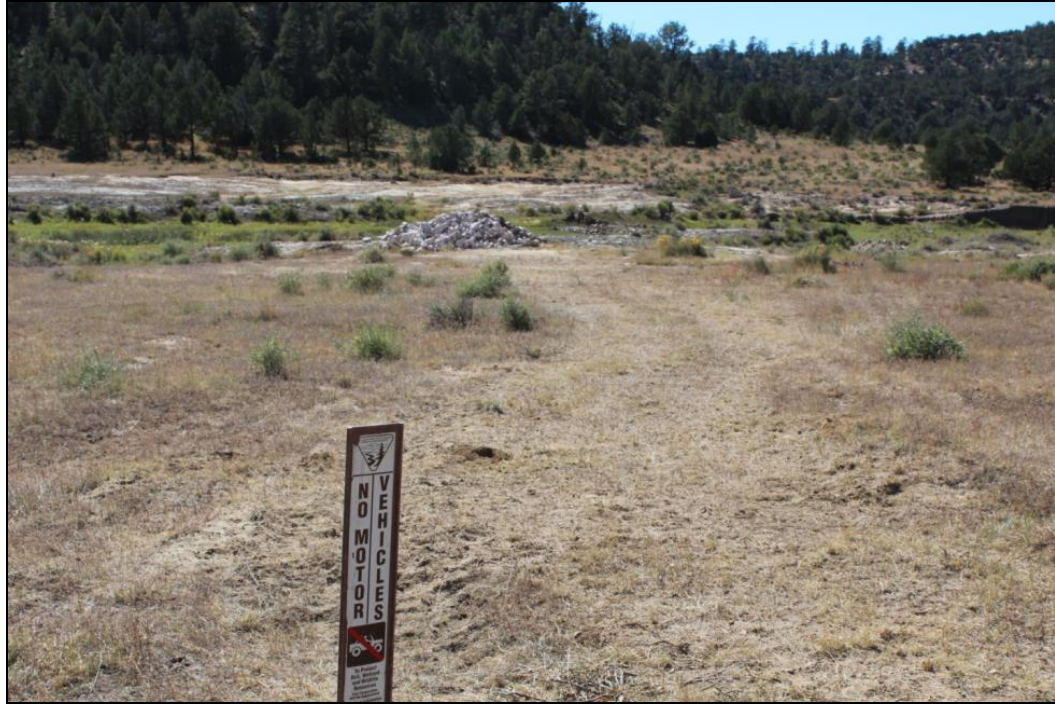
Figure 12. Piles of rock delivered in the Fall 2011. The rocks were later used by volunteers to hand install restoration structures due to wilderness concerns.

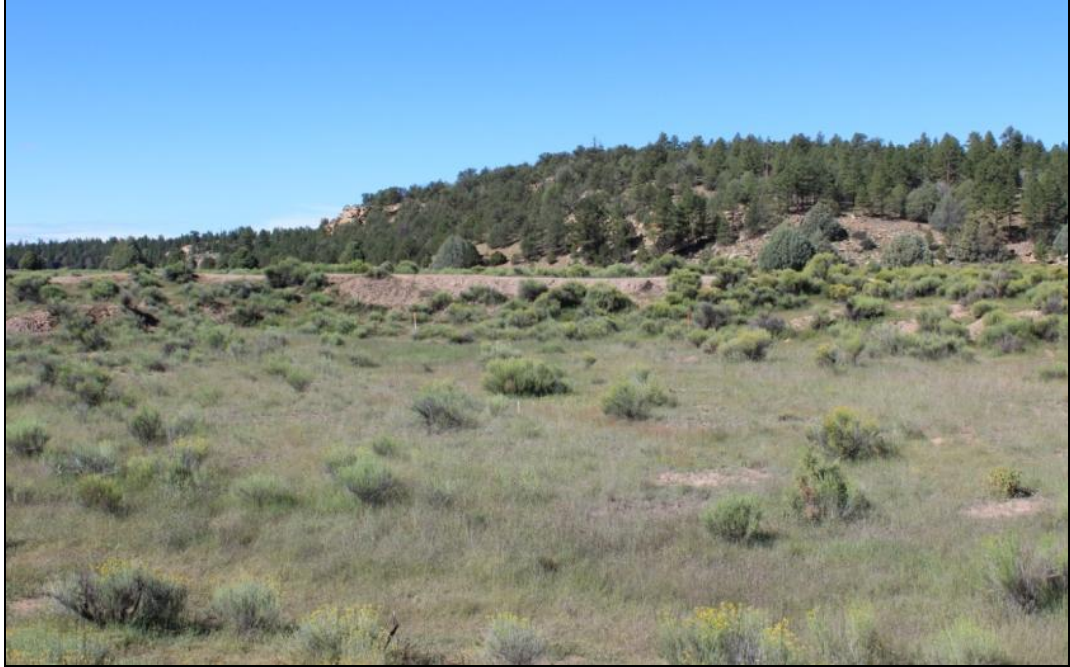
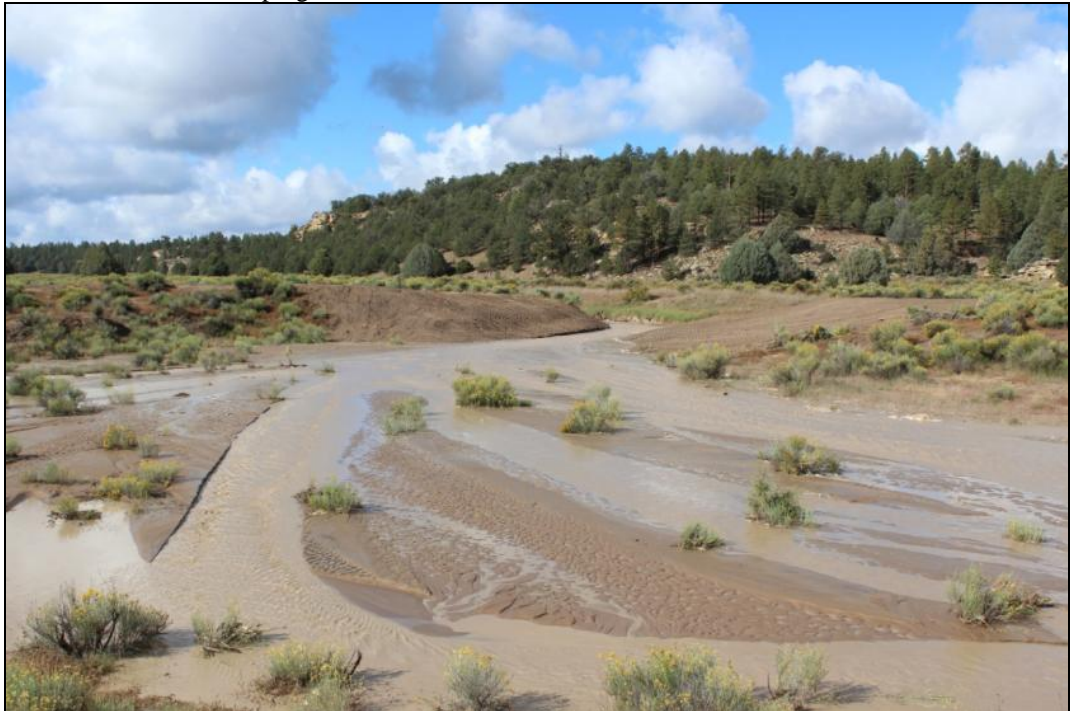
Figure b.

Figures 13.a and b. (Figure a) A berm across the valley was capturing flow and conveying it to a historic irrigation ditch. (Figure b) The berm was strategically breached according to the restoration design to return flow to the natural channel in valley center. Numerous acres of wetlands are still developing in this area.

- The Reach 1 Restoration was completed in September-October 2011. Material from a berm of an abandoned irrigation ditch was removed and used to plug the ditch to reconnect the spring wetland to low lying areas of valley right creating a high quality wetland area.
- On February 22, 2012, the Steering Committee met to discuss handwork construction of restoration structures under the “Minimum Tool” restriction to be completed during summer 2012. The Steering Committee conducted a site visit on April 19, 2012 where Bill Zeedyk explained how the innovative restoration structures were working.

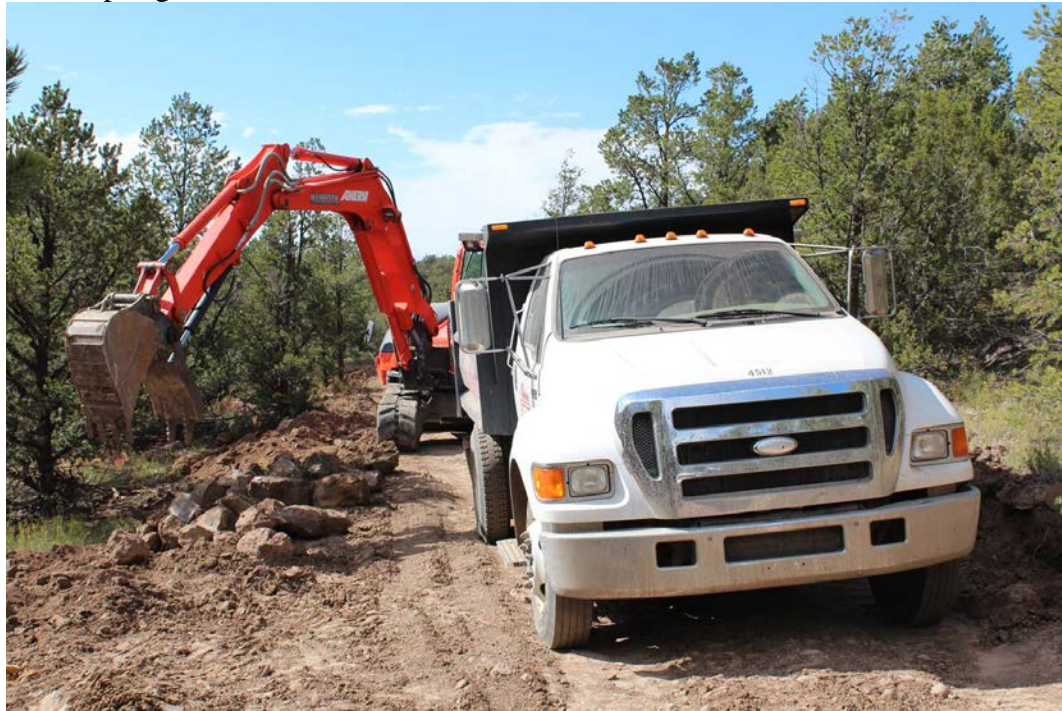
Figure 14. Harvesting rocks off dirt road by contractor for restoration structure hand work.

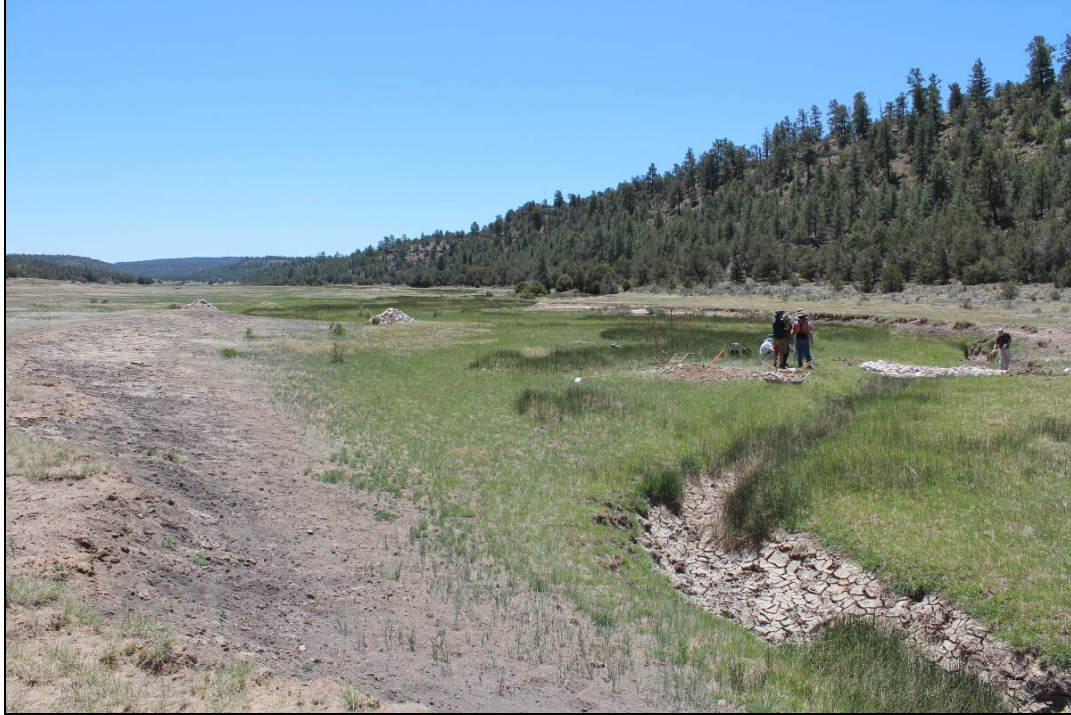
Figure 15. One-Rock Dam grade control structures constructed by volunteers promote the spreading of flow from small incised channels to expand wetland obligate species and groundwater infiltration across the valley floor. In the background are piles of rock staged for hand placement in designed structures.

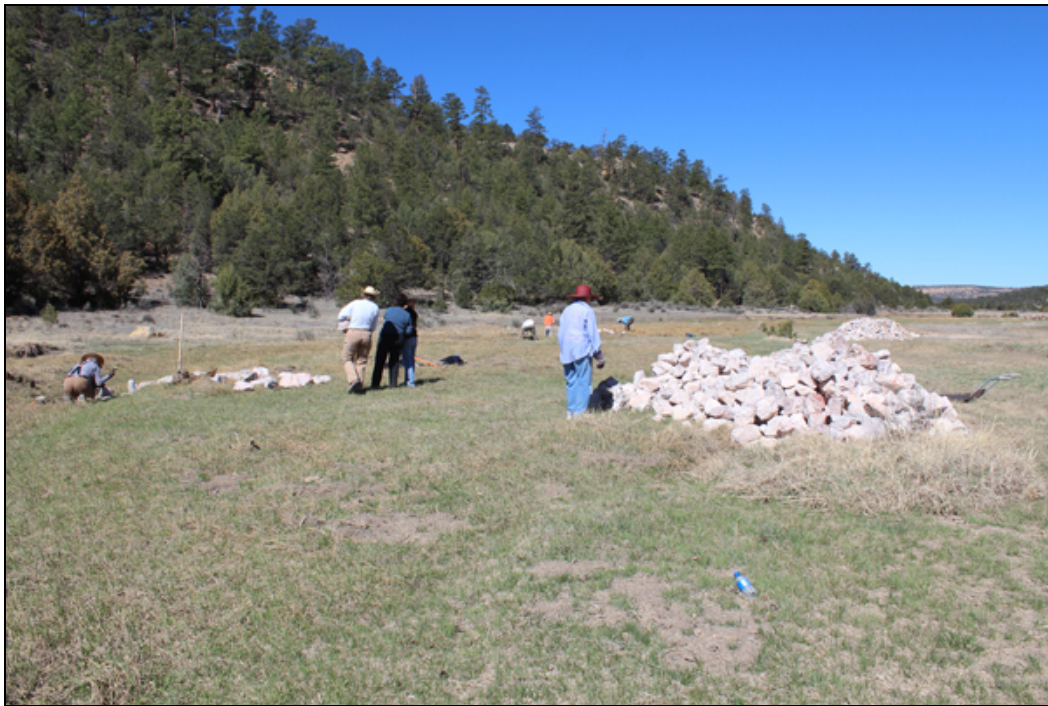
Figure 16. Volunteers move tons of rock by hand in the wilderness area. Placement of rock is guided by the design consultants.

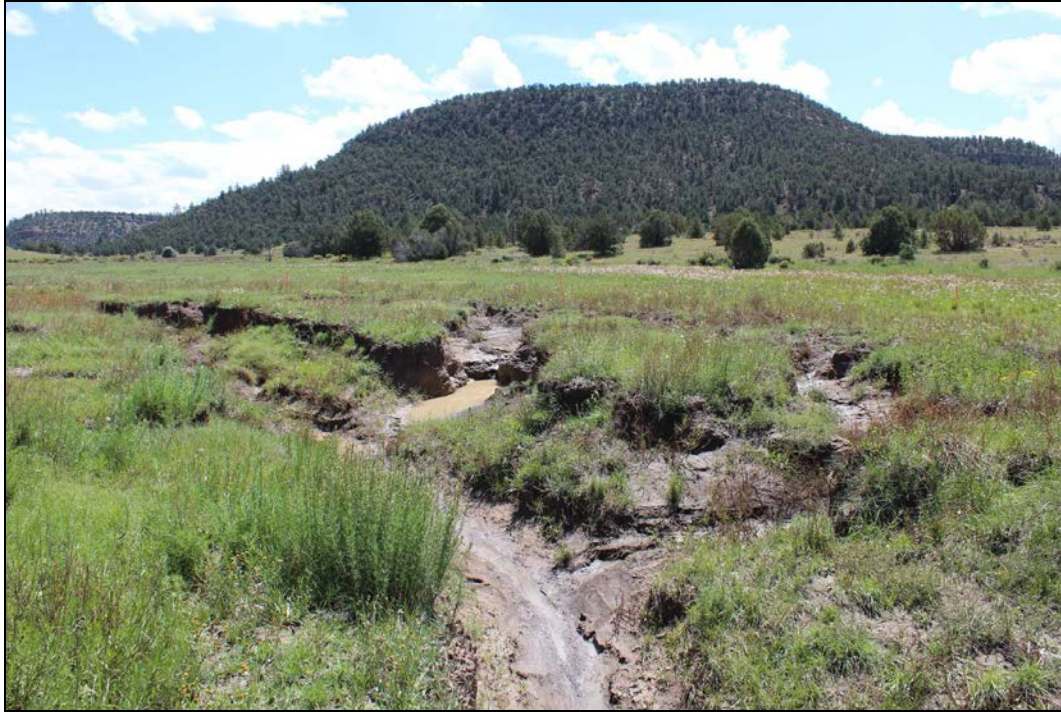
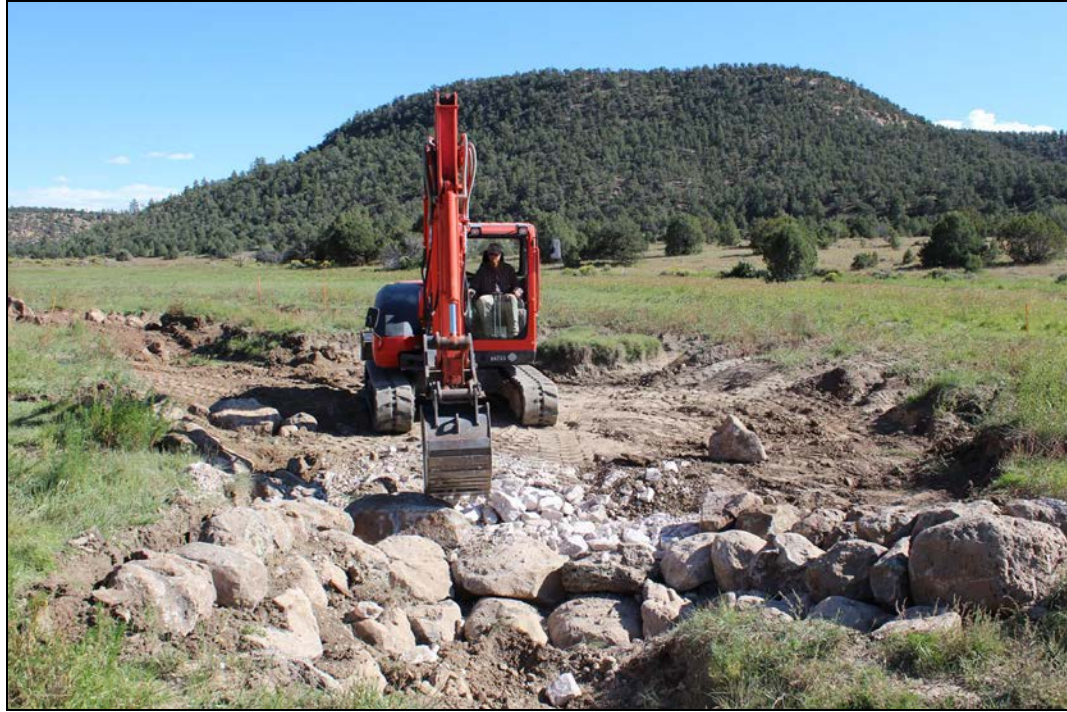
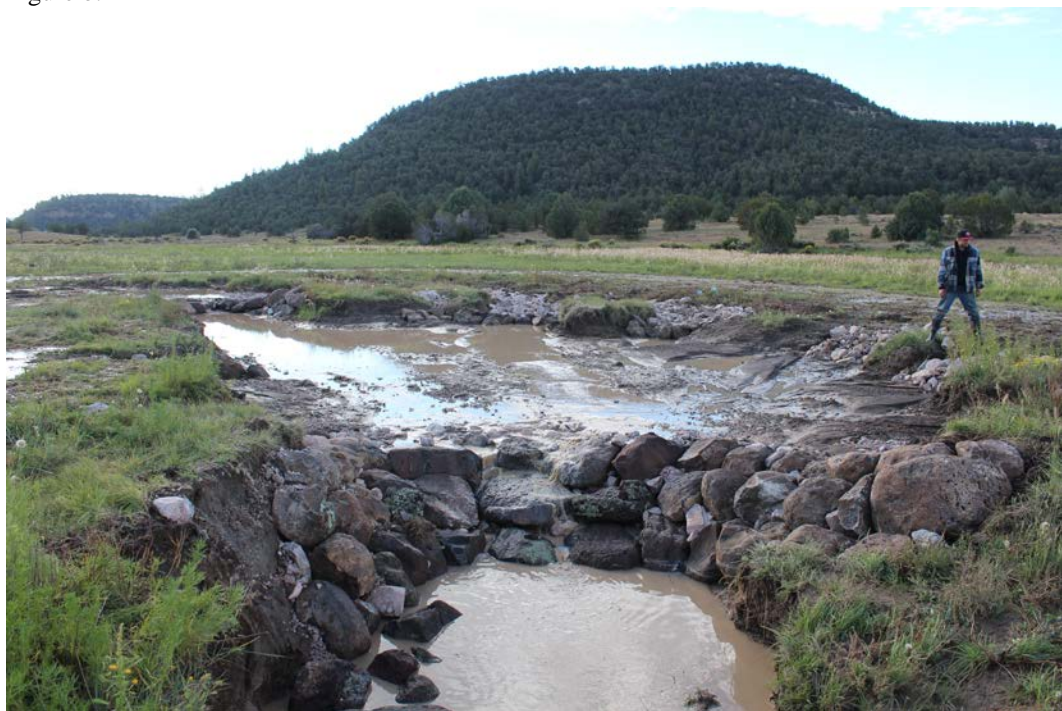
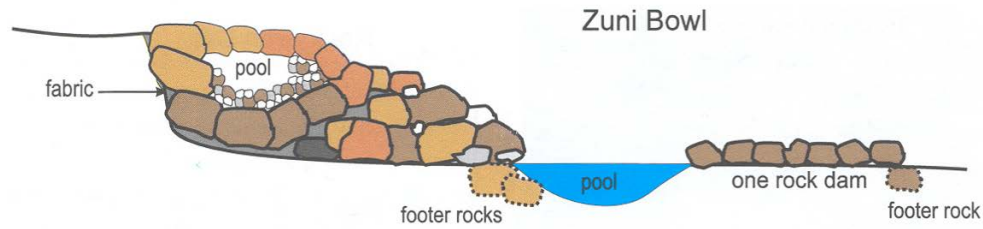
Figures 17a b c and d (Figure a.) Reach 6A before headcut work. (Figure b) During work on Reach 6A. (Figure c ) The finished product. (Figure d) Schematic of Zuni Bowl structure.

Figure c. This photo shows the use of a combination of innovative structures to arrest a large headcut and slow and distribute flow across the floodplain. In the background, a Media Luna structure spreads the flow and reduces flow velocities above the headcut. A number of Rock Rundowns armor small cuts around the main incised channel. A Zuni Bowl structure is used to heal low headcuts up to two feet high. Zuni Bowls harden the base of the cut to stop scour and undercutting; protect the face of the headcut from drying, sloughing and frost heave; and conserve moisture for enhanced plant growth. The rocks capture sediments, debris, seeds, and plant propagules, and act as rock mulch that protects young plants. They are frequently used in conjunction with one-rock dams.

(Figure d) Schematic From: Zeedyk and Van Clothier, 2009, "Let the Water do the Work".

- Restoration activities on Reach 6 using heavy equipment were completed. The equipment work was largely for headcut amelioration, using Zuni Bowls. A Zuni Bowl is a headcut control structure composed of rock-lined step falls and plunge pools that stabilizes actively eroding headcuts and prevents headcut migration. Rock for numerous grade control structures in Reach 6 and Reach 7 was staged using heavy equipment for completion by hand using volunteers.

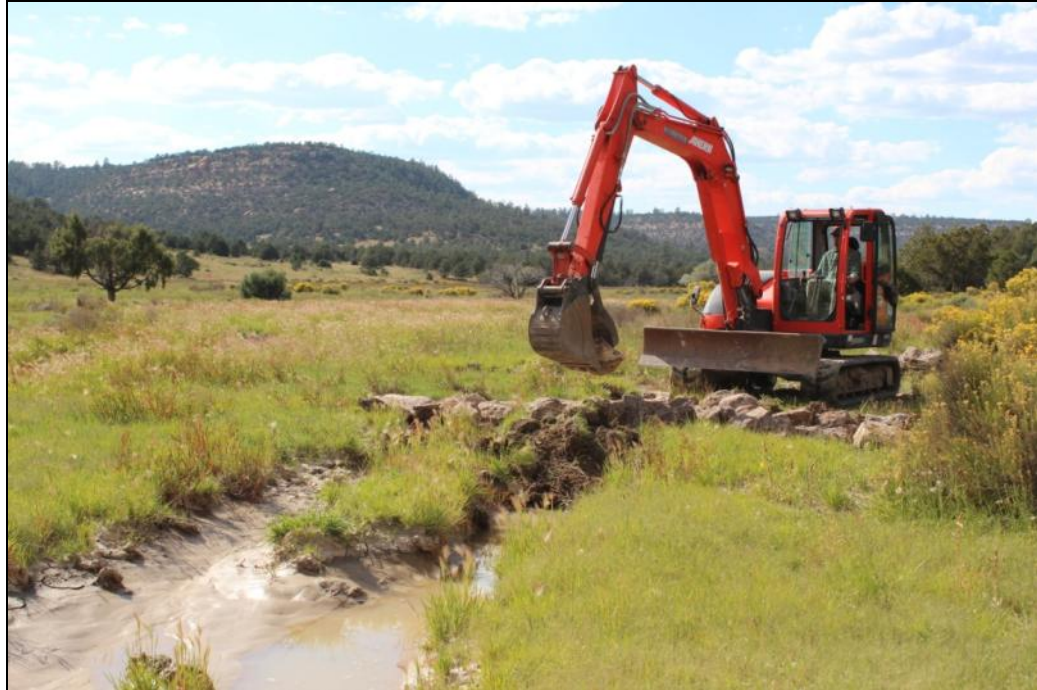
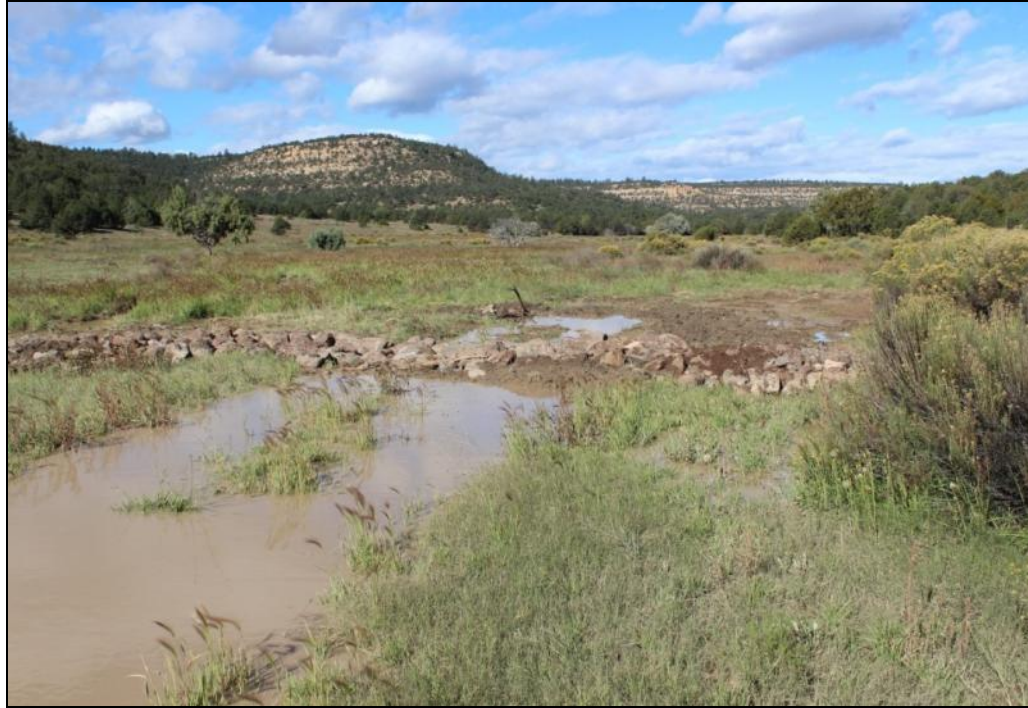
Figure b.

Figures 18a and b (Figure a) An abandoned road was capturing drainage and creating a gully.  
 (Figure b) Newly constructed structure cuts off flow to the ruts and returns flow to valley center.

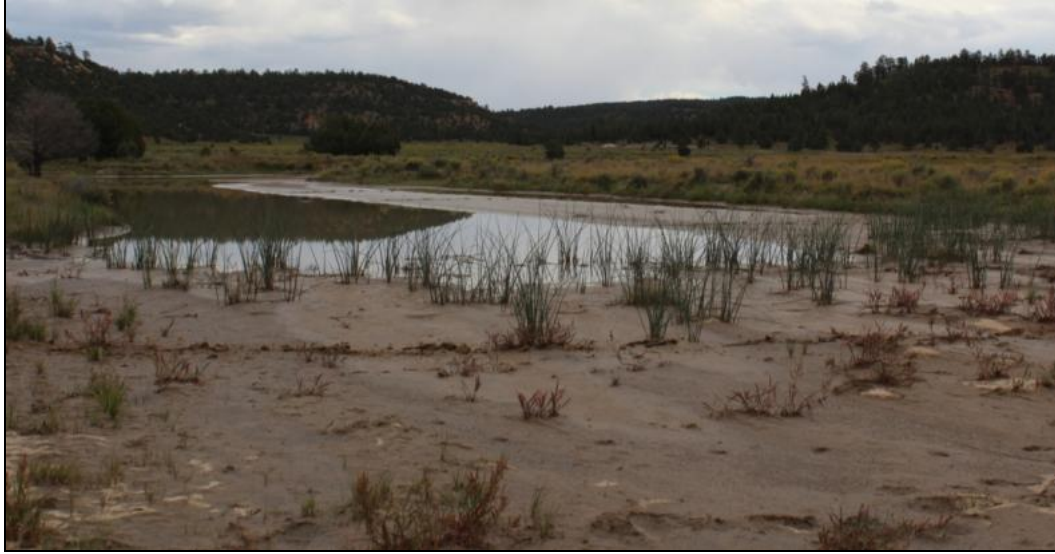
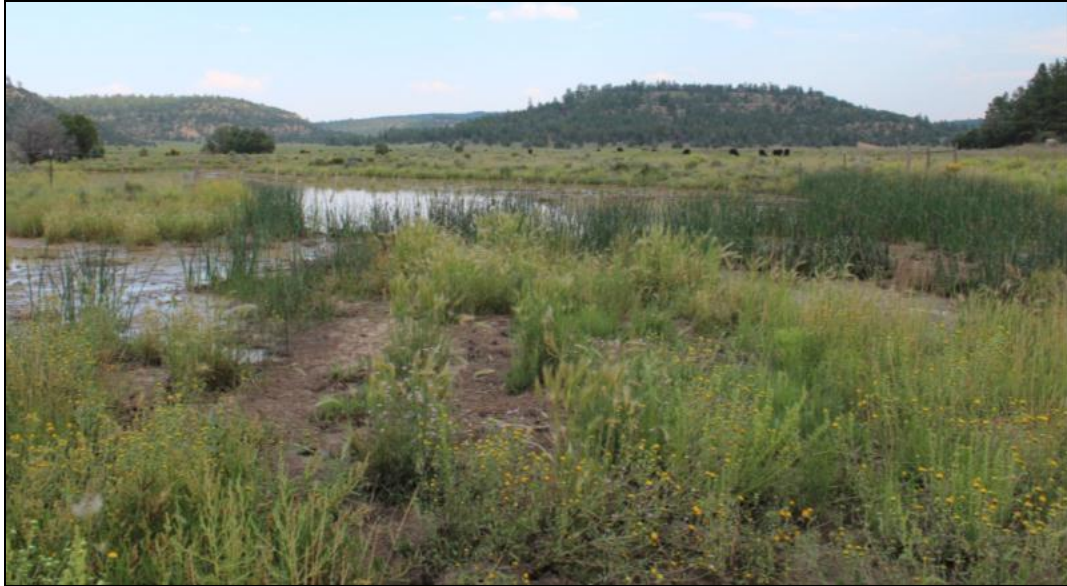
Figure b.

Figures 19a and b. (Figure a) Sediment plug forming “Lake Cebolla” before exclosure fence construction in 2011. (Figure b) Same area within an exclosure one year later in 2012.

- Two enclosure fences were constructed in September and October to: 1) create a “delta” into the “Lake Cebolla” (slope wetland) and sediment plug to restore 2 acres of wetlands upstream in the main and side channels, and 2) protect sediment plug from wind and stream erosion in order to maintain water levels and improve vegetative recovery in Reach 0.
- Restoration activities using heavy equipment allowed as part of the preferred alternative in the EA were completed September-October 2011, which mostly constructed larger structures and staged rock for further handwork to be done by volunteers in the Spring and Summer 2012.

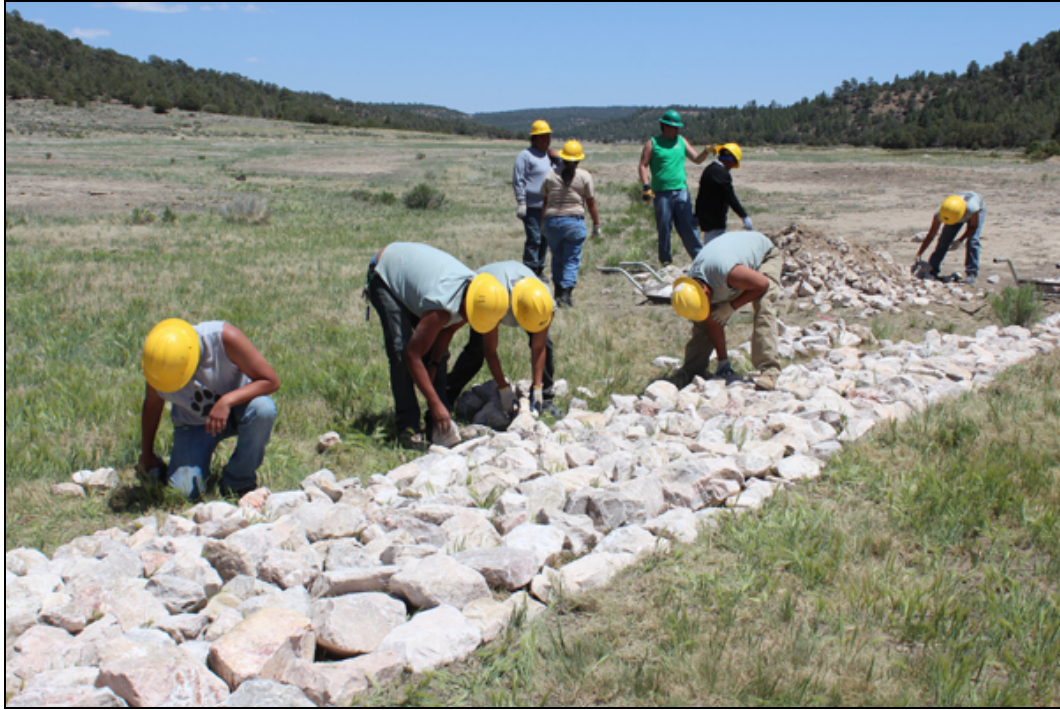
Figure 20. Acoma Pueblo SCC constructing flow dissipation structures.

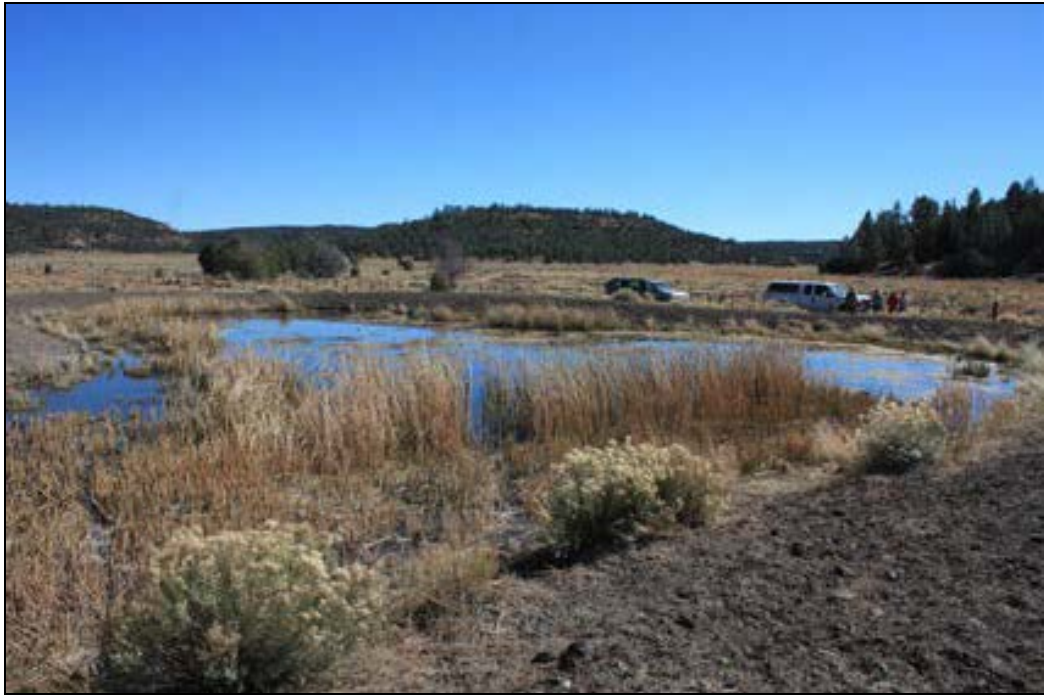
Figure 22. Little Cebolla Spring currently drains into a stockpond which is being considered for enhancing bat habitat.

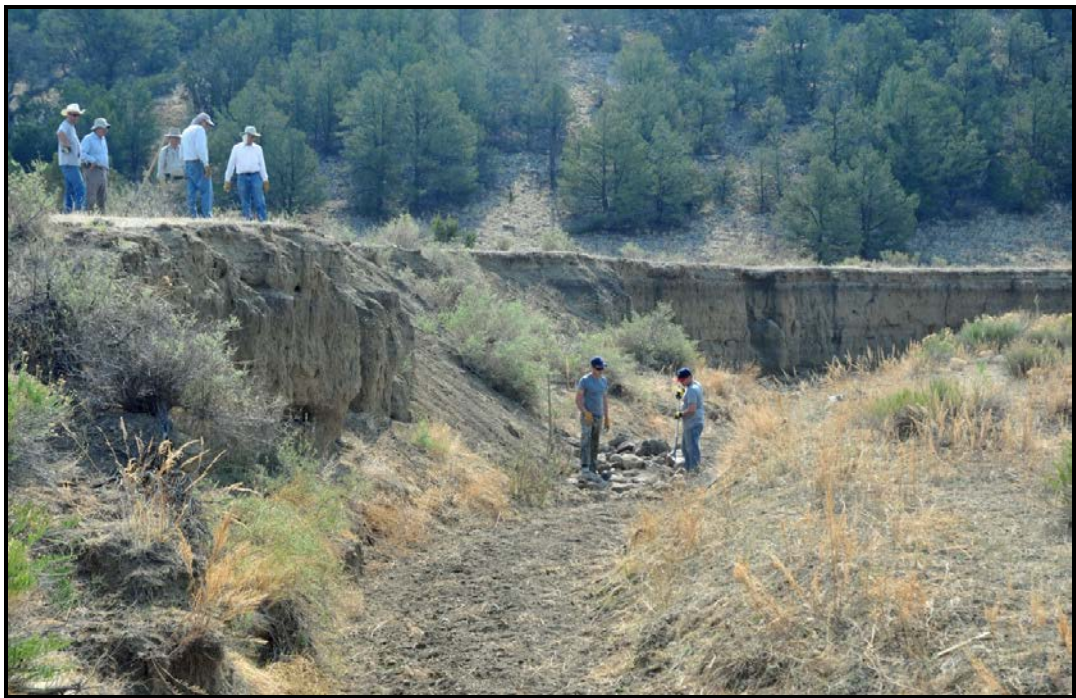
Figure 25. National Wild Turkey Federation volunteers building structures to induce meandering in Reach 7 (the critically incised portion of Cebolla Canyon downstream of the Cebolla Springs wetland) - Summer 2013.

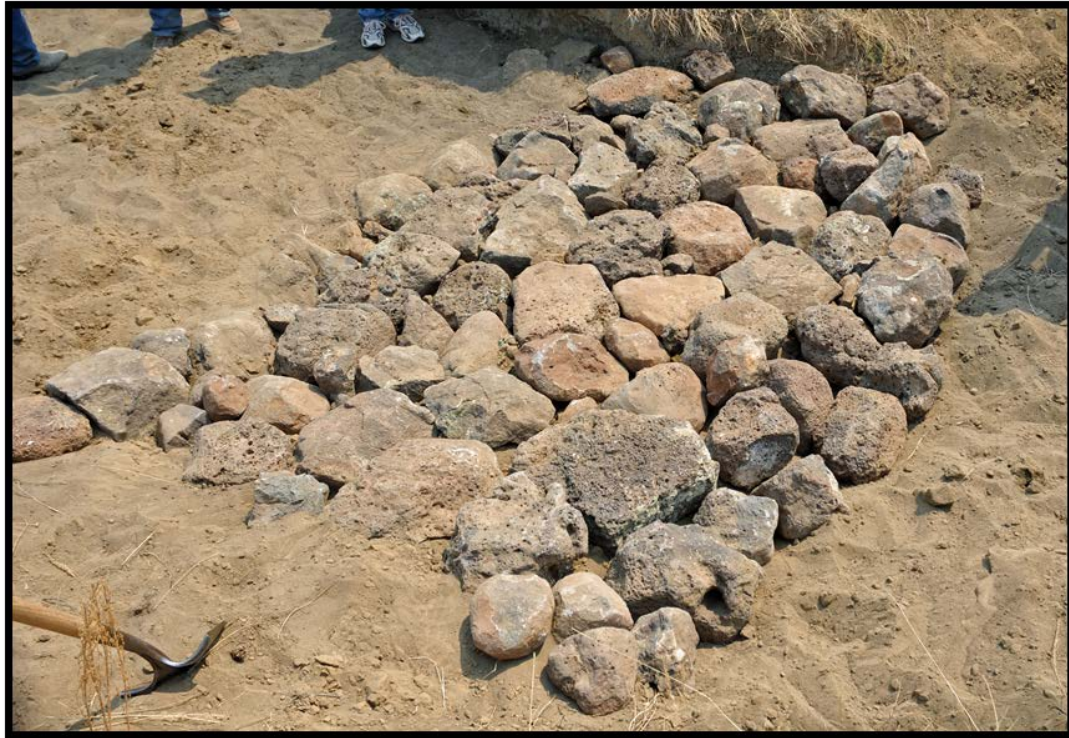
Figure 26. Example of one-rock dam rock work completed in Reach 7 by National Wild Turkey Federation.

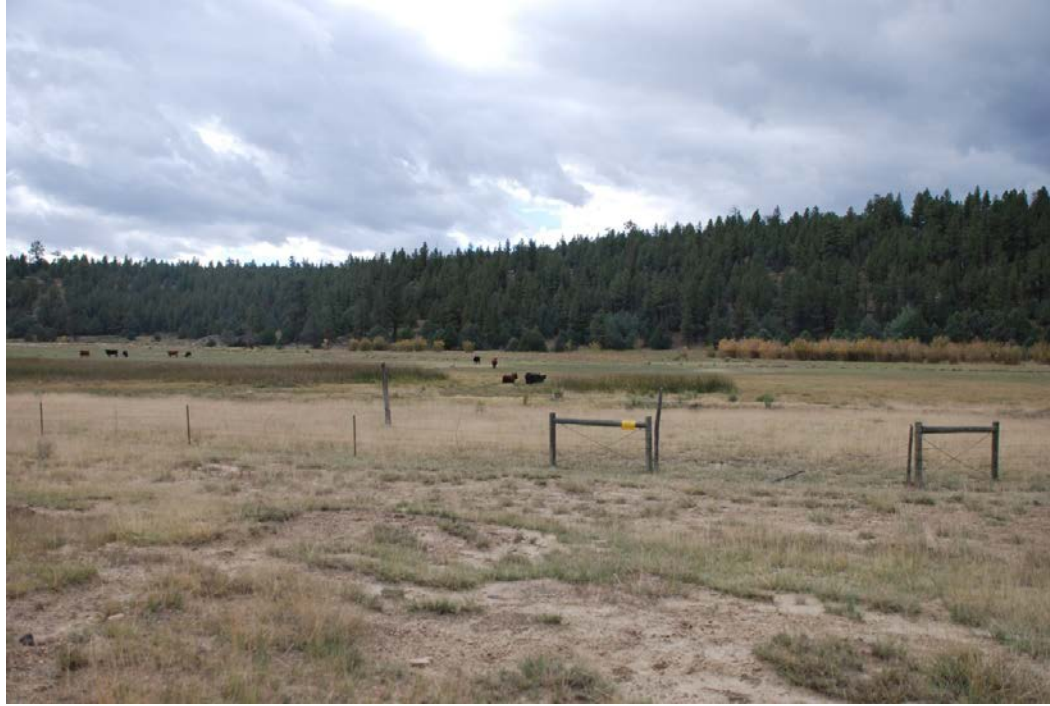
Figure 28. Cattle overgrazing the Cebolla wetland in the November 2013, just prior to final vegetation monitoring for the final monitoring report for this project.

- Approximately 50 trespass cattle were in the project area wetlands as the existing wetland exclosures were damaged due to a storm and flooding in September 2013. It was determined that the exclosures needed to be repaired as soon as possible because the cattle were degrading the wetland and overgrazing the newly establishing wetland vegetation.

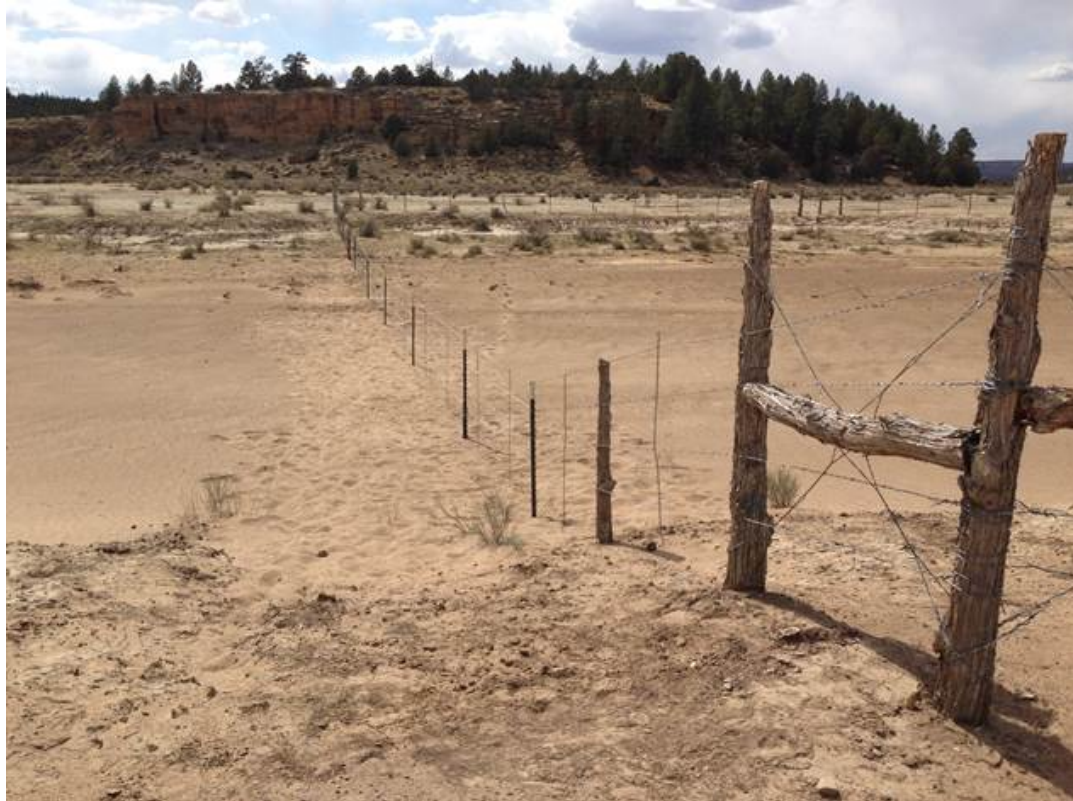
Figure 29. Exclosure fence repaired in March 2014 by BLM with project funds for materials.

- On November 2013, Maryann McGraw and Dan Guevara, NMED Watershed monitoring staff collected final overview photopoint data. During that time, trespass cattle were grazing the project areas.
- Maryann McGraw completed a request for quotes to repair the damaged water gap fencing on the project to prevent further grazing by trespass cattle. The Rio Puerco Alliance teamed up with BLM staff and a purchase order (for the fencing supplies only) was awarded to RPA in early December 2013.
- Keystone Restoration Ecology submitted a final monitoring report in December 2014.
- A draft of the Wetlands Action Plan was submitted to the WPC in January 2014. The WPC made extensive comments for revisions including the need for stakeholder and expert peer review before acceptance.
- The fence repairs were installed in March 2014 by BLM.

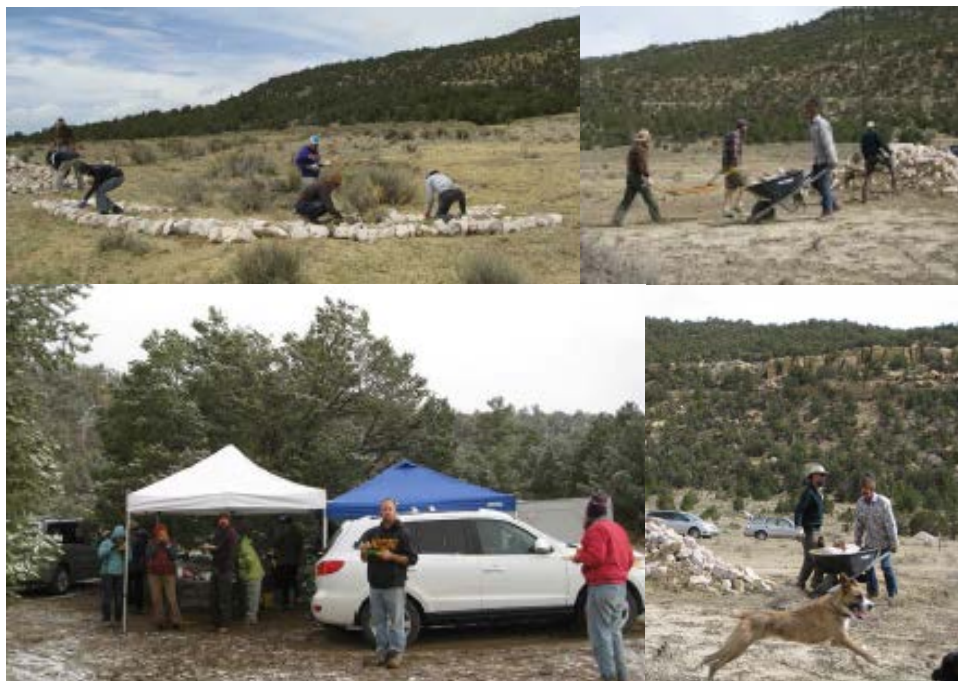
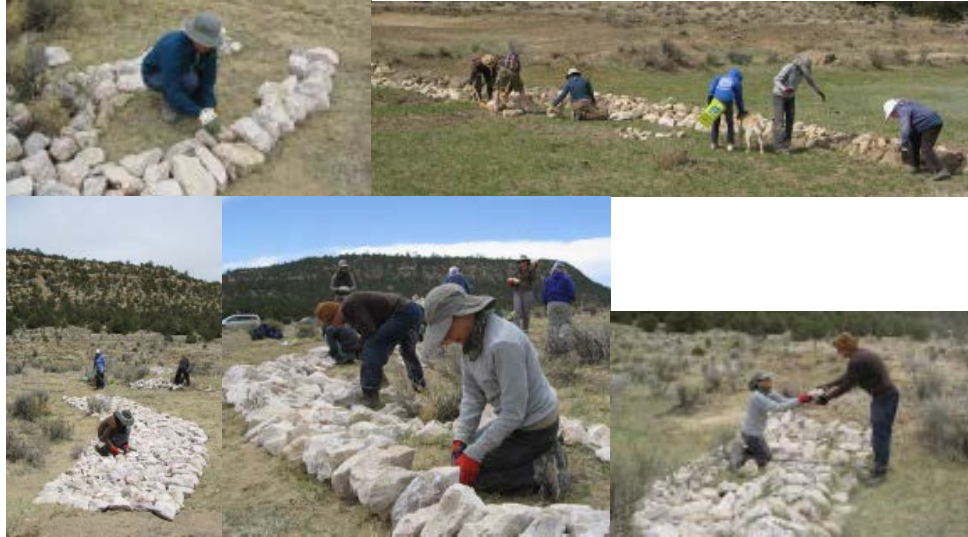
Figure 30. A collage of photos taken of volunteers constructing media lunas on Reach 3 during the April 2014 restoration effort by Albuquerque Wildlife Federation. The photos are from the May 2014 PineCone newsletter article.

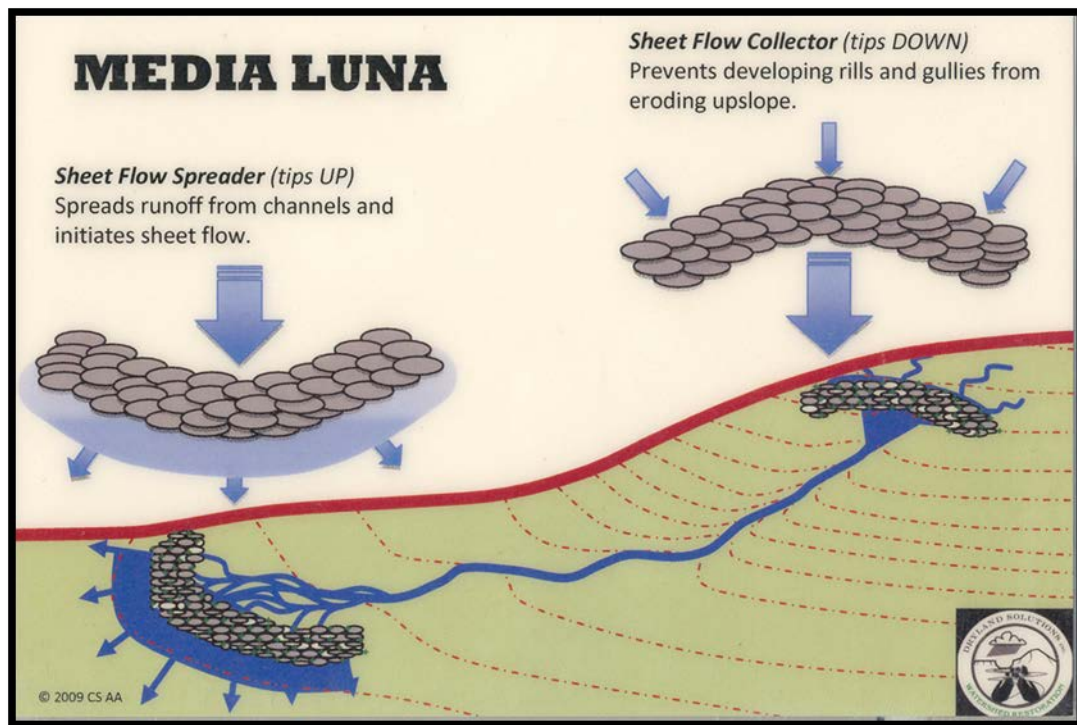
Figure 31. Media Luna Design. Schematic by Dryland Solutions Inc.
