**Final Report  
November 2014  
Restoring and Protecting Wetlands in Cebolla Canyon Closed Basin  
Assistance Agreement No. CD-966857-01-0C (FY2008)**

(This project is Part C of a larger 2008 grant award to NMED Wetlands Program entitled “NMED 2008 Wetlands Awards Project.”)

Restoring and Protecting Wetlands in Cebolla Canyon Closed Basin  
June 2014

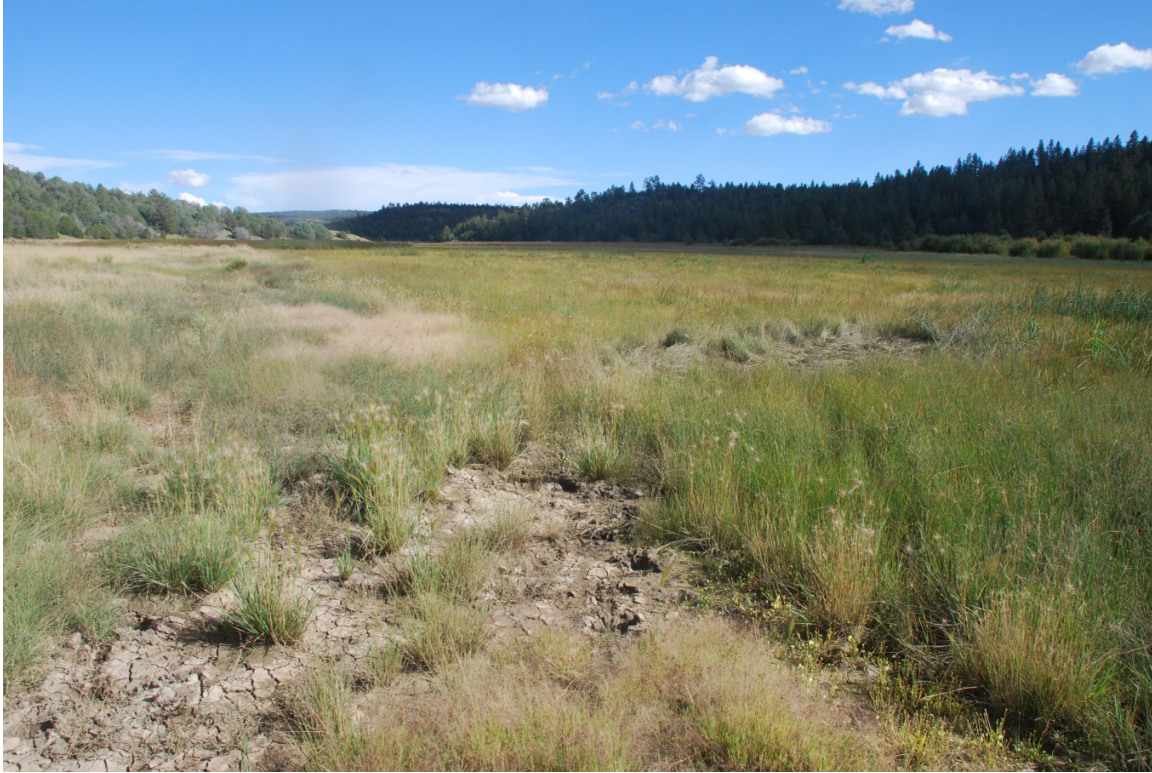
Figure 32. Wetland recovering after fencing was repaired, cattle removed and after the rainy season of Summer 2014. The fenceline repaired under this project is just visible in the far end of the valley. The photo was taken in September of 2014.
