# **FINAL REPORT**

## **Innovative Design and Restoration of Slope Wetlands in the Comanche Creek Watershed, New Mexico**

**Assistance Agreement CD#00F434-01 (FY2011)**

**New Mexico Environment Department**

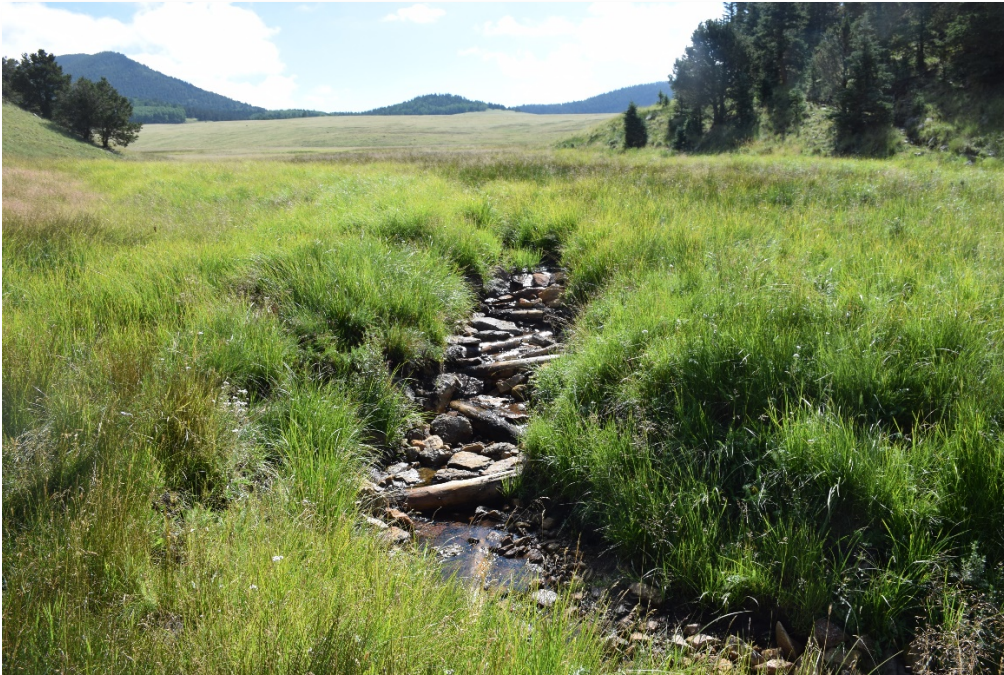
Log-rock run down structure, an innovative restoration technique designed and installed in  
Grassy Creek by this project

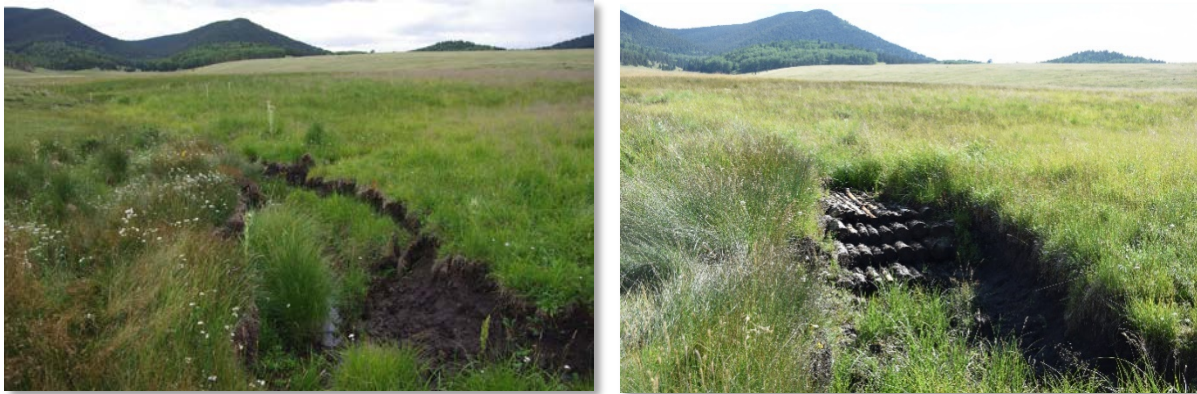
**Figure 1. Site 10, Advancing headcut in Upper Grassy Creek before treatment, August 2014 (left). Figure 2. Site 10, Upper Grassy Creek in August 2016, two years after construction of a log step fall structure arrested the headcut (right).**

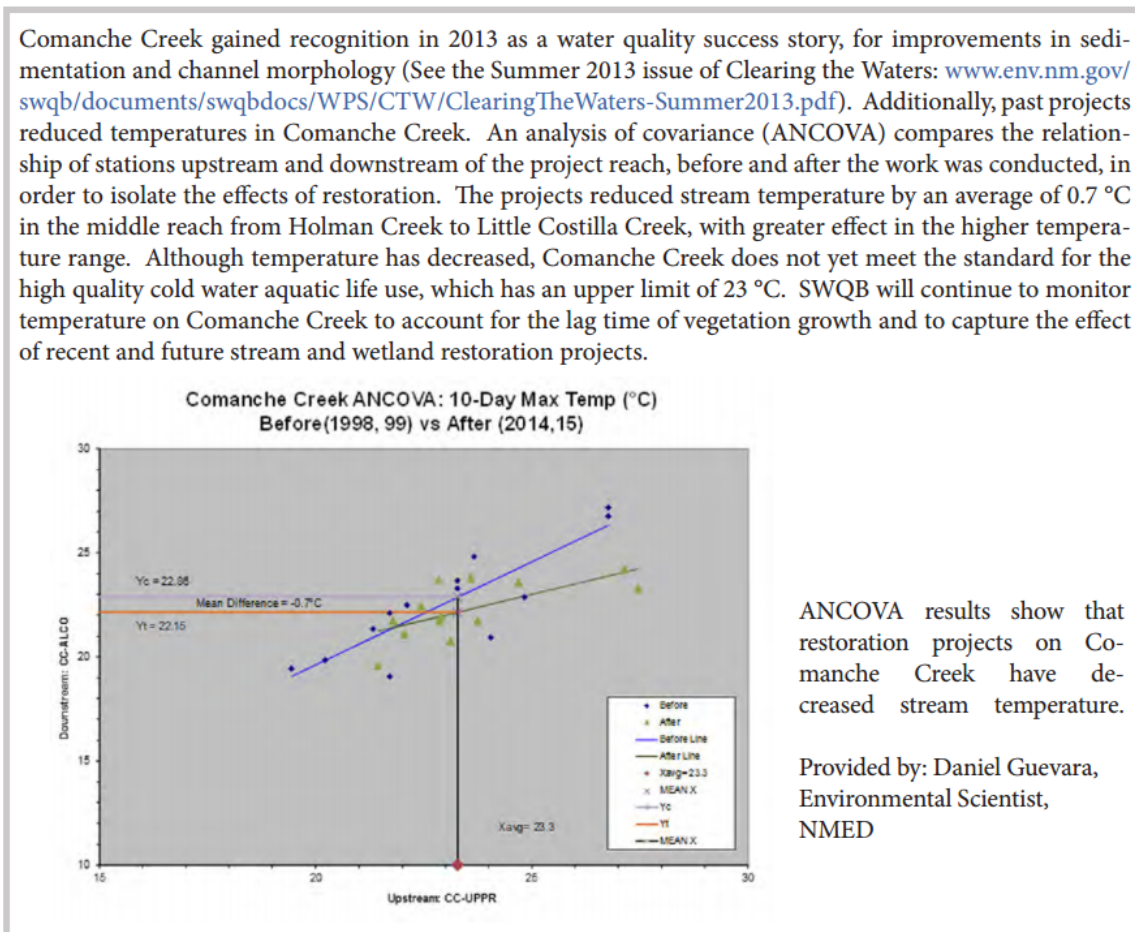
**Figure 7. Presentation of data showing a reduction in temperature in Comanche Creek.**

- The Project resulted in popular and useful publications. The Slope Wetlands Technical Guide, *Characterization and Restoration of Slope Wetlands in New Mexico, A Guide for Understanding Slope Wetlands, Causes of Degradation and Treatment Options*, is in its third printing.
- Because of the work done through this project, Quivira Coalition was nominated by US Forest Service – Carson National Forest, and received the *Rise to the Future- Exceptional Volunteerism* award in March 2016 from US Forest Service Headquarters.
- Water quality monitoring conducted in the main stem of Comanche Creek by the Surface Water Quality Bureau Effectiveness Monitoring Program Coordinator indicates that water temperature is on a downward trend over the period of 1999-2016, although the creek is still impaired for temperature.

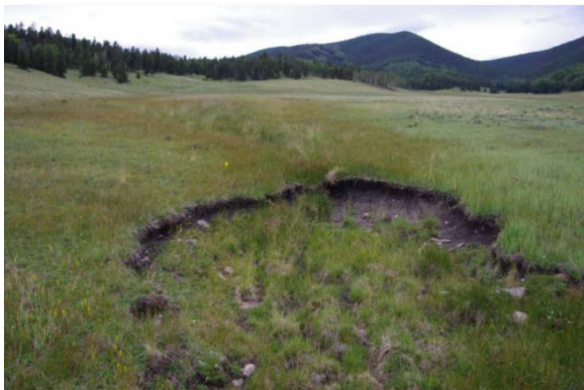
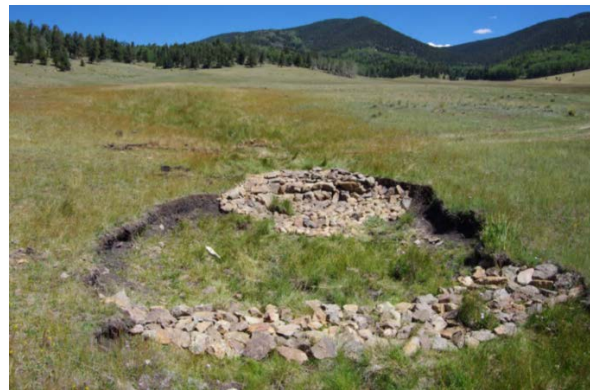
**Figure 11. Advancing headcut at Treatment Area Site 17 on Upper Grassy Creek, a tributary to Comanche Creek (*left*). Figure 12. The site was treated with a Zuni bowl and one rock dam to stop headcut advancement (*right*).**

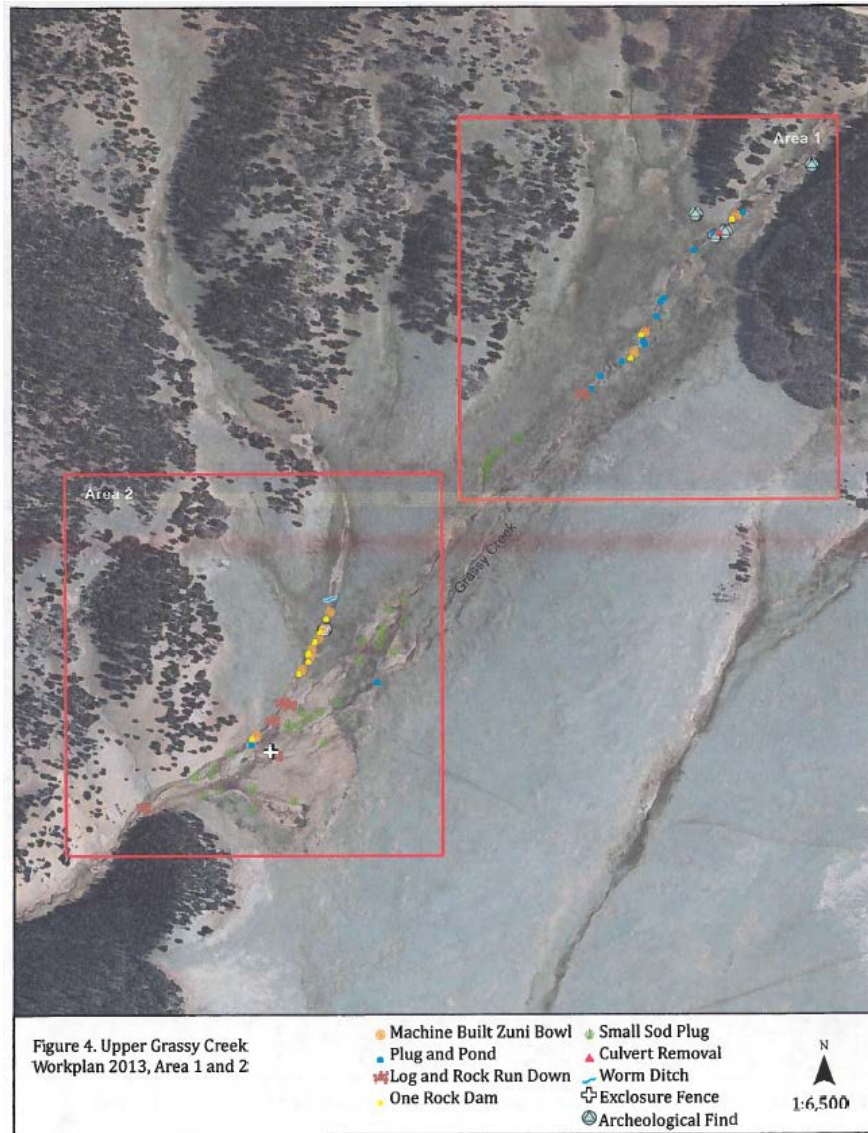
**Figure 13. Design document for location of restoration structures in Upper Grassy Creek. This document was part of the CWA 404 permit application, along with schematic drawing of the various structures that would be employed.**

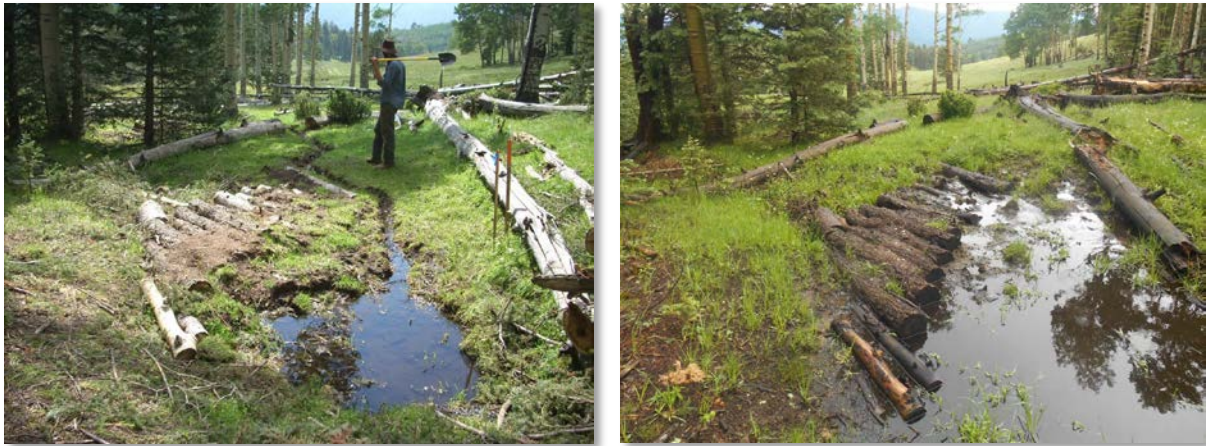
**Figure 14.** A log mat was installed in at Site 15 in Upper Springwagon Creek to raise the channel and lateral worm ditch was dug to redirect flow to rewet a meadow. Photo taken August 2013 just after installation (*left*). **Figure 15.** Site 15 in Upper Springwagon Creek two years after log mat and worm ditch Photo August 2013 just after completion (*right*).

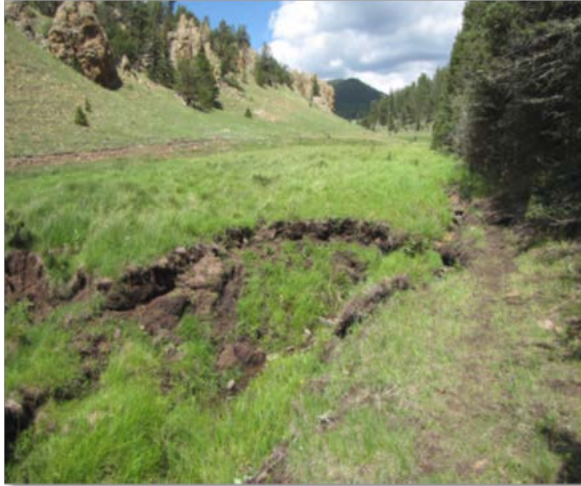
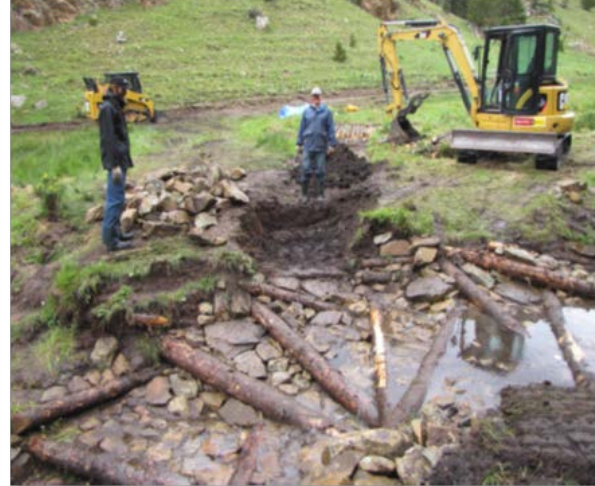
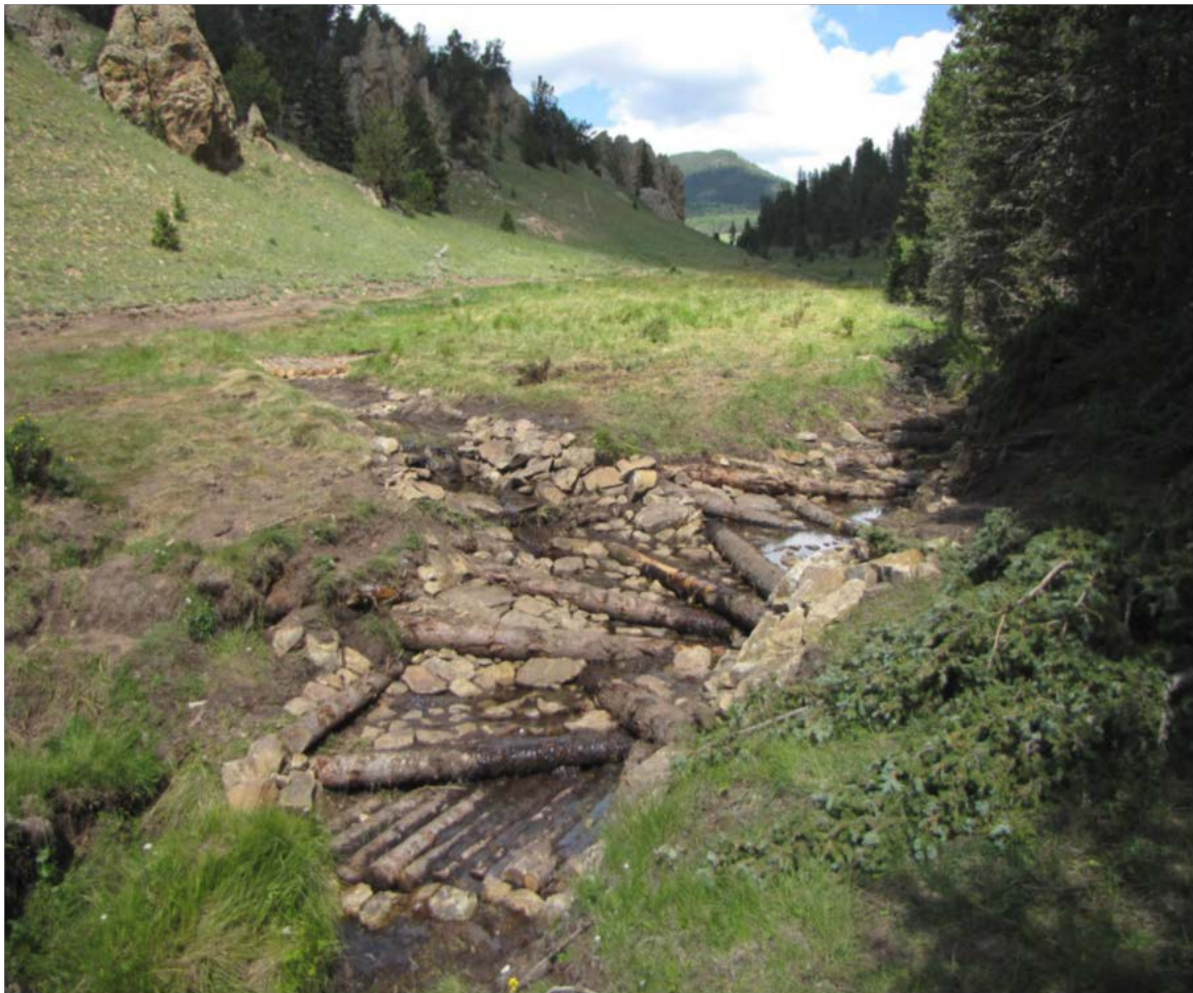
**Figure 18.** Site 10 in Lower Grassy Creek had a large headcut in a steep section of the channel (*top left*). **Figure 19.** Subcontractors used machinery to construct a log-rock rundown structure in August

2014 (*top right*). Figure 20. This structure holds the grade and prevents the headcut from migrating and draining the wetlands upstream (*bottom*).

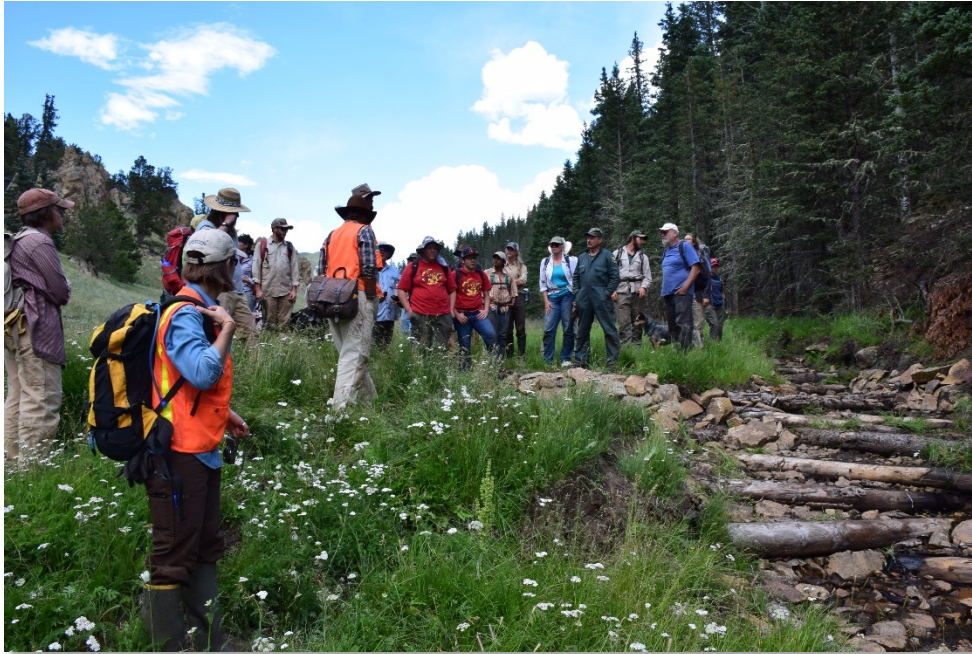
Figure 21. Volunteers listening to Craig Sponholtz, Watershed Artisans, describe the function of the log-rock rundown structure built by subcontractors at Site 10 in lower Grassy Creek.

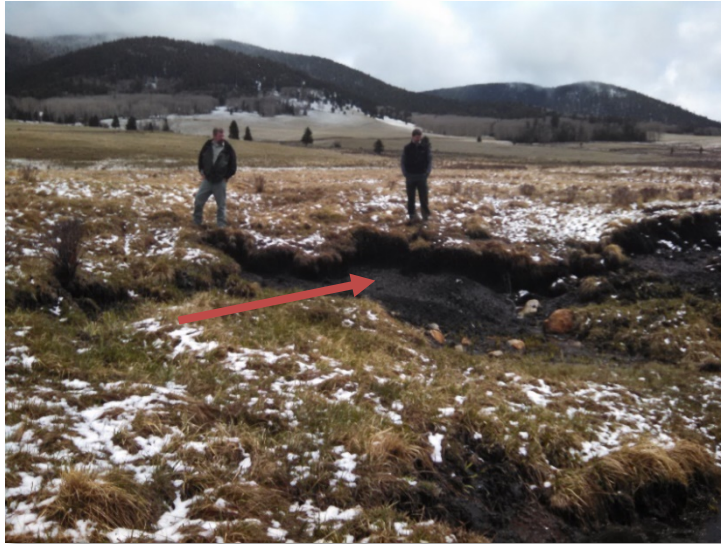
**Figure 23. Holman Creek during May 5, 2015 field trip. The red arrow points to a headcut that was draining a five-acre fen. The headcut was stabilized in 2015 by installing a Zuni bowl with funds from Coca Cola Company.**

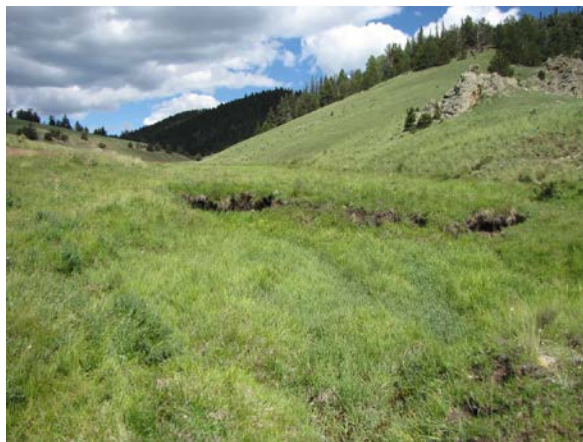
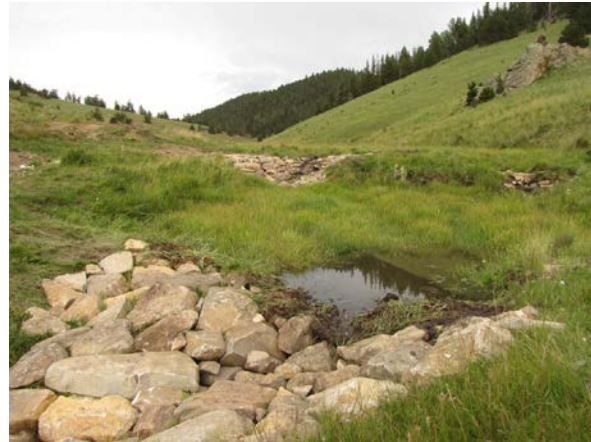
**Figure 25. Site 13, Lower Grassy Creek. Series of advancing headcuts, August 2013 (left). Figure 26. Site 13, two years later after stabilization with Zuni bowls built by the subcontractors, August 2015 (right).**

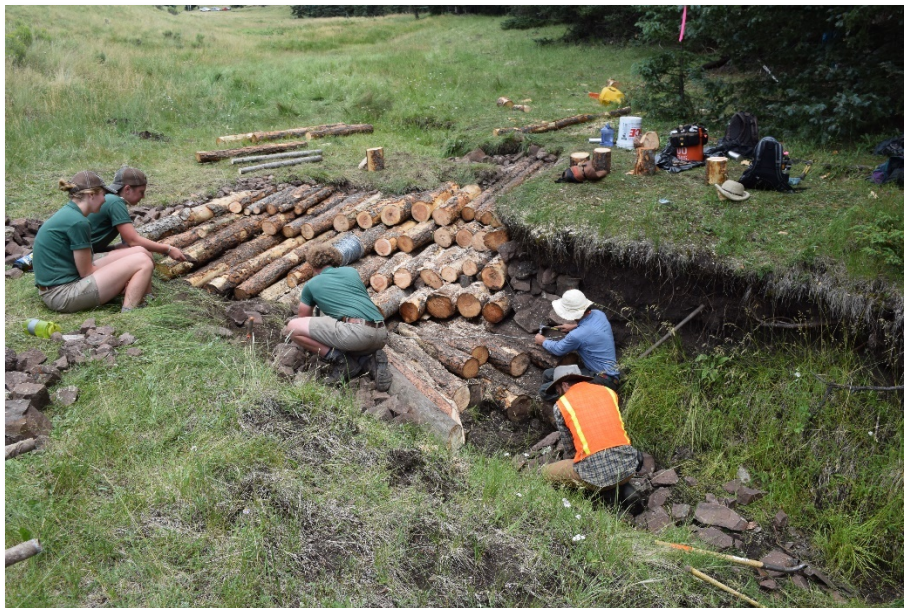
**Figure 27. Installation of a step fall structure at Site 2, Upper Springwagon Creek in August 2016.**

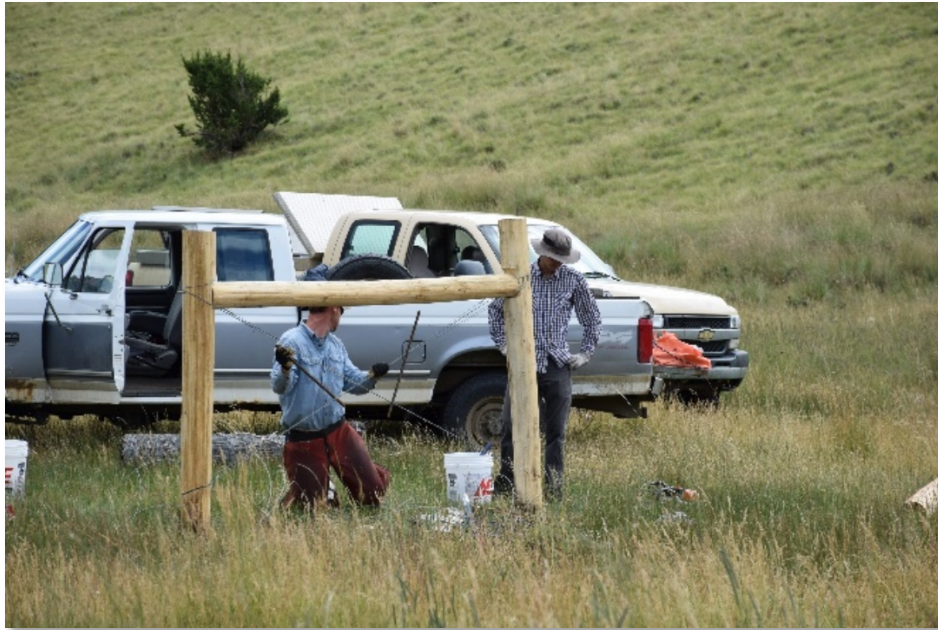
**Figure 28. Construction of a livestock exclosure fence around one of the plug and pond structures in a sensitive wetland area in Upper Grassy Creek in August 2016.**

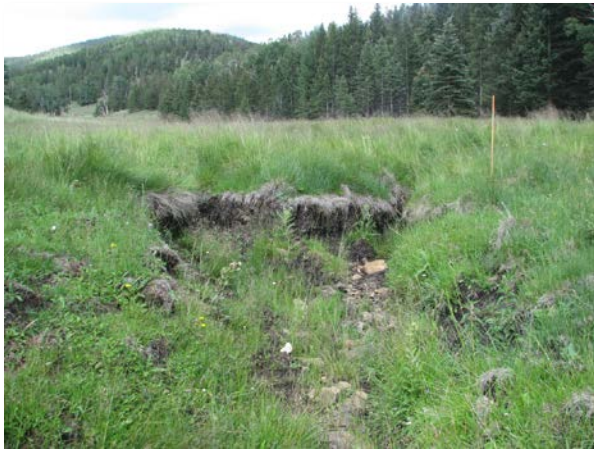
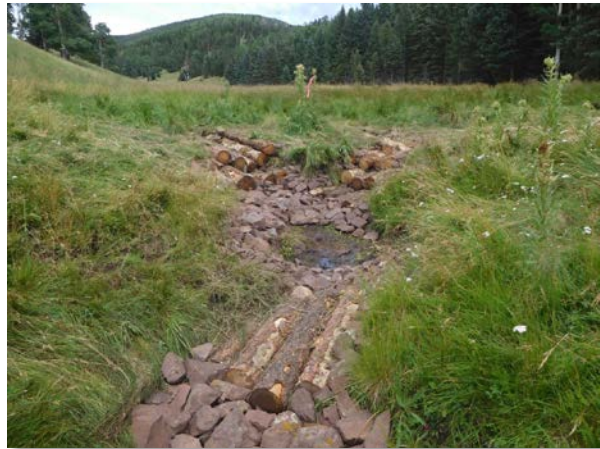
**Figure 29. Site 1, Upper Springwagon Creek, shows a migrating headcut, July 2013 (left). Figure 30. Site 1, immediately after installation of a log step fall and rock rundown structure to arrest the headcut in August 2016 (right).**

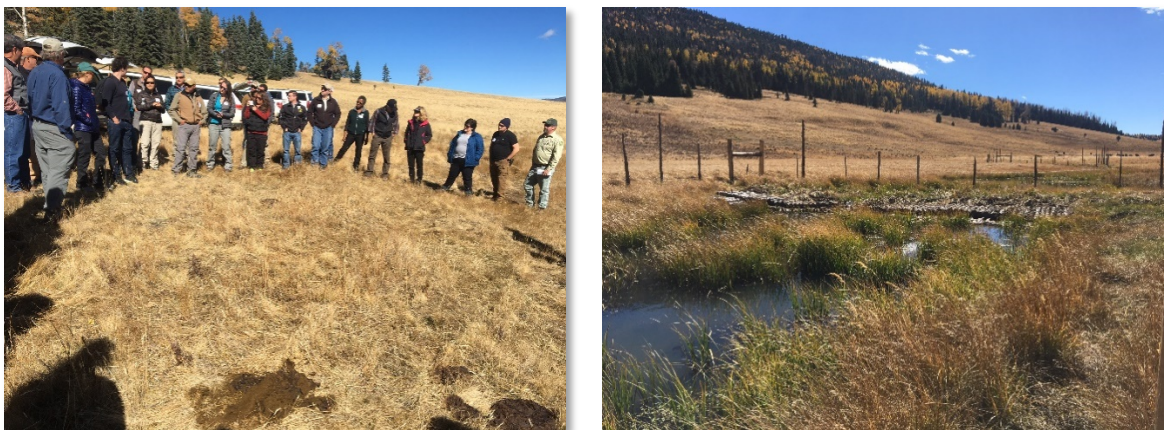
**32. A two tiered log mat in the headwaters of Comanche Creek that was built in 2016 with Coca Cola Company funding (right).**
