Final Report
La Cienega de San Vicente Wetland Project
October 2014

Wetlands Program
New Mexico Environment Department
Surface Water Quality Bureau

La Cienega De San Vicente Final Report

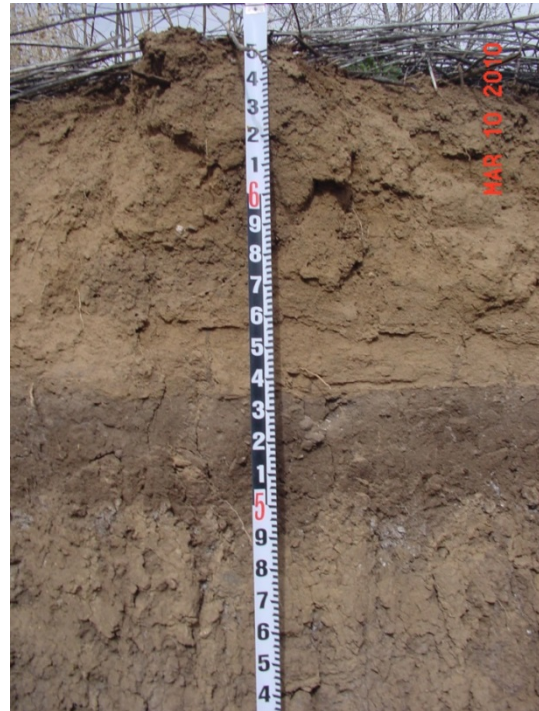
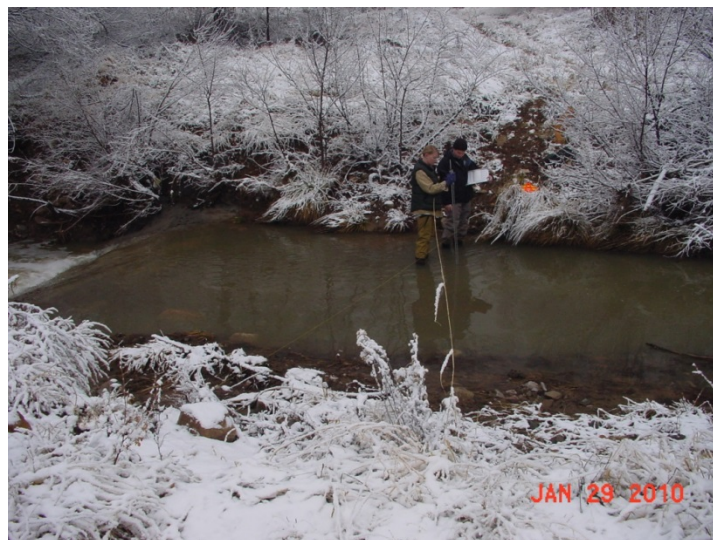
Project area soil survey (above) and stream cross-section (below).

Early on in the project the area was characterized for indicators of wetland hydrology, soils and vegetation. Several ground-water monitoring wells were installed, channel cross-sections and profiles were established and a soil survey of the area was completed. The baseline condition derived from hydrological, vegetation, and soils investigations showed that the San Vicente Site did not have hydric soils, has a very limited community of wetland plants, and did not currently have the requisite hydroperiod to be classed as a wetland. The site did have the potential to be a wetland if the hydrology of San Vicente Creek can be restored to allow for more frequent overbanking events to occur. However, San Vicente Creek is incised throughout much of the project area. Without some floodplain or channel modification the wetland condition was not likely to improve. The proximity of the San Vicente Creek and wetland to the town of Silver City both complicated and provided areas of opportunity. One of these complications was utility lines that criss-crossed the project area. Several phone lines, water mains and sewer lines cross the San Vicente Creek channel. These lines have always been subject to damage during high flow events in the creek. In 2008 the city’s main sewer line was broken in San Vicente Creek causing raw effluent to be discharged into the creek. One of the highlights of this project was the construction of an in-stream cross vane just below the sewer line. The cross vane not only protected the sewer line from future damage, but has caused some aggradation of

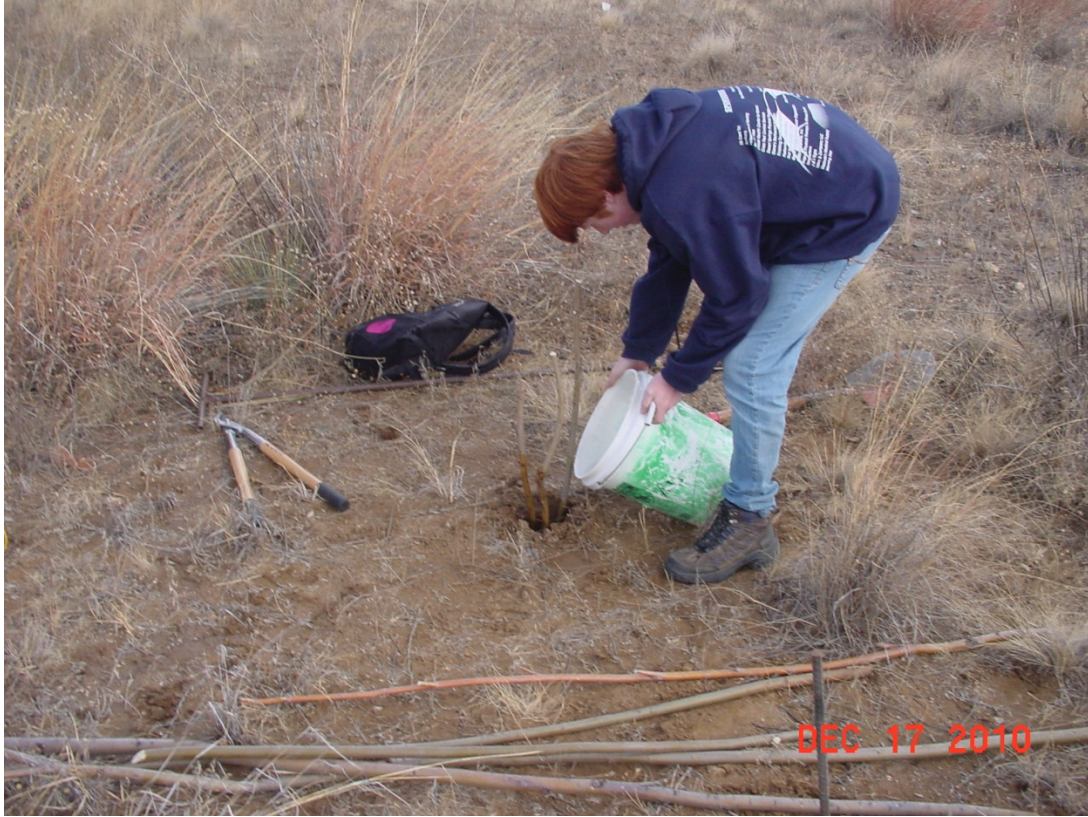
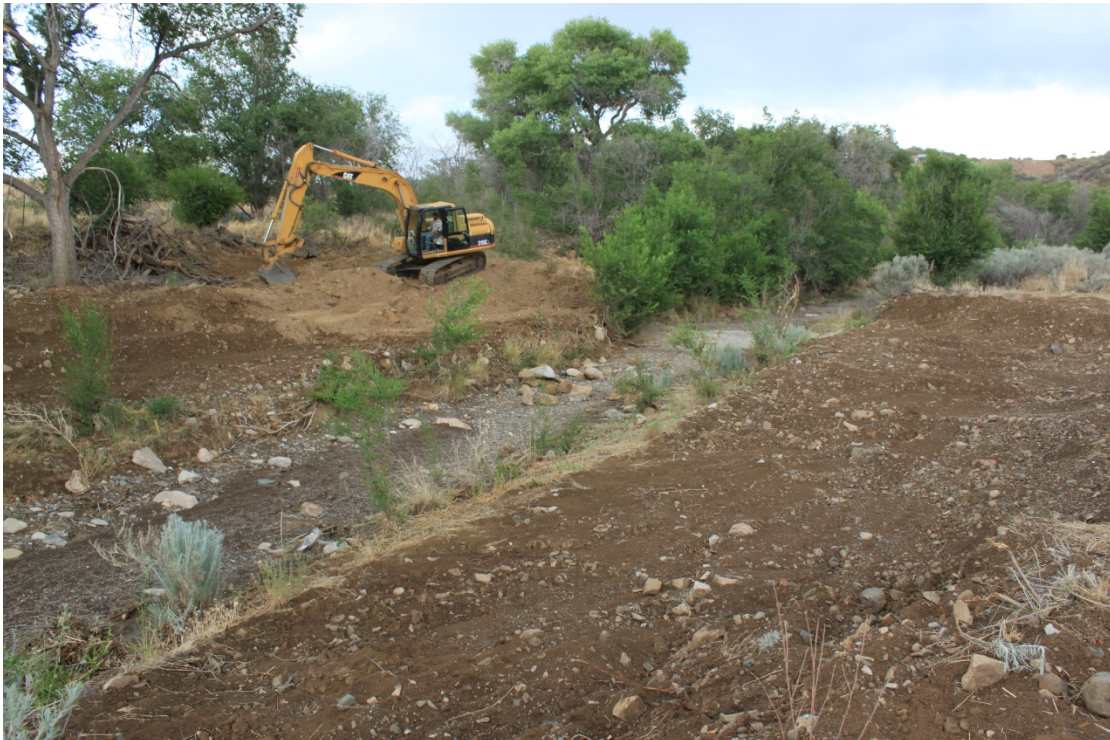
Watering in willow stakes (above) and construction of cross-vane (below)

Finally, late in the project term, a grade-control structure was built in San Vicente Creek to slow flood waters, allow for ground water recharge, protect a municipal sewer line and arrest the gradual incising of San Vicente Creek. The grade control structure was a rock cross-vane and Zuni Bowl, built by Stream Dynamics, Inc. The structure spreads water out onto the surrounding floodplain while slowing the velocity within the main channel. Planting of wetland and riparian species native to the area accompanied the construction of the cross-vane. Over 25 different species were planted, including some transplanted material that had been salvaged during construction of the cross-vane. The cross-vane was completed just prior to the summer rainy season. With several major storms and associated

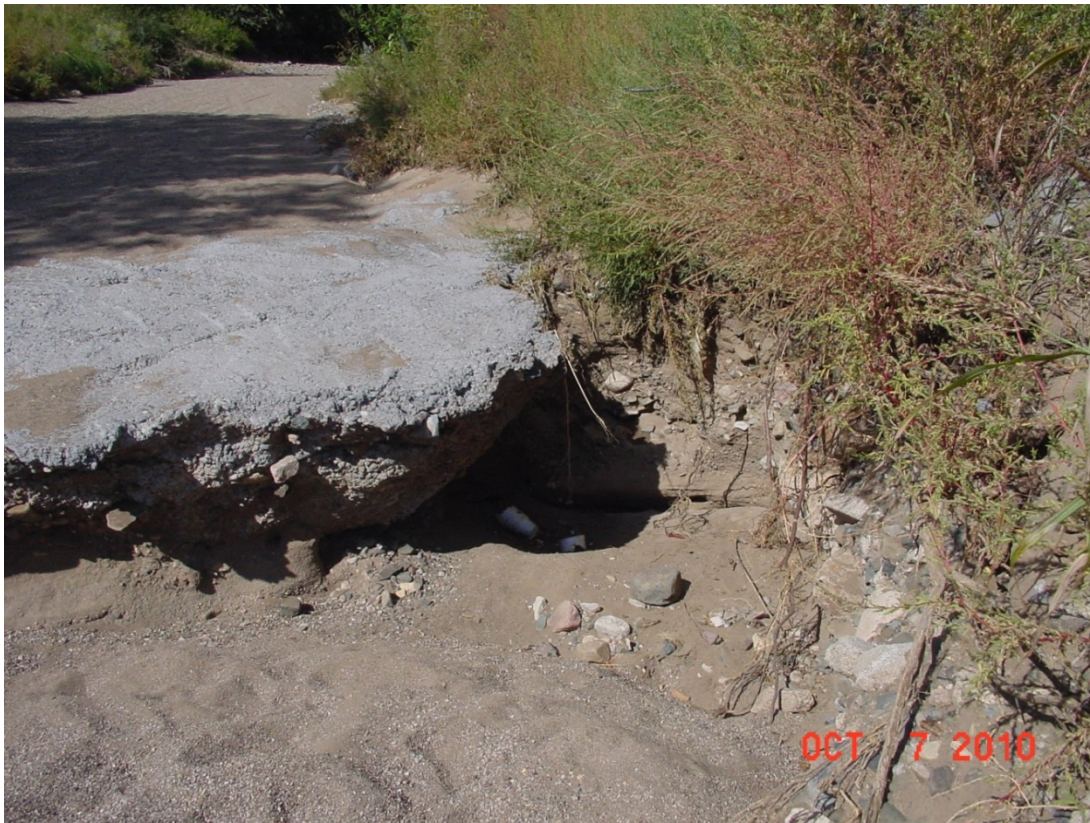
Main sewer line for Silver City crossing San Vicente Creek. Deep scour on the downstream side has compromised the concrete protection.

the streambed, and allowed for some overbank flow in portions of the wetland that had previously been disconnected from the floodplain. In terms of direct wetland creation, the cross vane resulted in approximately an additional quarter-acre. In terms of indirect impact of ground water recharge and potential to raise the water table and support wetland vegetation elsewhere, it is still too early to know. We will continue to track the site periodically with site visits and repeat photographs to try and document long term changes in the project area.

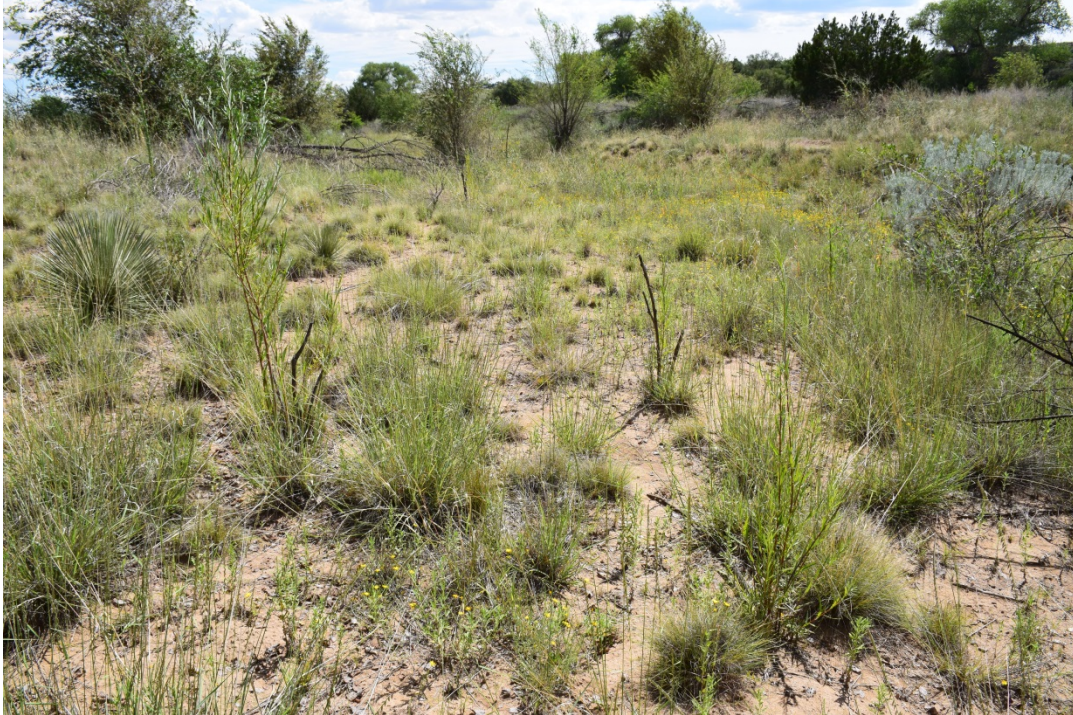
Willow stakes still alive and growing 3 years after installation in a very dry location.

a successful strategy. Most willow and cottonwood stakes and poles had an initial survivorship rate of 90% after the first growing season. After two or three years, the success rate has dropped, but still remains at between 65 and 70%. For a semi-arid climate, during a moderate to severe drought, the success is beyond our expectations.

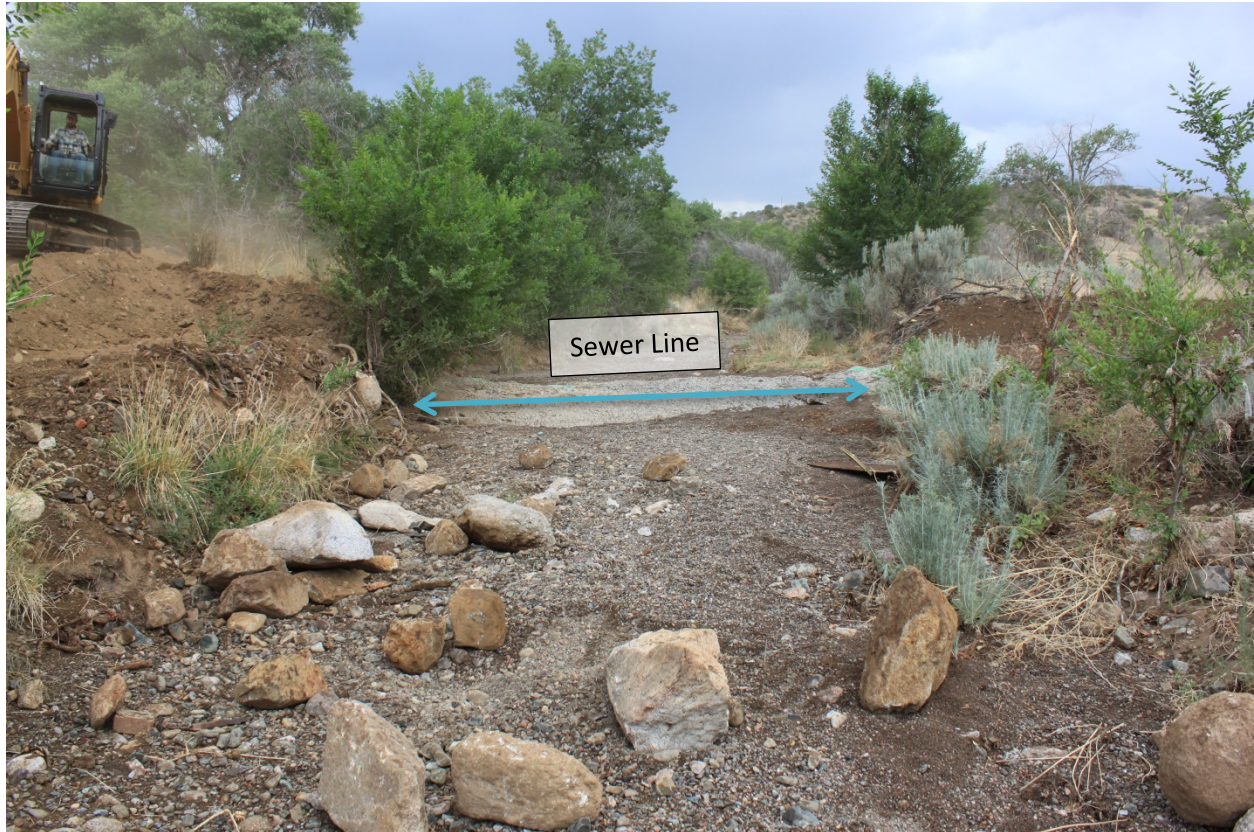
Beginning construction of cross-vane to protect the sewer line and also raise spread flood waters out onto the adjacent floodplain. The sewer line had been broken several times in the past and was repaired by surrounding the pipe in concrete. However, the concrete accelerated flood flows and scour holes formed on the downstream side of the concrete, exposing the pipe.

The cross-vane that was built on San Vicente Creek is dual purpose. It both protects a vulnerable sewer line while slowing and spreading flood flows across the floodplain. Positioning the vane just below the sewer line slows incoming flood water allowing sediment to drop out of suspension around the sewer line creating maintenance free protection for foreseeable future. Similar types of in-stream structures could be built as part of the permitting process for new construction. The costs would be relatively minor compared to emergency repairs or replacement of damaged lines. Adding some sort of engineered in-stream protection to utility lines would also reduce the life-cycle costs of proposed developments and serve as a form of water protection by preventing damage and discharge to surface waters. They should be viewed as not just stream improvements, but also as components to anti-degradation policies.

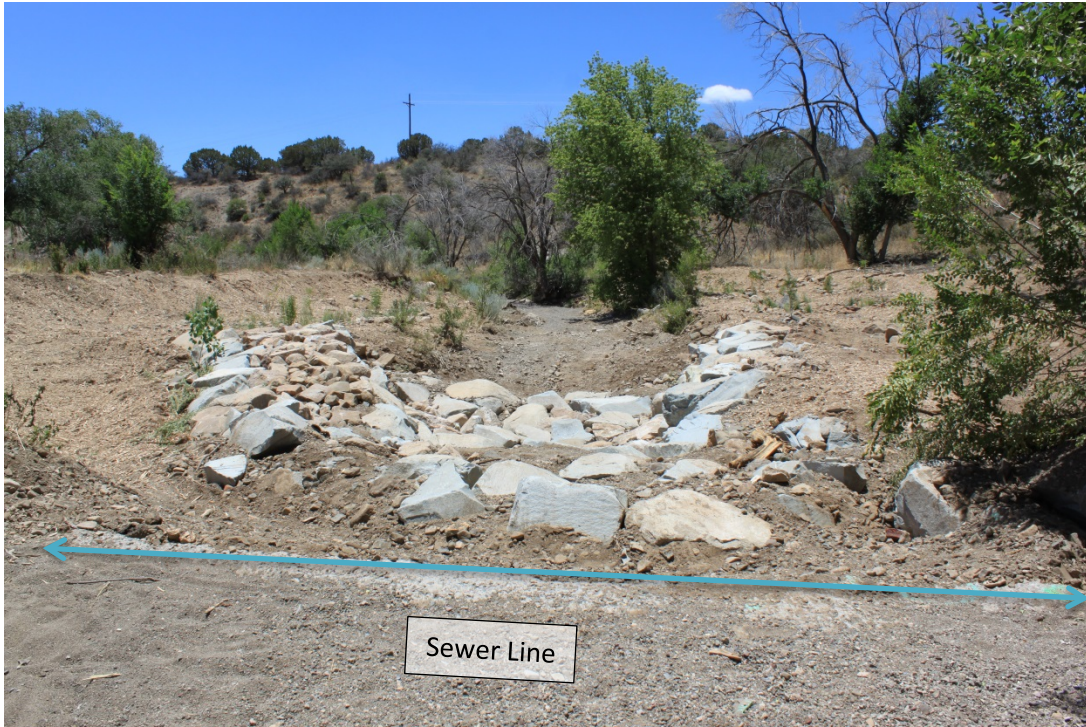
Completed cross vane during a moderate flood event with flood waters spreading onto floodplain.

flooding events, the cross vane has remained undamaged and fully functional. It has protected the city's sewer line while simultaneously slowing and spreading the floodwaters across the floodplain.

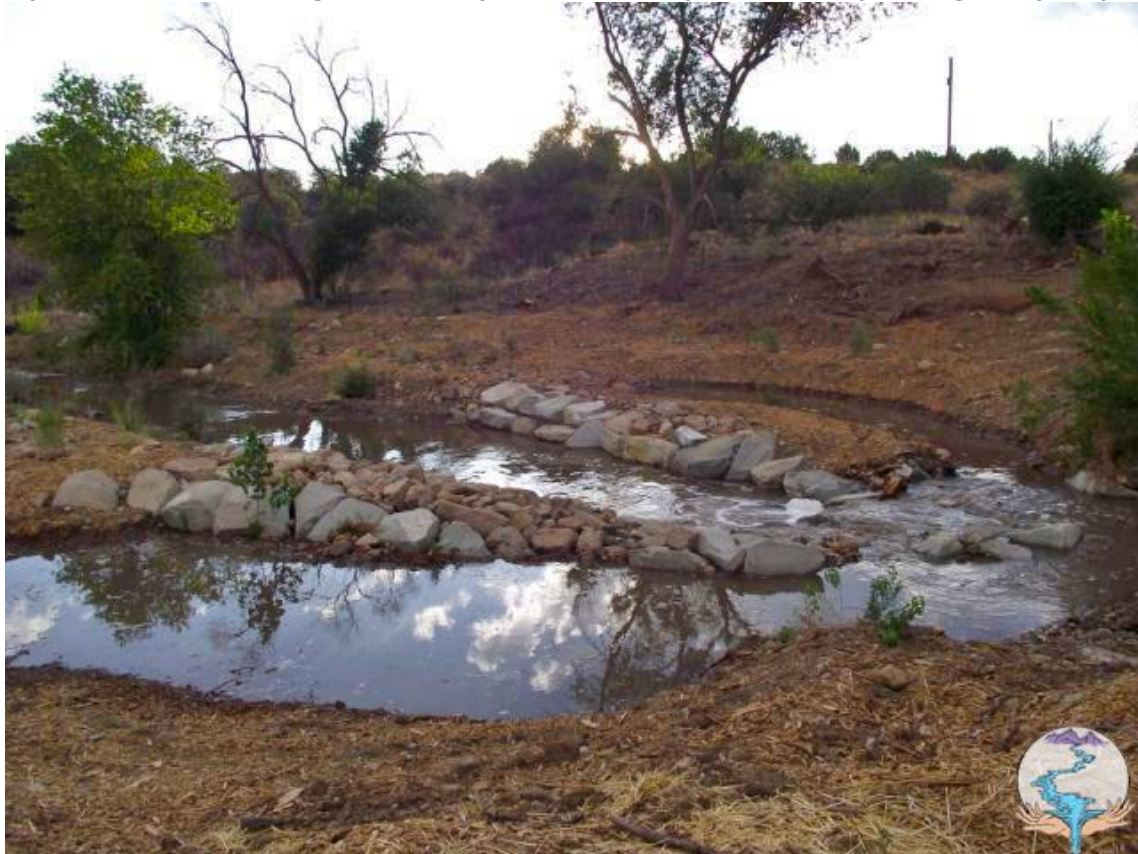
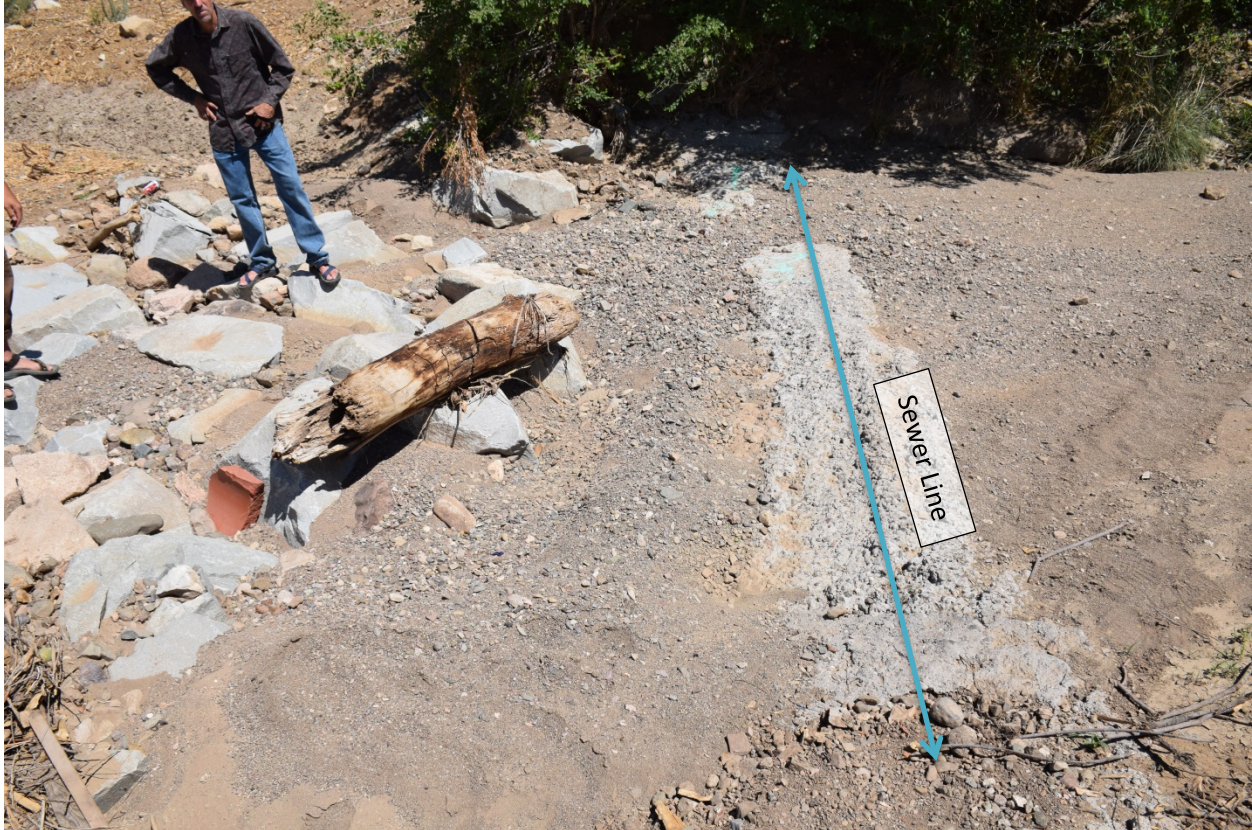
Post flooding sediment deposition. Sewer line now protected from scour by cross-vane.
