Rio de Las Vacas Wetlands Restoration Project Final Report
FY05 EPA WETLANDS PROGRAM DEVELOPMENT GRANT PROGRAM, Region 6
CWA Section 104(b)(3),
June 30, 2011
CD966016-01-0

Final Report
June 2011
Rio de Las Vacas Wetlands Restoration Project
Assistance Agreement #CD-966016-01-0

Project Description and Location

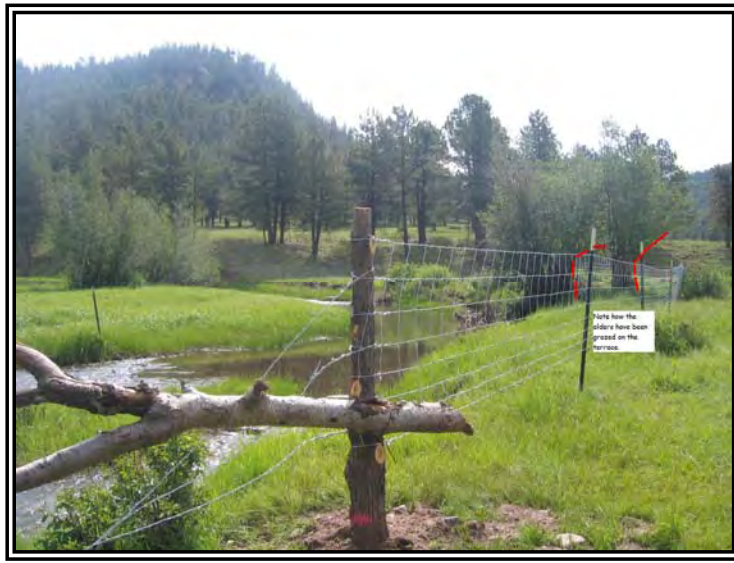
Photo 1. Hemi-enclosure fence enclosure, an innovative installation along the Rio de las Vacas.

Task 1. Hemi-Exclosure fence implementation. Twenty hemi-exclosure fences were constructed in the summer of 2008. These fences were an innovative design concept conceived by Bill Zeedyk. The hemi-exclosure fences are less expensive to construct because they take fewer materials and less labor. They also are less likely to be subject to vandalism by people or destruction by animals because the stream can still be accessed, however the more vulnerable cutbank side of the stream is protected. Also, the fence does not cross the stream, which reduces the need for maintenance following flood events. Photo 1 below shows a hemi-exclosure fence one year after construction. Note how the alders have been grazed on the right side of the photo, the stream terrace side. In contrast, Photo 2 shows previous attempts at fencing along Rio de Los Vacas, where the traditional barbwire fence is broken down and is ineffective at excluding cattle. Photo 3 shows cattle in the stream and riparian area demonstrating the need for riparian exclosures. Note the paucity of woody vegetation in the riparian area. Another important facet of this fence design is that vandalism (cutting fence wire) is less likely to occur because the fences do not present an obstruction to people, they are usually short enough to walk around.

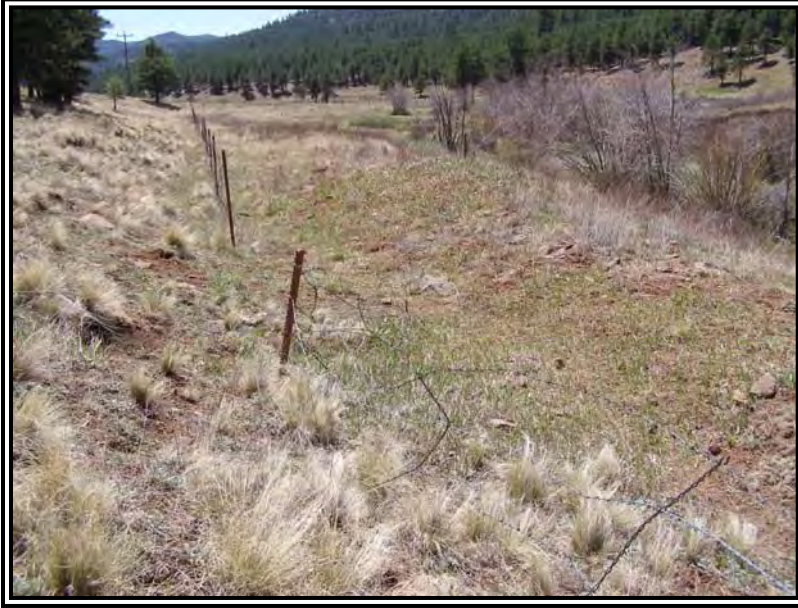
Photo 2. Damaged and down barb-wire fence along the Rio de las Vacas.

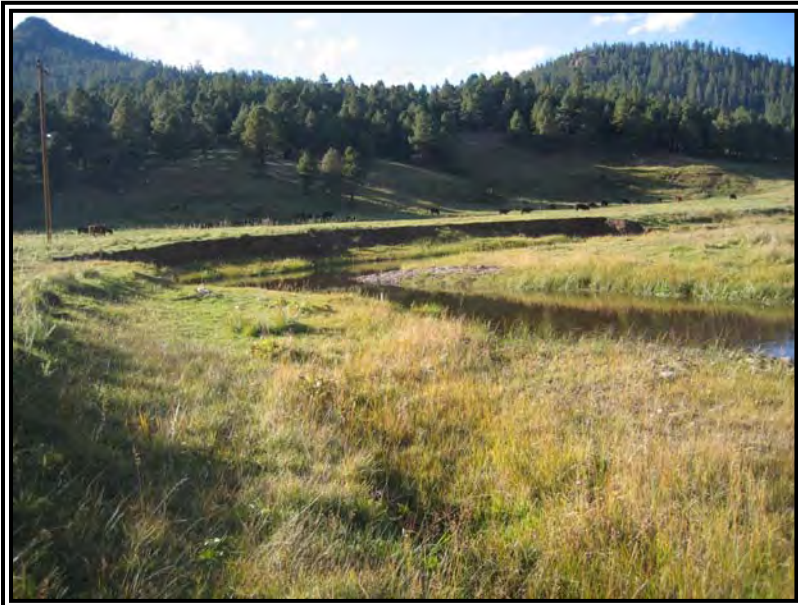
Photo 3. Cattle grazing on the flood plain of the Rio de las Vacas. Note lack of riparian species.

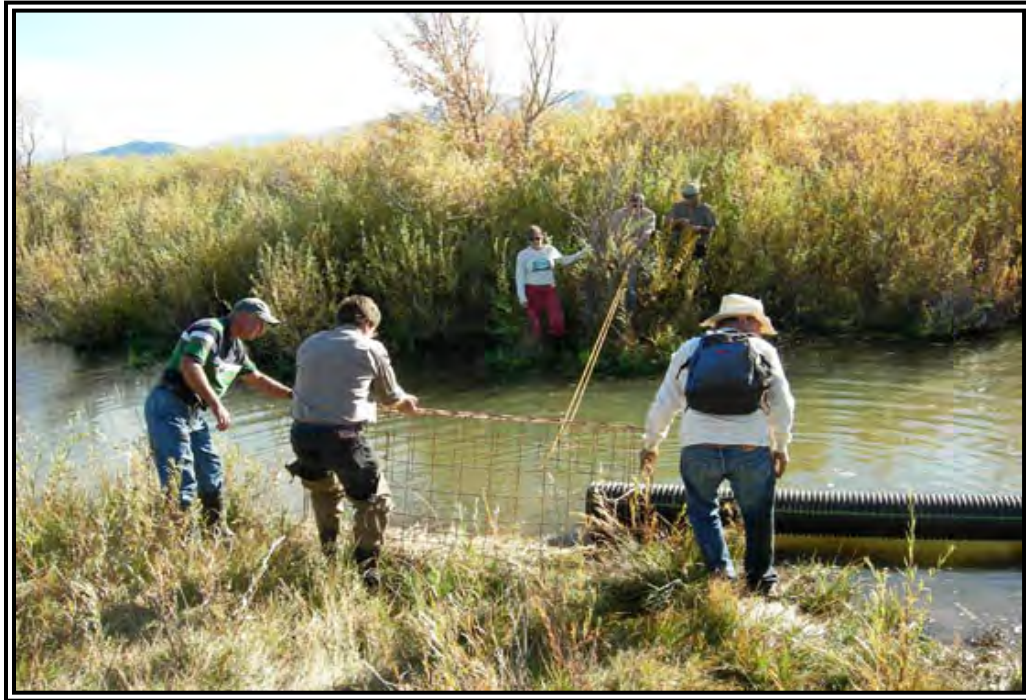
Photo 5. Making a Beaver Deceiver

A free workshop titled “Beavers Belong” was sponsored by Animal Protection of New Mexico on May 30, 2006. Various experts from around the country gave presentations to approximately 25 attendees in the morning. The afternoon was spent in the field learning hands-on how to construct a “beaver deceiver,” watching a tree-wrapping demonstration, and observing the use of live beaver traps. Speakers included Sherrie Tippie of Wildlife 2000; Skip Lisle of Beaver Deceivers International; Paul Polechla, research associate professor at the Museum of Southwestern Biology of the University of New Mexico; Josh Rector of NM Department of Game and Fish; Sid Goodloe, rancher and conservationist. Talks focused on human and beaver coexistence, relocating beavers, mitigation methods, how beavers enhance rivers and wildlife, rules and regulations of trapping beaver, and beaver biology. SWQB attended and had a booth at the event.

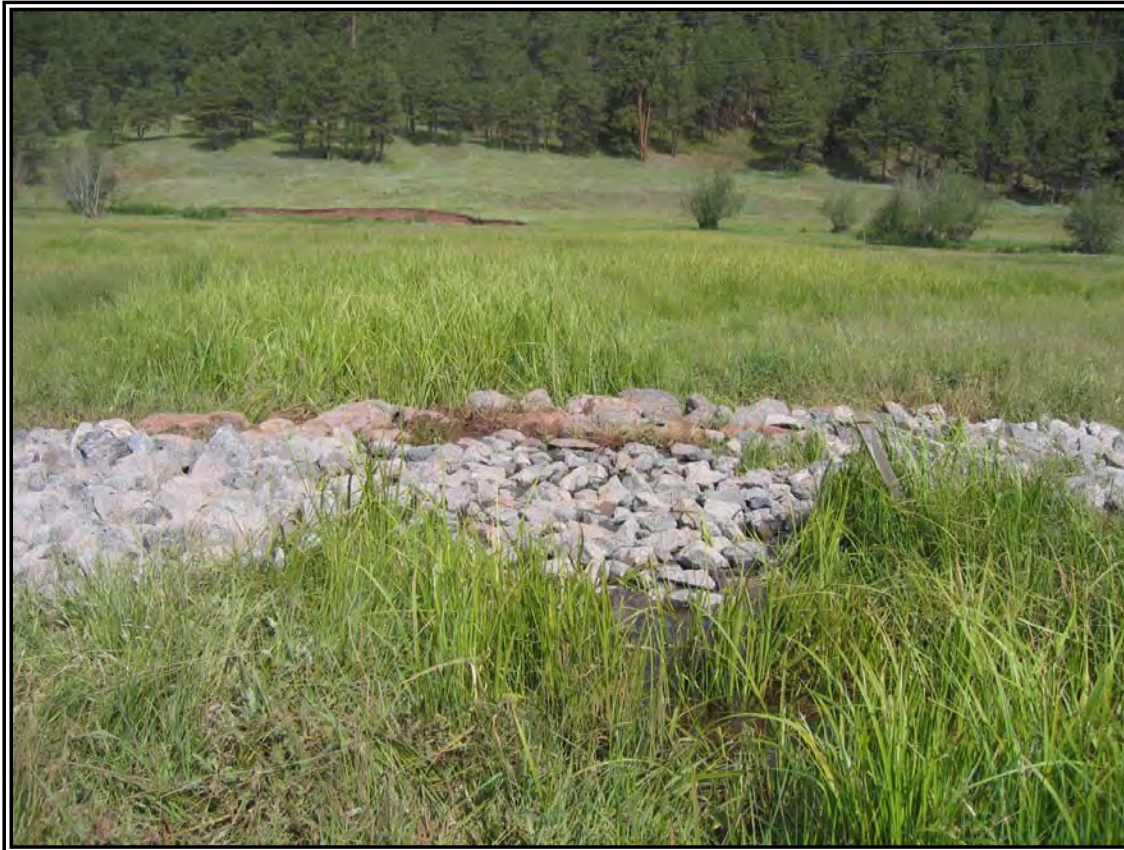
Photo 7. Media luna on Telephone canyon.

wetlands of Telephone Canyon as it drains to the Rio de las Vacas, which has been subject to erosion damage from dispersed camping. Other problems that contributed to erosion and drainage of wetland areas include ruts that are created during driving activity on seeps or during wet weather. A legacy road that was turning into two rutted trenches was treated to keep it from turning into an arroyo. The trenches were filled in and drains were put in the road to disperse and drain water off the roads.

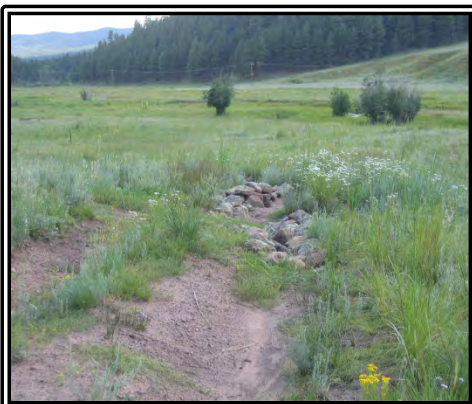
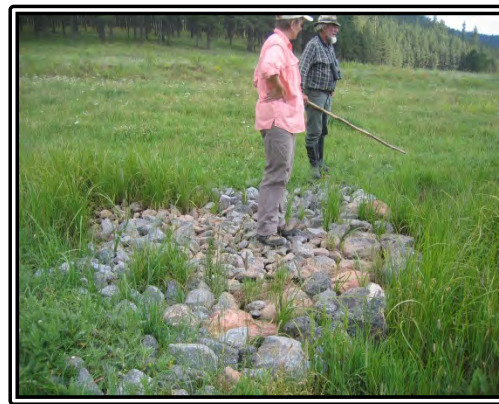
Photo 8. Left - road restoration, Right - Zuni bowl with C. Cook, USFS Fisheries Biologist and Bill Zeedyk

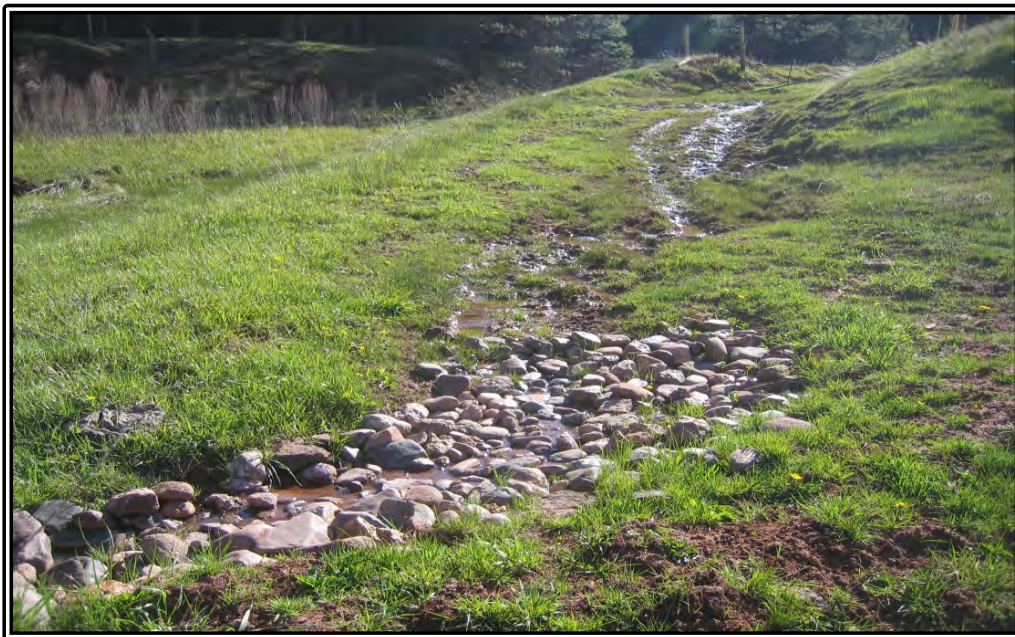
Photo 9. Turkey Canyon springs. One rock dam

During the 2009 work weekend, the work focused on the main dispersed camping area at the confluence with Turkey canyon. This area was treated with 3 Zuni bowls, and 3 one-rock dam structures. This is a popular recreational site. There are several roads and we have suggested that the USFS minimize road density here. The structures will be effective to reduce the erosion from seeps that have been both overgrazed and/or have headcuts associated with them. There are many seep and springs in the Turkey Canyon area. The one-rock dams and Zuni bowls will stabilize and slow down the surface drainage on the wetlands adjacent to the Rio de las Vacas and make it difficult for cattle to trod on.

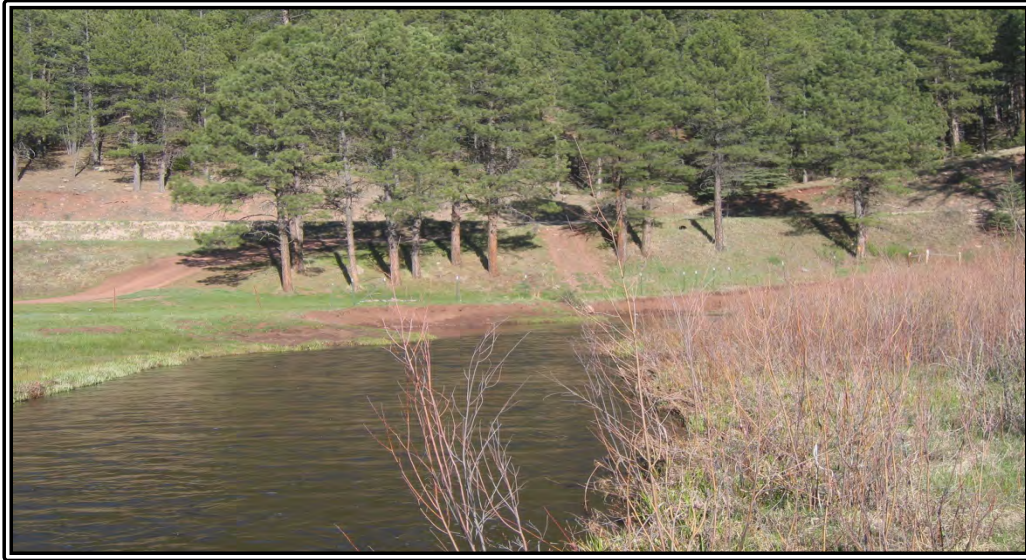
Photo 10. Roads on dispersed camp site, Turkey Canyon

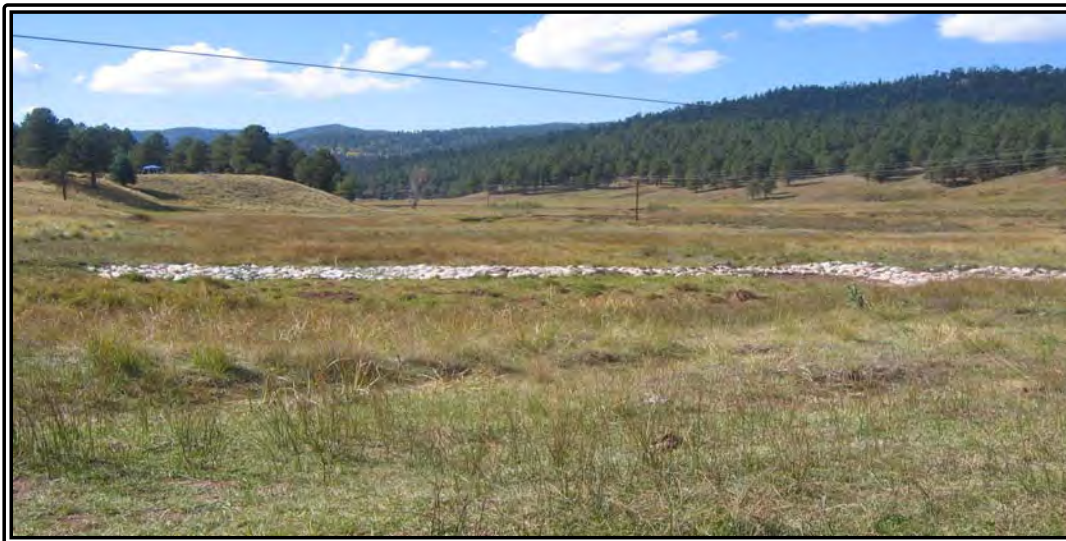
While not used heavily as a dispersed camp site, the drainage from the School Section Canyon was a focus for the work weekend in 2010. It was treated with 6 Zuni bowls on headcuts, 6 one-rock dams, and work on the road to keep trenching or headcutting from occurring in the ruts. A short channel was excavated by Rangeland Hands, Inc., to link School Section Canyon tributary to a former wetland site on the Rio de las Vacas left terrace, upstream from present wetland flow. This was planned to create a new wetland approximately 2 acres in size. The flow splitter was stabilized with a boulder flow splitter and four cobble channel liners. The function of this structure will split flow specifically during snowmelt.

Photo 11. Flow splitter on School Section Canyon

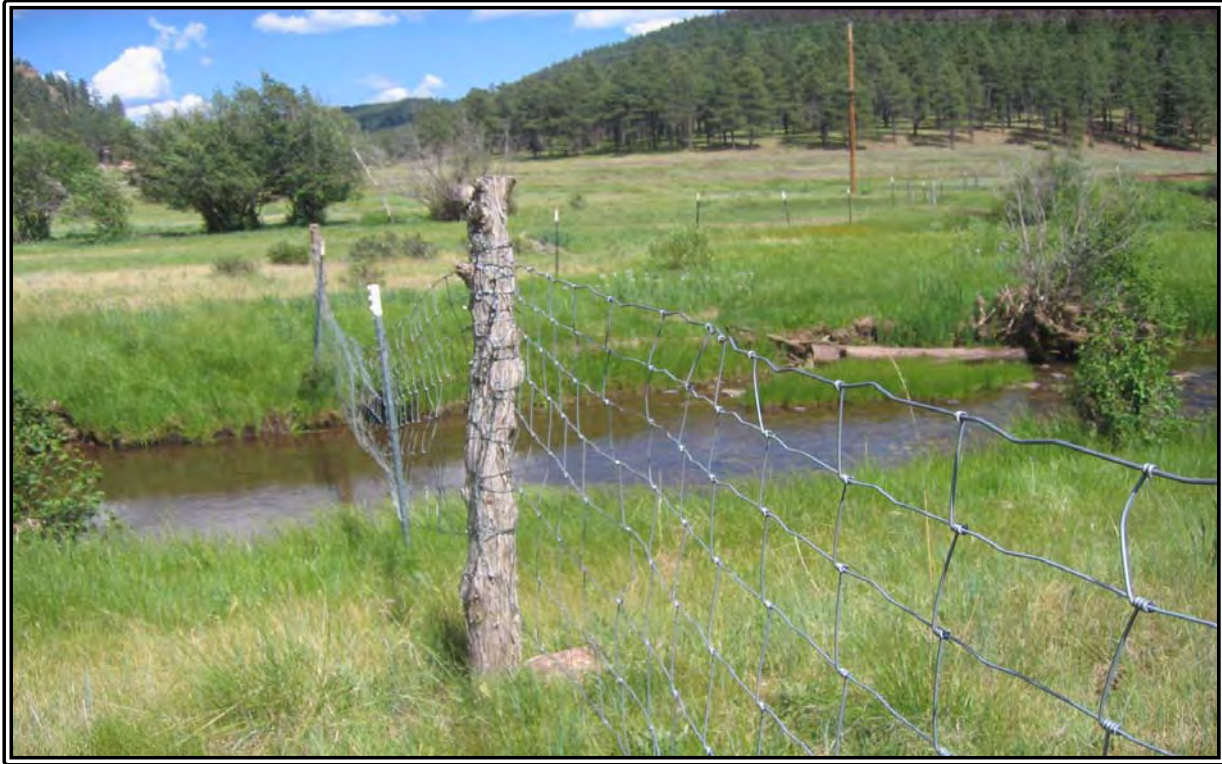
Photo 12. Mini-exclosure in upper reach

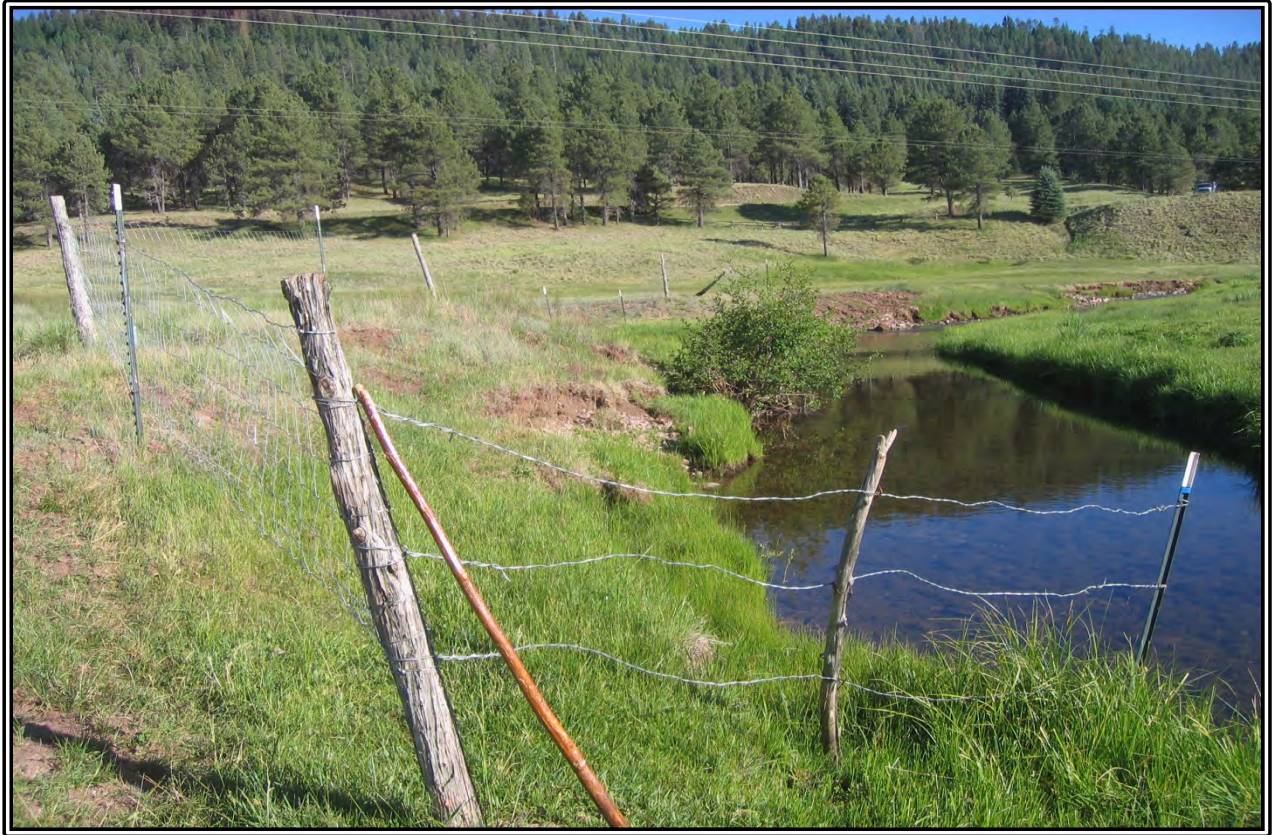
Photo 13. An example hemi-exclosure fence.

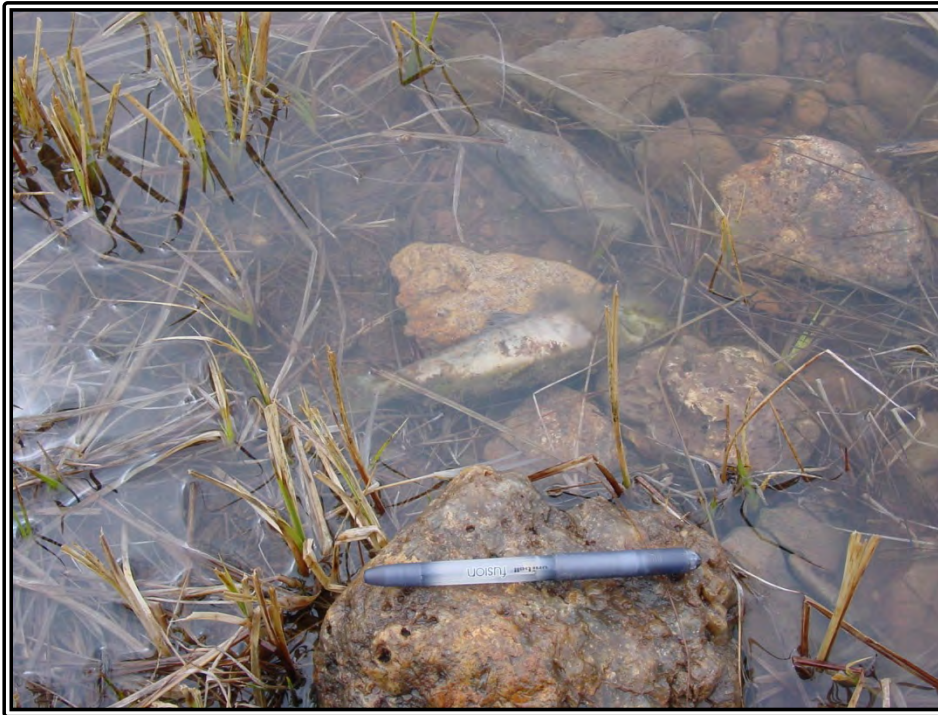
Photo 16. Fish kill 2006

During the life of this project two unlikely and unfortunate events occurred. In while we were walking the stream length it was observed that the fish were dead. Further investigation showed benthic die off and the algae was discolored.

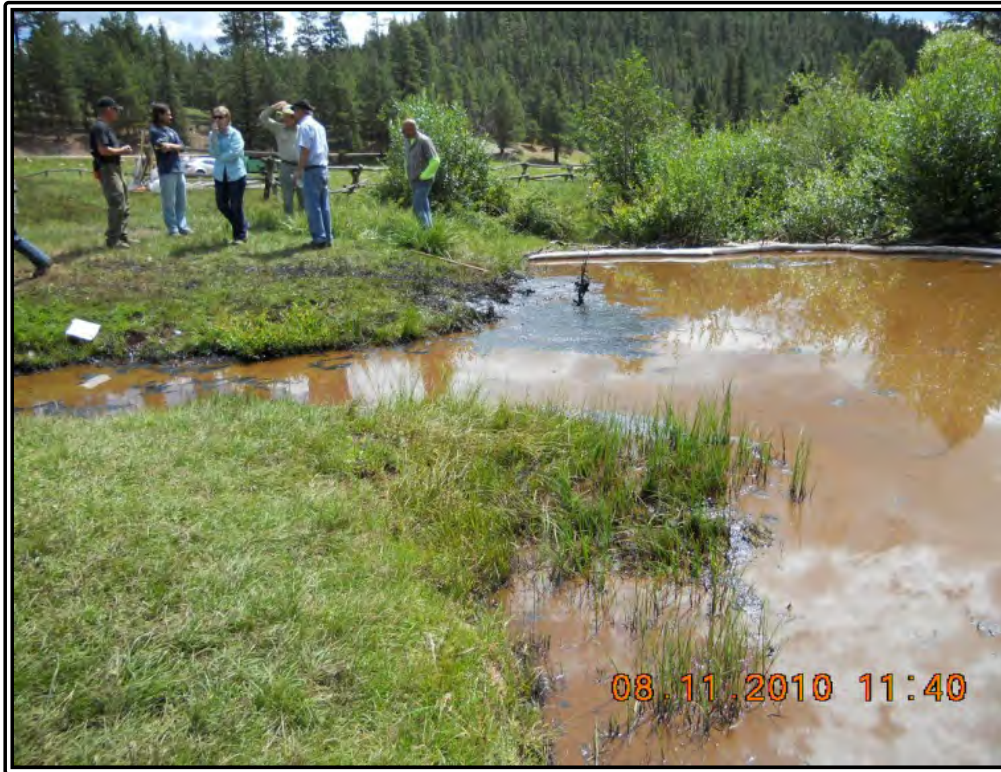
Photo 17. Asphalt spill August 2010

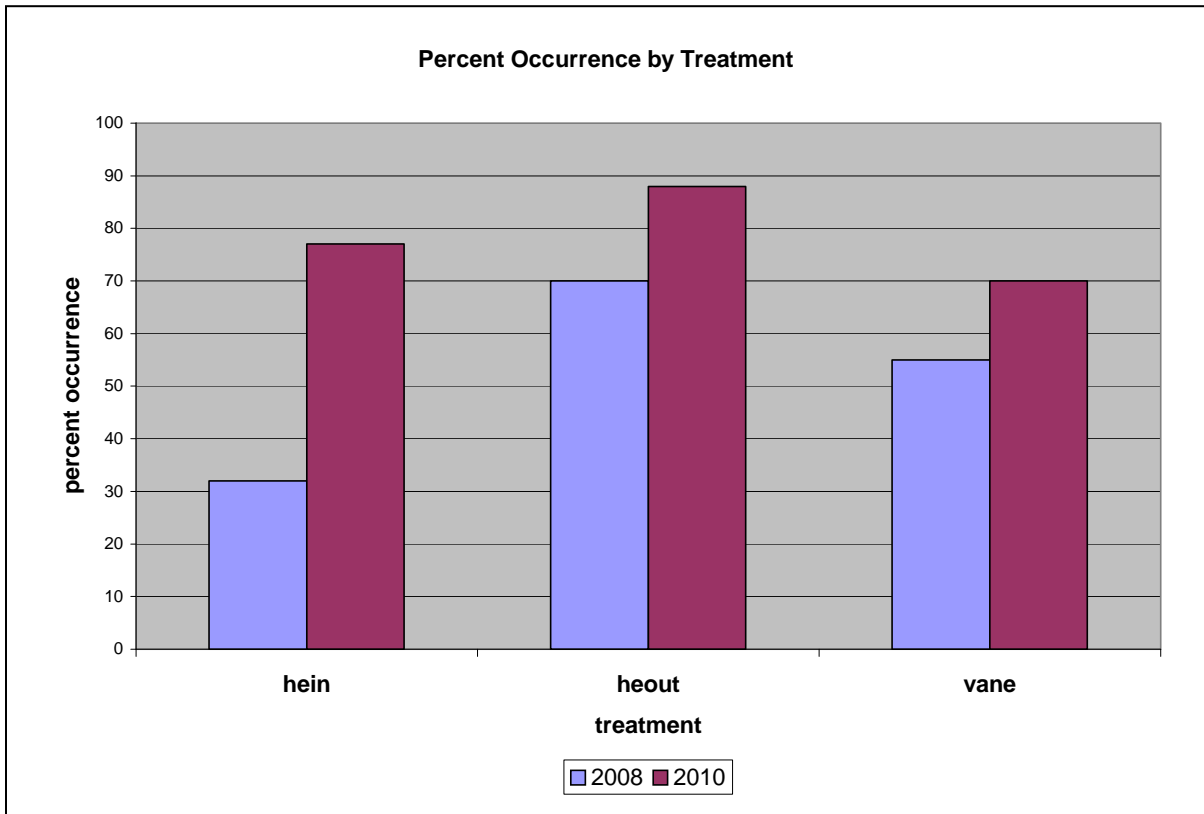
This chart compares percent occurrence by treatment between 2008 and 2010. Percent occurrence compares bare soil with any vegetation, and is very similar to percent cover for each bank transect. Overall, the hemiexclosures inside the large exclosure showed the largest increase in percent occurrence, from 31% to 77%, a significant increase, with a ($P < 0.0001$). The hemiexclosures outside the large exclosure also had a significant increase, from 70% to 88%, with a ($P = 0.0012$). The vanes (control) showed an increase in percent occurrence from 55% to 70%, but this increase was not significant ($P = 0.13$).

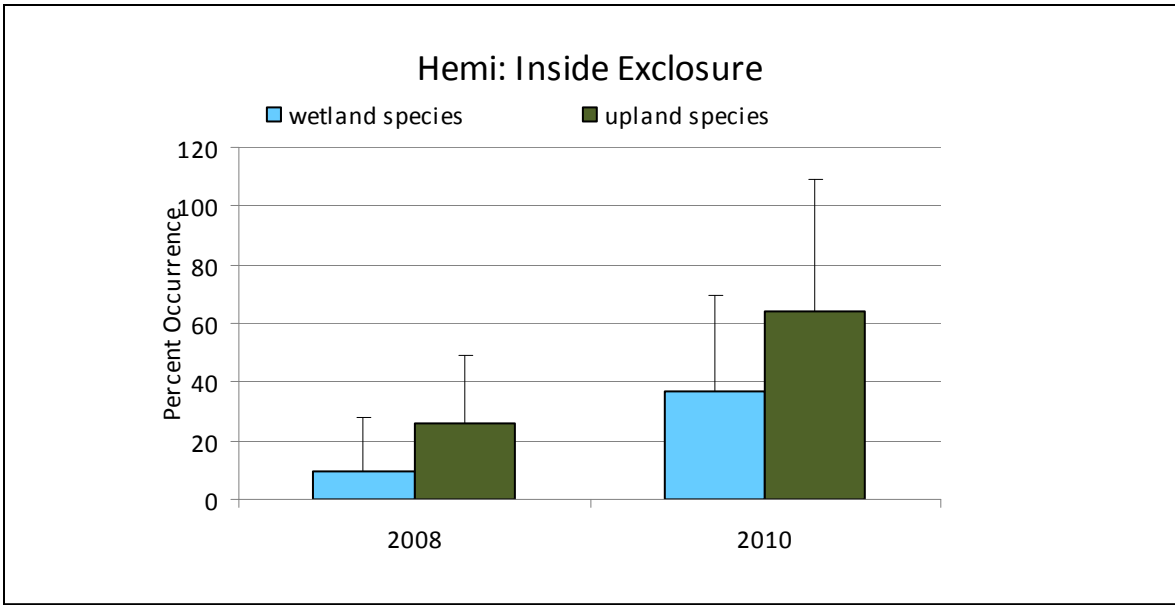
This chart shows that percent occurrence for both wetland and upland species increased from 2008 to 2010. The proportion of wetland to upland species was not significantly different from 2008 to 2010 (Chi-sq $p > 0.05$). The error bars represent one significant deviation from the mean. There were more wetland species inside the exclosure, and this proportion increased in the two years of the study. The presence of the large exclosures at the site for many years, may be the reason for the larger proportion of wetland species in this treatment, than hemis outside the large exclosures, as seen below.

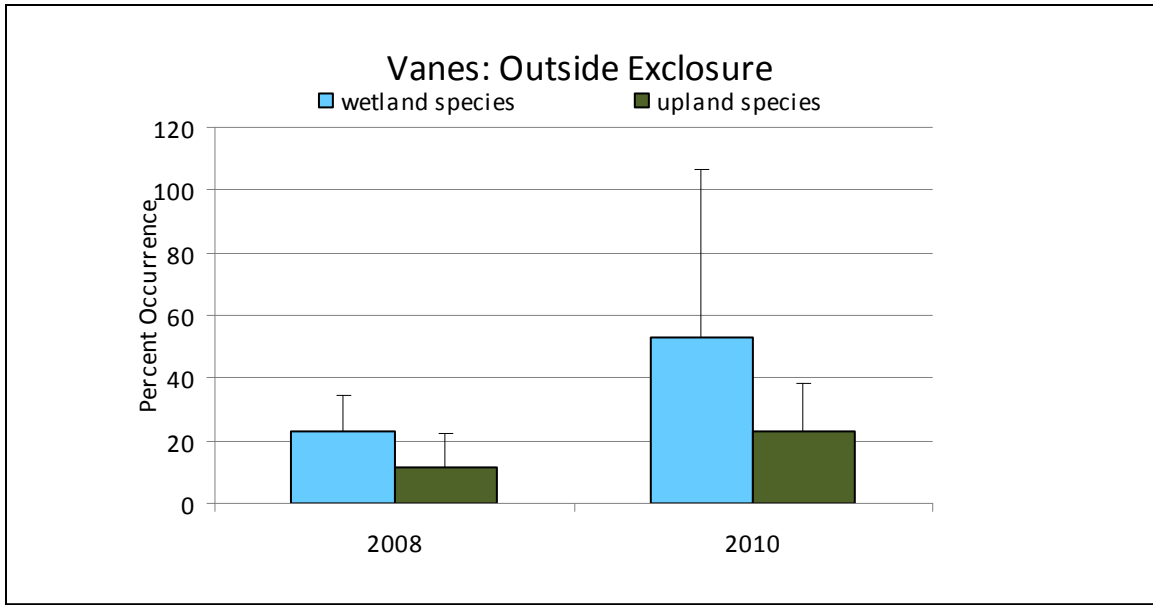
The vanes were used as a ‘control’ for the hemiexclosures, as they were not built until summer 2010. This is an imperfect control, but shows bank erosion over two winter and summer runoff seasons without any hemiexclosures. The percent occurrence for both wetland and upland species increased from 2008 to 2010. The proportion of wetland to upland species was not significantly different from 2008 to 2010 (Chi-sq $p > 0.05$). The error bars represent one significant deviation from the mean.

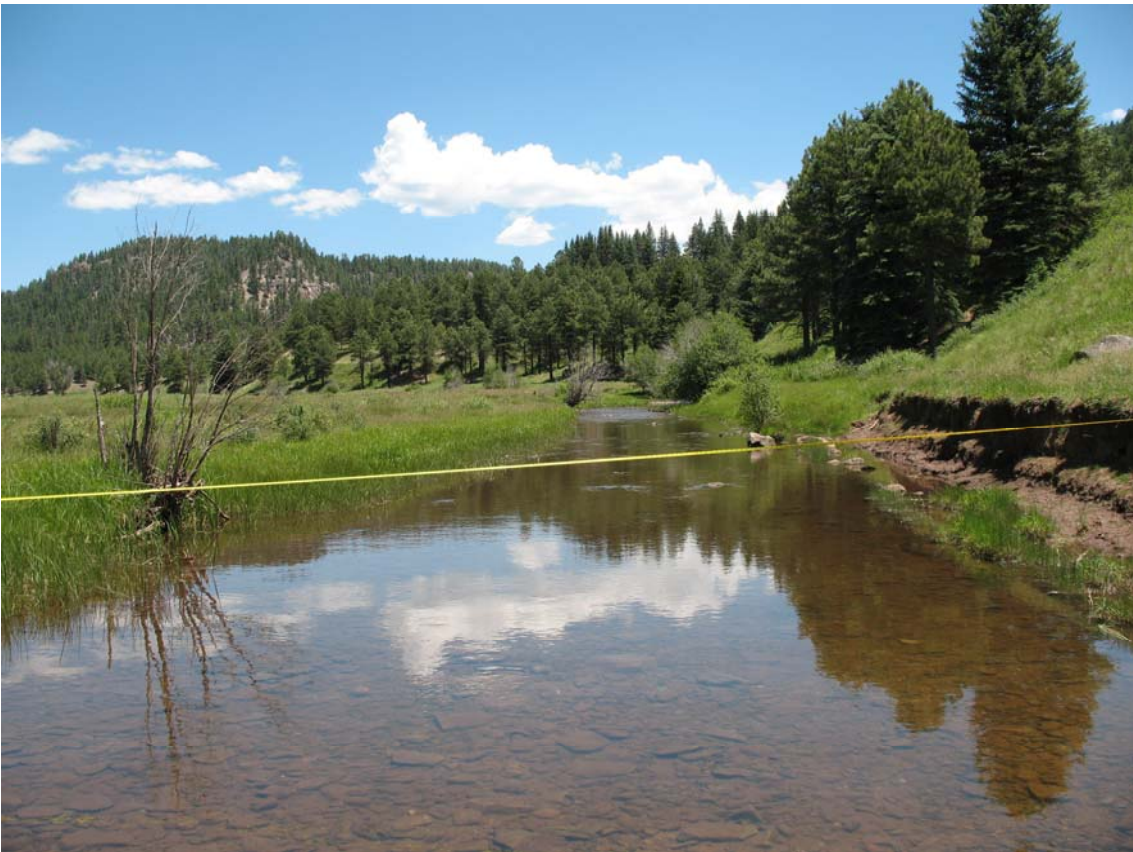
The site is located at approximately 7,900 feet above mean sea level and surrounding hillslopes host mixed conifers. The valley bottom is mostly open and covered with grasses and wetland species such as cattails and sedges in low lying areas. Alders and dogwoods are sparse but present upstream and downstream of the site (Figure 2).

Figure 2. Photo viewing upstream (north) from transect 3 prior to well emplacement.

(Figure 2) into a small terrace and steeply rising hill slope interrupted by the road cut. The right bank slopes gradually out of the stream (Figure 3).

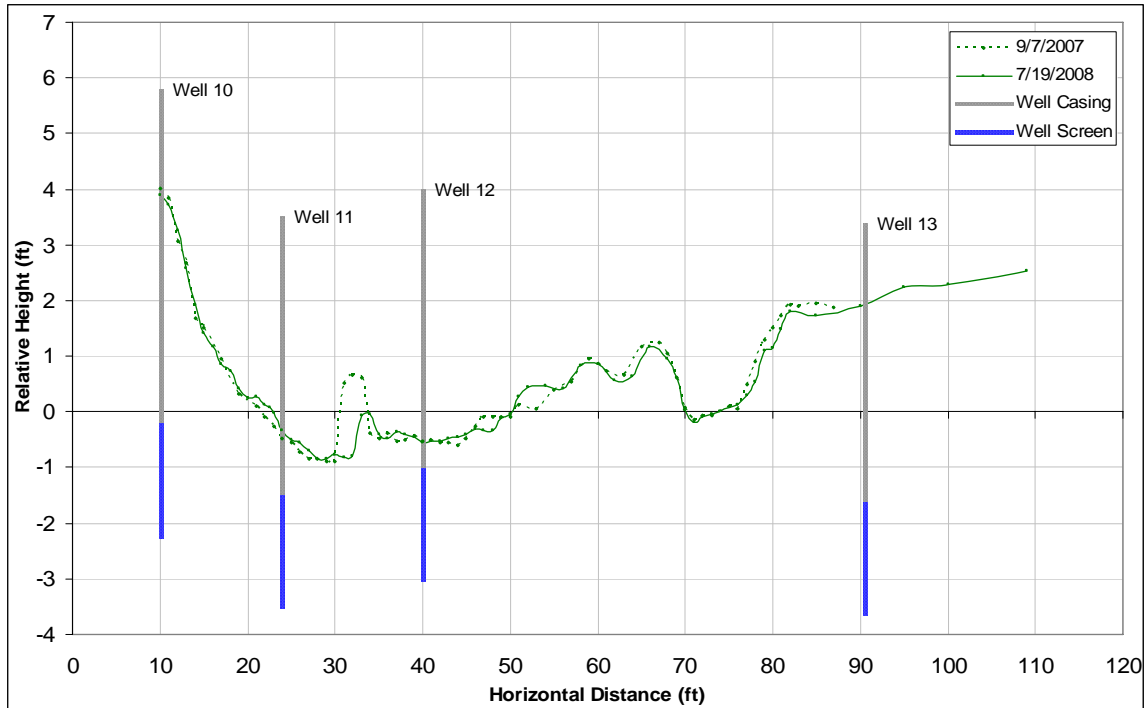
Figure 13. Well locations on transect 4; 30 feet downstream of transect 1 and the farthest downstream transect. Green lines are surveyed cross-section dimensions at post-run off flows for 2007 and 2008. Base flow on 6/24/07 is 0 ft reference.

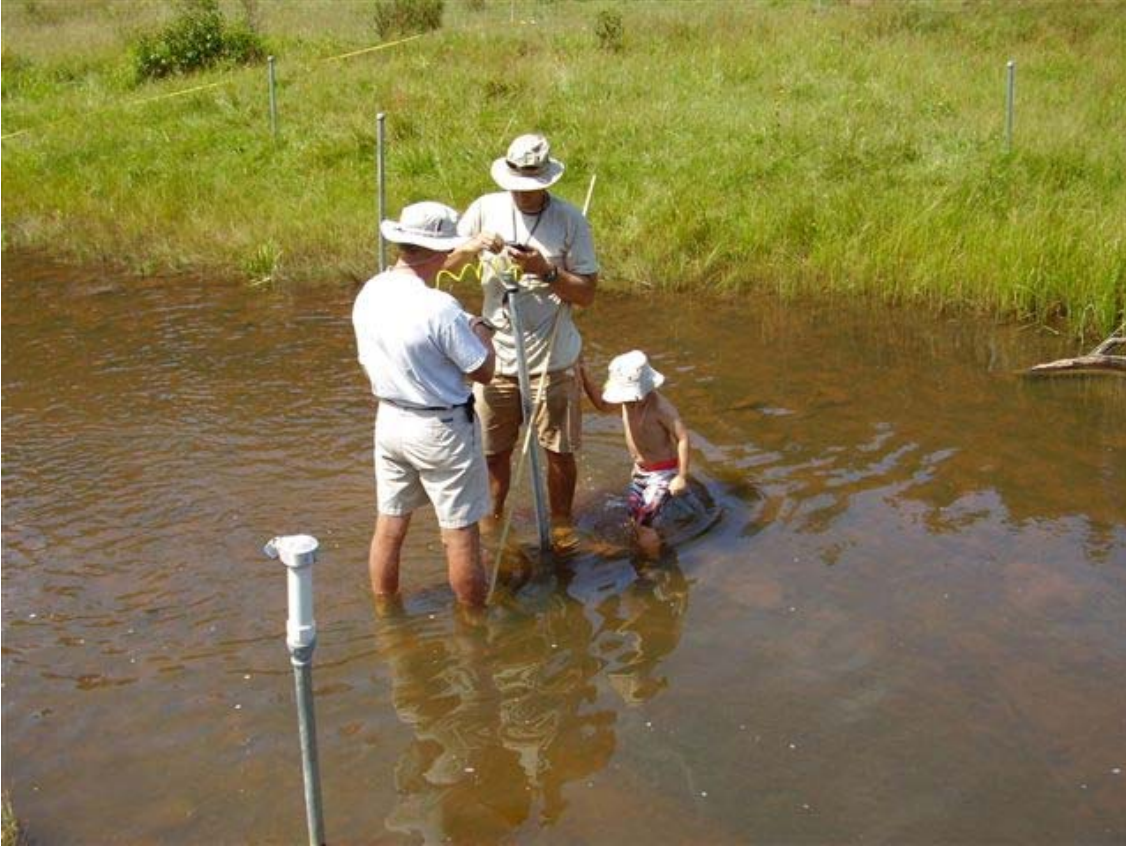
Figure 14. Instrumenting an instream well.
