FINAL REPORT

**Innovative Restoration of Historic Wetlands Along Sulphur Creek,
Valles Caldera National Preserve**

Assistance Agreement CD#00F585-01-0 (FY2012)

New Mexico Environment Department

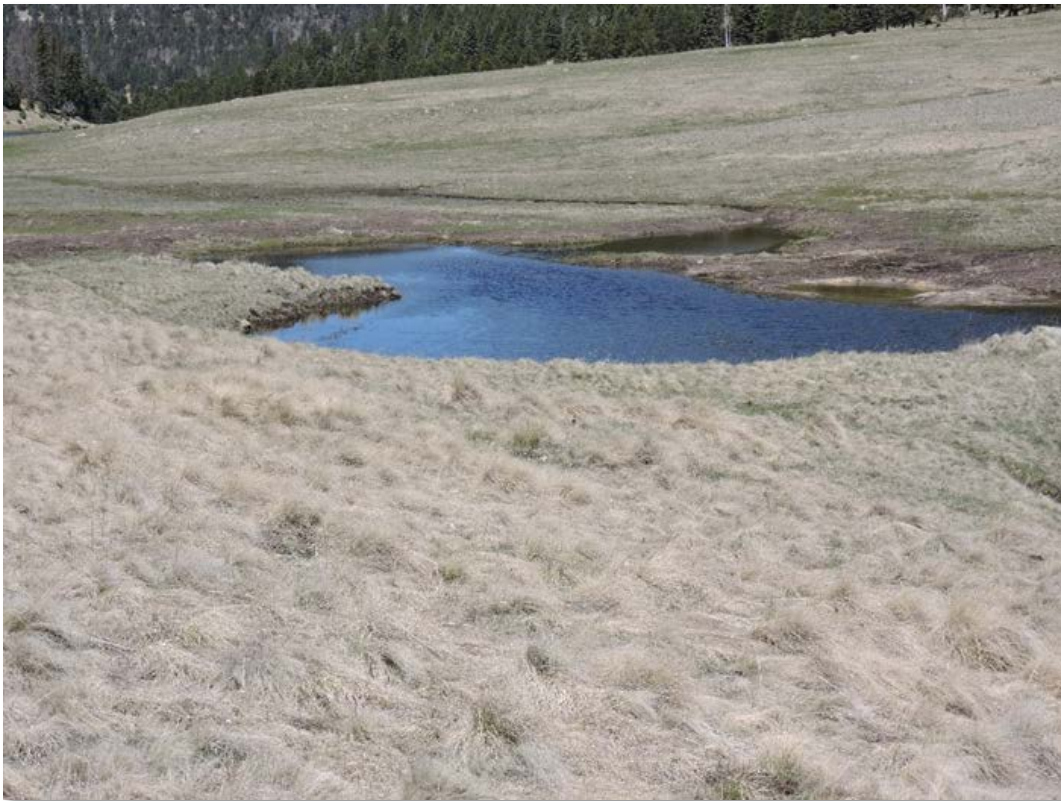
*Plug and pond structure, an innovative restoration technique designed and installed in
Valle Seco at the headwaters of Sulphur Creek (July 2017)*

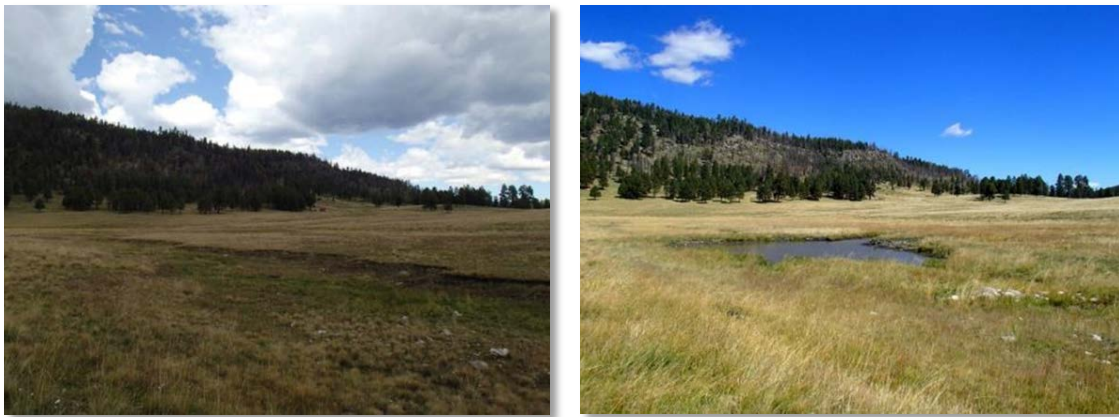
Figure 3. (left) Channelized flow in Tributary 1 of Valle Seco had desiccated historic wetlands (Fall 2014).

Figure 4. (right) A plug and pond structure at the same location has spread water across the valley and rewetted the wetlands in the foreground (Fall 2017). Both photos are taken looking upstream. Photos courtesy of Steve Vrooman.

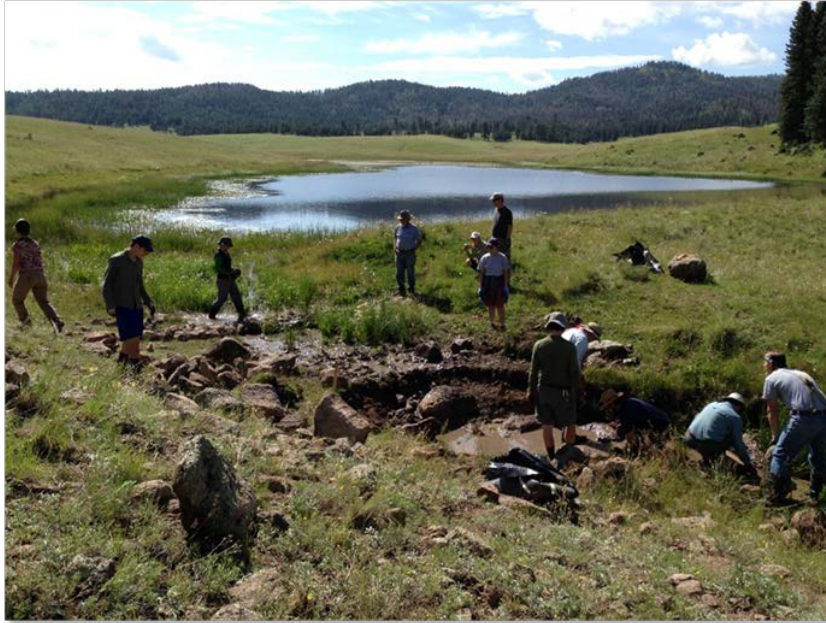
Figure 7. Volunteers constructing a series of zuni bowls and one rock dam to stabilize the spillway of an historic pond at Valle Seco (June 2016).

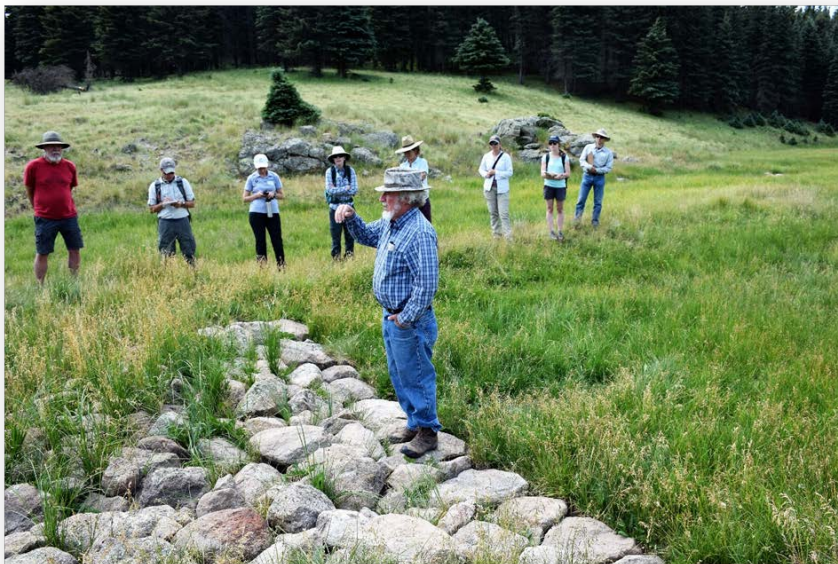
Figure 8. Bill Zeedyk, Zeedyk Ecological Consulting, explains the function of a one rock dam on a field trip to Sulphur Creek (July 2017).

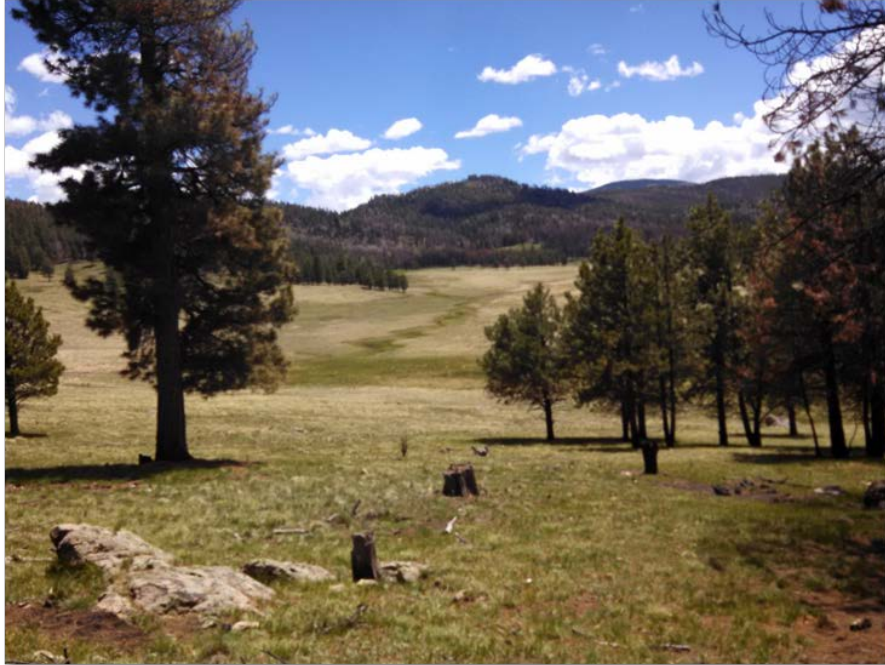
Figure 11. Slope wetlands in Tributary 1 of Valle Seco at the headwaters of Sulphur Creek prior to restoration (Spring 2012).

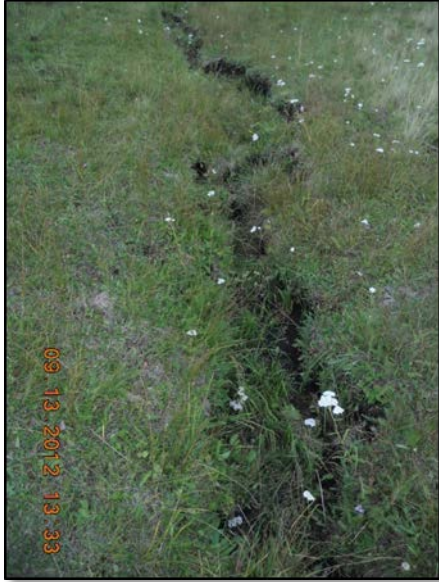
Figure 12. Looking upslope at a thin ribbon of slope wetlands (September 2012). An objective of the project is to increase wetland acreage laterally across the width of this valley.

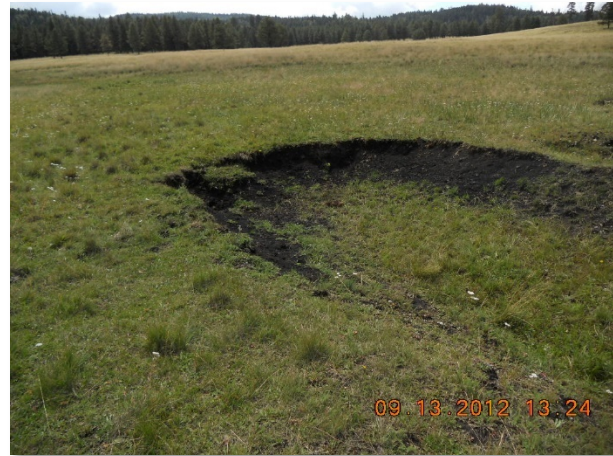
Figure 13. Numerous small channels were draining the slope wetlands (September 2012). Plugging the channels would spread the water and expand wetland acreage.

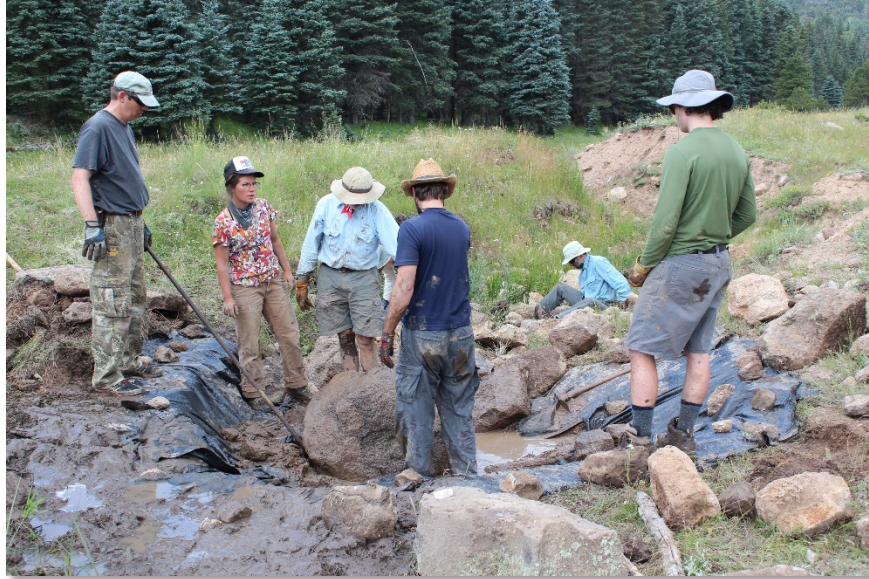
Figure 17. Volunteers considering placement of a large anchor rock in a Zuni bowl. Geotextile fabric was laid under the zuni bowl to help capture sediment (July 2015).

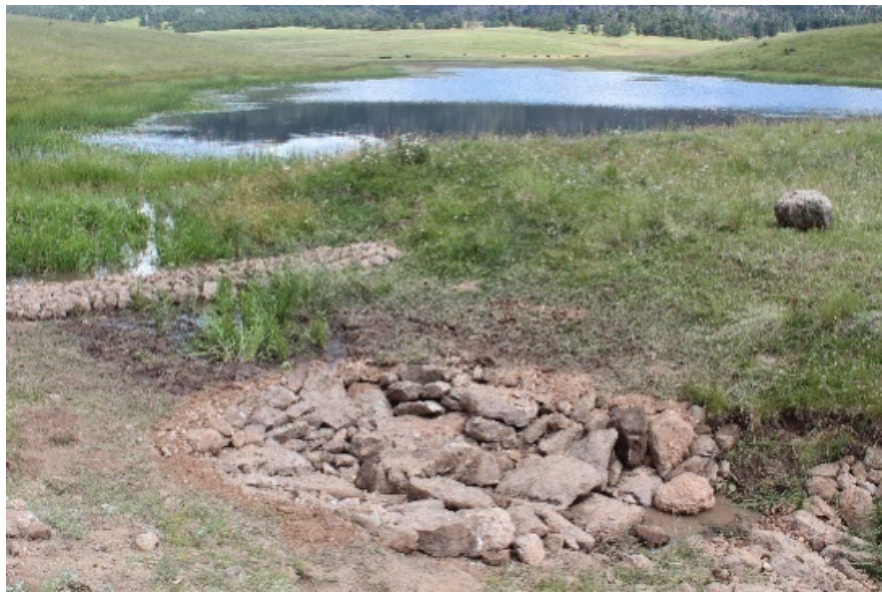
Figure 18. Completed one rock dam and Zuni bowl (center of photo). The Zuni bowl is the same structure shown under construction in Figure 17 (July 2015).

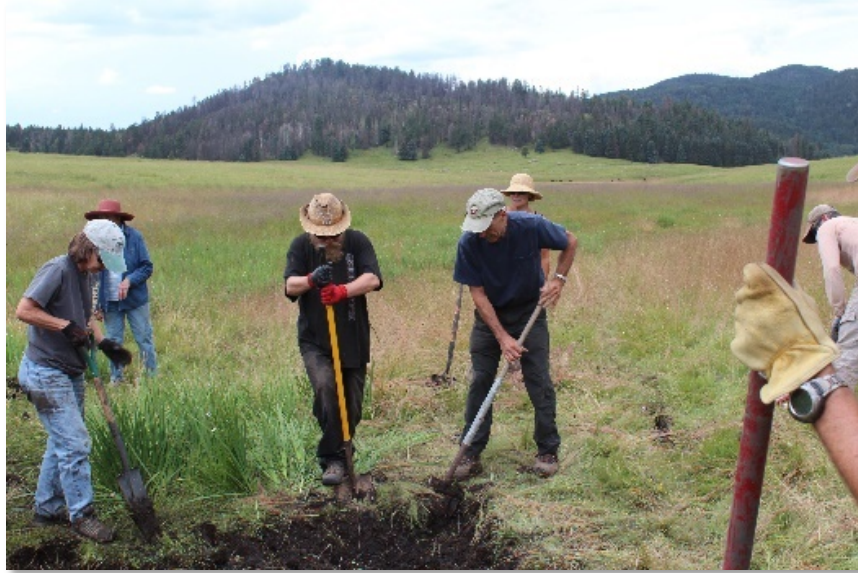
Figure 19. Volunteers digging a worm ditch to re-route water in Valle Seco (July 2015).

- At the July 2015 workshop, volunteers also dug worm ditches upstream of the pond. The worm ditches are used to address erosion and expand wetland acreage. Instead of water flowing in a main channel, part or all of the water is diverted along contour upstream of a headcut, thereby starving the headcut of the water and energy required for its continued development. The sod dug from the worm ditch is then used to help repair the headcut, along with rock structures such as Zuni bowls. The sod has abundant strong rush and sedge roots that bind the structures in place.

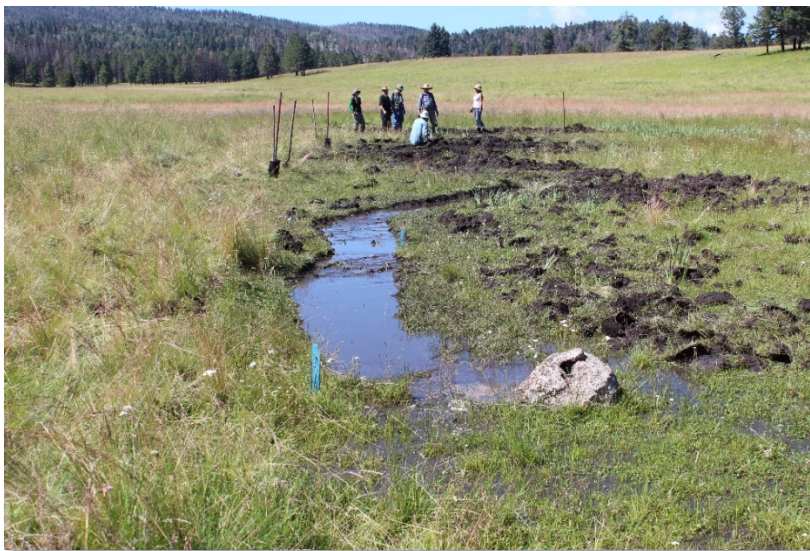
Figure 20. Volunteers completing a worm ditch. This photo is looking upslope and water is spilling out of the worm ditch in the foreground. When working in a wet area, the new flow paths are apparent immediately. (July 2015)

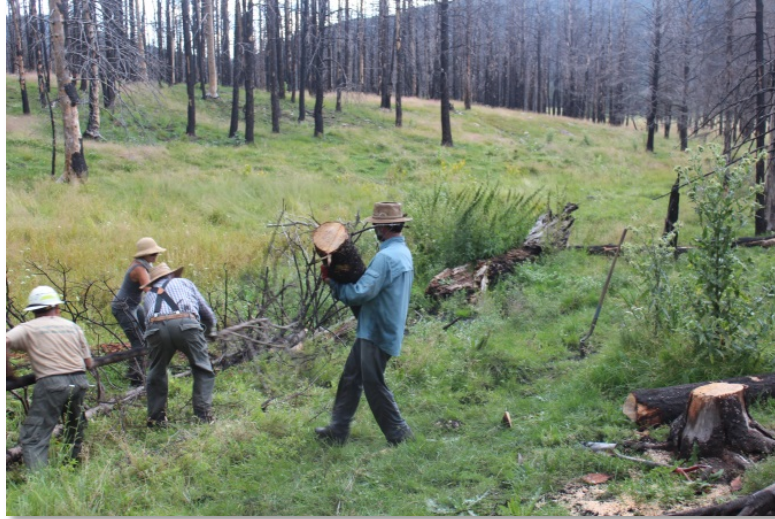
Figure 22. Volunteers stuffing a felled tree into a channel in the burn area at the headwaters of Tributary 1. The tree plugs the channel and causes flow to spill out onto the wetlands (August 2015).

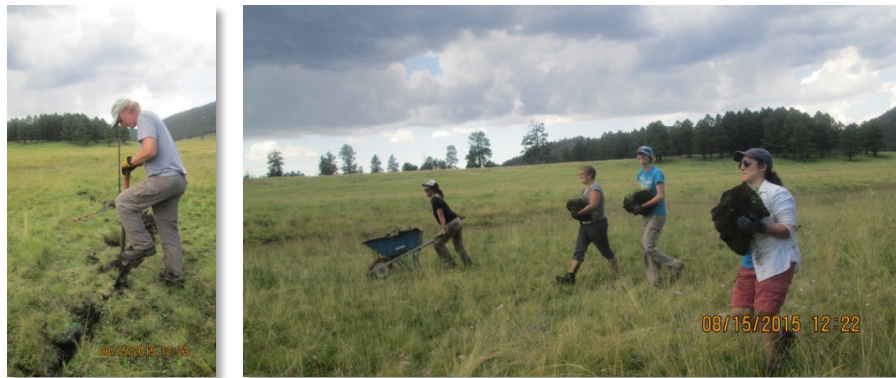
Figure 23. Volunteers digging a worm ditch (left) and carrying sod to plug channels (right) (August 2015).

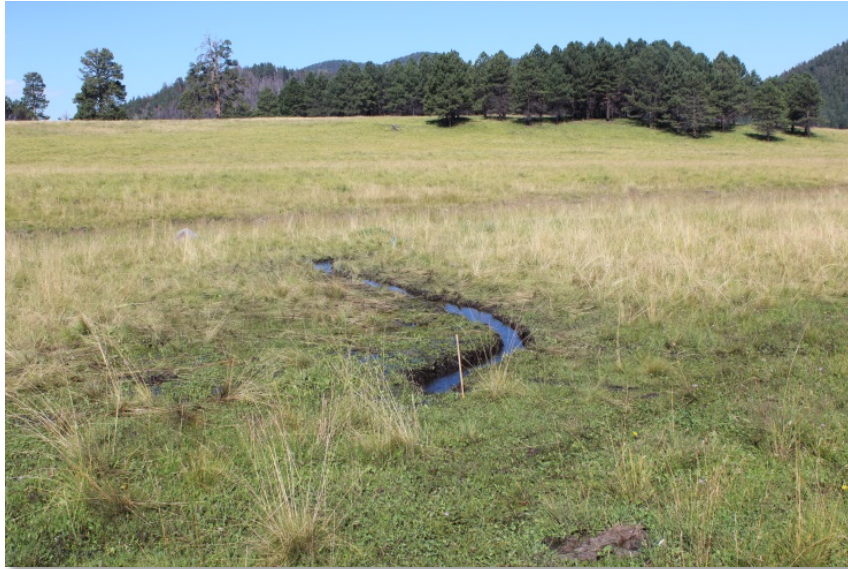
Figure 24. Worm ditch completed by volunteers as it began to spread water across the valley (August 2015).

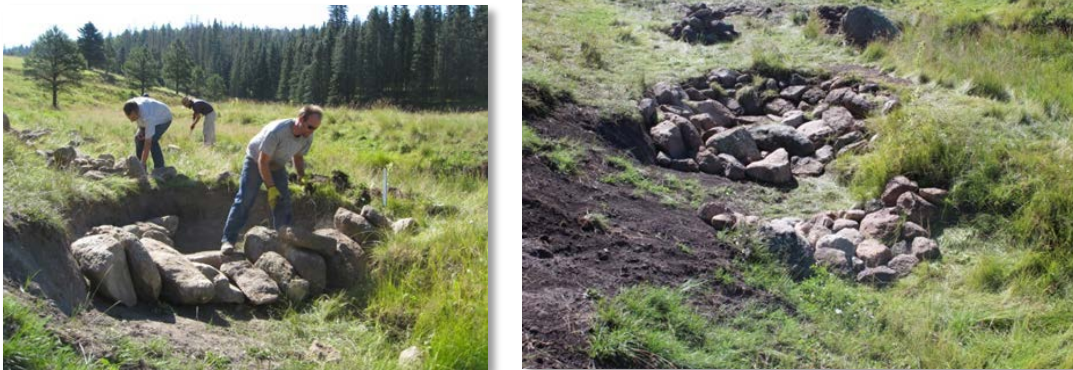
Figure 25. Volunteers building Zuni bowls to prevent headcuts from advancing upstream (August 2015).

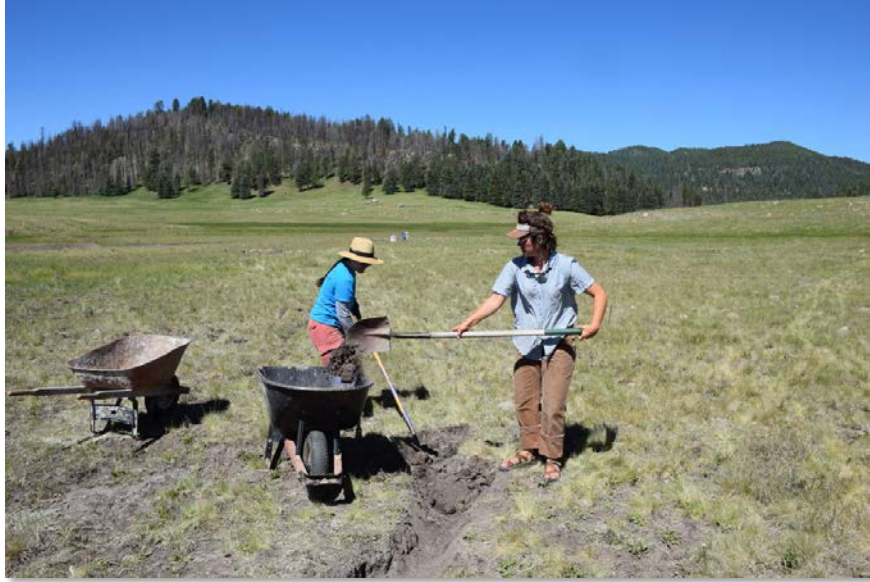
Figure 26. Volunteers digging a worm ditch to spread water in Valle Seco (June 2016).

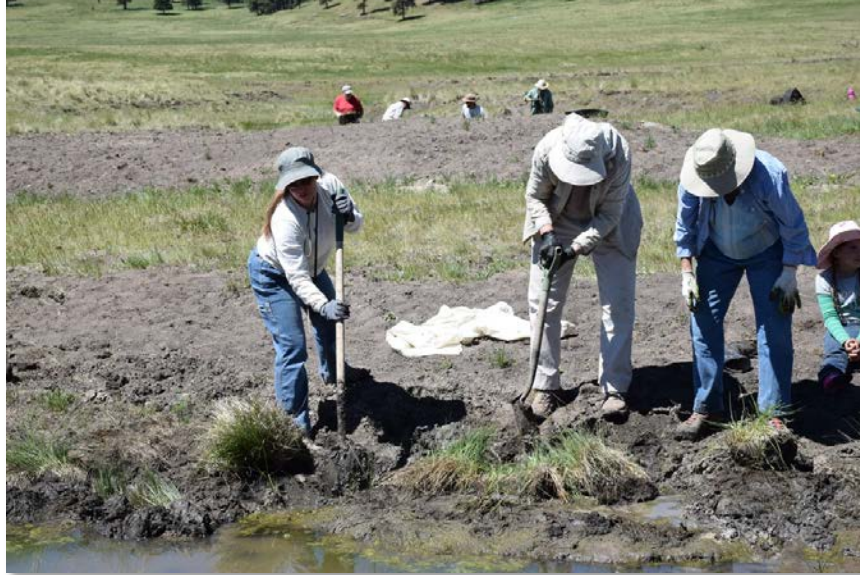
Figure 28. Volunteers transplanting sod to vegetate the perimeter of a plug and pond structure (June 2016).

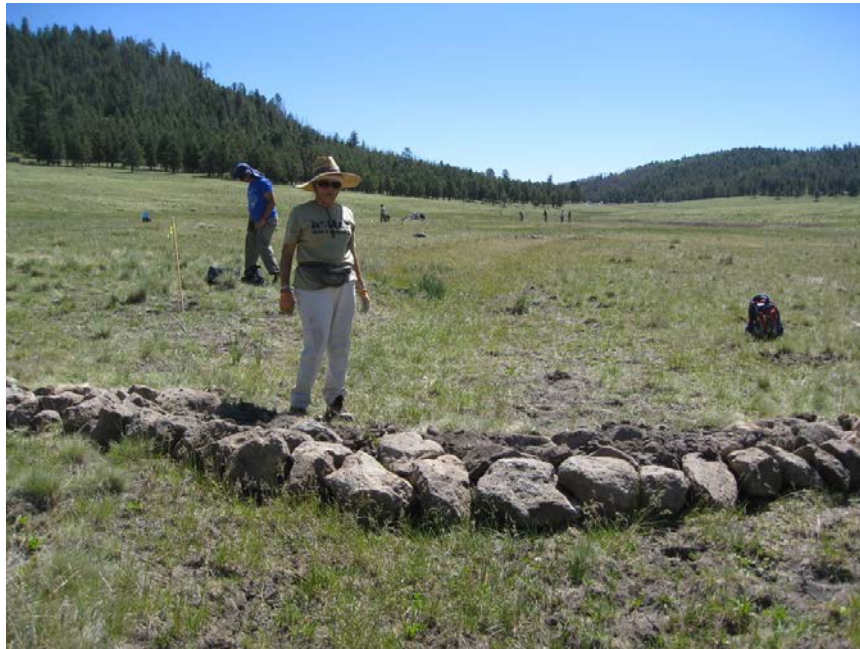
Figure 29. A completed media luna will spread surface water to rewet historic wetlands. Looking upstream in Valle Seco (June 2016).

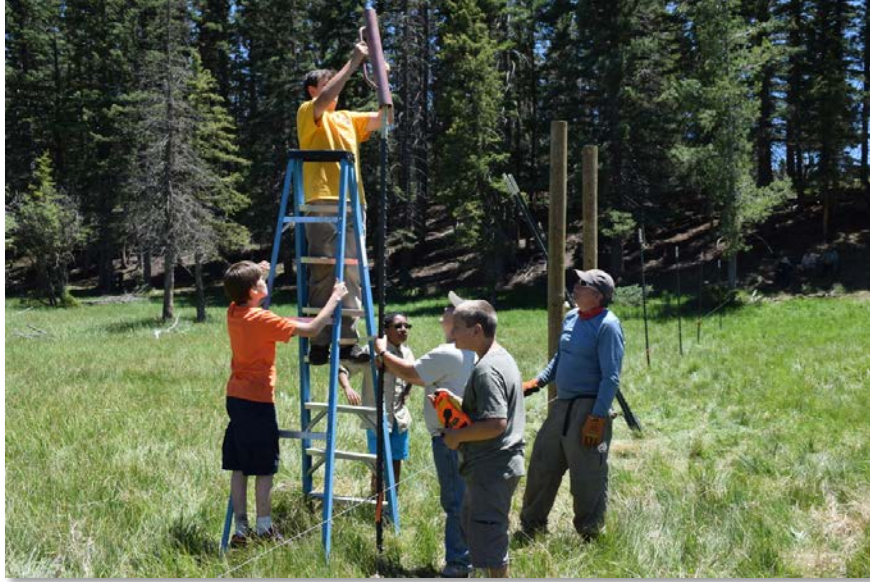
Figure 30. Boy scouts constructing elk exclosure fencing to protect old Bebb's Willows (June 2016).

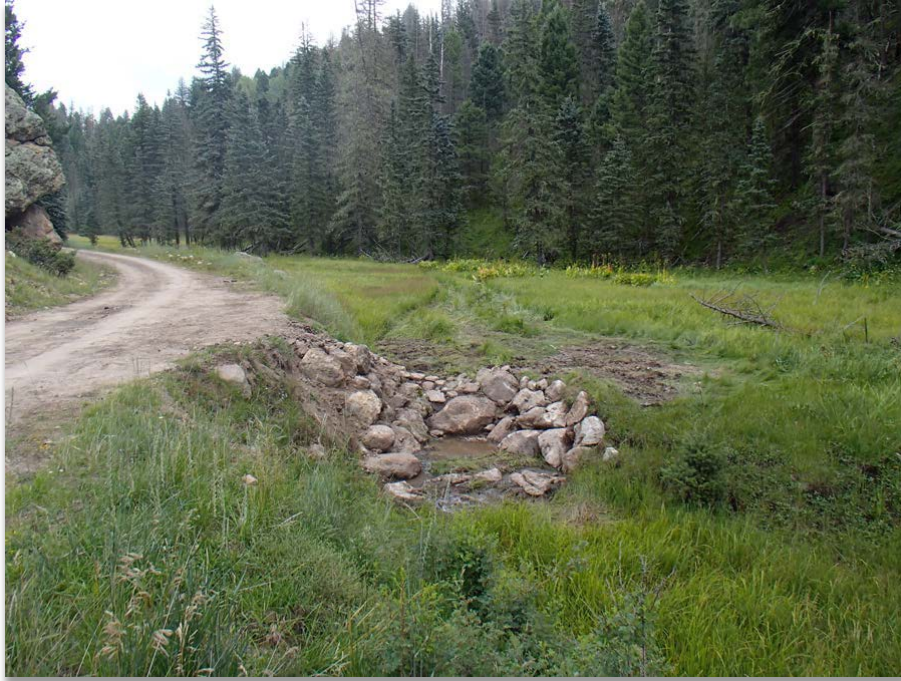
Figure 32. Road work included this machine-built Zuni bowl that collects runoff from Road VC08 (September 2016).

- In August and September 2016, Keystone Restoration Ecology built plug and pond structures in Tributaries 1, 2, and 4 of Valle Seco and along the mainstem of Sulphur Creek. Road work was completed using machinery at several sites in August and September 2016. Zuni bowls were constructed along Road VC08 to collect and infiltrate runoff from the road. The rocks for the Zuni bowls and structures built by volunteers were gathered by machine and by hand along Road VC06, then the area was re-graded to improve vehicle travel and runoff.

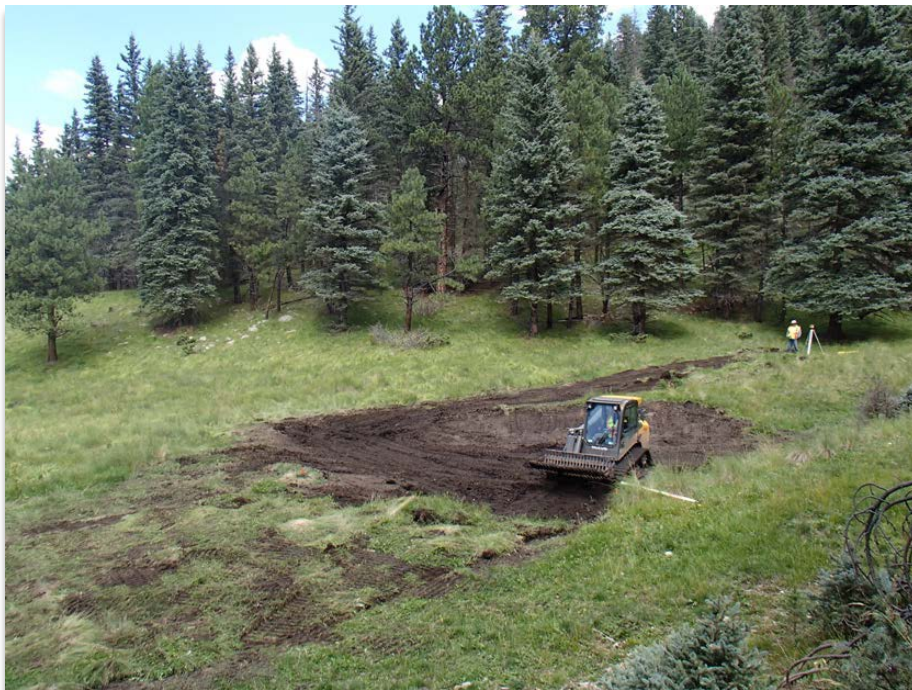
Figure 33. Machine construction of a plug and pond structure (August 2016).

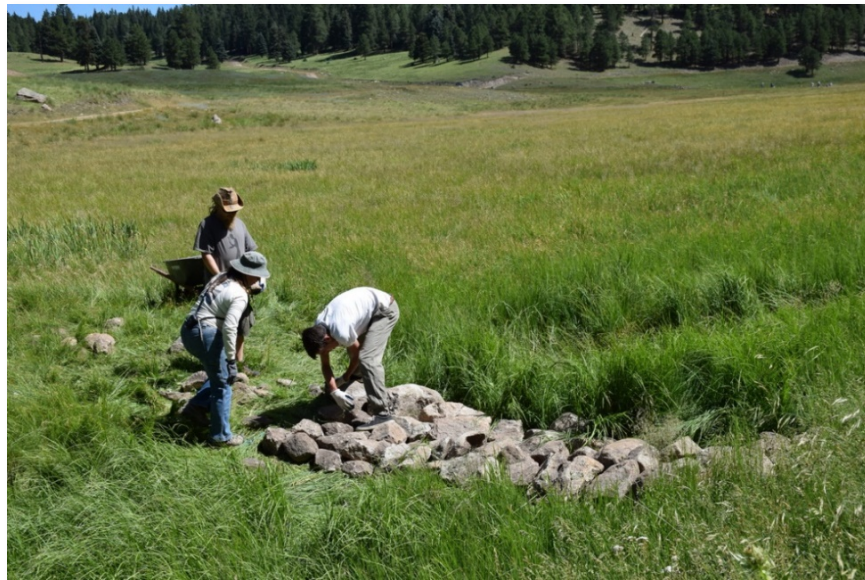
Figure 36. Volunteers building a one-rock dam to raise the water table along Sulphur Creek (July 2016).

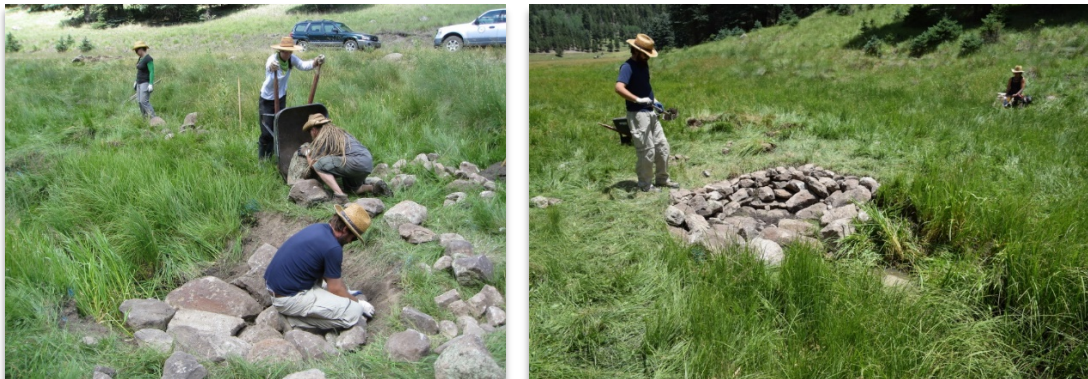
Figure 38. Volunteers building a Zuni bowl to arrest a headcut in the wetlands along Sulphur Creek (July 2016).

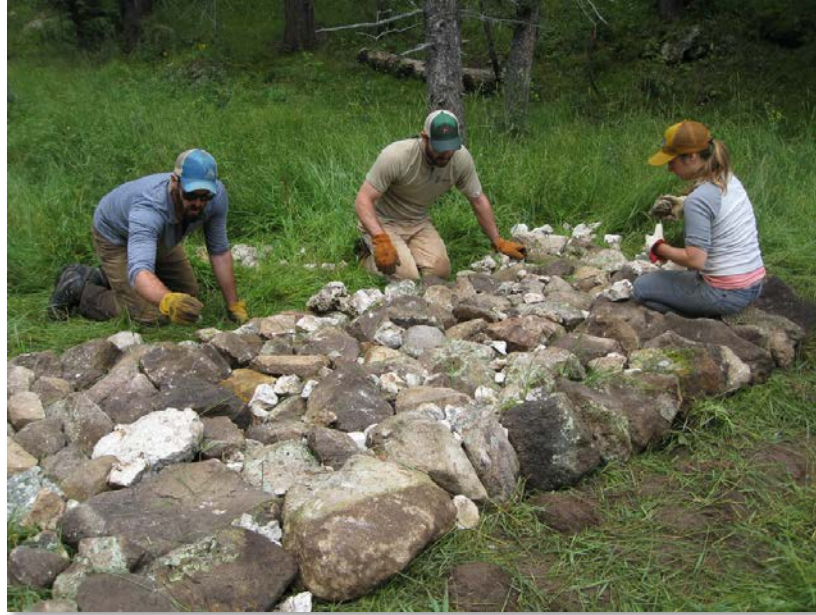
Figure 39. Volunteers building a one rock dam to raise the water table and capture sediment along Sulphur Creek (August 2017).
