**Final Report  
June 25, 2012**

**Restoring Wetlands and Wet Meadows on the Valles Caldera National  
Preserve Project  
Assistance Agreement #CD-966016-01-0**

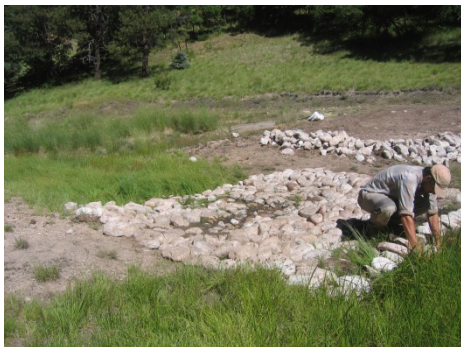
1. *Upper Pond. Two spillways were armored with rock rundowns and reshaped to be of identical elevation in order to maintain stream flow to downstream wetlands while preserving the pond as key wildlife habitat.*

*Spillways had eroded and threatened to breach. Additional rock was stockpiled at site for placement by volunteers.*

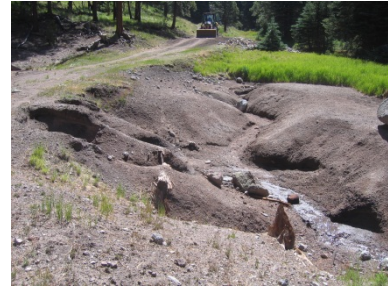
3. *Road drainage structures. Nine rolling dips were installed between the upper pond and Well Pad #1. These treatments will minimize mobilization and delivery to the wetlands*

*while harvesting road runoff at the most advantageous locations for wetland stabilization and expansion. Drainage outfalls were stabilized with rock mulch where the potential for erosion was present, especially where runoff spills onto non vegetated soils at sulfur vent sites.*

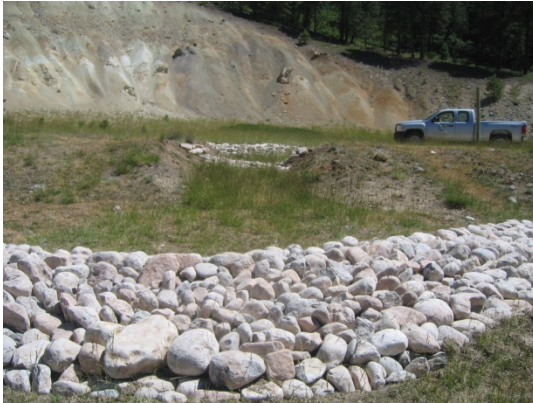
4. *The site known as Well Pad 1, was stabilized for erosion control and sediment abatement. Treatment consisted of*

*constructing an earthen berm 360 feet in length, installing 2 cobble rundowns (60 feet by 10 feet each), 2 media luna rock structures (45 feet by 6 feet) and (30 feet by 6 feet), 1 Zuni Bowl headcut control structure, 5 one rock dams and 2 rolling dips to divert road and hill slope runoff across the well pad. The area treated is approximately 1.5 acres. As the result of treatment, portions of the site should evolve to ephemeral wetland. Moist*

*soil species such as Baltic rush, white Dutch clover, Kentucky bluegrass and common dandelion are already present.*

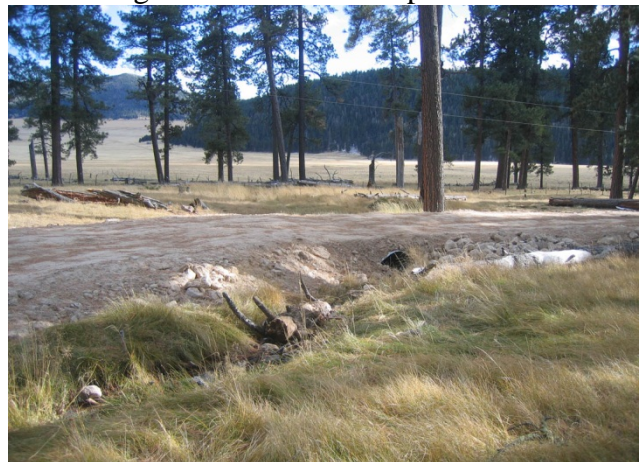
- At the most westerly site, there was a low-water crossing with wetlands below. A porous fill to spread water from La Jara Creek across the meadow was installed and would potentially create 1½ acres of wetlands.

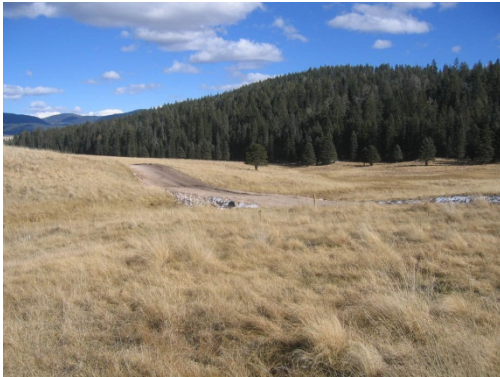
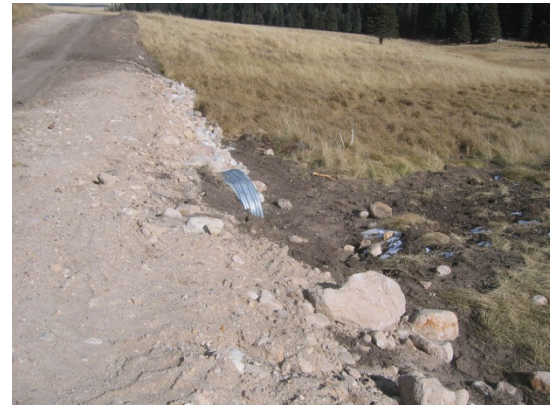
- At the site just west of the Bunkhouse, a porous fill to spread water was installed, and would potentially create an acre of wetland.

- At the Bunkhouse site, we improved the road crossing which will improve water quality as well increase wetlands.

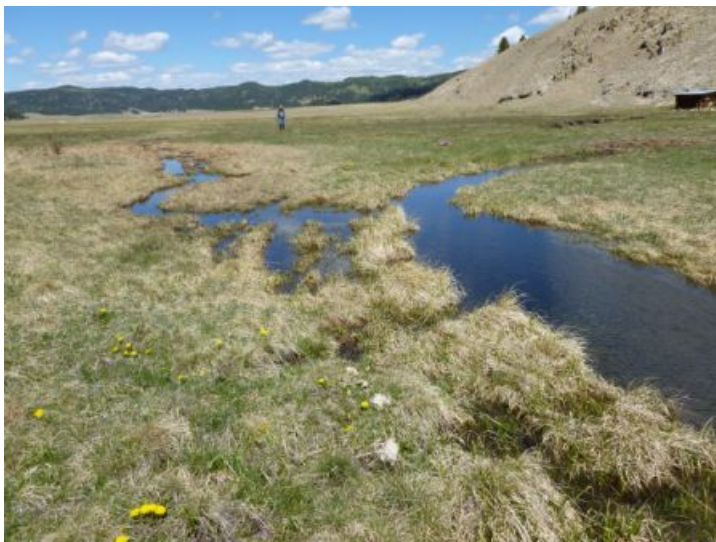
One of the first implementation practices in the San Antonio watershed was to increase wetland habitat area south of the warm springs Cabin, using volunteers to repair a headcut that was draining the wetland, and use sedge wads to spread out the slope wetlands flow from springs in the terraces. Here is a photo of the project work. We expect to see an increase of at least 15 acres of wetland habitat in this section.
