**WATER QUALITY SURVEY SUMMARY**  
**FOR THE**  
**BEAR CREEK WATERSHED**  
(From Dorsey Spring to Horseshoe Bend)  
**2006**

Prepared by  
Surface Water Quality Bureau  
New Mexico Environment Department  
**January 2009**

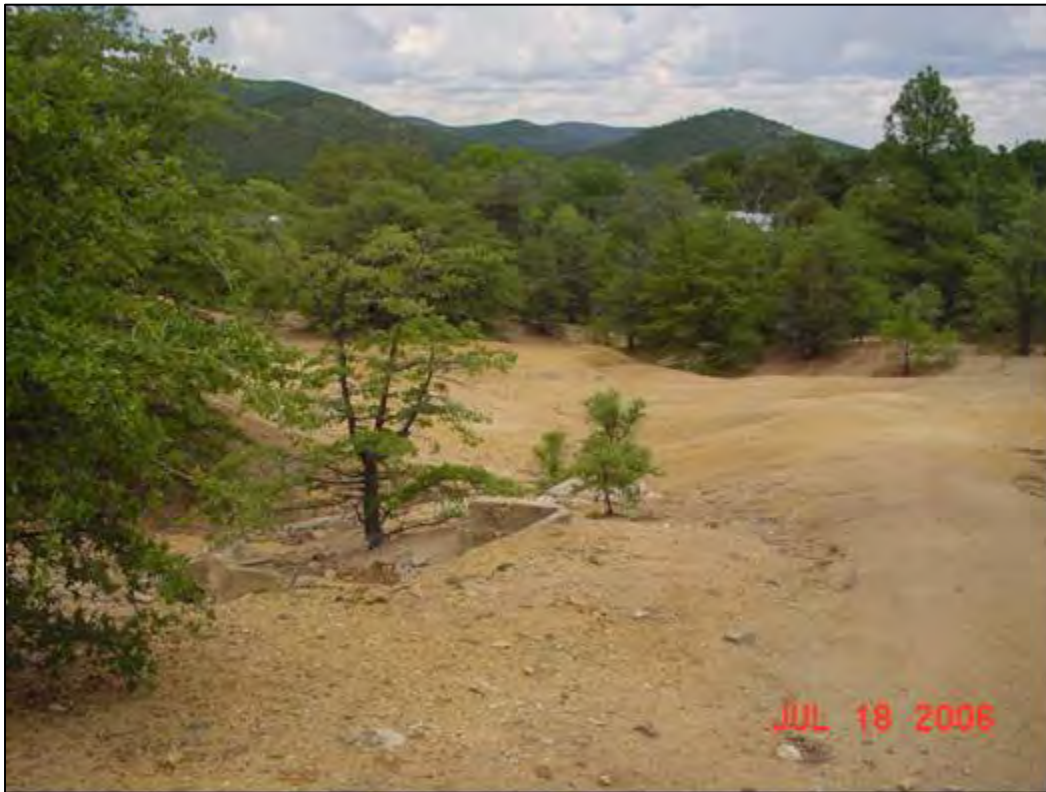
**Photo 2.** Historic mill tailings in upper Bear Creek Watershed

Gold was discovered in the Pinos Altos Mining District in 1860 and mining has left waste rock and mill tailings in the upper part of the watershed (**Photo 2**). Placer gold claims were located and worked (channel and bank gravels) in the upper most part of Bear Creek and downstream to near Horseshoe Bend. Mining impacts from placer deposits occur in the form of piles of worked gravels within and along the channel, loss of riparian vegetation, stream bank destabilization, and disruption of fluvial process and landforms. Lode claims (hard rock mining) were located to mine the source of the placer deposits resulting in waste rock piles with mixed base metal sulfide ores. Weathering of base metal sulfides generates sulfuric acid dissolving the ores and putting metal ions into solution. Over the last decade, most interest in the old mining claims has been for potential subdivision development for residential homes. Some mining sites have been reclaimed such as the old Mammoth Mill site (**Photo 3**) and the Cyprus Mine but many sites remain as potential sources of pollution.

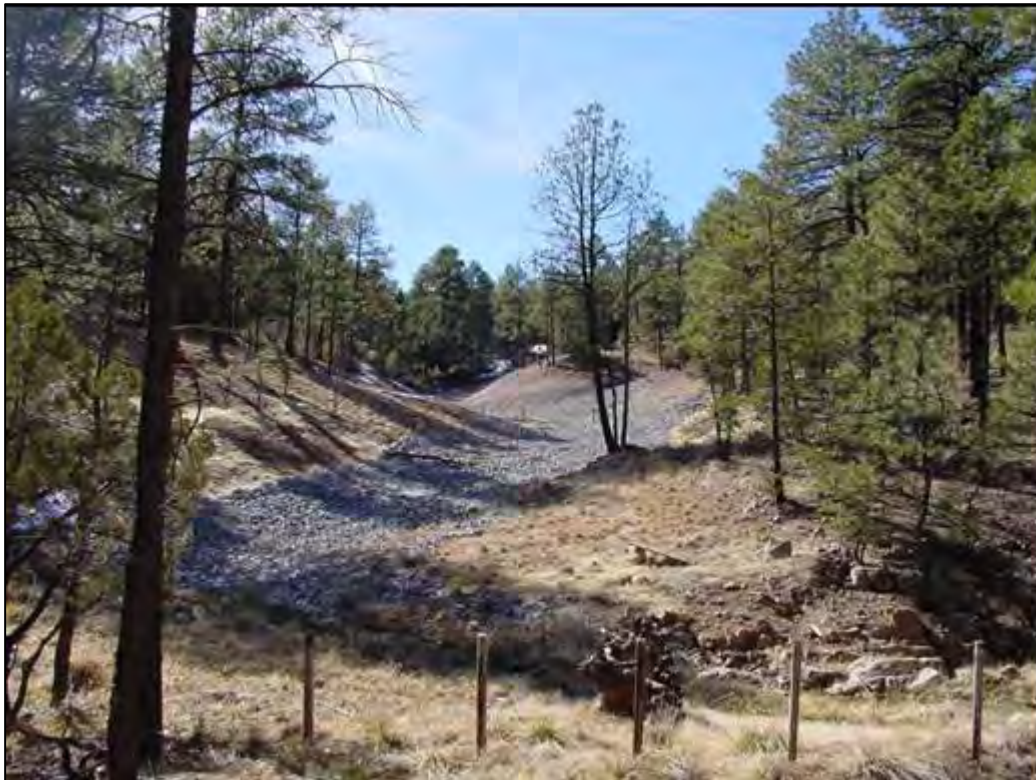
**Photo 3.** Post-reclamation Mammoth Mill Site.
