# **Black Canyon Riparian Restoration Plan**

## **A Watershed-Based Plan to Reduce Stream Temperature and Improve Habitat for Gila Trout**

Produced by the New Mexico Environment  
Department in Cooperation with the Upper Gila  
Watershed Alliance

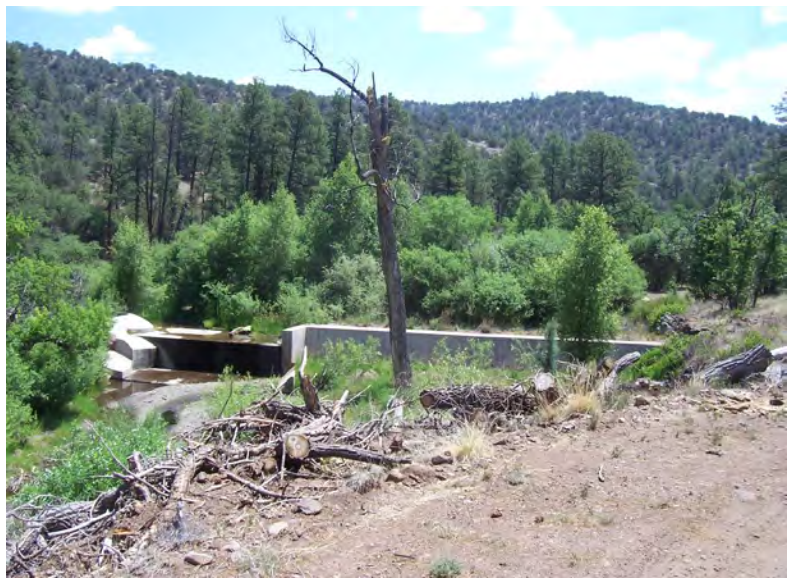
Figure 2. The fish barrier installed in Black Canyon Creek to prevent migration of non-native trout upstream.

Ironically, wildfire has played a significant role in the establishment of Gila trout to Black Canyon Creek. The Bonner Fire in 1995 sent heavy ash flows into the creek killing all fish. This provided an opportunity to build a fish barrier to retard upstream movement of non-native fish. Through a cooperative effort between the Gila National Forest, the US Fish and Wildlife Service and the New Mexico Department of Game and Fish, Gila trout were reintroduced above the barrier in 1998. The fish barrier proved to be ineffective in preventing non-native fish from migrating upstream so a new concrete barrier was completed in August 2011 to address the old barrier's flaws (Figure 2). Despite annual

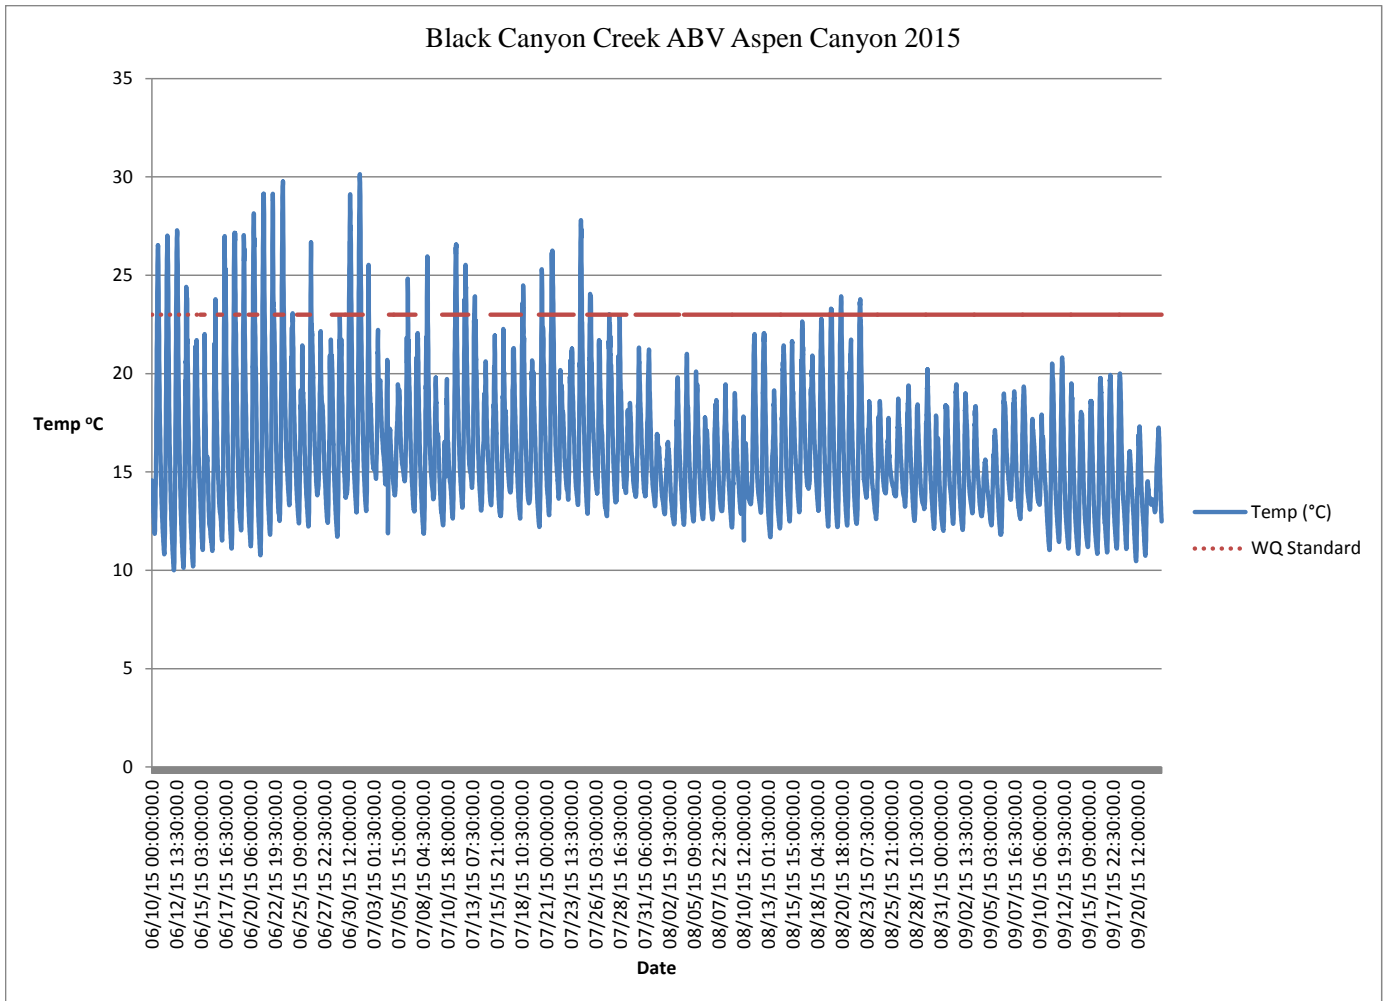
Figure 6. Temperature recorded every 15 minutes in Black Canyon Creek above the confluence with Aspen Canyon June 10, 2015 – September 30, 2015. The WQ standard depicted is the single max of 23 °C. The 4T3 20 °C standard was also exceeded on most days throughout June and July.

Temperature loggers were deployed at Black Canyon above Aspen Canyon and at Bonner Canyon from June 10 to September 30, 2015. The water temperature was recorded every 15 minutes for the duration of deployment. Both loggers exceeded the WQ standard shortly after deployment. The temperature logger deployed at Black Canyon above Aspen Canyon showed the WQ standard was exceeded multiple times in June and July, but the water began to cool down by late July (Figure 6). The cause of the dramatic drop in water temperature in late August is unknown but is attributed to the onset of summer monsoon rains.

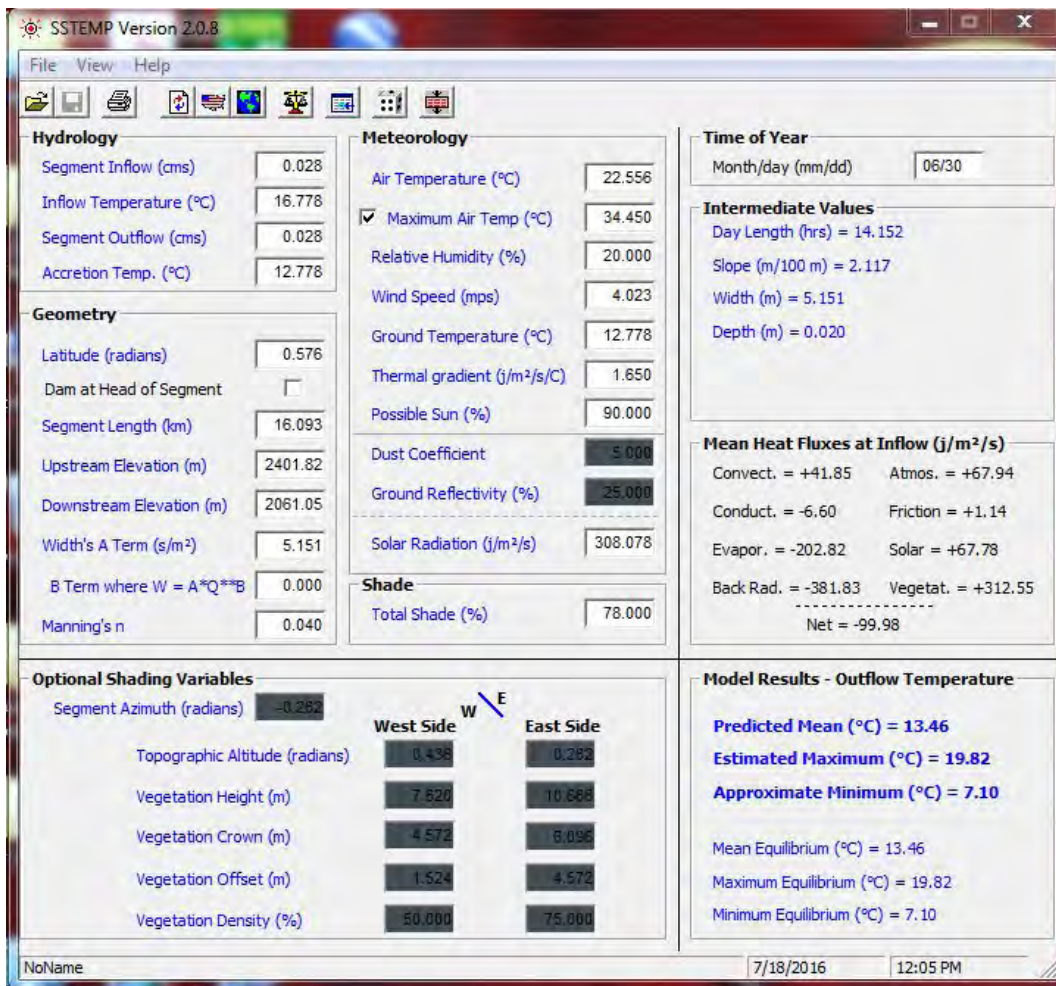
Figure 7. The SSTEMP model run for the target load of 78% canopy on Black Canyon Creek.

The *Total Maximum Daily Load for Temperature on Black Canyon Creek* only modeled the shading and solar loading of the reach downstream of the project area. In addition to providing spatial and temporal water temperature trends that clearly documented exceedance of the WQ standard, the temperature logger data and the canopy data from the project were used to re-calculate the target load reductions for Black Canyon Creek from the Aldo Leopold Wilderness boundary to the headwaters. The solar load allocation and necessary reductions to meet the WQ standard for the project reach were determined by re-running the SSTEMP model with the new input variables. The solar load under current conditions (49% canopy) was determined to be 157.12 joules/meter<sup>2</sup>/second. The solar load necessary to maintain the water temperature within at the 43T 20 °C WQ standard was calculated to be 67.68 joules/meter<sup>2</sup>/second. This is the target that was used to develop the TMDL and requires an overall load reduction of 89.52 joules/meter<sup>2</sup>/second. A value of 78% shade was estimated to be the amount of shade needed to bring the water temperature within the WQ standard. As a result, this watershed plan prescribes 78% shade to achieve a temperature under 20 °C and reduce the solar load by 89.52 joules/meter<sup>2</sup>/second in order to reach the target load of 67.68 joules/meter<sup>2</sup>/second (Figure 7).
