WATER QUALITY SURVEY SUMMARY
FOR THE
CHAMA RIVER AND SELECT TRIBUTARIES

2007

Surface Water Quality Bureau
New Mexico Environment Department

January 2011

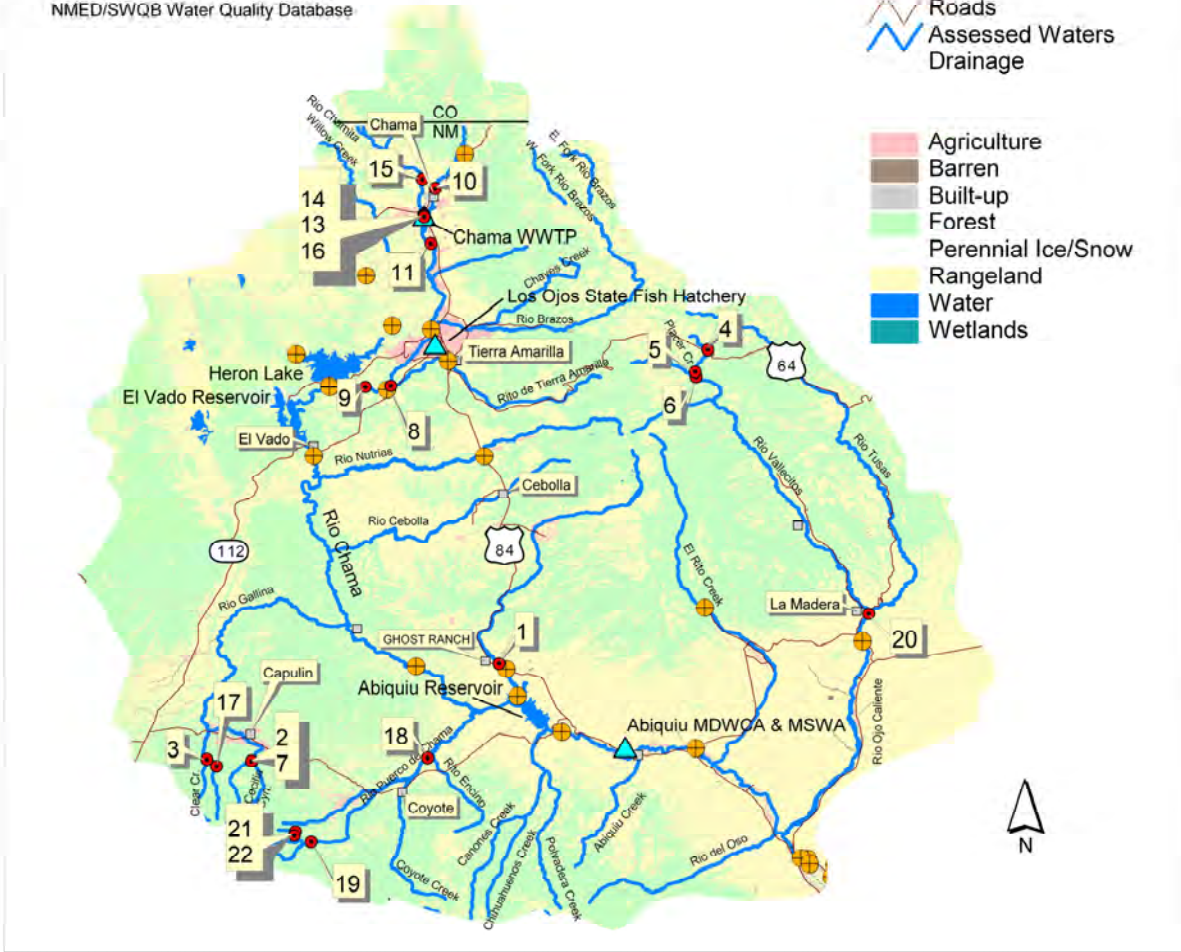
Figure 1. Location of Rio Chama watershed sampling stations

Rio Chama Watershed Land Use/Cover

Source Data:
National Hydrography Dataset 2004
National Landcover Dataset 2000
NMED/SWQB Water Quality Database

- Stations
- ▲ NPDES Permits
- Gages
- Roads
- Assessed Waters Drainage

- Agriculture
- Barren
- Built-up
- Forest
- Perennial Ice/Snow
- Rangeland
- Water
- Wetlands

Land use/cover and ownership information specific to each watershed based on the National Landcover GIS grid is presented below and in [Figures 1 and 2](#) above:

A map of the study area is provided in [Figures 1 and 2](#). The station numbers, USEPA Storage and Retrieval database (STORET) identification codes, and rationale of AUs and sampling stations selected for this survey are provided in [Table 1](#). Stations are often located at AU breaks to include all inputs from that upstream watershed area before entering a new AU. The Village of Chama Wastewater Treatment Plant (WWTP) effluent channel was also sampled to account for pollutant loading from this permitted facility into the receiving stream.
