**WATERSHED RESTORATION ACTION STRATEGY
(WRAS)**

COMANCHE CREEK WATERSHED

Prepared by

The Quivira Coalition

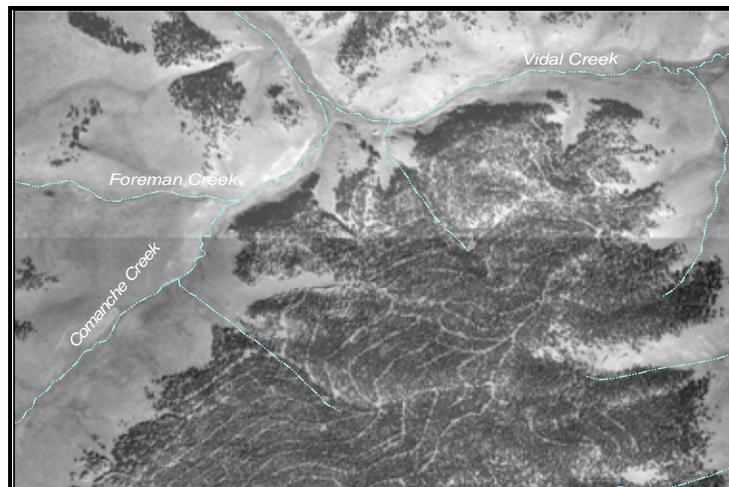
Figure 1. Roads from jammer logging near the confluences of Comanche Creek with Forman and Vidal Creeks. DOQQs from the late 1990s are courtesy of USFS Carson National Forest. The line across the middle of the picture is the join between two aerial photographs.

The Vermejo Park Ranch property was also heavily logged using a method called jammer logging. This method uses a cable and winch system to drag or skid logs uphill to a collection and loading area (Stokes et al 1989:16). Jammer cables have a reach of only 100 to 300 feet, so jammer logging requires the construction of closely spaced roads or terraces. **This method put a new road every 150 feet up many hillsides.** These road networks are clearly visible in aerial photos today (Figure 1).

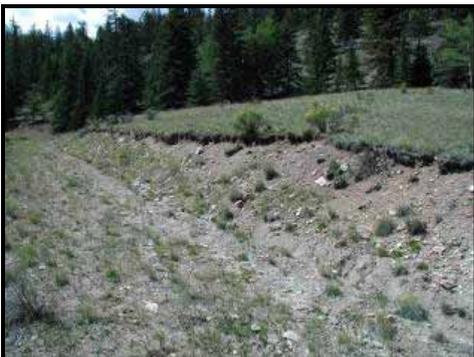
Figure 4. Road cut beginning to revegetate.

Under Forest Service management approximately ~300 miles of road have been closed in the Valle Vidal since 1982. Approximately 42 miles remain open for public access and approximately 100 miles of road have had no work done to them in 15 years. Many of the closed roads have revegetated naturally (see Figure 4) and are stable, but some are still major contributors of sediment to Comanche Creek.

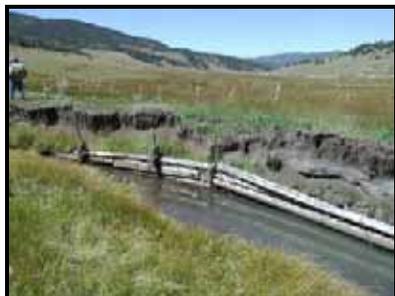
Figure 6. Revetment structure in Comanche Ccreek built in the late 1980s.

There have been a variety of efforts to stabilize and improve habitat along Comanche Creek and they have resulted in mixed levels of success. Revetment structures and small wood and rock in-stream habitat structures installed in the mid to late 1980s (see Figure 6) failed rapidly. Failure most likely was due to improper design, placement, and construction relative to channel characteristics, and the inability to withstand heavy stream flows during spring and summer rain events.

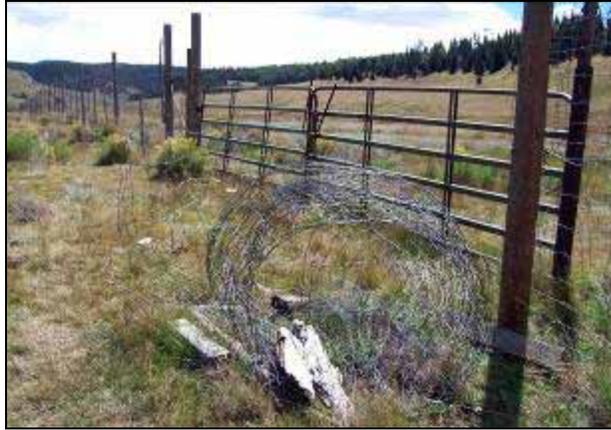
Figure 7. Pipe gate on large enclosure – this gate is too low to effectively exclude elk. Figure 8. South-east corner of fence is down allowing for cattle and elk access. Photos taken September 2005.

Cattle exclosures and separate elk/cattle exclosures constructed in the 1980s and 1990s were effective, but are now in need of repair or replacement. Three large exclosures were constructed in the mid-1980s that together enclose roughly 85 acres. Only the large exclosure (on the west side of Gold Creek in the middle reach) is in a semi-functional state. During a September 2005 visual assessment, the south-east corner was down and the gate is low enough to allow for elk use. Evidence of recent use by both elk and cattle were observed inside the exclosure (Figures 7, 8, and 9). With improvements in replacement materials and sustained maintenance these exclosures will become more effective at vegetation regeneration. The other two exclosures (close to the intersection of Little Costilla drainage) are completely non-functional and it may prove worth while to remove the old fencing materials.

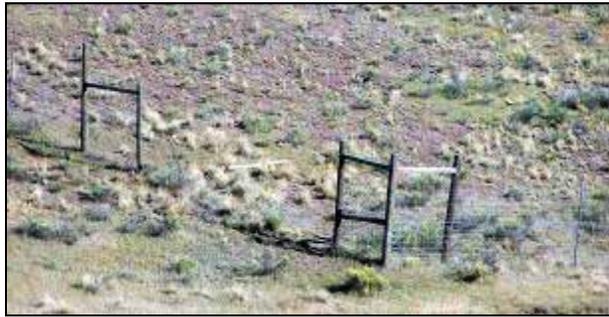
Figure 9. Overgrazed and trampled vegetation shows evidence of use by elk and or cattle inside the large Gold Creek enclosure, September 2005.

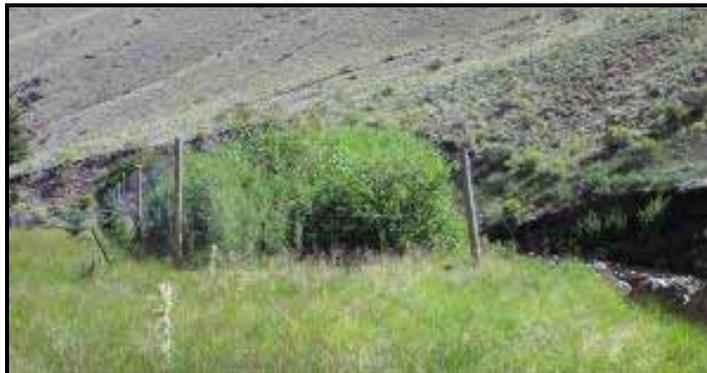
Figure 10. Woody riparian vegetation growing within a mini cattle/elk enclosure built in the 1990s (photo taken August 2002)

In 1991 the New Mexico Environment Department and Carson National Forest cooperated in using a CWA section 319(h) grant from the U.S. EPA to stabilize erosion along Comanche Creek (NMED 1996). Because large enclosures may interfere with the natural migration patterns of the elk, and elk are less likely to jump into a smaller/confined space, five small, “point-bar” enclosures installed in 1994 remain in place and have been successful at propagating woody vegetation, especially willows. Efforts to plant cottonwood poles have had little success. However, small enclosures constructed to protect existing willow plants provided a safe haven for the natural regeneration and establishment of cottonwoods and willows in the lower reach of Comanche Creek (Figure 10). Numerous cottonwood and willow volunteers have sprouted and survived within these enclosures. During the May 2005 high water event, these enclosures held up well and only required minor repairs.

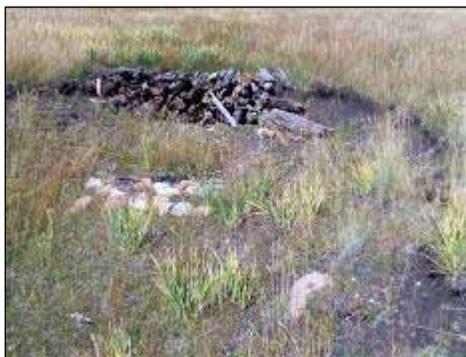
Figure 12. A log and fabric structure installed in the Holman Creek wet meadow, September 2003.

Upland erosion control treatments installed along side drainages of Comanche creek are designed to slow the movement of water, collect soil, nourish vegetation and prevent sediment from entering the creek. Examples include One Rock Dams, Rock Baffles, Rock Bowls, Worm Ditches and a Log and Fabric Headcut Control Structures (Figures 11-12). In 2002-2003 171 erosion control structures were installed during on-the-ground educational workshops using volunteer labor.

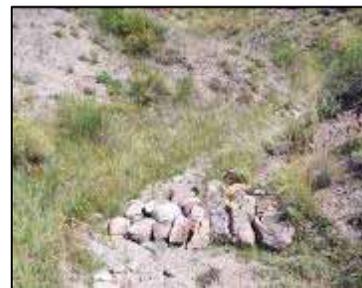
Figure 11. A Rock Baffle on Comanche Point Gully, installed September 2003.

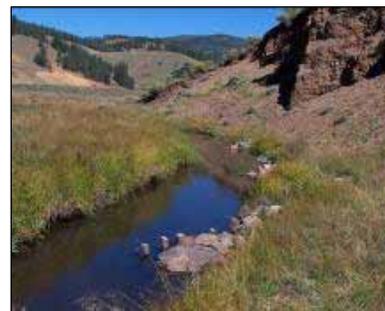
Figure 13. Three Vanes installed along an eroding bank during a 2004 work shop (Photo taken September 2005)

Instream treatments consist primarily of vanes and rock plugs. Vanes are wooden posts or rock structures installed at strategic locations in Comanche Creek to direct stream flow left or right, away from eroding banks to reduce sediment production and promote streambank vegetative growth. (Figure 13). Fifty-six vanes will be installed along the lower reach. There are currently seventeen vanes along eroding banks of the lower reach and thirty-nine are

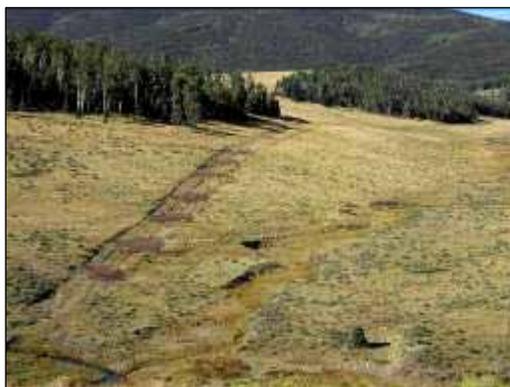
Figure 15. Rolling waterbars installed on an old road to the east of Gold Creek, September 2004.

- ❖ 0.2 mi. road completely restored to natural contours;
- ❖ 1 stream crossing rehabilitated to restore natural floodplain banks and decrease sediment from FS Administrative use road;
- ❖ 5.2 miles (approx.) stabilized with rolling grade dips & waterbars;
- ❖ 2 culverts removed that were affecting the stream channel;
- ❖ 1 culvert plugged - not needed for road drainage and better handled; surface flows with a grade dip;
- ❖ 2 culverts functionality improved with install of associated grade dips;
- ❖ Holman Creek (old timber sale access road) 1.3 miles (approx.) stabilized with rolling grade dips & waterbars;
- ❖ Gold Creek 1.8 miles (approx.) stabilized with rolling grade dips & waterbars. (Figure 15); Chuckwagon Canyon 3.4 miles (approx.) stabilized with rolling grade dips & waterbars; and 1.0 miles road completely restored to natural contours.

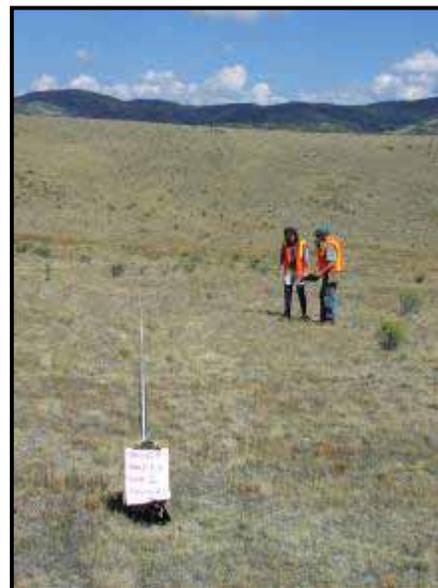
Figure 18. Upland Monitoring Photo Point in Upper Comanche Creek Watershed

1. Photo points – permanent photo points allow qualitative monitoring of vegetation and landscape changes through time.
2. Line-point intercept for vegetative cover and composition – this is a rapid, objective way of assessing ground cover consisting of vegetation, litter, rocks, and biotic crusts, and involves recording the types of cover encountered at regular points along each monitoring transect.
3. Gap intercept or substitution of measurement to nearest perennial plant – gap intercept measures the proportion of a monitoring transect covered by plant canopy. Spaces greater than 20 centimeters are considered gaps.

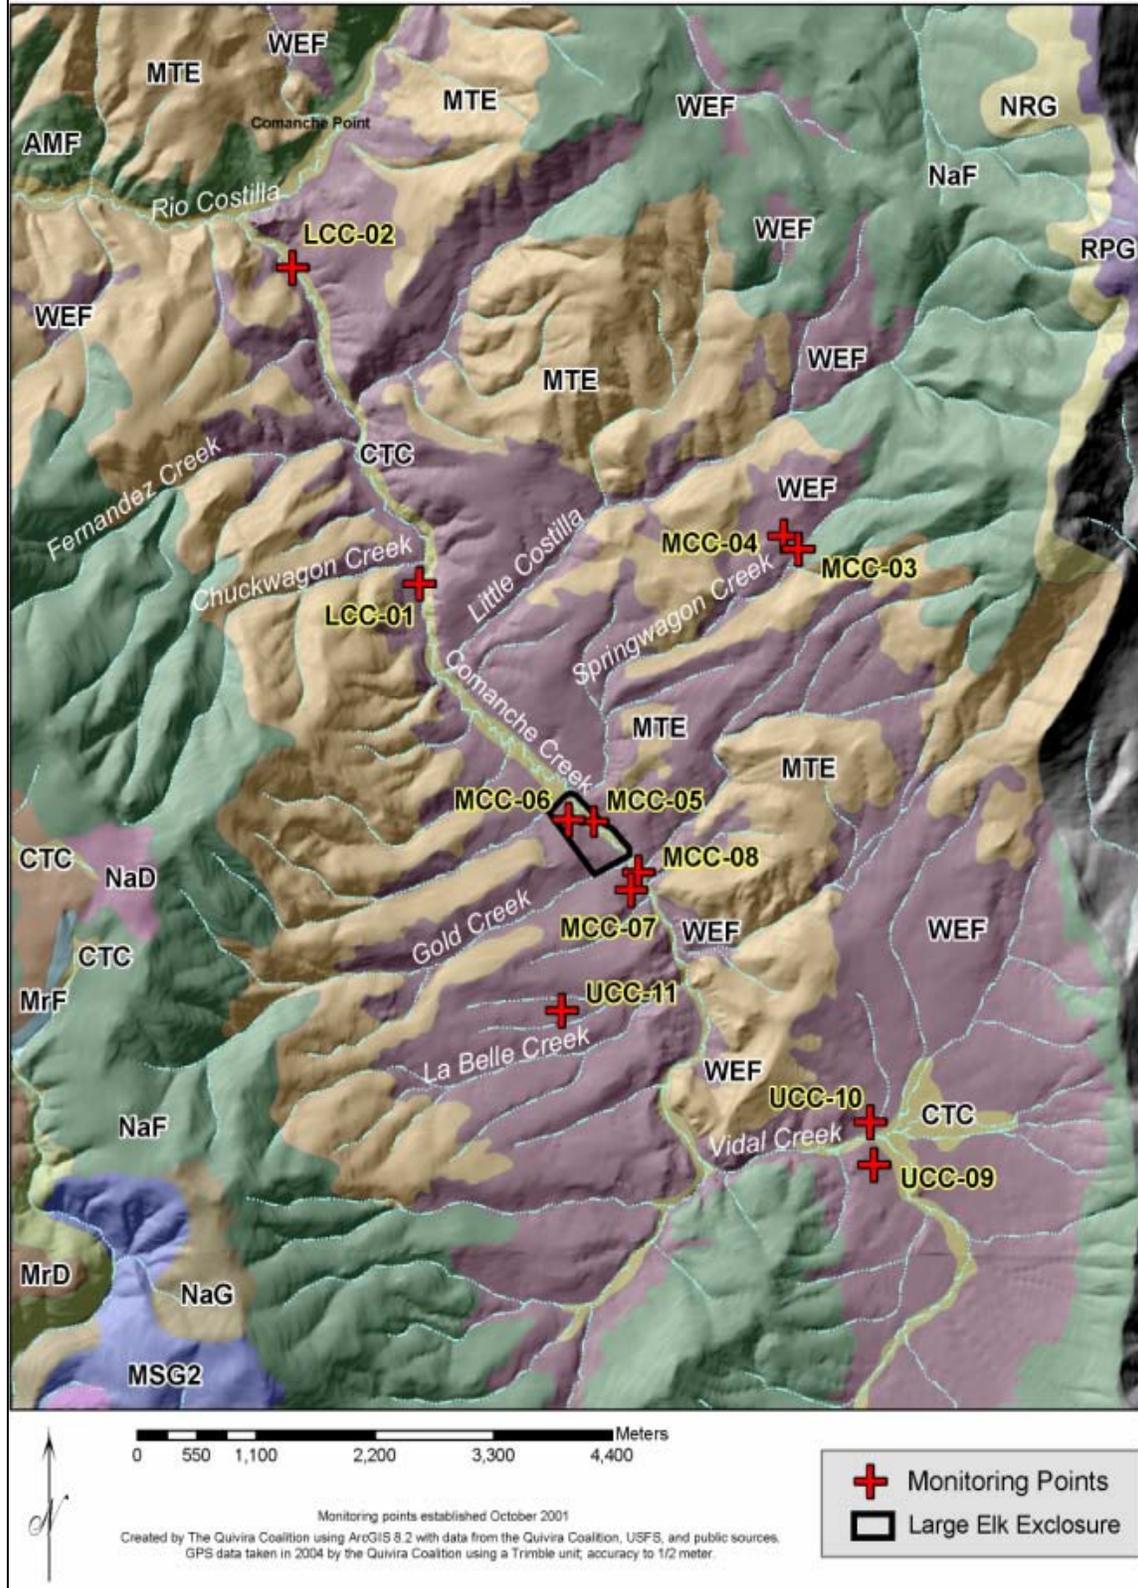
MAP C Comanche Creek Upland Monitoring Sites & Soil Types
