**WATER QUALITY SURVEY SUMMARY**  
**FOR THE**  
**JEMEZ RIVER WATERSHED**  
**(FROM SAN YSIDRO TO HEADWATERS EXCLUDING WATERS IN THE**  
**VALLES CALDERA NATIONAL PRESERVE\*)**  
**2005**

Prepared by  
Surface Water Quality Bureau  
New Mexico Environment Department

**June 2009**

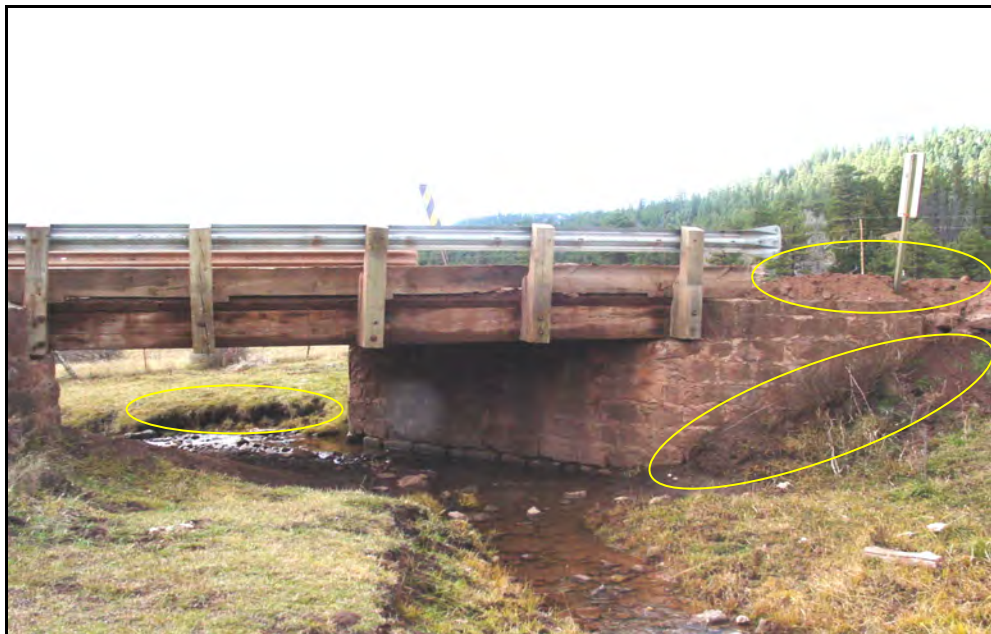
**Figure 5. Road maintenance spoils in the Rito Peñas Negras**

Stream bottom deposits were a common cause of non-support for the study area. A total of 6 sites survey were found to have fines greater than 20%. Of these four sites were also found to have stream condition index score (SCI), based on macroinvertebrate sampling, indicating fair or poor conditions (Table 11). SWQB staff observed evidence of road maintenance (or lack thereof) that appeared to contribute significant quantities of sediment to stream channels at bridges and arroyo crossings. Excessive sediment stresses aquatic communities and can contribute to stream bank destabilization. SWQB staff documented evidence of maintenance at the bridge over the Rito Peñas Negras. Spoils from grading operations have been pushed over the bridge abutments, eventually moving into the channel. The consequent increase in bedload impairs channel function, destabilizing the banks and adding even more sediment to the channel.

In addition to the immediate effects of sediment input to stream channels, the cumulative impacts can be far reaching. As sediment accumulates in channels, they become shallower and must increase their width to accommodate flow. This further increases sediment inputs, causes the channel to become wider and shallower (increased width/depth ratio), decreases sinuosity, and increases gradient, which then initiates down-cutting. Down-cutting advances downstream and upstream, eventually denying the stream access to its floodplain, lowering the water table below
