# WATER QUALITY ASSESSMENTS FOR SELECTED NEW MEXICO LAKES

# LAKE WATER QUALITY MONITORING, TROPHIC STATE EVALUATION, AND STANDARDS ASSESSMENTS FOR:

## Eagle Nest Lake and Fenton Lake

**Water Quality and Biological Assessment Survey of Eagle Nest Lake,**  
**Colfax County, April 19, July 19 and October 18, 2005.**  
**Danny R. Davis, Principal Investigator**

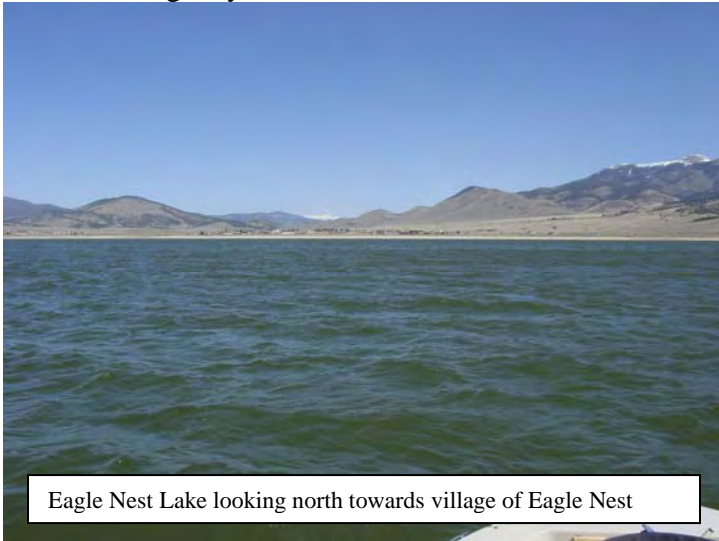
Eagle Nest Lake looking north towards village of Eagle Nest

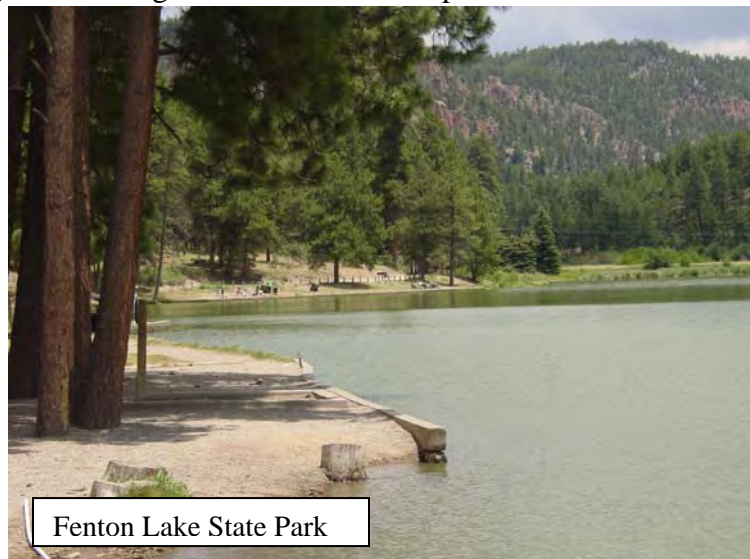
Fenton Lake State Park

Fenton Lake is a small lake located within the Santa Fe National Forest within the Jemez Mountains west of Santa Fe, New Mexico. It is the only significant impoundment within the Jemez watershed, and though it has been studied extensively in the past, a recent forest fire was located in an area immediate to the lake, and has resulted in serious sediment and water quality problems.

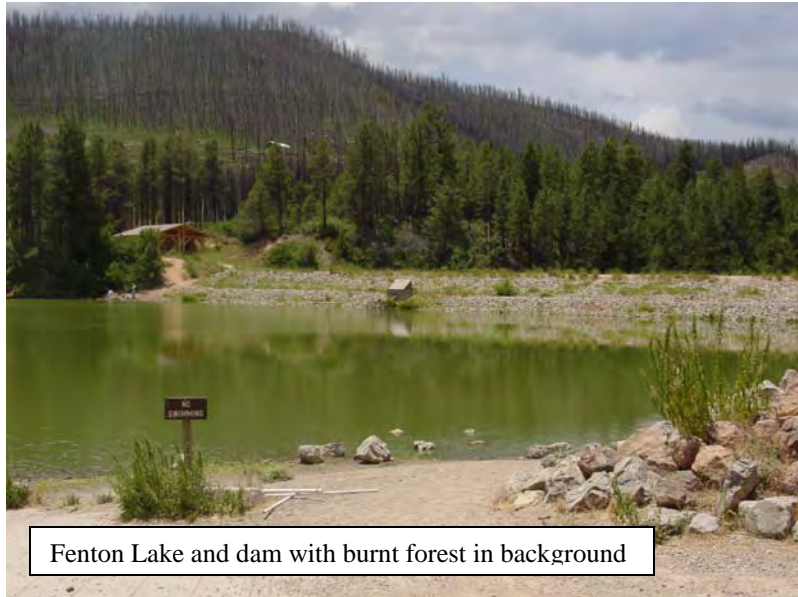
Fenton Lake and dam with burnt forest in background

watershed to lake size ratio. This huge watershed to lake size ratio helps to explain why Fenton Lake continues to suffering from nutrient enrichment. In August of 2002, a 4,600 acre forest wildfire scorched the mountains to the east of Fenton Lake resulting in high sediment and ash input to the lake. The photo above shows some of the burnt forest in the background. As would be expected, the maximum depth has been significantly reduced due to sediment input from the burnt areas. Early estimates by Potter (1983) calculated a

maximum volume of Fenton Lake at about 264 acre feet; however, this has been significantly reduced since her classification study occurred. Potter also examined the nutrient load contributed by the village of Seven Springs, and the New Mexico Department of Game and Fish operated Seven Springs Fish Hatchery, the latter known to contribute nutrients to Cebolla Creek. The image above also shows the very green condition during the sampling visit, an indication of heavy nutrient load.
