WATER QUALITY SURVEY SUMMARY
FOR THE
MIDDLE RIO GRANDE
(FROM ANGOSTURA DIVERSION NEAR ALGODONES
TO ISLETA DIVERSION NEAR ISLETA PUEBLO)
1999

Surface Water Quality Bureau
New Mexico Environment Department

August 2004

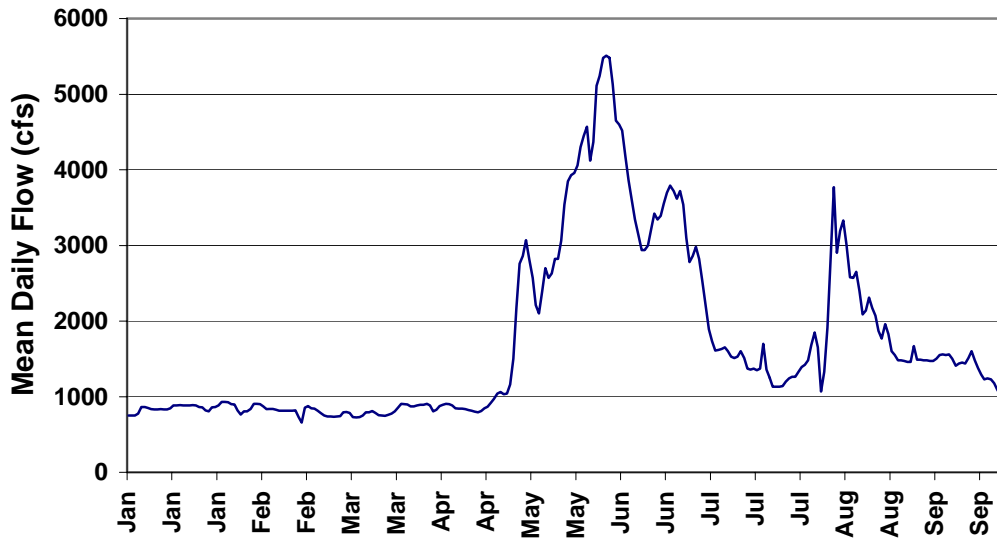
Figure 1. Rio Grande Flow at USGS Gage at San Felipe

Stream flows for the Rio Grande in this reach are measured at the United States Geological Survey (USGS) gaging station at San Felipe and the USGS gaging station near Albuquerque. Flow data are provided for the sampling dates in Table 2 and are presented graphically for the entire year in Figures 1 and 2.

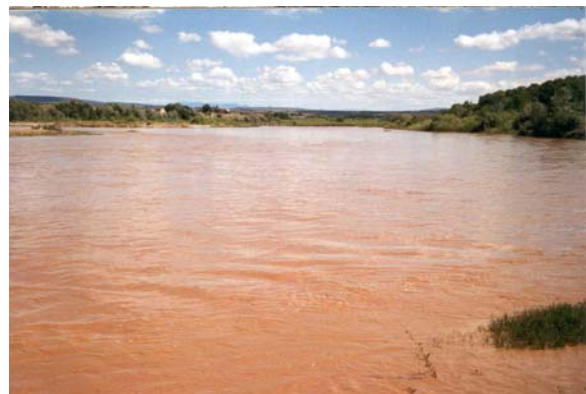
Station 2

Station 2, the Rio Grande at the Highway 44 Bridge near Bernalillo was cold to warm, slightly alkaline and had low levels of the parameters of interest. There was one exceedence of the single sample numeric standard for fecal coliform bacteria, and the monthly geometric mean standard of 200 colonies/100ml was exceeded, indicating that the secondary contact use was impaired.

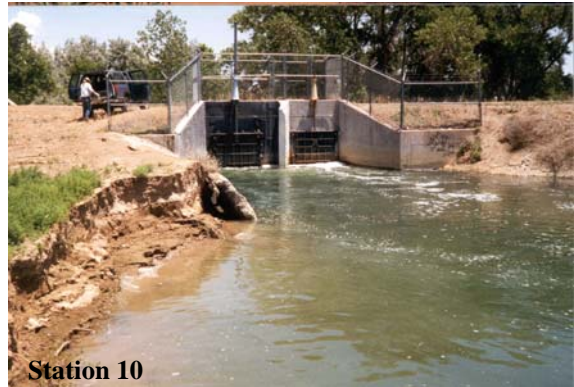
Station 10, the Albuquerque Wastewater Treatment Plant Outfall was warm, clear, and acidic to slightly alkaline with low concentrations of the parameters of interest. There were 4 exceedences of the acute standard for total chlorine residual constituting a violation of the standard and impairment to the warm water fishery use.

The two stations that encompassed wastewater treatment plant, Stations 3 and 10, both had exceedences of the chlorine standard. Wastewater treatment facilities require permits to discharge into a stream and are monitored through the National Pollutant Discharge Elimination System (NPDES) Program. Enforcement of the applicable chlorine standards for wastewater treatment plant discharges are addressed through the NPDES program and therefore no TMDL will be required.
