## WATER QUALITY SURVEY SUMMARY FOR THE MIMBRES RIVER WATERSHED 2009

Prepared by New Mexico Environment Department Surface Water Quality Bureau July 2011 THIS PAGE LEFT INTENTIONALLY BLANK.

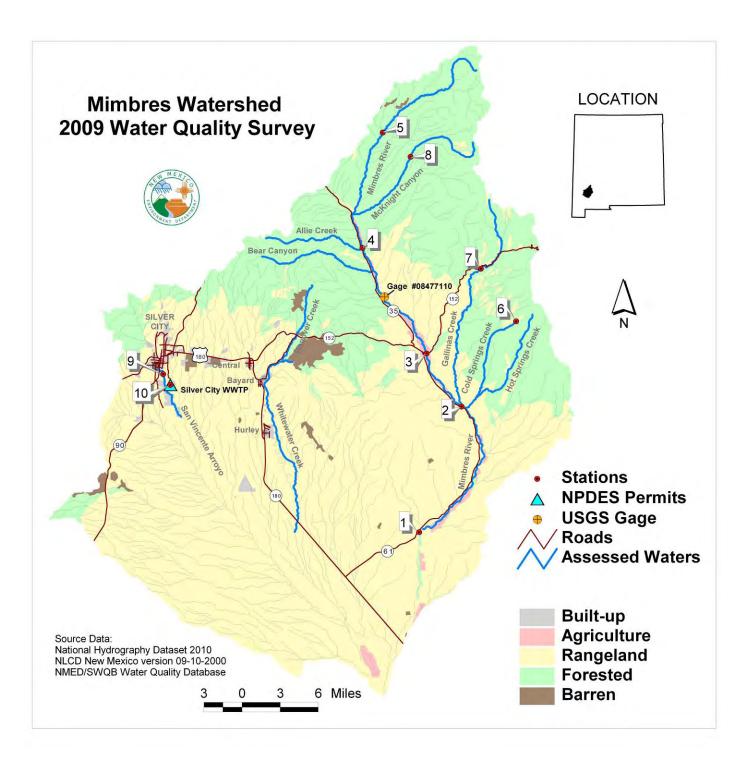
Figure 1. Land use/land cover in the Mimbres watershed

Historic and current land uses in the Mimbres River watershed include mining, forestry, farming, ranching, and recreational activities. Land use/cover includes 70% rangeland, 27% forest, 2% barren soil, <1% agriculture, and <1% urban/residential (Figure 1). Land ownership is mainly United States Forest Service (USFS) in the headwaters and private at lower elevations; however the Bureau of Land Management (BLM) and State of New Mexico also own and manage tracts of public lands in the lower portions of this watershed. Land ownership is 58% private, 28% USFS, 10% State, 4% BLM, and <1% Department of Defense (Figure 2). The Mimbres River watershed is located in Omernick Level III Ecoregion 23 (Arizona/New Mexico Mountains) in the headwaters and Level III Ecoregion 24 (Chihuahuan Desert) in the lowlands. The elevation range for the various sampling sites in the survey spanned from 1,540 to 2,180 meters (5,052 to 7,152 feet above sea level). Annual precipitation ranges from 76 centimeters (30 inches) in the conifer forests at higher elevations to 25 centimeters (10 inches) in the semi-arid grasslands at lower elevations (NRCS 2007). Mean maximum July temperatures range from 27 to 33°C (81 to 92°F) while the average January minimum temperatures range from -11 to -4°C (12 to 24°F).

A map of the study area is provided in Figures 1 and 2. The station numbers, USEPA Storage and Retrieval database (STORET) identification codes, and sampling rationale of the stations selected for this survey are provided in Table 1. Stations were often chosen because they were within a perennial reach or to bracket potential pollutant sources. The stations were not necessarily located at AU breaks because of the semi-arid landscape of this watershed and lack of perennial flow along the entire AU. The Silver City Wastewater Treatment Plant (WWTP) effluent channel was also sampled to estimate pollutant loading into the receiving stream.

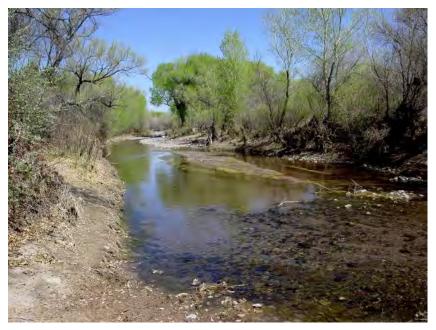
Macroinvertebrate data were assessed at two sites (Table 10). The M-SCI threshold of 56.70 was used to determine biological impairment for the Mimbres River at the upper Nature Conservancy property. This site had an M-SCI score greater than 56.7 indicating no impairment. The Mimbres River at the Rancho del Rio site is located at the bottom of the last perennial stretch of the Mimbres River where the mountains transition into desert grasslands (Photo 1). This site is near the ecoregion boundary and is more closely associated with Ecoregion 24b, Chihuahuan Desert Grasslands, therefore it was assessed using the RBP approach, as allowed by the AP. The RBP score for this site was 67% of the reference site. This AU will be listed for unidentified benthic-macroinvertebrate impairment.

**Photo 1**. Mimbres River at Rancho del Rio below Dwyer, NM.

In the Mimbres River below Dwyer, NM at Rancho del Rio, the fish community was dominated by Rio Grande suckers, with only two longfin dace collected. This is in marked contrast with the collection performed at the same location in 2002, when longfin dace (a warm-water species) comprised 81% of the catch; however in both instances, only those two species were collected. The fish found in the lower section of the Mimbres River from both historic (2002) and current (2009) datasets indicate this reach is also in a transition zone with a mix of both cool- and warmwater species being found. In addition, water quality appears to be moderately good since the community was dominated by a species with an intermediate tolerance to water quality degradation. The presence of a majority of gravel spawners also indicate the channel substrate is of good quality with a mix of cobbles and gravels and a high enough oxygen content to allow eggs to survive.
