**WATER QUALITY SURVEY SUMMARY**  
FOR THE  
**RIO PEÑASCO WATERSHED**  
(From Hope, NM to Headwaters)  
**2003**

Prepared by  
Surface Water Quality Bureau  
New Mexico Environment Department  
**February 2007**

NEW MEXICO ENVIRONMENT DEPARTMENT  
**SURFACE WATER QUALITY BUREAU**

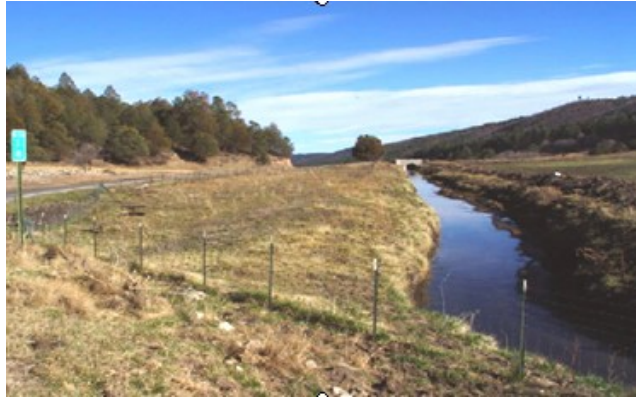
practice of moving the stream out of its natural channel and diverting it into an artificial conveyance above the valley floor to facilitate flood irrigation.

**Photo 1.** Rio Peñasco flowing in a conveyance channel

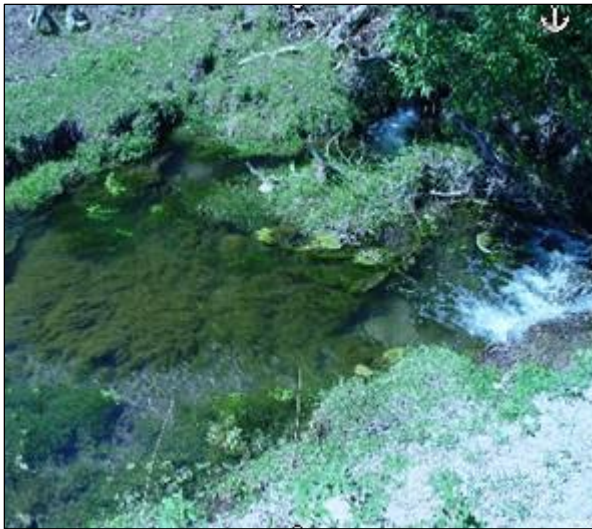
Review of field notes and photographs also indicates that, while concentrations of nitrogen and phosphorus species were generally low, algal growth had reached nuisance levels. The lowest nutrient concentrations were found in the Agua Chiquita below the Methodist Assembly waste water treatment plant (NPDES permit number NM0028886). There is no clear pattern to changes seen in the concentrations of nutrients over time.

Sources for nutrients include the local geology, livestock and wildlife. Springs in karst landscapes like the Rio Peñasco watershed can often produce significant quantities of nutrients; it should be noted, however, that large numbers of elk and cattle were observed in or near the channel. Another potential source of nutrient input to waterbodies is runoff from burned areas; though this cannot occur upstream of the burned region.

**Photo 2.** Heavy algal growth in the Rio Peñasco channel
