WATER QUALITY SURVEY SUMMARY
FOR THE
SAN JUAN AND ANIMAS WATERSHEDS
(Navajo Nation at Hogback to the Colorado border)
2010

Surface Water Quality Bureau
New Mexico Environment Department
August 2012

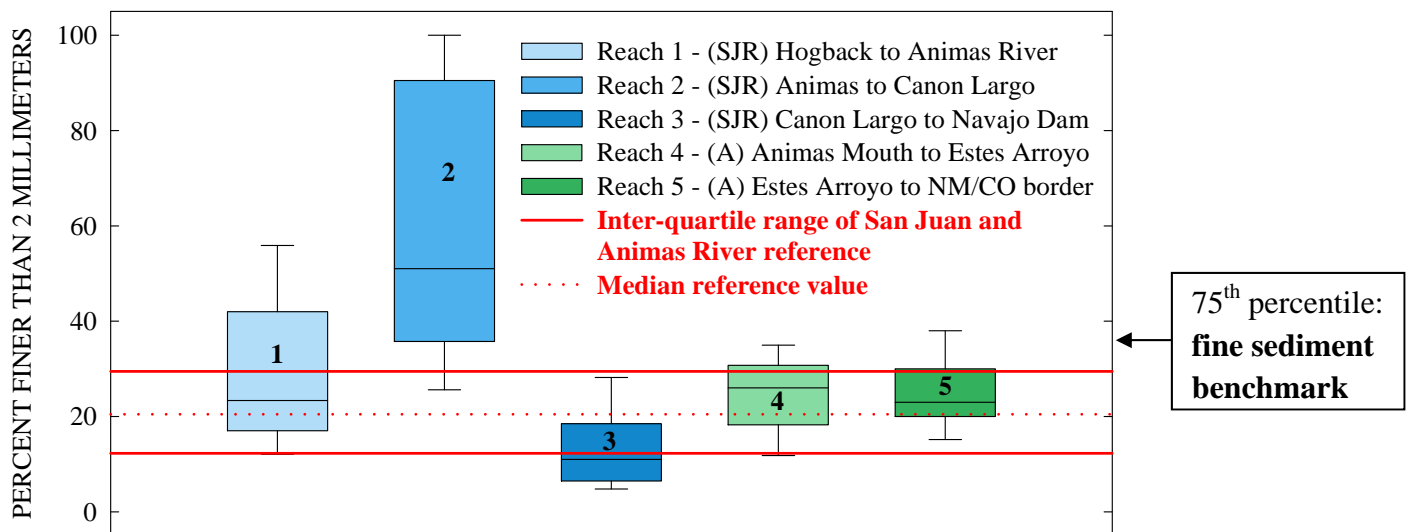
Figure 3. Percent (%) sand and fines box plots for all study sites in the 2002 NSL study and fine sediment benchmark based on coarse-material sites (adapted from Heins, et al. 2004)

between two of the three % sand and fine values measured in 2010. Given this discrepancy, SWQB believes collection of additional data is warranted to confirm the impairment before proceeding with TMDL development for this reach. Therefore, the sediment listing for the Animas River (Estes Arroyo to Colorado border) is noted as “Category 5C” on the 2012-2014 Integrated List.

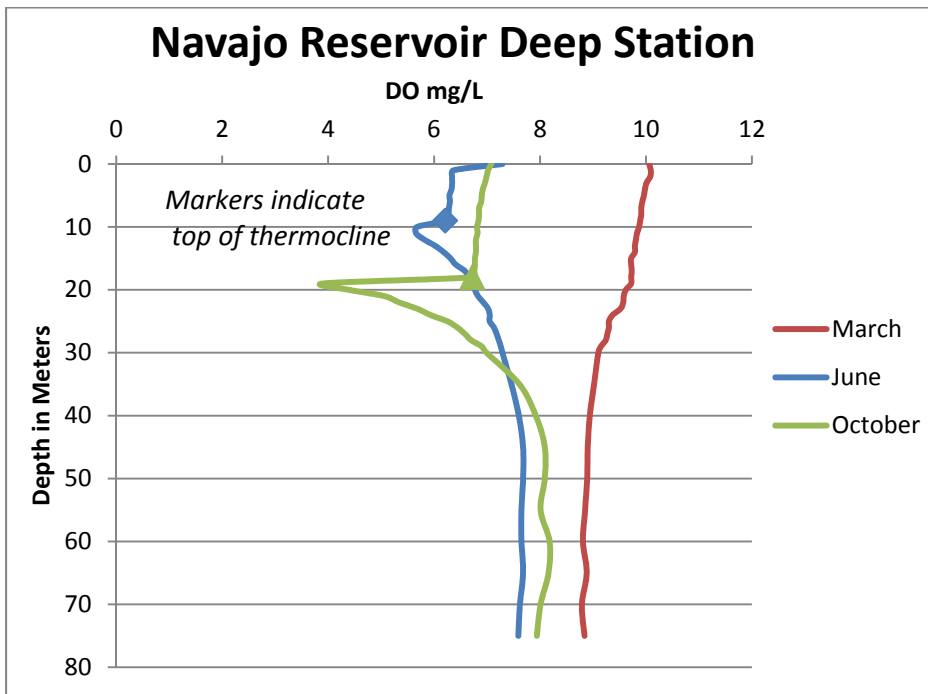
Figure 5. Navajo Reservoir dissolved oxygen depth profiles.

Note: profiles include only the first 75 meters due to equipment limitations.

Chemical/Physical data for Navajo Reservoir were collected only down to 75 m (246 ft) due to the limitations of the sampling equipment (the deepest part of the reservoir exceeds 100 m depth). There were no chemical exceedences in either lake, but both lakes stratified during the warmer months. Lake Farmington exhibited an anoxic hypolimnion (DO < 0.5 mg/L) during October sampling, but did not exceed the DO criterion (Figures 4 and 5; Tables 12 and 13). Both lakes exceeded the cold water aquatic life temperature criterion; however, they both were found to support the warm water aquatic life temperature criterion.
