WATER QUALITY SURVEY SUMMARY
FOR THE
UPPER RIO GRANDE WATERSHED
(Cochiti Reservoir to the Colorado border)
2009

Surface Water Quality Bureau
New Mexico Environment Department
March 2012

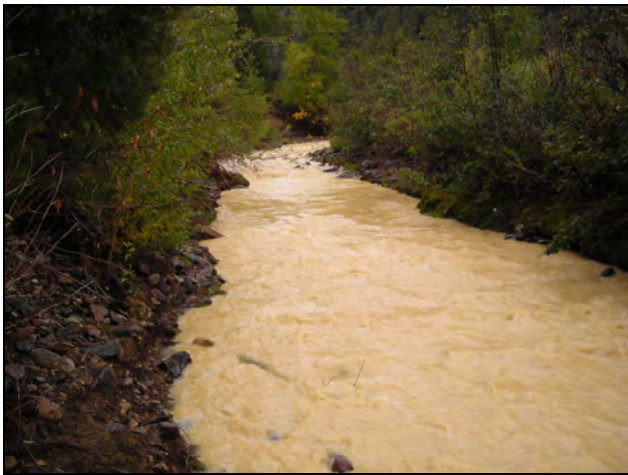
Photo 1. Photo of high turbidity, in response to monsoon thunderstorm, observed on the Red River above Chevron Questa Mine site looking upstream (9/16/2009).

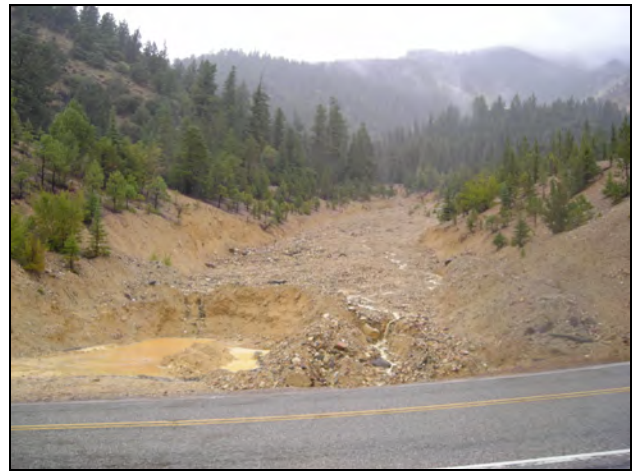
Photo 2. Photo looking uphill from Highway 38 at sediment source about 1 mile downstream of Red River WWTP (9/16/2009).
