GLORIETA GEOSCIENCE, INC.

RE: Variance Request Before the New Mexico Water Quality Control Commission

Ironhorse Permian Basin, LLC (Formerly Lakeside Dairy) Site Map

Groundwater Elevation and Monitoring Well Proposal Map

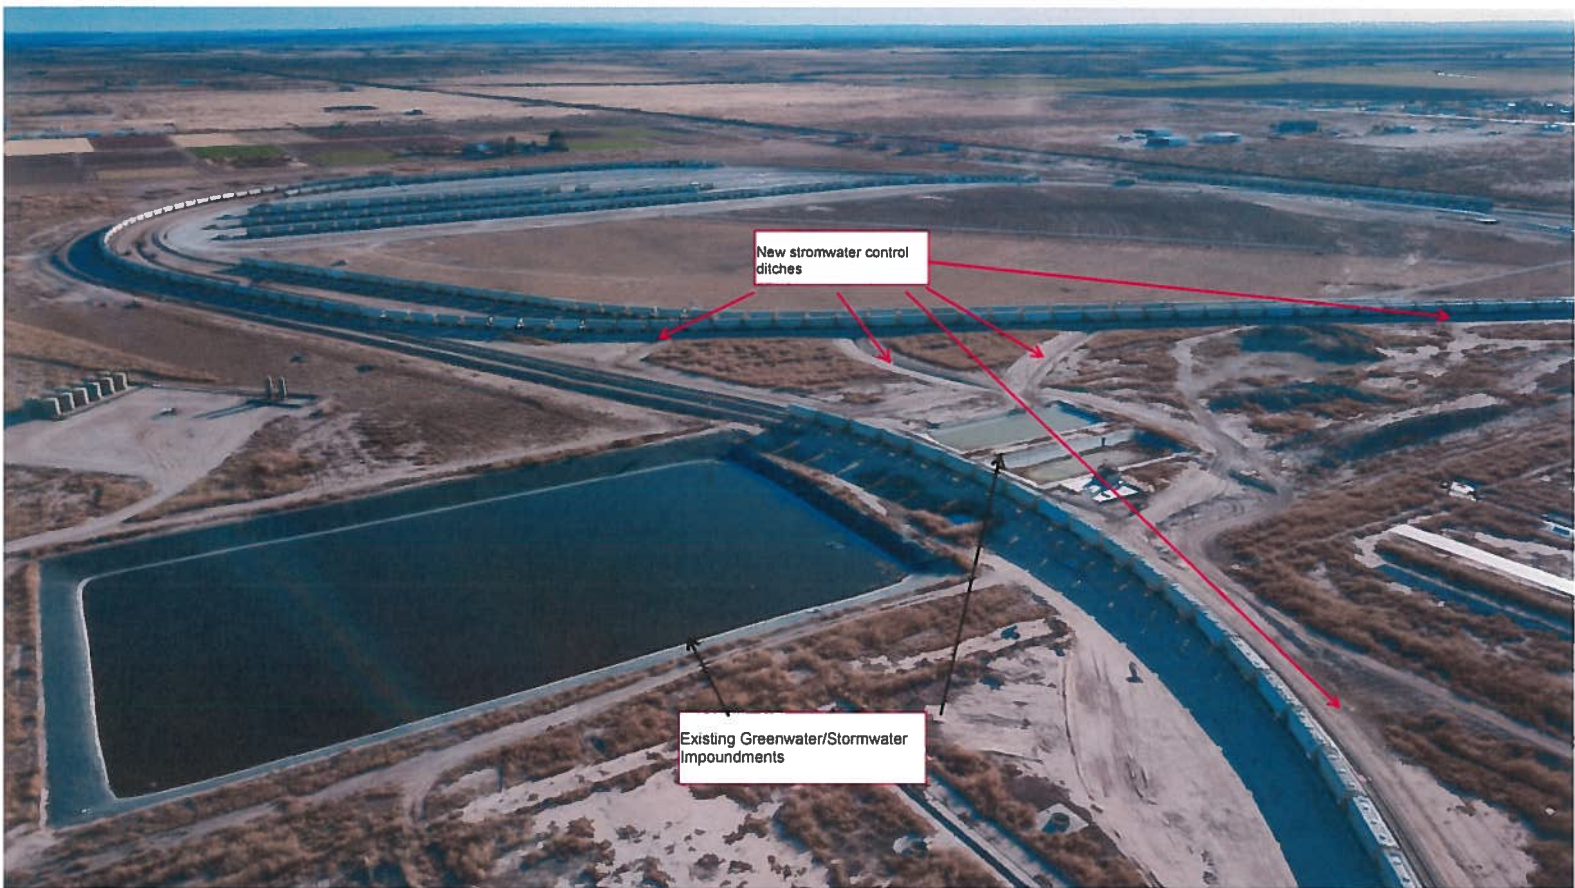
New stormwater control ditches

Existing Greenwater/Stormwater Impoundments

1. The primary purpose for the lagoon would be for storage of groundwater pumped from facility wells to be used for commercial water sales.
2. A secondary use is for continued use to provide stormwater control and retention at the facility. IPB has purposely designed, engineered and developed the rail terminal and track layout and site drainage to utilize the existing impoundments for stormwater collection. The developed property consists of tack beds, roads and loadout areas that are less permeable to stormwater infiltration than under the former dairy operation. Without the existing impoundments, stormwater runoff would damage multiple tracks, switching facilities and potentially flood neighboring farmer's fields. (Attached aerial photos).

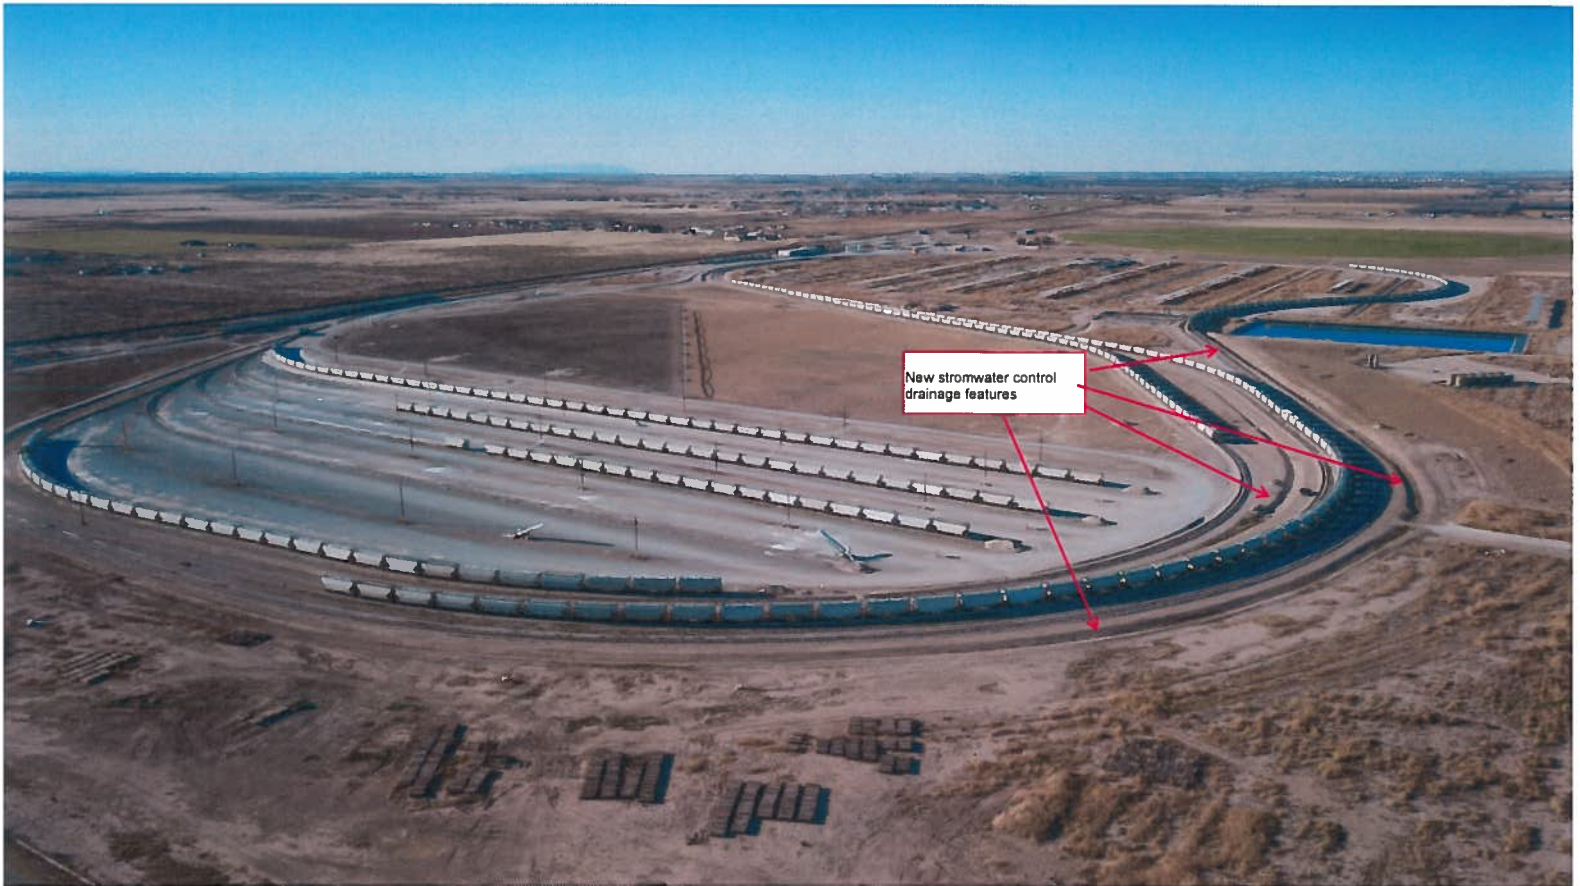
New stormwater control drainage features

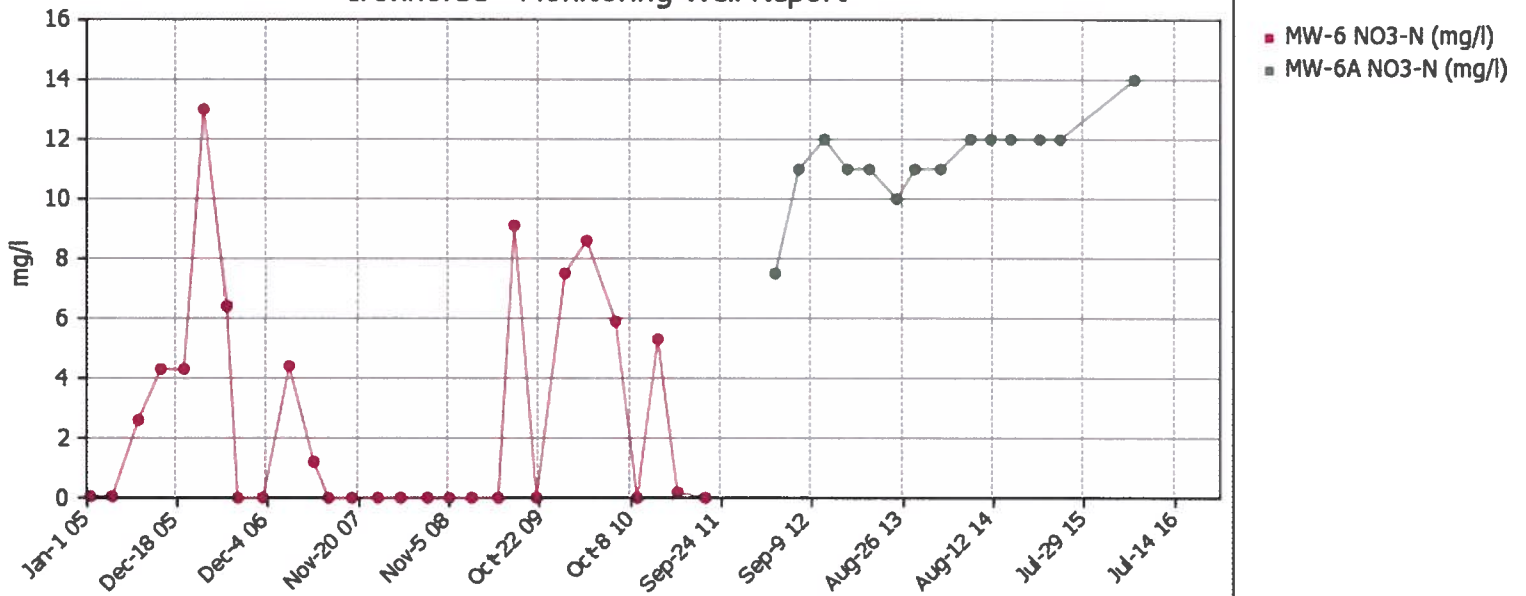
Ironhorse - Monitoring Well Report

As it relates to the green water/stormwater impoundment, slightly elevated nitrate concentrations were observed in monitoring well, MW-6A, located immediately downgradient from the green water lagoon. However, the elevated nitrate is likely associated with the former land application area (former South Field) located west (upgradient) of the green water lagoon that was present prior to construction of the lagoon and not from the lagoon itself. It is anticipated that the nitrate concentration at this location will meet the WQCC standard since the source activities were discontinued in 2013. See attached graph.
