**Assessment of
Solid Waste Management Units
at the
Waste Isolation Pilot Plant**

**Supporting Documentation for
RCRA Facility Assessment**

**NMED/WIPP 93-001
May, 1994**

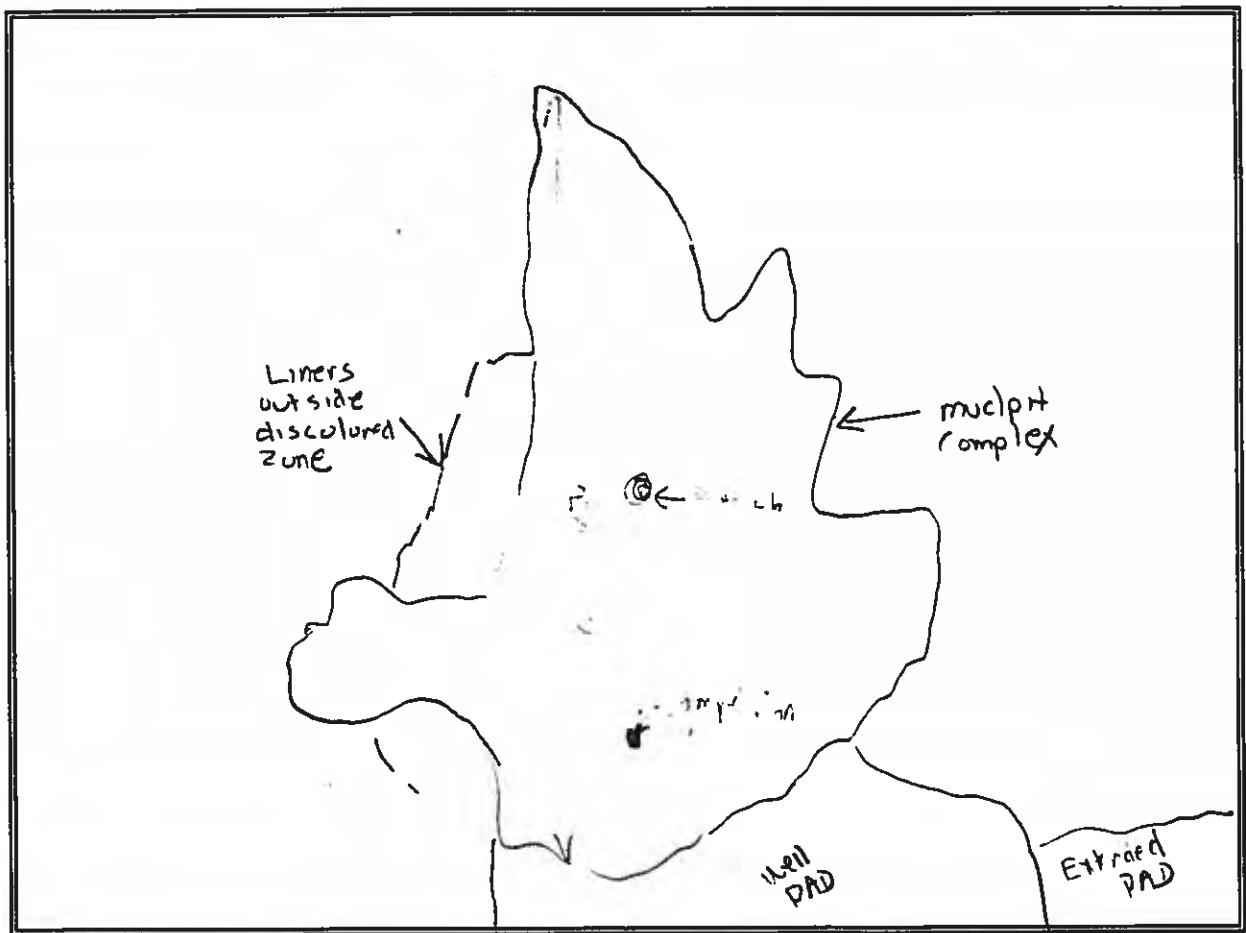
Comments: Sample Location in what appears to be middle of mud pit complex with abundant liners exposed; soil is dark gray and discolored.

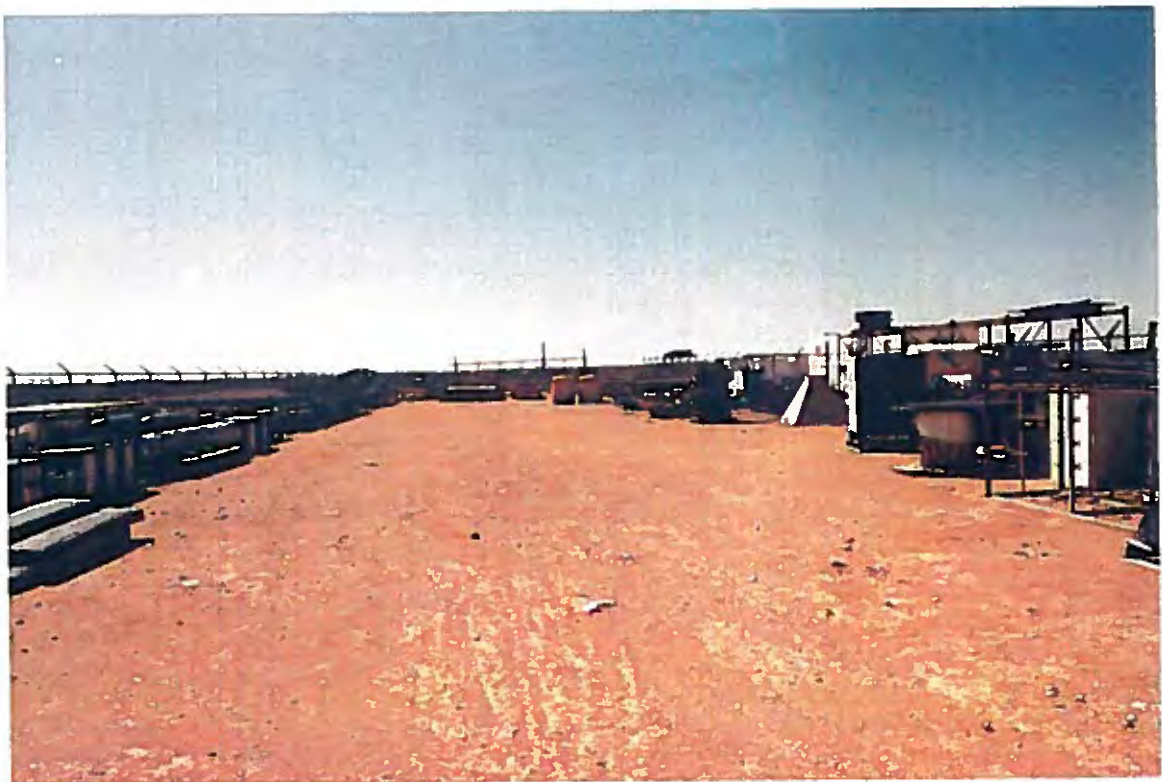
SWMU No. 004-a, Storage Yard, Portacamp

- Improperly stored concentrated nitric acid was observed on the east side of the SWMU 004a Portacamp Storage Yard (Sandia National Laboratory-managed). Staff suggest the acid be containerized properly and removed to an appropriate storage area.
- Housekeeping could be improved in all locations; however, SWMU 004b (Reclaimables Storage Yard) displayed especially poor housekeeping, including improper segregation of recyclable or reclaimable metals and materials.
- The spent batteries stored at SWMU No. 004-b (Reclaimables Storage Yard) contain sulfuric acid and represent a potential source for a release to the environment. Staff suggest that spent lead acid batteries be removed from the reclaimables yard and handled within the Hazardous Waste Staging Area as a hazardous material.

Sandia National Laboratory - East side

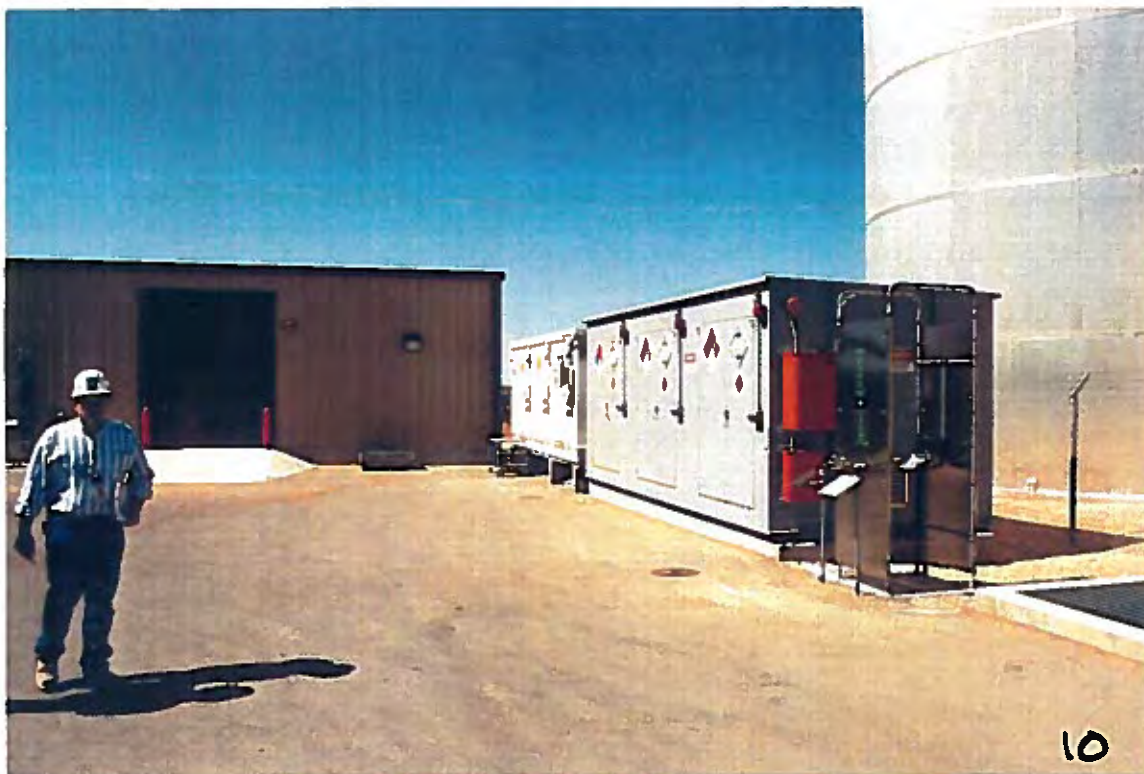
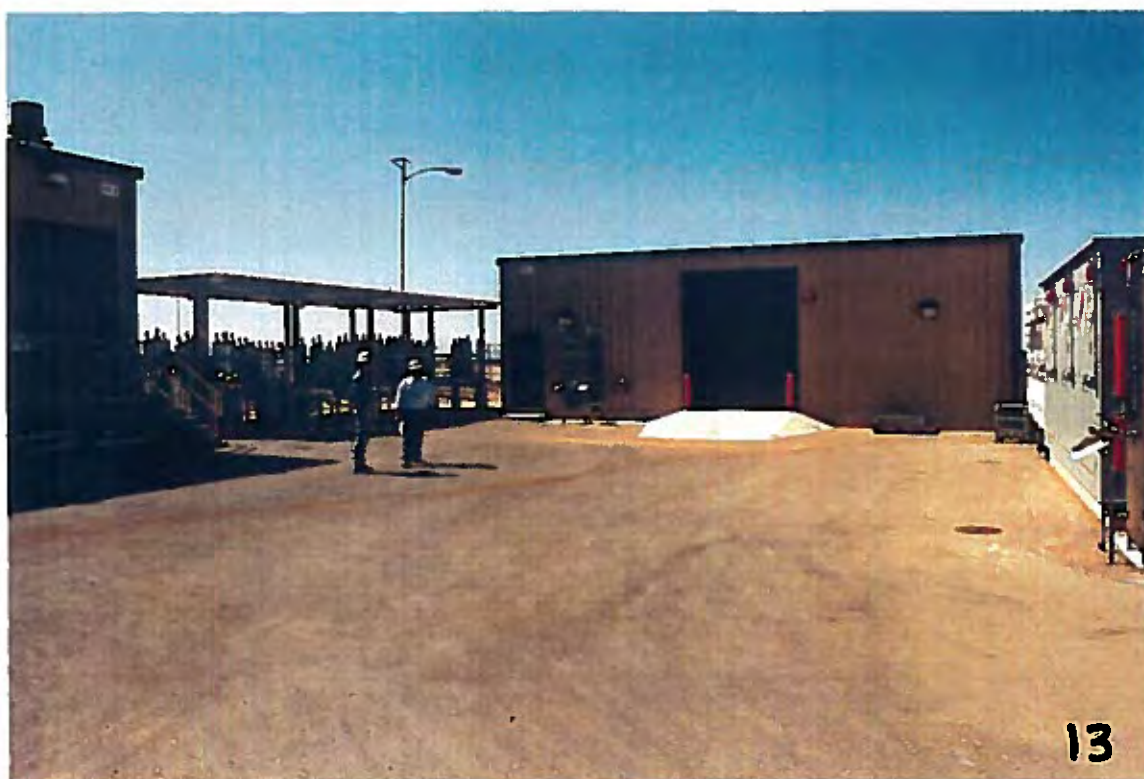
Appendix 4.8.12

- SWMU 008l (Facility 474B) is the current "Hazardous Waste Staging Area", while SWMU 008n (Facility 474A) is proposed for a similar function sometime in the future. Both have the potential for contaminating the adjacent water storage tanks. As stated in the technical assessment, potential contamination is most likely negligible; however, the present design allows a possible exposure pathway to site employees.

SWMU No. 008-1, Hazardous Waste Staging Area, Blg. #474-B
Building B (white), Building A future use (gray), Water storage Tanks on right

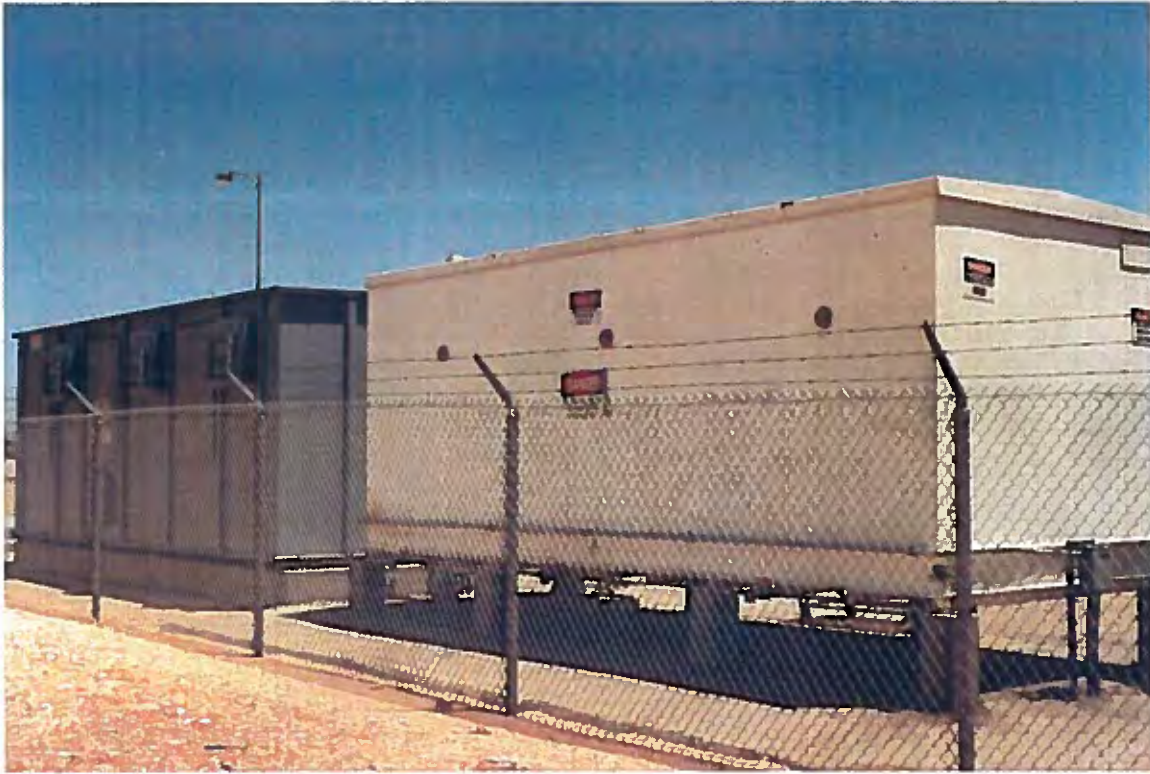
Appendix 4.8.14

SWMU No. 008-n, Hazardous Waste Staging Area, Blg. #474-A (FUTURE)

Building B (white building) is currently used as the staging area and building A (gray) is for future use.

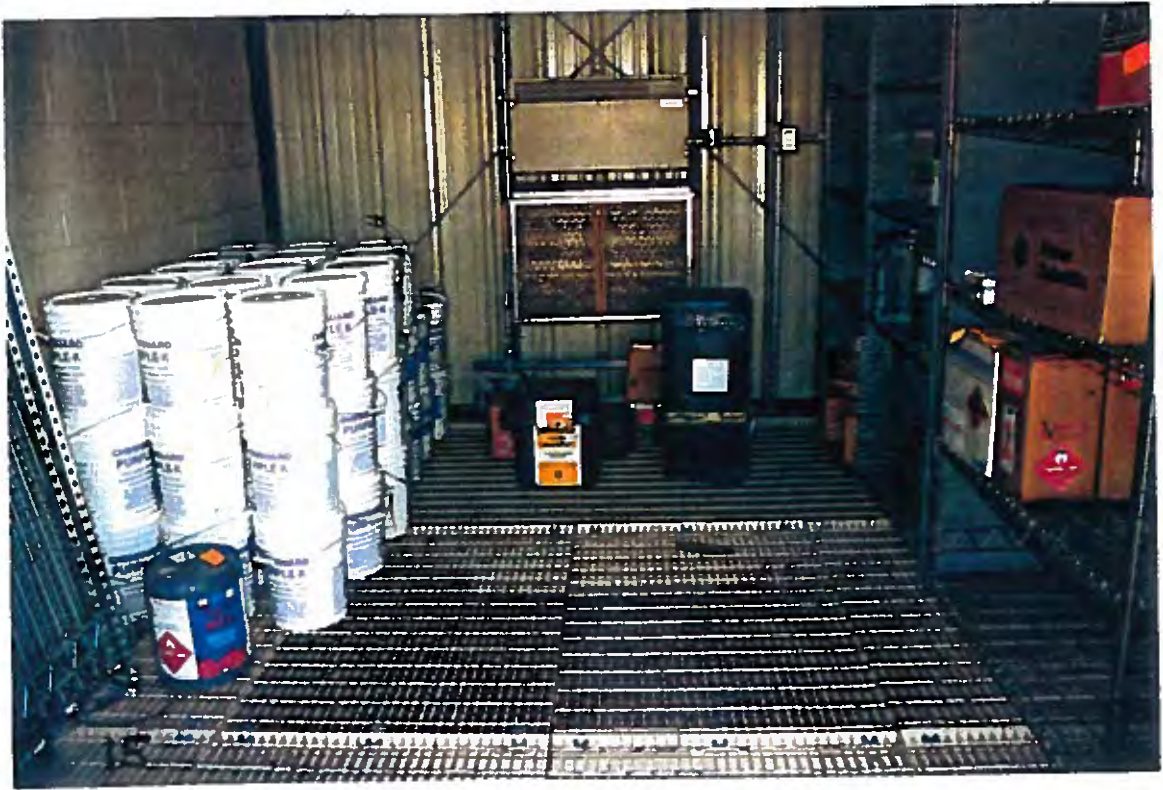
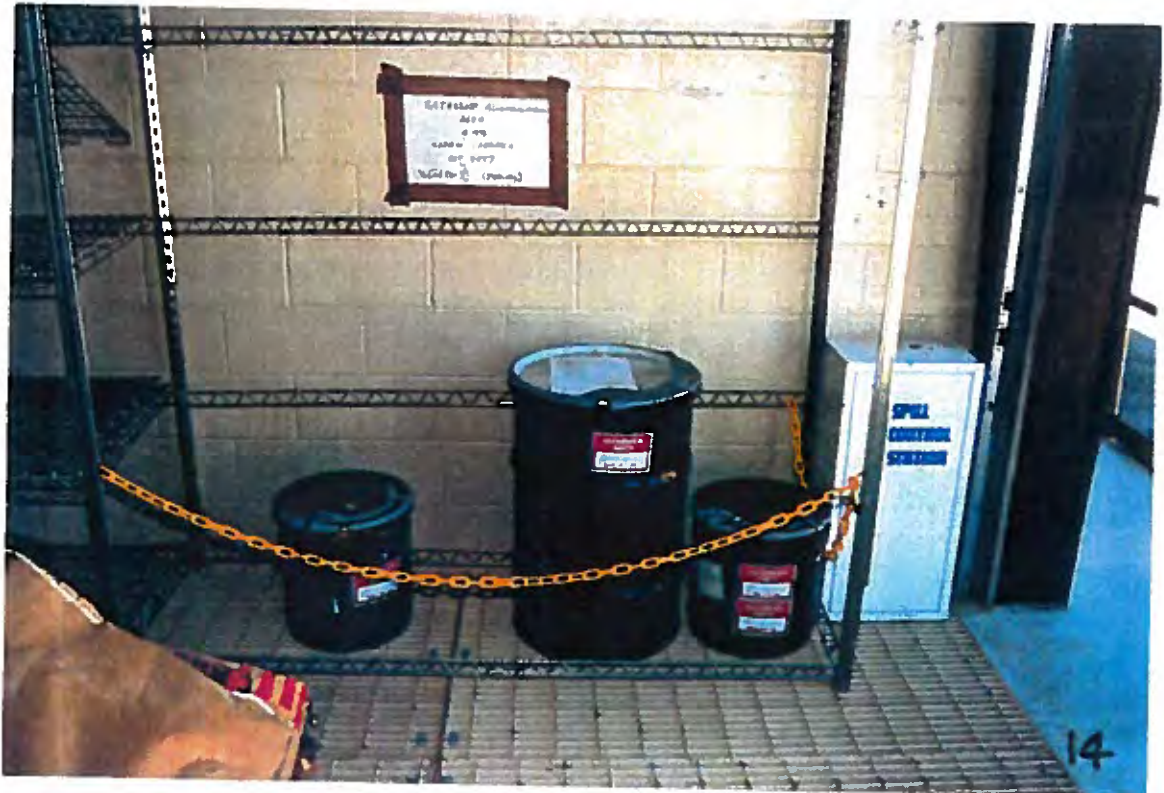
Appendix 4.8.15

- This assessment finds an unidentified SWMU located at Facility 474E, a building which contains Satellite Accumulation Area (SAA) #15. Proposed No. 008-o, Satellite Accumulation and Hazardous Materials Storage Areas (Blg. 474-E) should be a solid waste management unit. Quantities of hazardous materials and some hazardous waste are managed at this location. An exposure pathway also exists for Facility 474E, as the individual isolation bays are equipped with unfiltered ventilation systems that exhaust to the atmosphere.

SWMU No. 008-o, Satellite Accumulation and Hazardous Materials Storage Area
Bldg. 474-E

Middle Bay - Hazardous Materials Storage

East Bay - SAA #15

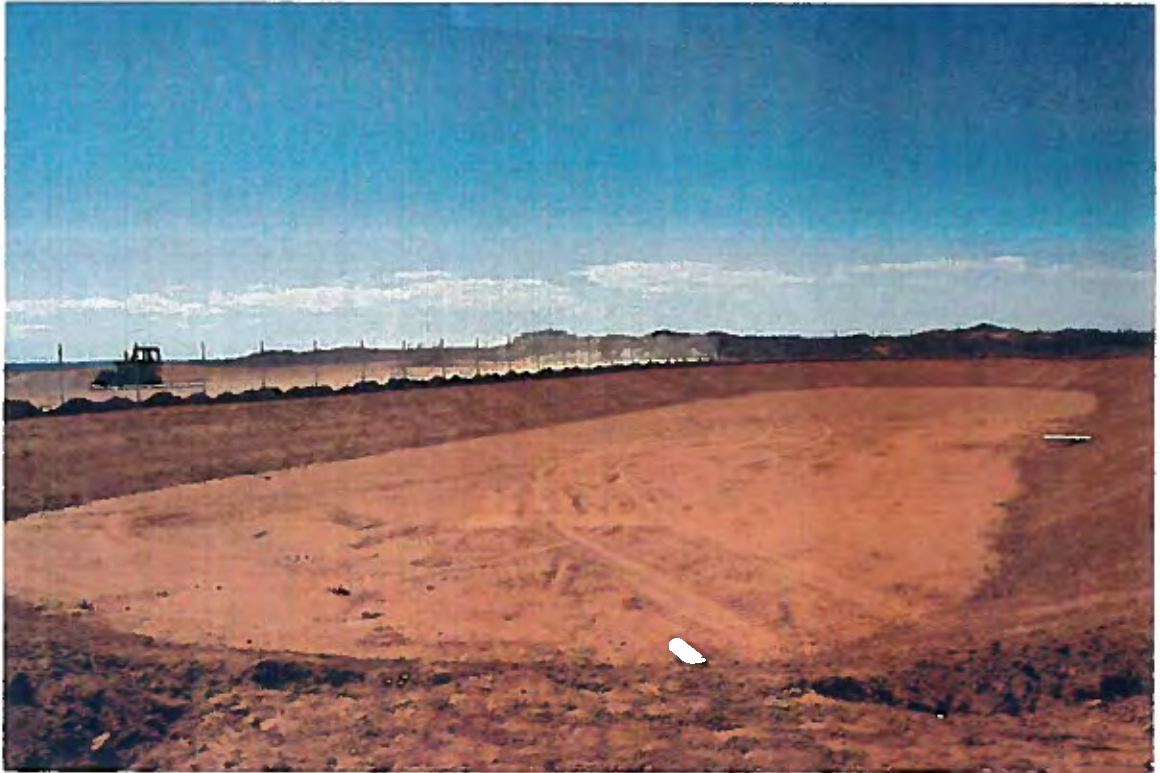
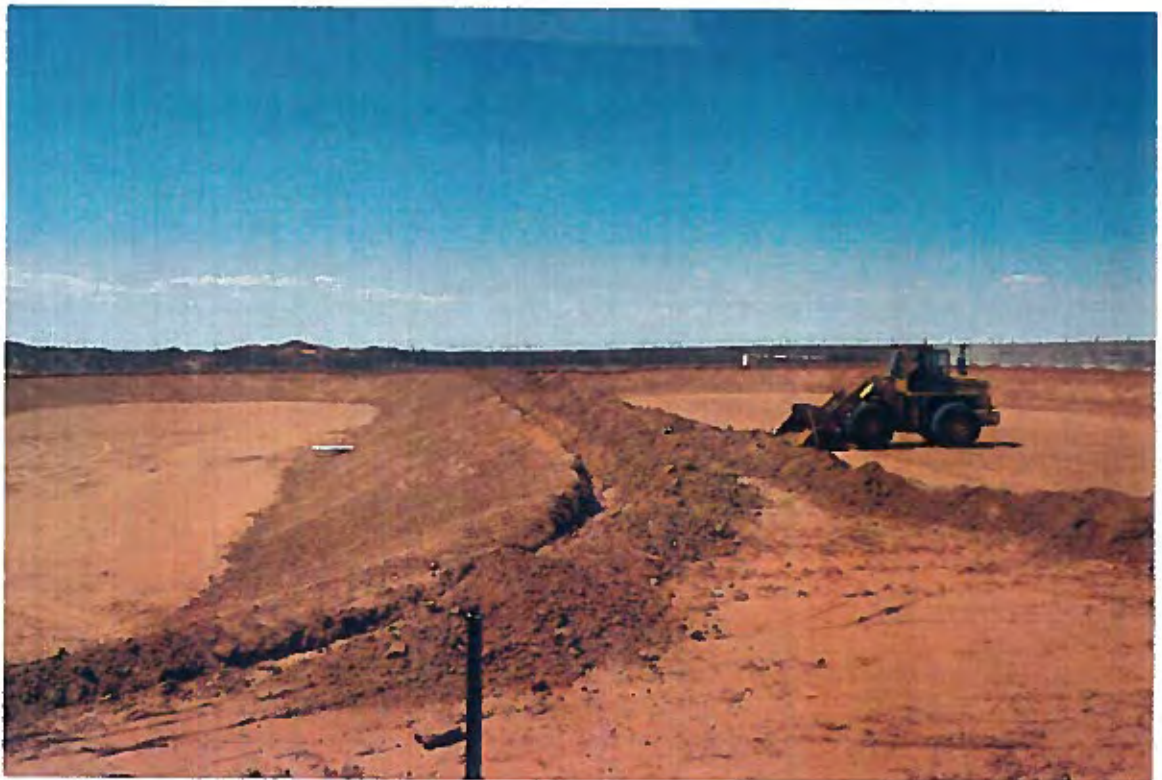
SWMU No. 011, Sewage Treatment Facility

March 1993 Construction of Lined Parallel Evaporation Cells to replace the existing Evaporation Cell
