NEW MEXICO
ENVIRONMENT DEPARTMENT

Re: Raton Wastewater Treatment Plant; Minor Municipal; SIC 4952; NPDES Compliance Evaluation Inspection; NPDES #NM0020273; August 20, 2019

NPDES Compliance Inspection Report

Further Explanations
Raton Wastewater Treatment Plant
Compliance Evaluation Inspection
NPDES Permit No. NM0020273
Inspection Date: August 20, 2019

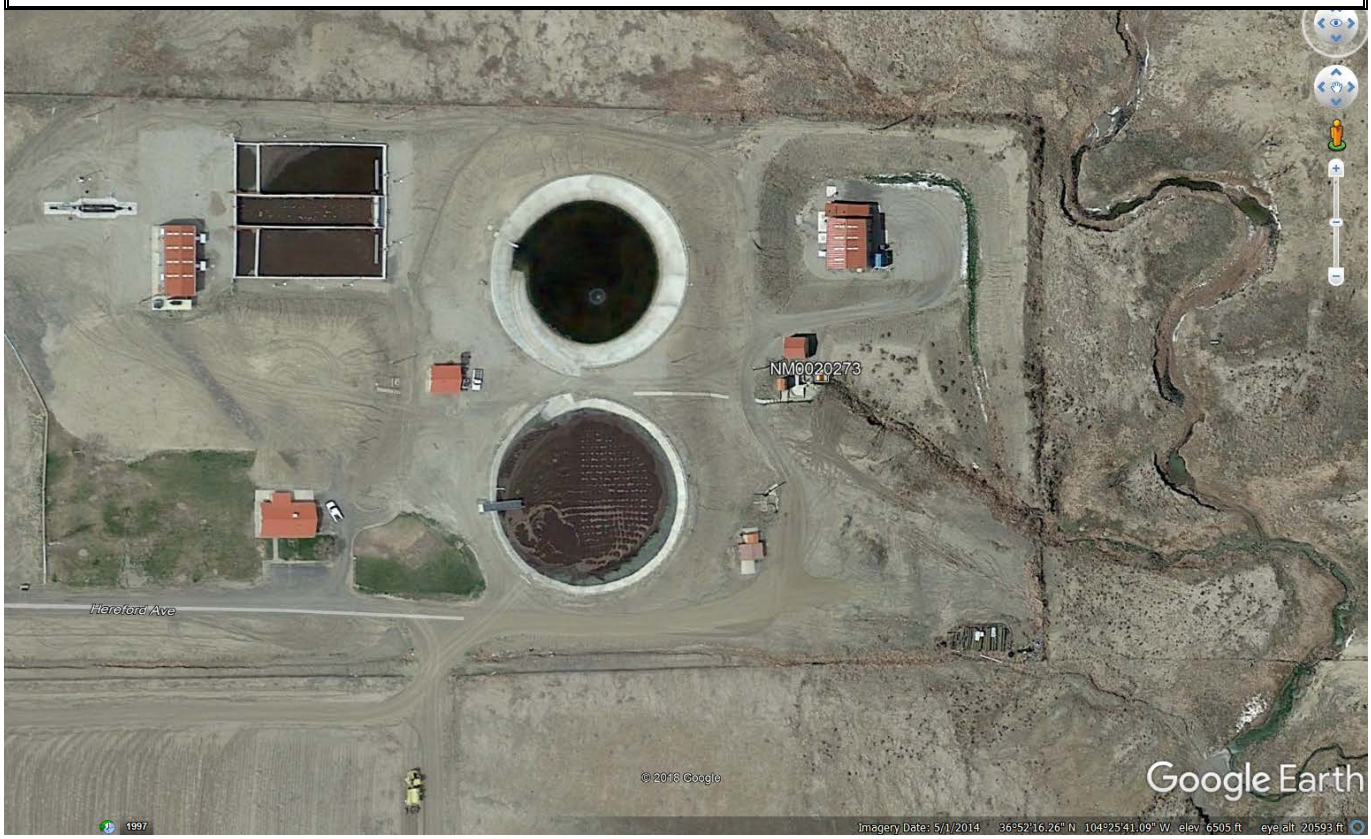
NMED/SWQB Official Photograph Log Photo # 1		
Photographer: Google Earth	Date: 5-1-14	Time: unknown
City/County: Colfax County		State: New Mexico
Location: Raton Waste Water Treatment Plant		
Subject: aerial view of WWTP, sludge disposal in field to south

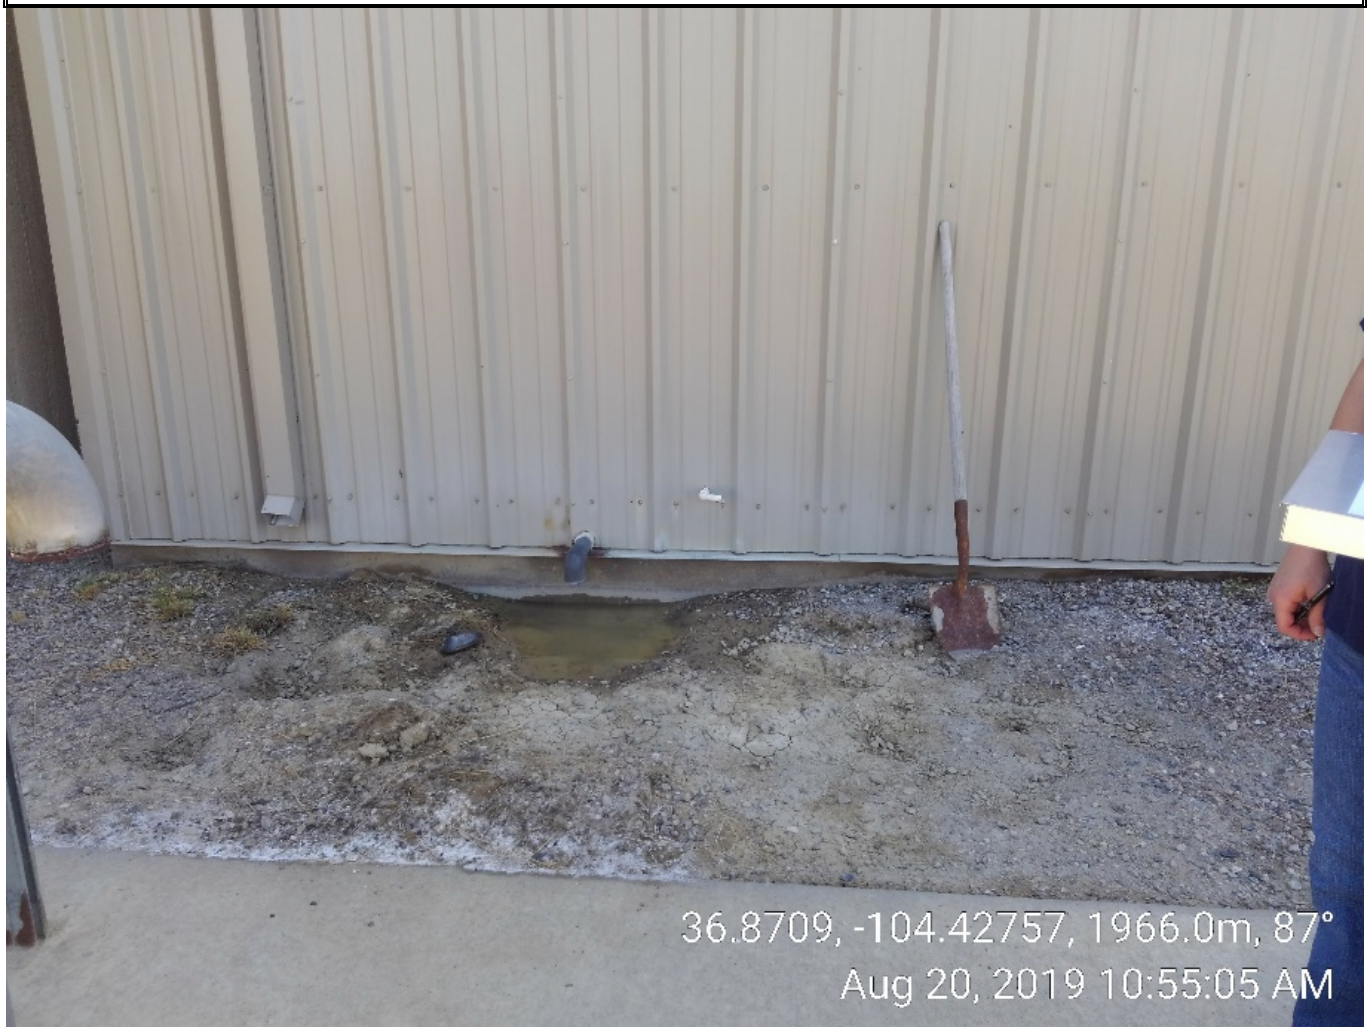
NMED/SWQB Official Photograph Log Photo # 2		
Photographer: Jennifer Foote	Date: 8-20-19	Time: 10:55 am
City/County: Colfax County		State: New Mexico
Location: Raton Waste Water Treatment Plant		
Subject: water softener discharge
