**Re: Southwest Aviation/ Las Cruces International Airport; MSGP; SIC 4581; NPDES Compliance Evaluation Inspection; NPDES# NMR053399; May 2, 2018**

# NPDES Compliance Inspection Report

# NPDES Industrial Storm Water Checklist (MSGP)

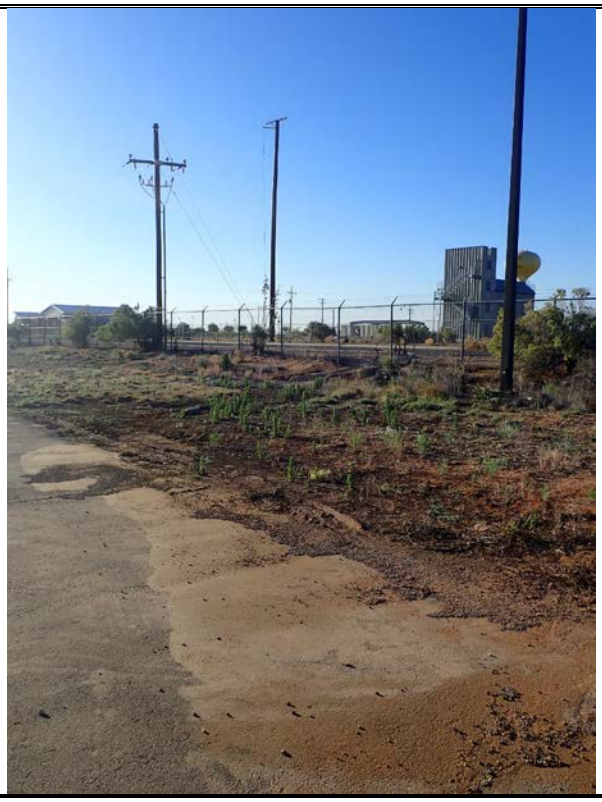
| NMED/SWQB<br>Official Photograph Log<br>Photo # 6 | | |

| NMED/SWQB<br>Official Photograph Log<br>Photo # 6 | | |
|---|---|---|
| Subject: oil stain and rags on ground near airplane | | |
