Re: **Abrazo Homes LLC/Santa Monica Estates; CGP; SIC 1521; NPDES Compliance Evaluation Inspection; NPDES # NMR10009D; December 20, 2017**

NPDES Compliance Inspection Report

NPDES Construction General Permit Inspection Report – State of New Mexico

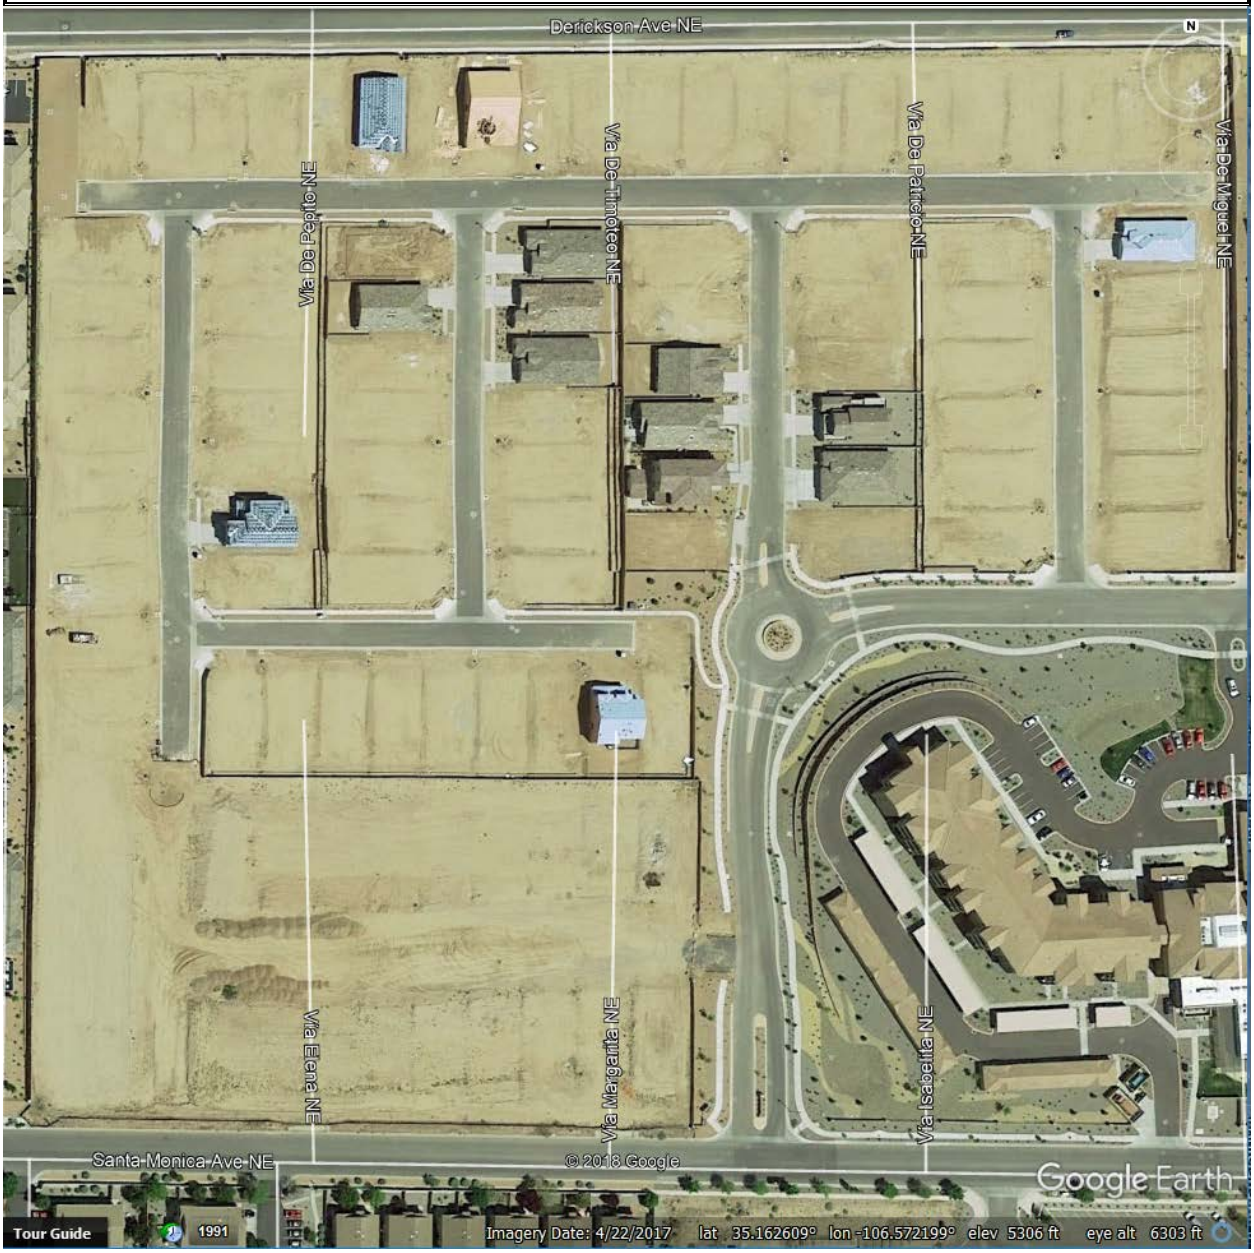
NMED/SWQB Official Photograph Log Photo # 1		
Photographer: Google Earth	Date: 4/22/17	Time: n/a
City/County: Albuquerque, Bernalillo		State: New Mexico
Location: Santa Monica Estates		
Subject: Aerial photo taken in April 2017, of disturbed areas included in greater plan of development for Santa Monica Estates

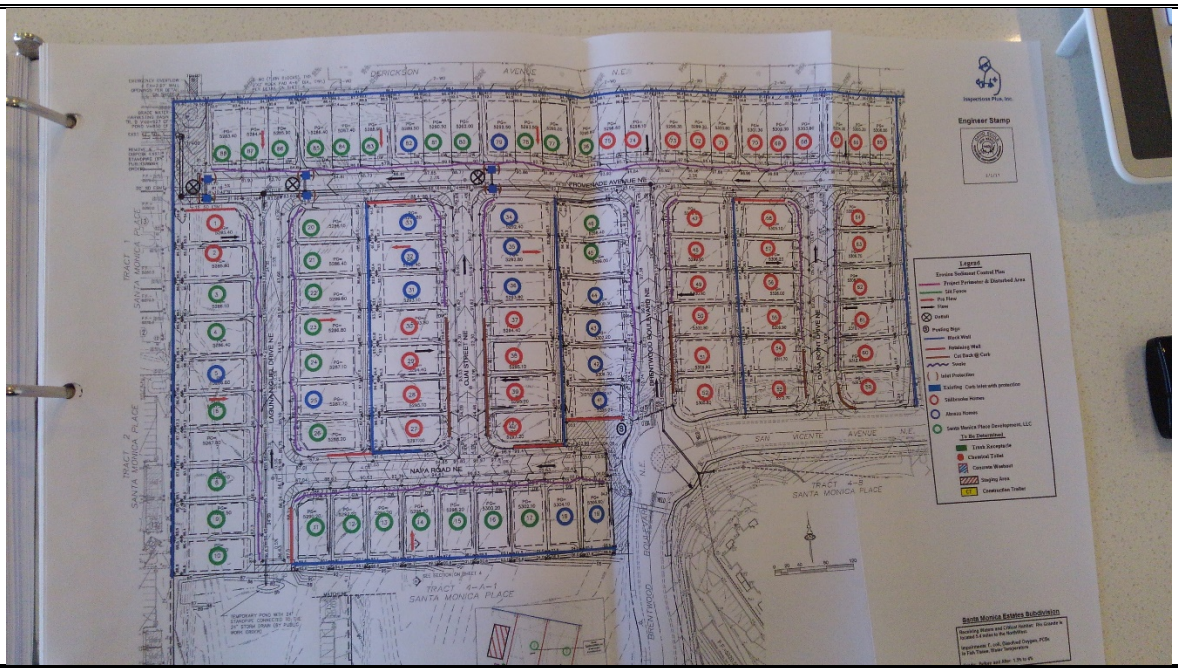
NMED/SWQB Official Photograph Log Photo # 2		
Photographer: Jennifer Foote	Date: 12/20/17	Time: 1:35 pm
City/County: Albuquerque, Bernalillo		State: New Mexico
Location: Santa Monica Estates		
Subject: Abrazo/TQM SWPPP site map showing parcel ownership for the three owners.
