Construction of the new Pajarito Environmental Education Center is at former TA-45, where soils data indicate some contamination.

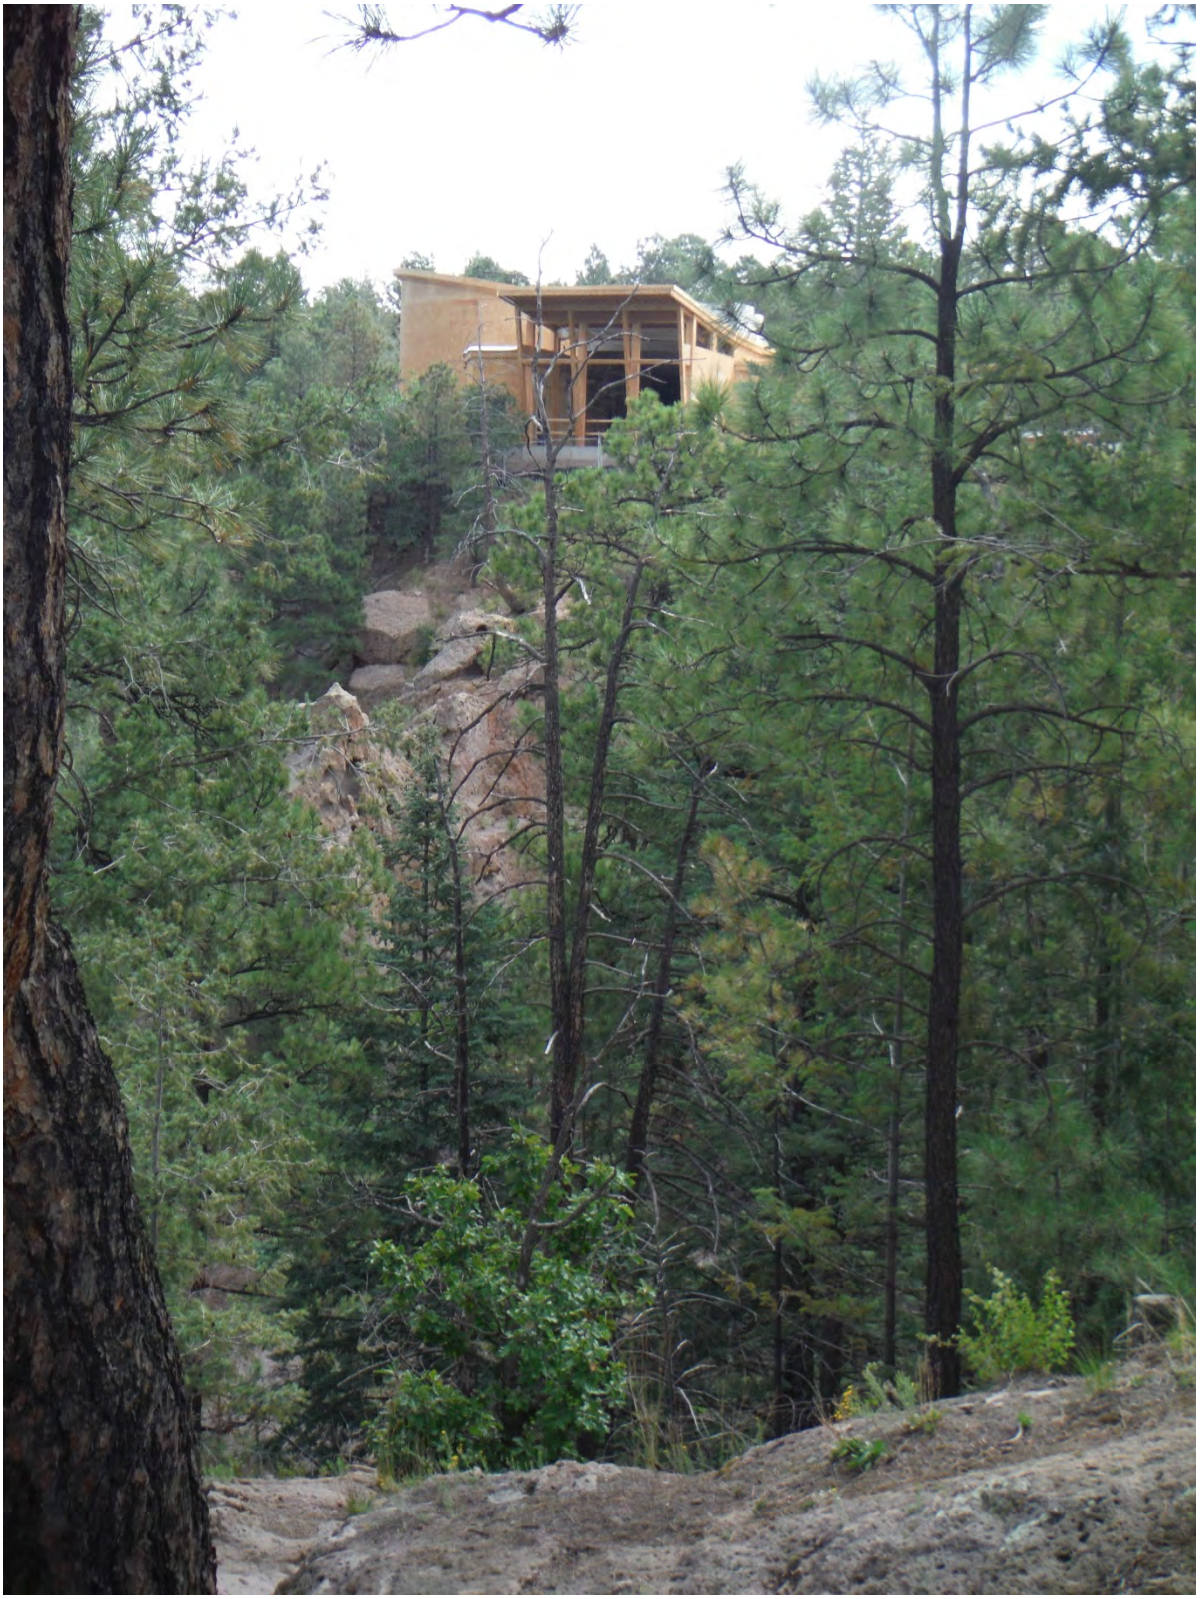
Photo 1: View east across Acid Canyon at the Pajarito Environmental Education Center (former TA-45)
