NEW MEXICO
ENVIRONMENT DEPARTMENT

Surface Water Quality Bureau

Re: New Natural Gas Pipeline Hydrostatic Testing Water Discharge at County Road (CR) 57A, Santa Fe County, New Mexico; Enterprise Mid-America Natural Gas Pipeline WEP III Project, Segment 3; Minor; Unpermitted Discharge; SIC 4213; NPDES Reconnaissance; NMU001869; November 8, 2013

NPDES Compliance Inspection Report

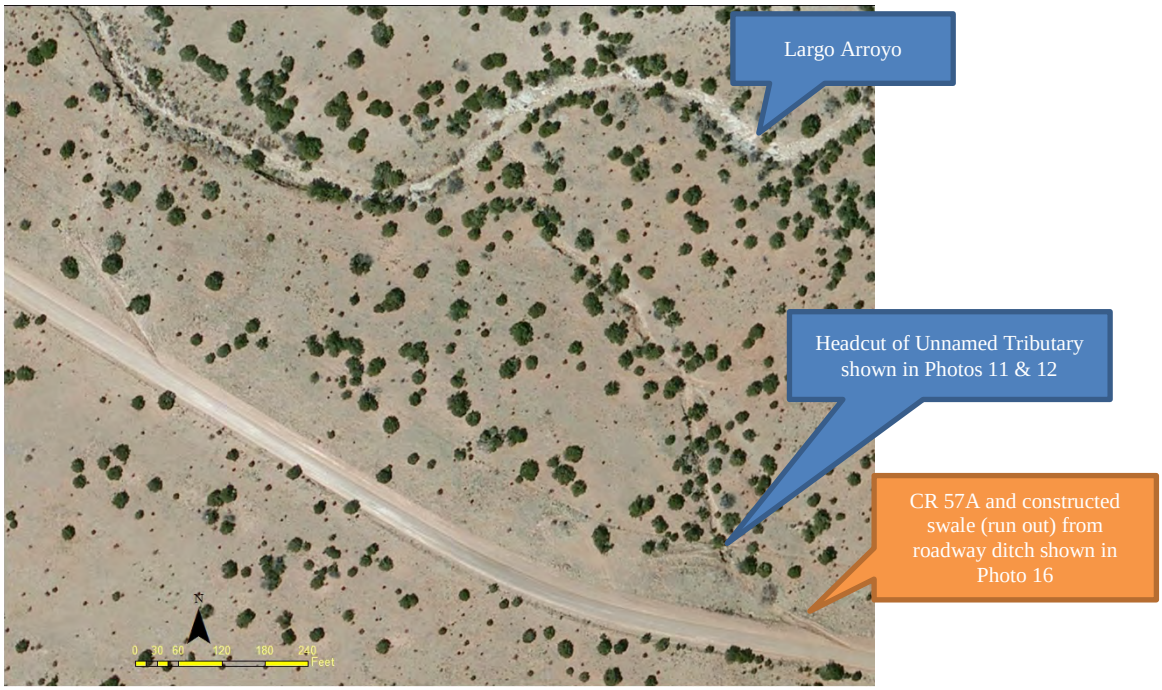
NMED/SWQB Aerial Photograph	
City/County: North of Golden / Santa Fe	State: New Mexico
Location: Santa Fe County Road 57A, Approximately 1,500 Feet Northwest of Intersection of NM 14 and CR 57A
