## List of Compliance Concerns

**Warning of Significant Compliance Concerns**

<b>Inspection Type: Compliance</b>	<b>Case Number: 2570</b>	Inspection Start Time: 10:45:00 AM	Date: 27-Feb-14
------------------------------------	--------------------------	------------------------------------	-----------------

**Re: Enforcement Recommendation Josie's Country Market (FID 54493)**

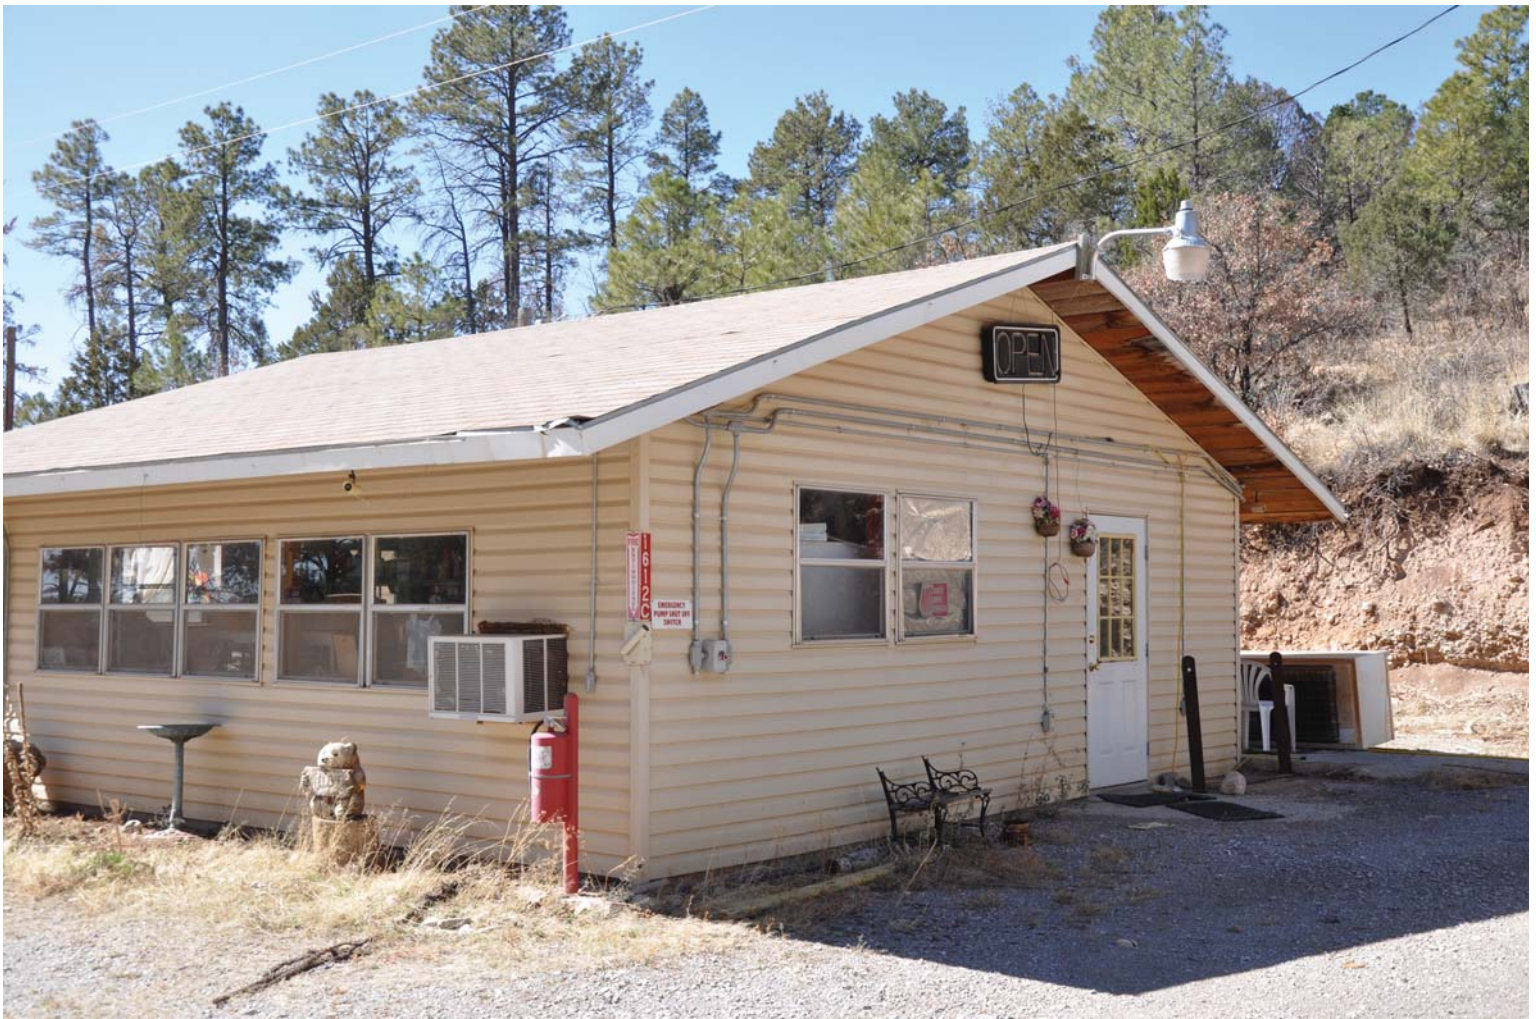
Facility Name: Josie's Country Market Facility Number: 54493 Photograph Number: DSC\_0096

Description:  
Picture taken while facing SW and looking at the store at this facility.

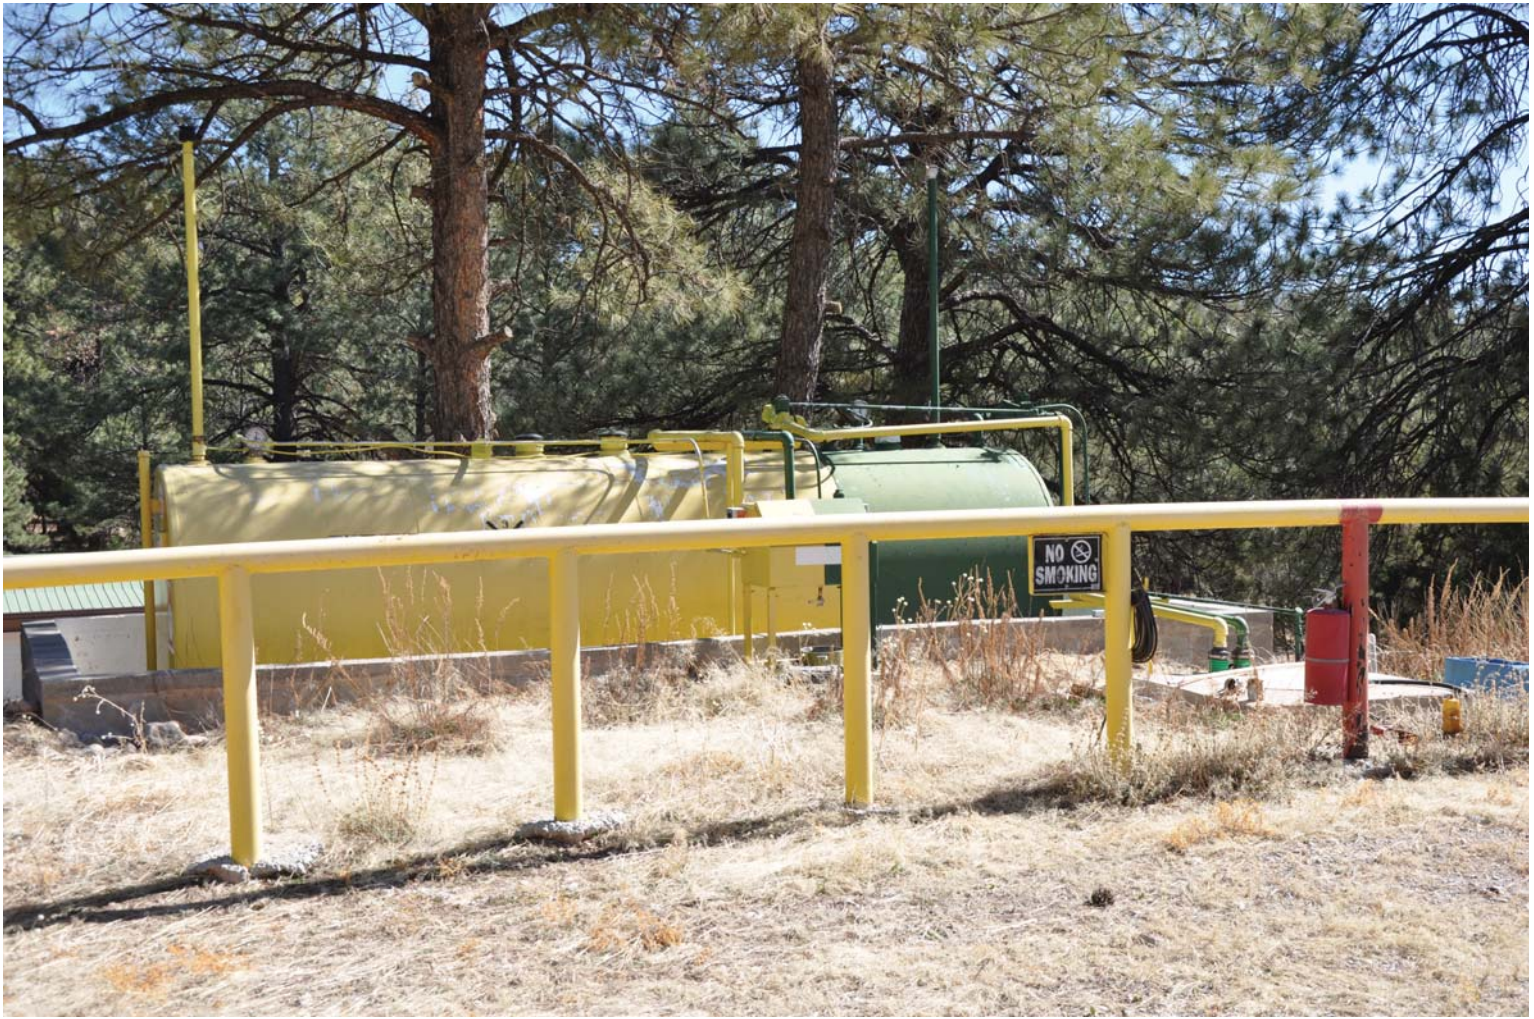
Facility Name: Josie's Country Market Facility Number: 54493 Photograph Number: DSC\_0097

Description:  
Picture taken while facing east and looking at the AST at this facility.

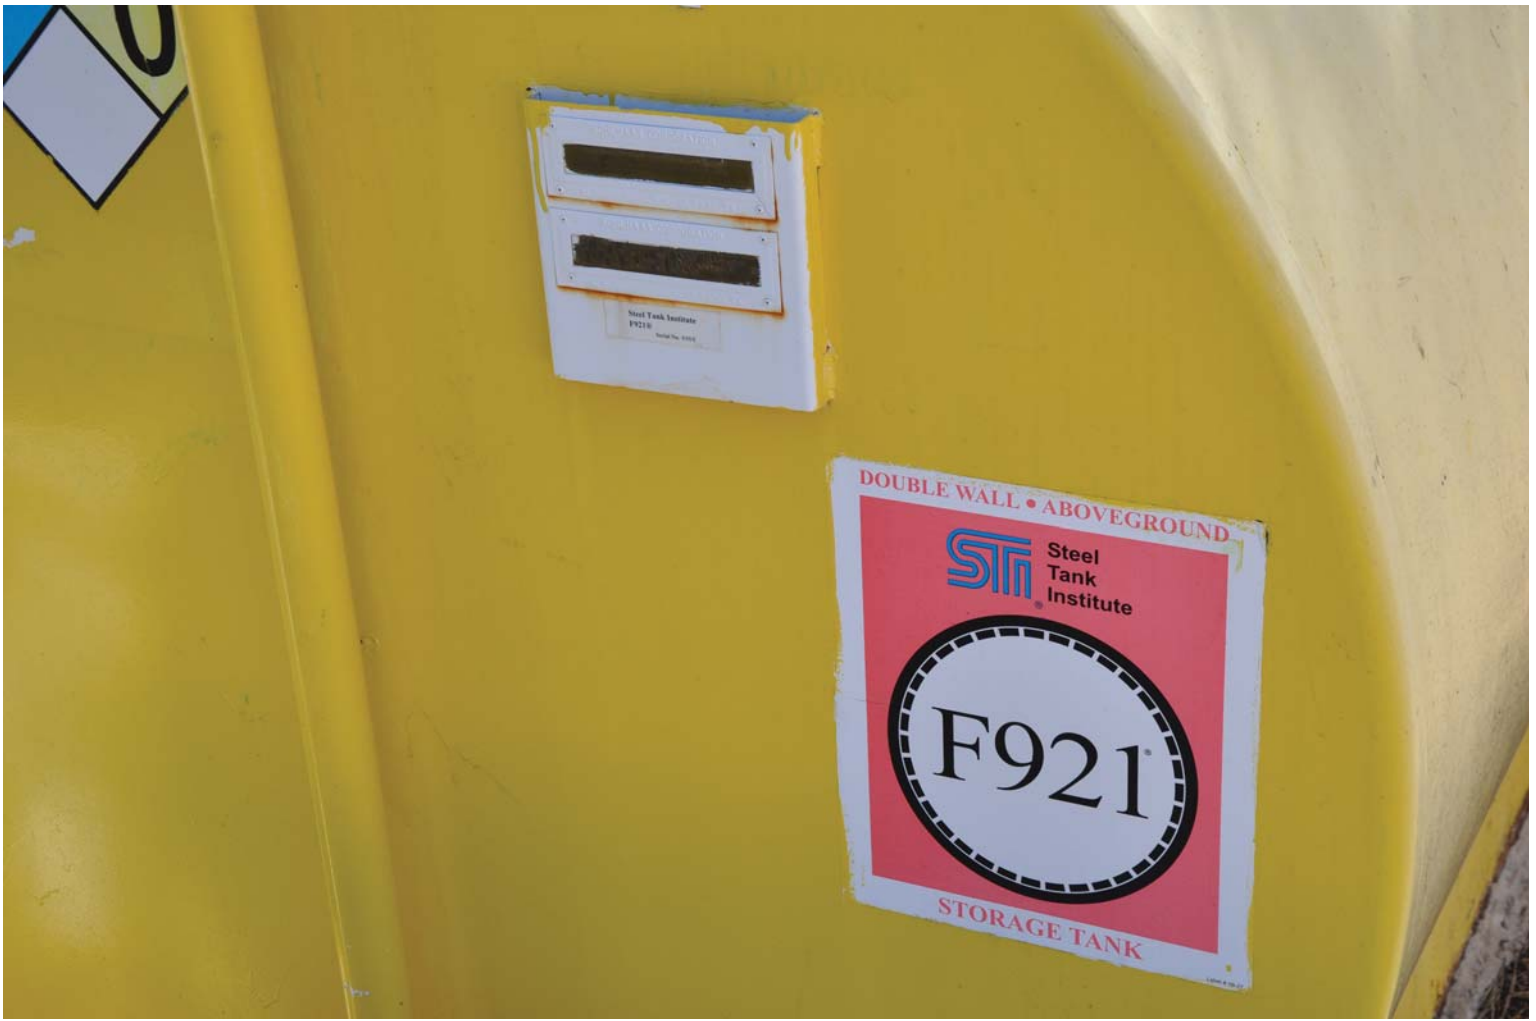
Facility Name: Josie's Country Market Facility Number: 54493 Photograph Number: DSC\_0098

Picture taken while facing SE and looking at the labels on the north end of the AST.

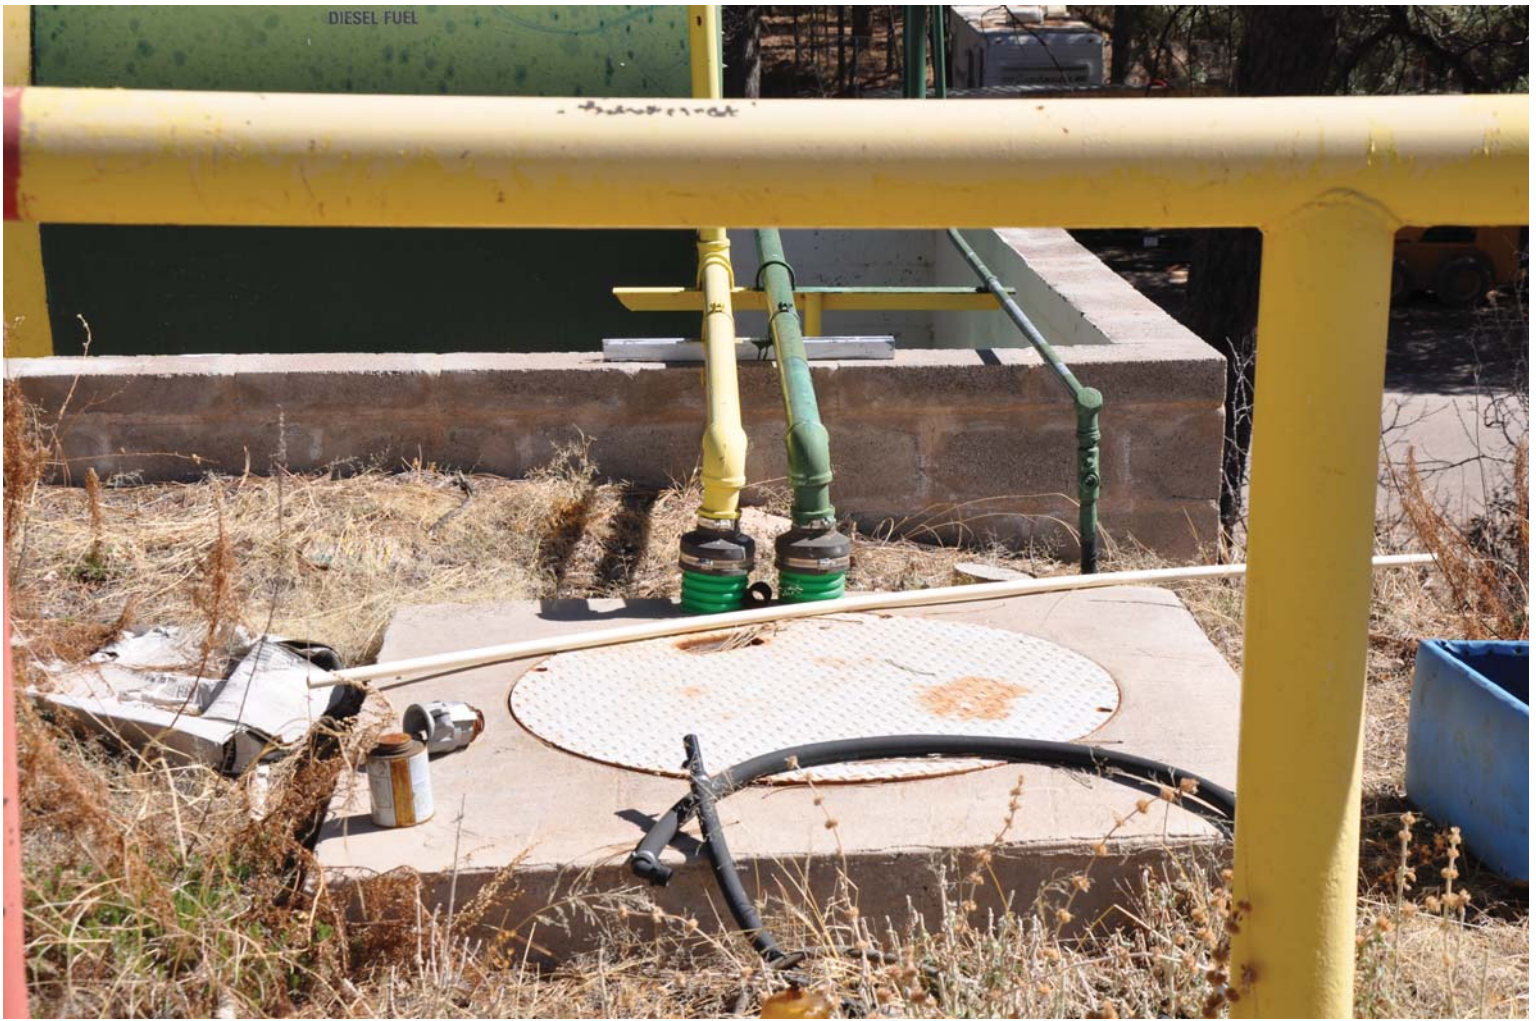
Facility Name: Josie's Country Market Facility Number: 54493 Photograph Number: DSC\_0103

Description:  
Picture taken while facing east and looking at the transition sump on the SW side of the tank.
