NEW MEXICO ENVIRONMENT DEPARTMENT

Re: **Resurrection Mining, LLC Rio Puerco Uranium Mine; Major Non-Municipal, SIC 1094,
NPDES Compliance Evaluation Inspection, NM0028169, August 6, 2015**

**Compliance Evaluation Inspection
Resurrection Mining LLC – Rio Puerco Mine
NPDES Permit #NM0028169, August 6, 2015**

Further Explanations

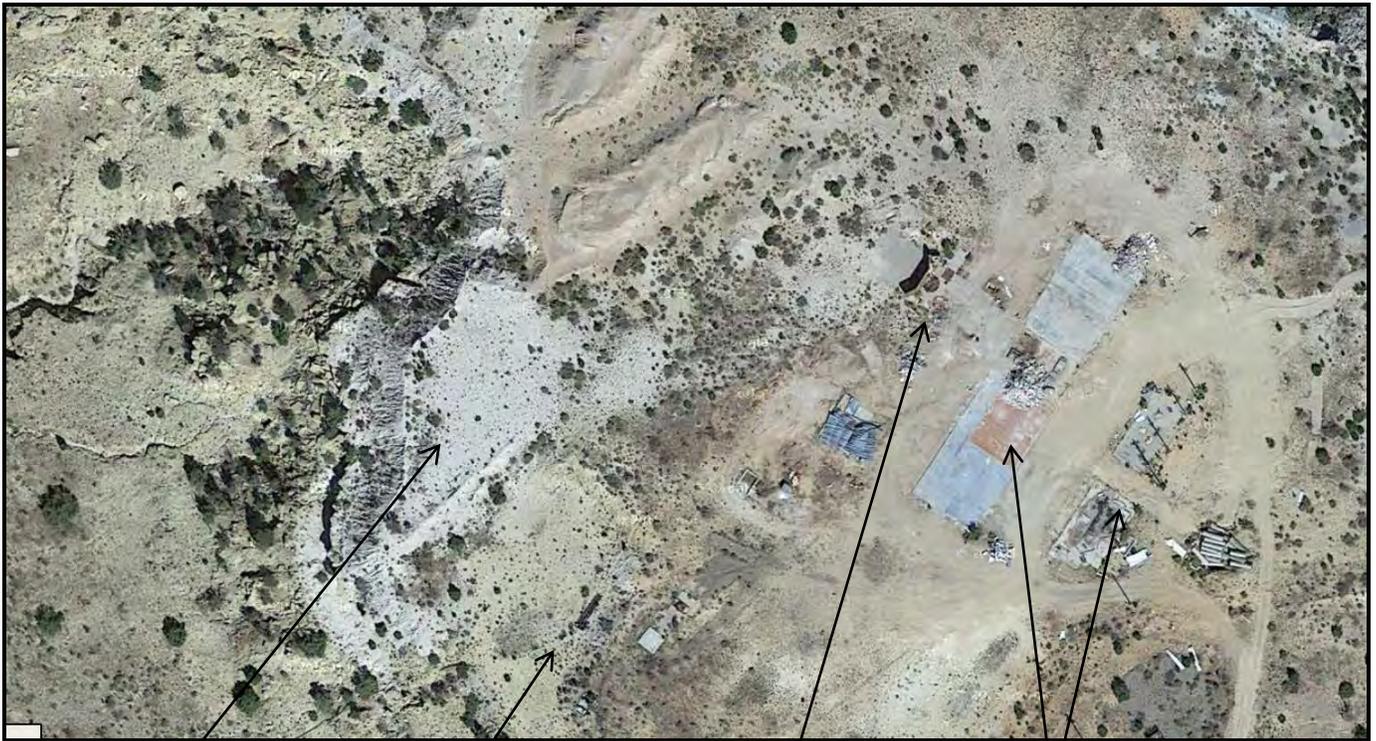
**NMED/SWQB
Google Overview**

35.269	Date: September 1, 2010	-107.19617
City/County: Approximately eight miles south of Marqueez, NM		
Location: Resurrection Mine formerly the Uranium King Mine, facing northwest.		
Subject: Overview of the Resurrection Mine formerly the Uranium King Mine.
