NEW MEXICO ENVIRONMENT DEPARTMENT

Re: Major Municipal; SIC 4952; Compliance Evaluation Inspection; CRRUA Sunland Park
Wastewater Treatment Plant; NPDES Permit No. NM0029483; November 20, 2014

NPDES Compliance Inspection Report

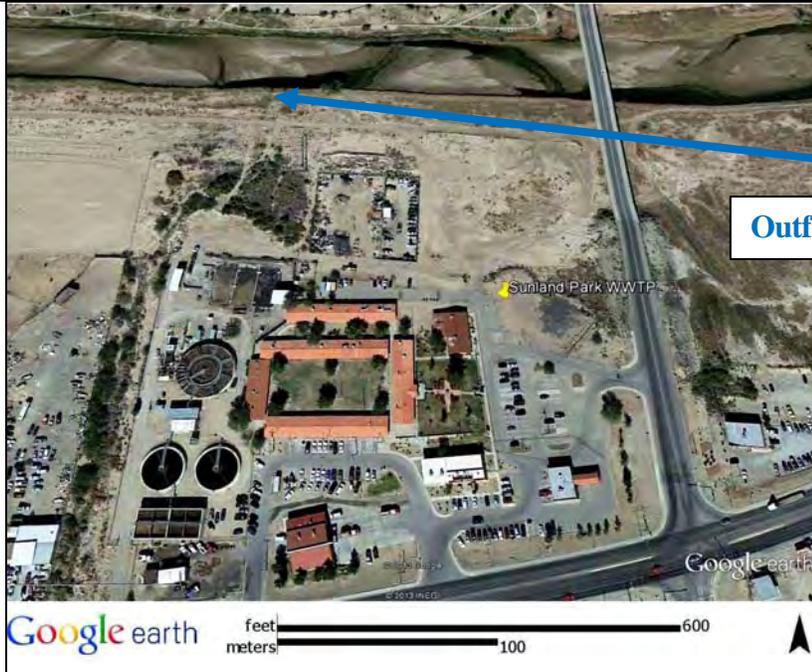
Location: CRRUA Sunland Park Wastewater Treatment Plant

Subject: Aerial View of the facility.

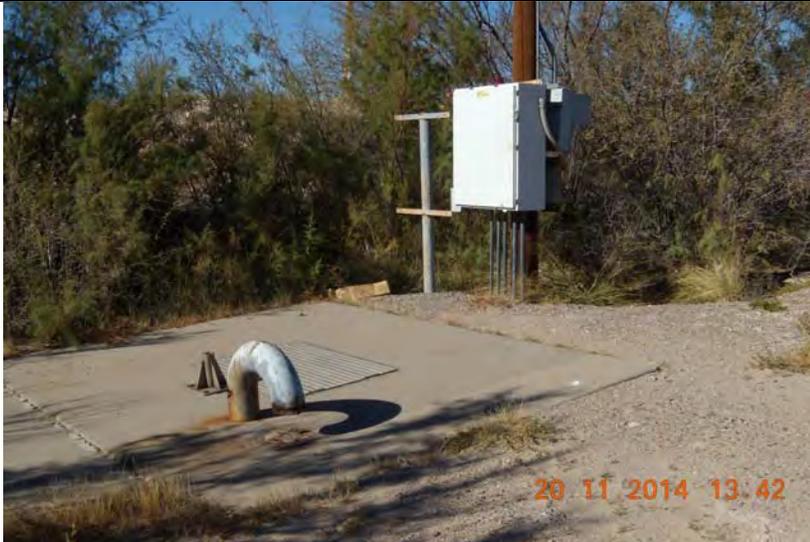
Location: CRRUA Sunland Park Wastewater Treatment Plant - Race track lift station.

5. Collection system – lift stations – inadequate alarm systems. No back up power, evidence of past overflows based on debris seen around the lift station. Three lift stations were visited as part of the inspection, the Racetrack liftstation, the Santa Teresa lift station and the Dias Lago lift station (see attached photos).

Subject: Lift station – overall view of location.

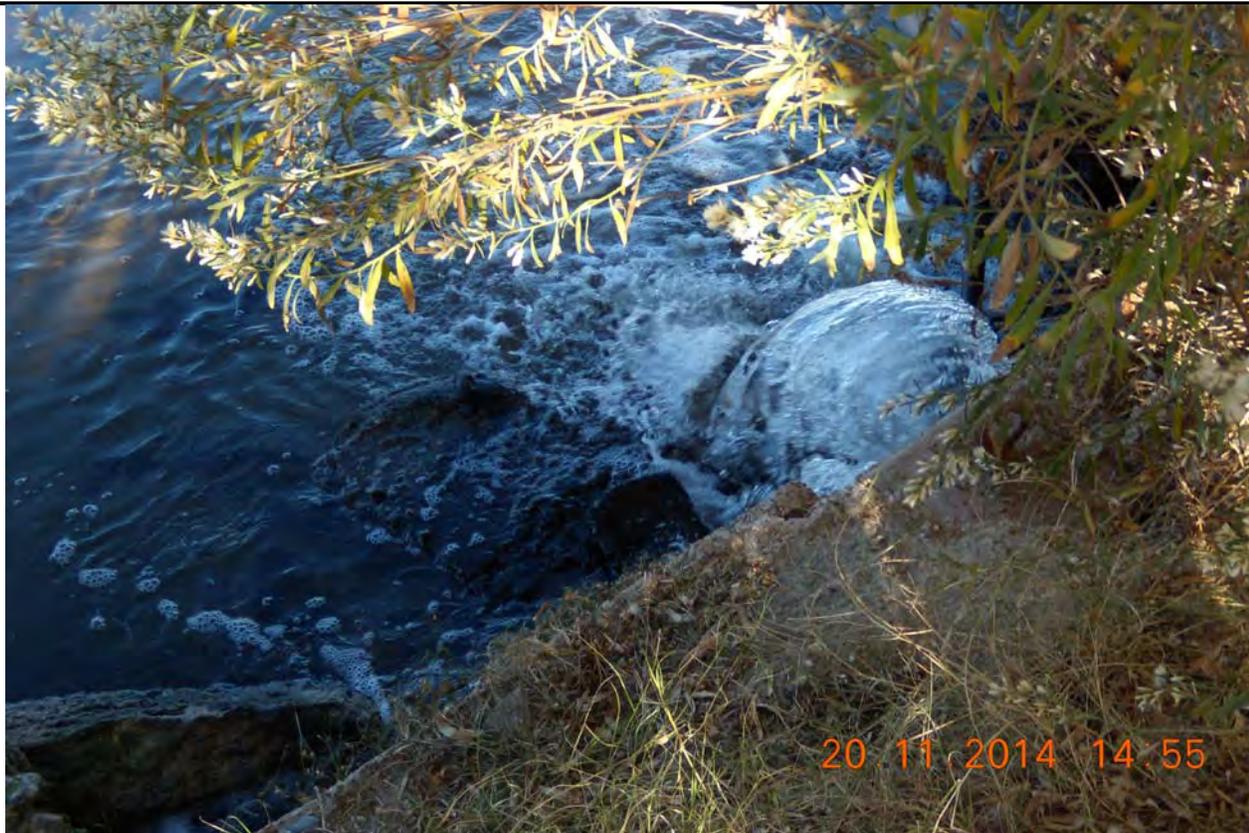
Location: CRRUA Sunland Park Wastewater Treatment Plant - Outfall to the Rio Grande

Subject: Outfall to the Rio Grande

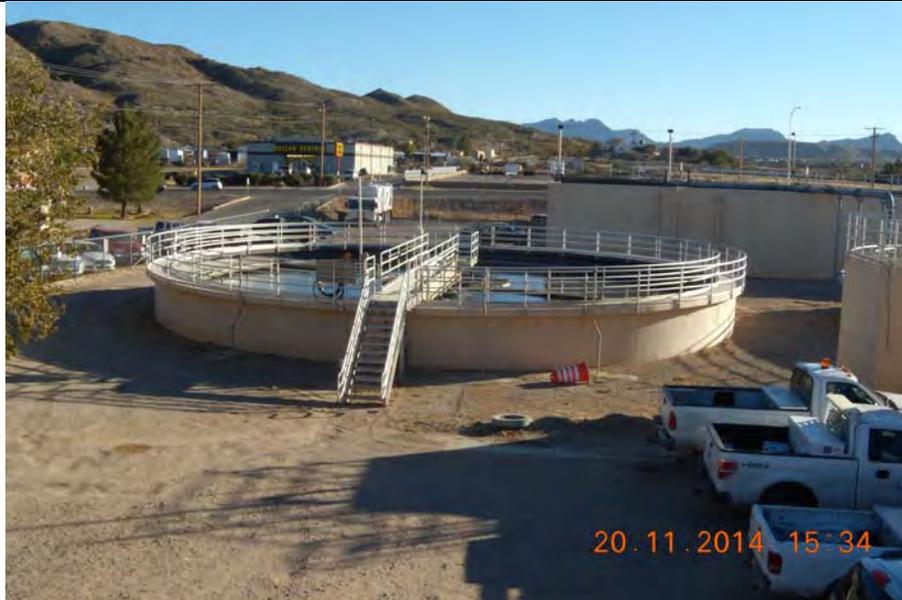
Location: CRRUA Sunland Park Wastewater Treatment Plant

14. Final Clarifiers had a small amount of floating solids that indicate older sludge and inadequate wasting of solids (see attached photo). The clarifier weirs were clean and free of algae and collected solids. An operator was cleaning the weirs the day of the inspection.

Subject: Secondary Clarifier.

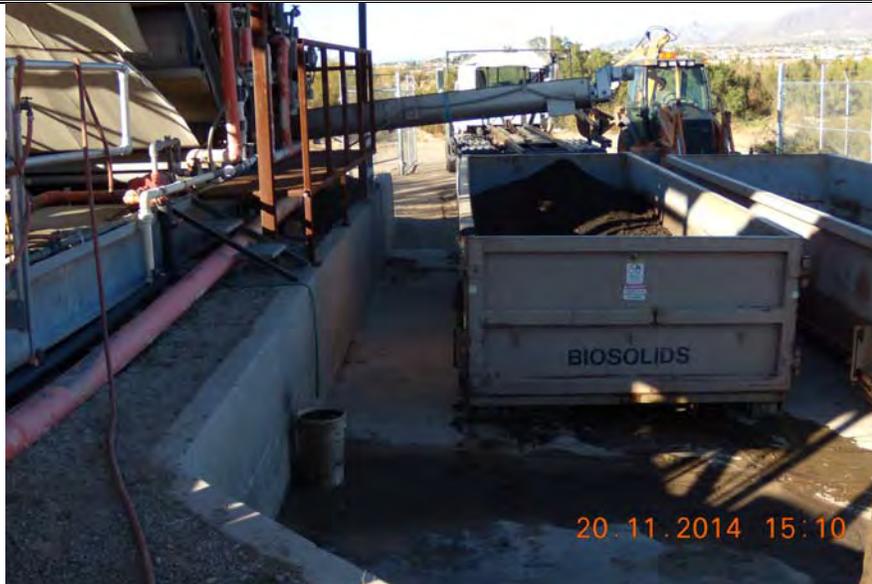
Location: CRRUA Sunland Park Wastewater Treatment Plant

1. The DMRs for the sludge monitoring for January 2014 have the wrong year dated on them.
2. Sludge handling equipment is out of operation. The sludge dewatering belt press is torn and broken. This is adding to the entire WWTP being overloaded with solids. This condition if not corrected is likely to result in reduced effluent quality.

Subject: The solids belt press and drying beds area.
