NEW MEXICO ENVIRONMENT DEPARTMENT

Re: Minor Municipal; SIC 4952; Compliance Evaluation Inspection; CRRUA Santa Teresa Wastewater Treatment Plant; NPDES Permit No. NM0030201; February 25, 2015

NPDES Compliance Inspection Report

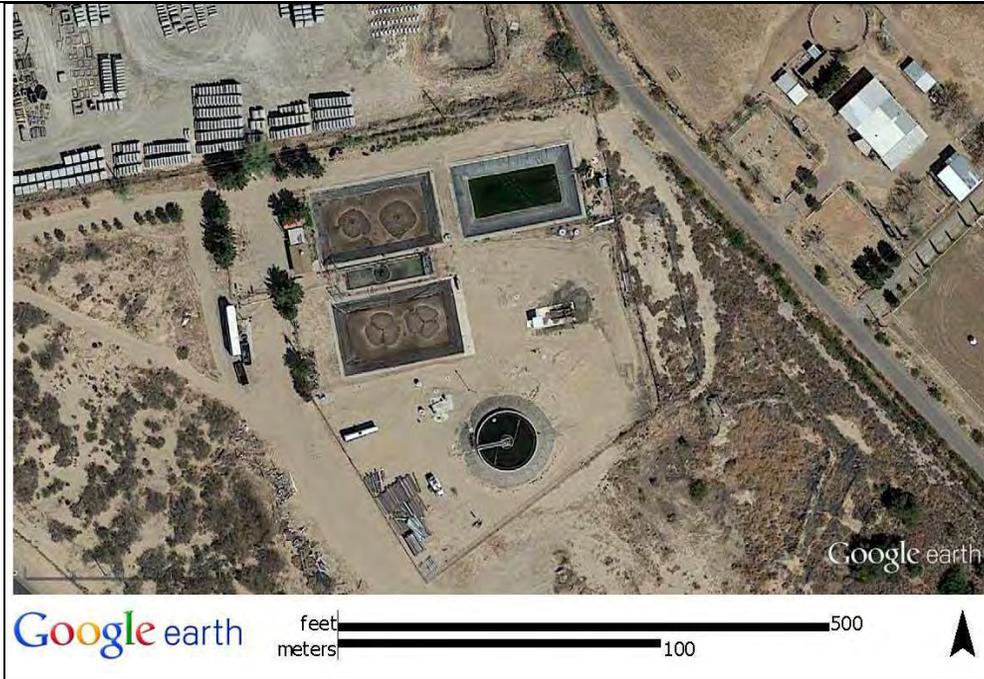
**NMED/SWQB
Official Photograph Log
Photo # 1**

Photographer: Google Earth	Date: 1991	Time: Unknown
City/County: Santa Teresa / Dona Ana		State: New Mexico
Location: Sunland Park North – Santa Teresa Wastewater Treatment Plant		
Subject: Aerial View of the Sunland Park North – Santa Teresa Wastewater Treatment Plant

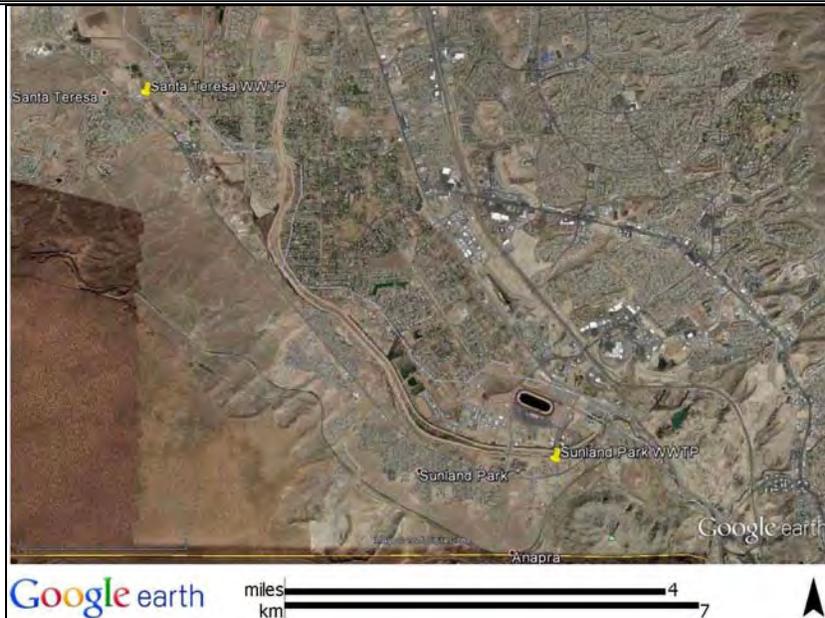
**NMED/SWQB
Official Photograph Log
Photo # 2**

Photographer: Google Earth	Date: 1991	Time: Unknown
City/County: Santa Teresa - Sunland Park / Dona Ana County		State: New Mexico
Location: Sunland Park North – Santa Teresa Wastewater Treatment Plant		
Subject: Aerial photo show the distance between the Sunland Park North – Santa Teresa WWTP NM0030201 and the Sunland Park WWTP NM0029483 is greater than 7 miles.
