NEW MEXICO
ENVIRONMENT DEPARTMENT
Surface Water Quality Bureau

RE: Industrial Storm Water, SIC 1499, NPDES Compliance Evaluation Inspection, Morningstar Minerals Corporation / Humate Mill and Manufacturing Facility, Farmington, NMR05HG37, May 3, 2012

Morningstar Minerals Corporation
Humate Mill and Manufacturing Facility
NMR05HG37
Compliance Evaluation Inspection – Industrial Stormwater
May 3, 2012

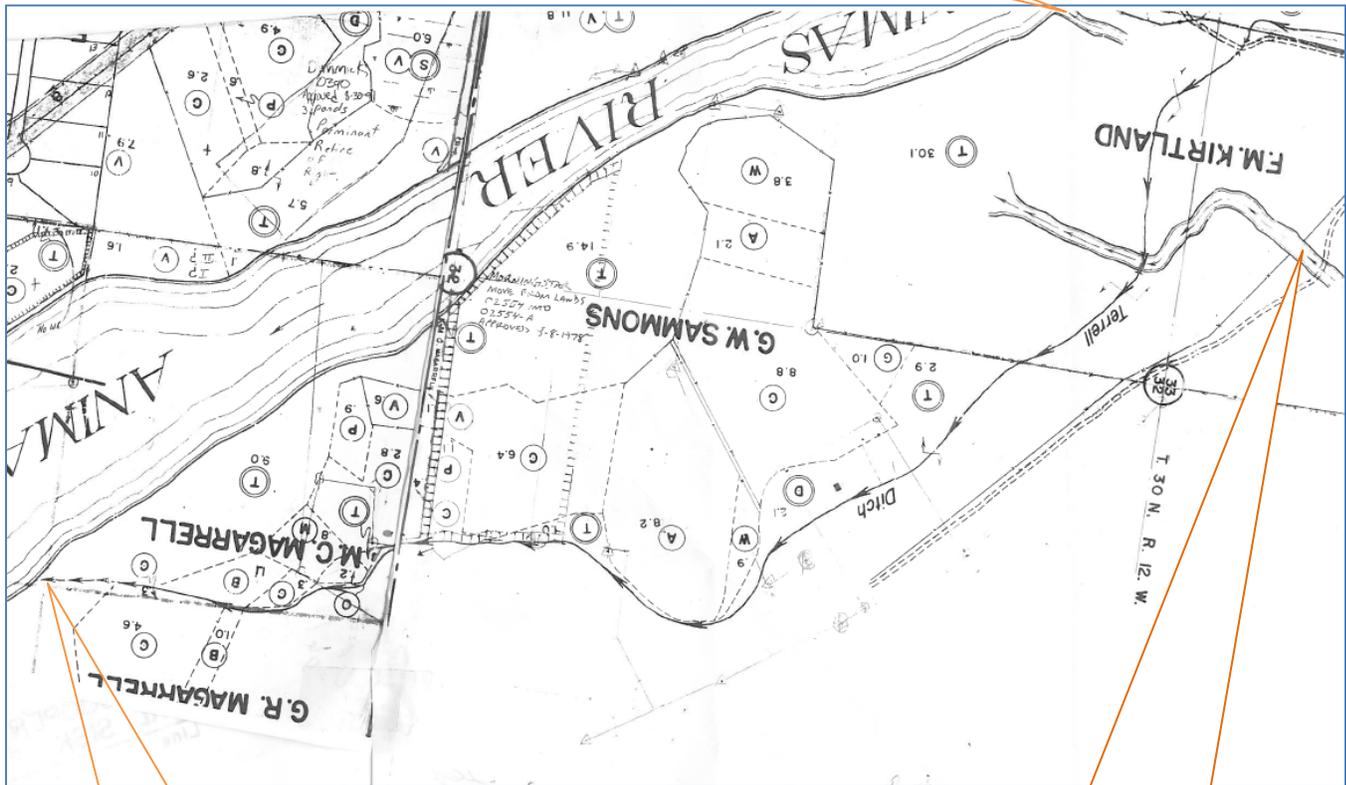
Figure 3: Water Rights Maps

Created by: Erin S. Trujillo	Map Source: NM OSE Aztec, New Mexico Water Right Map copies obtained 06/29/2011
City/County: Near Farmington / San Juan	State: New Mexico
Location: Morningstar Minerals Corporation Mill and Manufacturing Facility	
Subject: Surface water right maps show the flow direction of Terrell Ditch south of Animas River and the site from northeast to south then west to the Animas River. Hargis Arroyo labeled on topography map (Figure 2) is not shown to continue to the Animas River. Upstream of where Terrell Ditch is shown to enter the Animas River, only one channel or ditch is shown to enter Animas River upstream (northeast) of the Morningstar operations.

Location upstream of Morningstar operations where a channel or ditch is shown to enter the Animas River

Location where Terrell Ditch is shown to enter Animas River

Although not labeled, this flow channel appears to be at the location of Hargis Arroyo shown on topo and flood maps

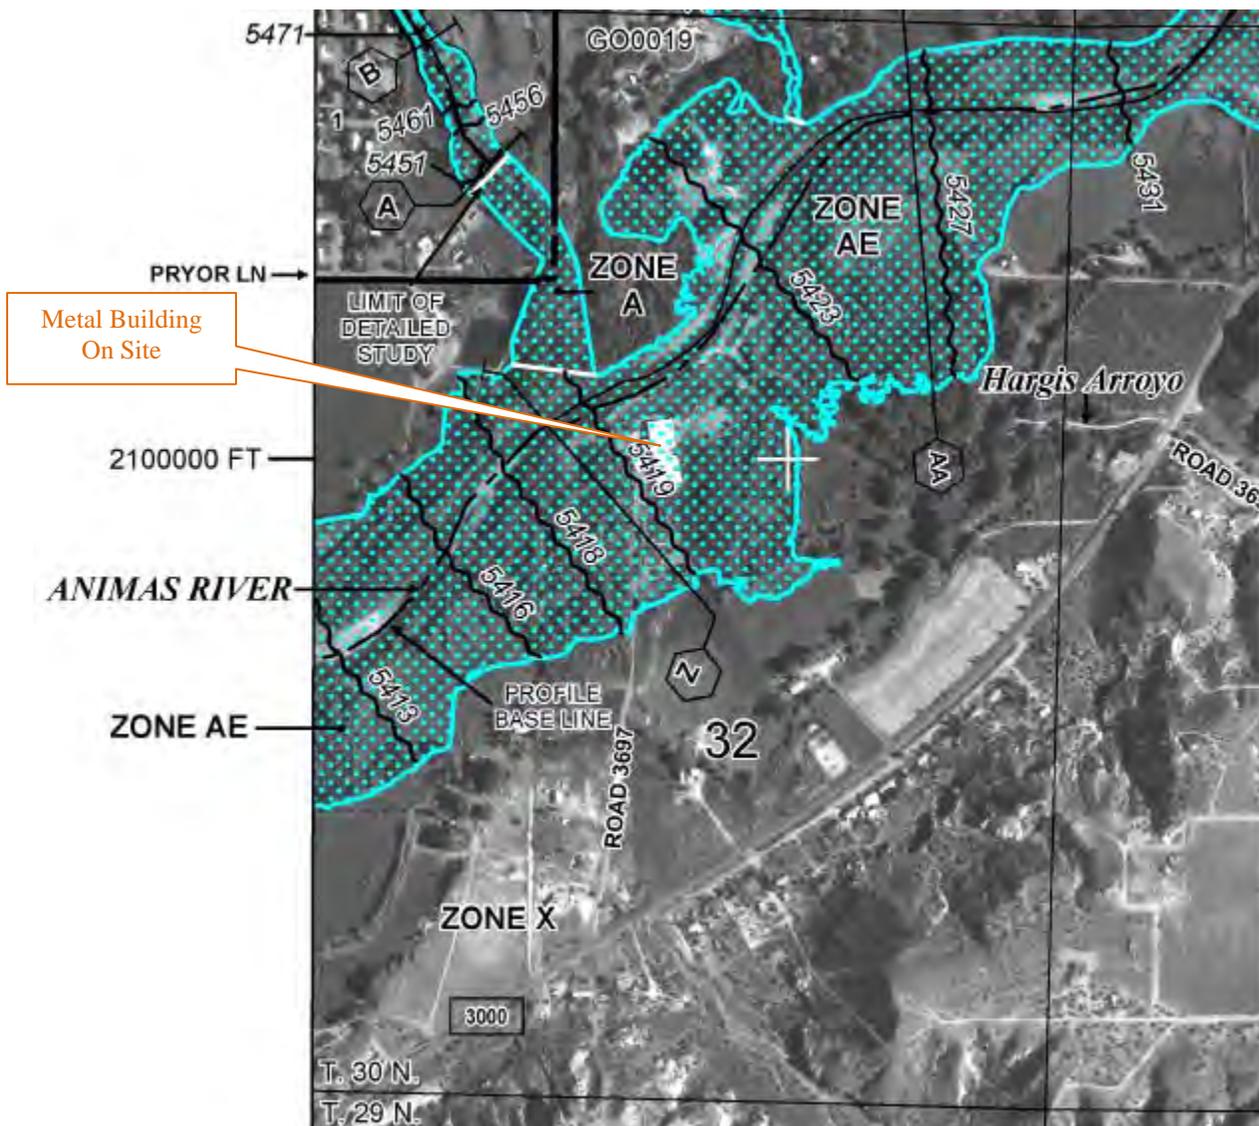
Figure 4: Flood Insurance Rate Map (FIRM)

Created by: Erin S. Trujillo	Map Source: On-line National Flood Insurance Program FIRM #35045C0715F effective August 5, 2010
City/County: Near Farmington / San Juan	State: New Mexico
Location: Morningstar Minerals Corporation Mill and Manufacturing Facility	
Subject: Flood map shows the metal building on site and the special flood hazard area subject to inundation by the 1% annual chance flood (100-year flood). Zone AE indicates that base flood elevations have been determined.

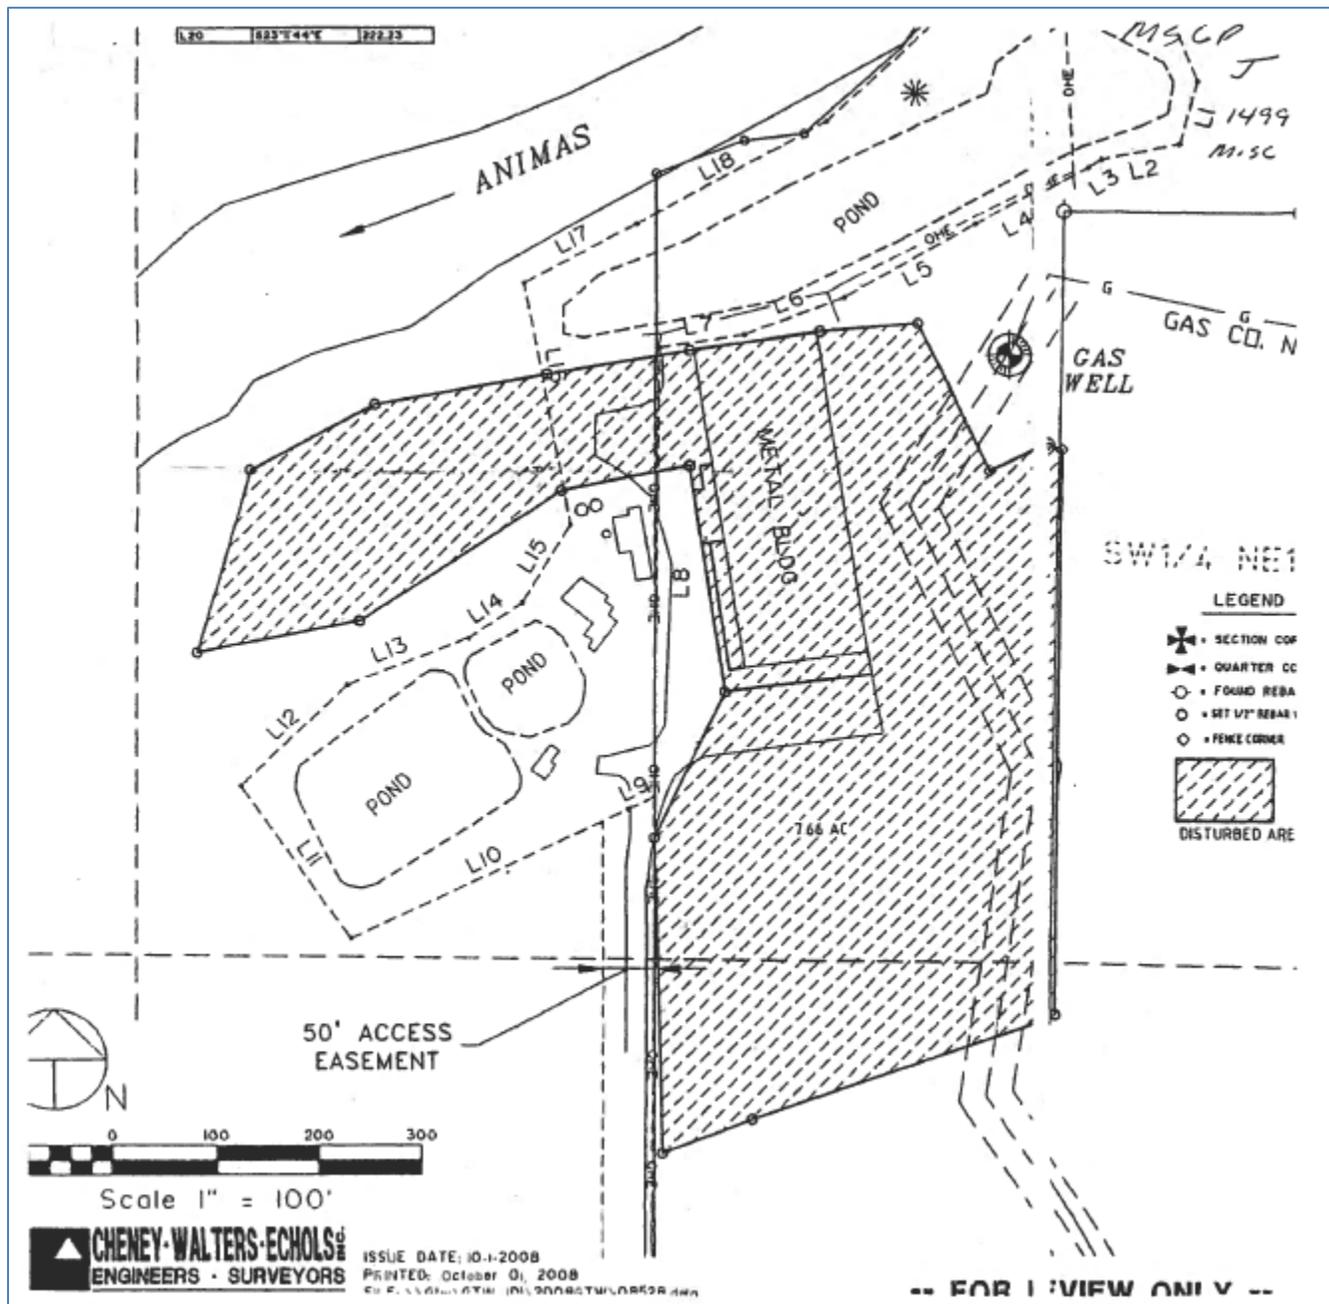
Figure 5: Morningstar Disturbance Map

Created by: Erin S. Trujillo	Map Source: Mr. Wharton in e-mail to inspector on 07/01/2011 after the previous inspection
City/County: Near Farmington / San Juan	State: New Mexico
Location: Morningstar Minerals Corporation Mill and Manufacturing Facility	
Note: Gas well is not correctly located on this map.

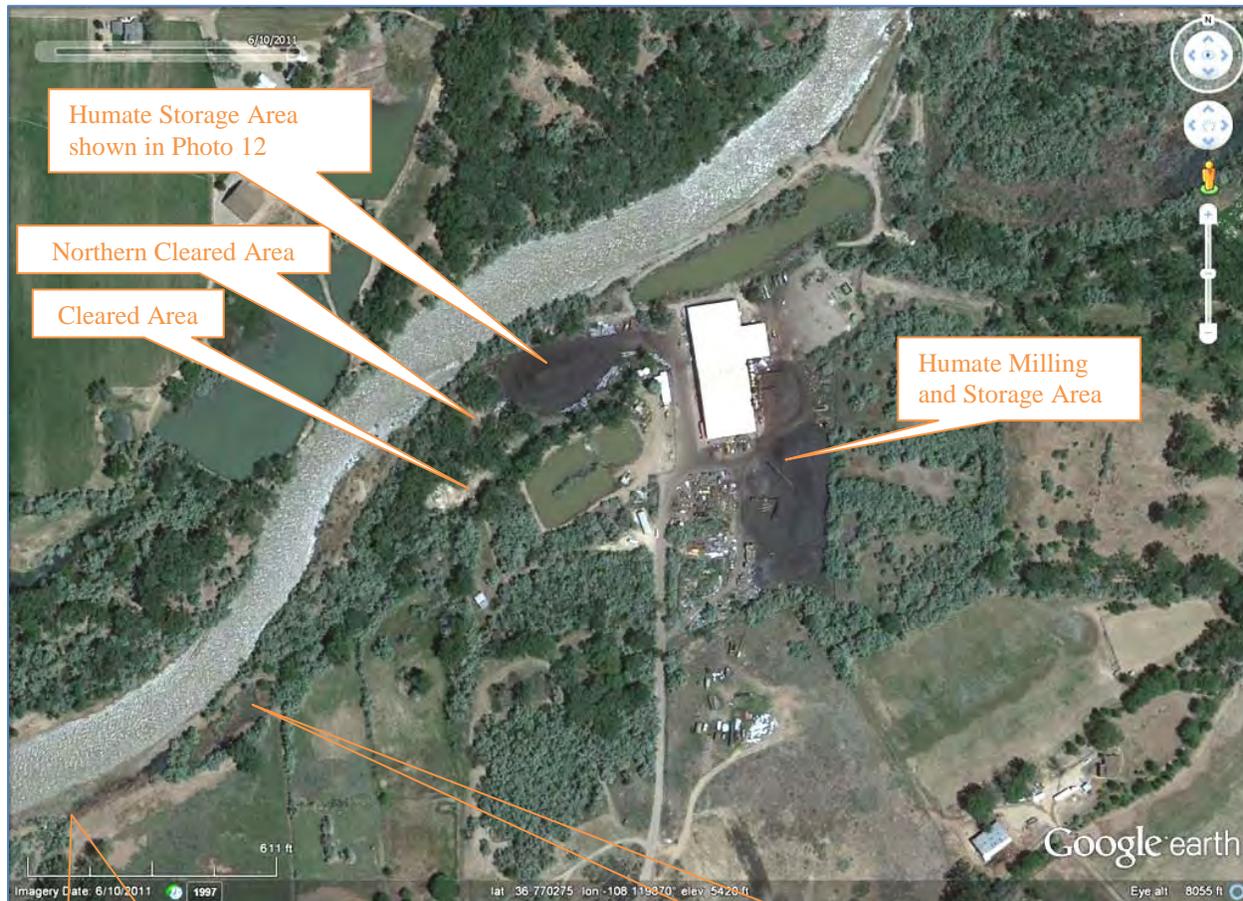
Figure 11: Aerial Photograph dated 06/10/2010

Photos 14 thru 17 show material storage and structures (silt fence and concrete barriers) at a northern cleared area at the western end of the humate storage area shown in Photo 12. The cleared area is visible in the 06/10/2011 aerial photograph (Figure 11). This northern cleared area near the Animas River was relatively flat. The local topography appeared to slope to the south—southeast and back toward the humate storage area. The silt fence and barriers did not appear to be intended for erosion or sediment control as confirmed by Mr. Wharton. The silt fence in this area was not trenched. Torn bags containing potash according to Mr. Wharton and Mr. McMahon were observed (Photo 16) in this area. Mr. Wharton stated that potash is not used in Morningstar operations. A heavy equipment backhoe existed west of the barriers (Photo 15). The aerial photograph measured distance from where material, silt fence and concrete barriers were observed during the tour north-northwest to the Animas River is approximately 130 feet.

Photos 19 and 20 show a silt fence and dark solids on the upland area along this trench. The upland or cleared area is visible in the 06/10/2011 aerial photograph (Figure 11). The silt fence was not trenched. A pile of dark solids which appeared to be humate from the mill and manufacturing facility were west of the silt fence outside disturbed areas shown in Figure 5.

Created by: Erin S. Trujillo	Map Source: Google Earth
City/County: Near Farmington / San Juan	State: New Mexico
Location: Morningstar Minerals Corporation Mill and Manufacturing Facility	
Date: Additional cleared areas visible. Brightness and contrast was increased 20% from original image for report.

Approximate location of the surface water or seepage along Animas River on the Chitwood parcel observed on the day of this inspection

Approximate location of cattail pond (Photos 38 and 39) on the Chitwood parcel observed on the day of this inspection
