RE: Minor Non-Municipal, SIC 1711, NPDES Reconnaissance Inspection, New Mexico Highlands University / Student Union Geothermal Well Drilling, NMU001737, June 9, 2011

NPDES Compliance Inspection Report

**New Mexico Highlands University - Student Union
Geothermal Well Drilling Area
NPDES Tracking No NMU001737
Reconnaissance Inspection
June 9, 2011**

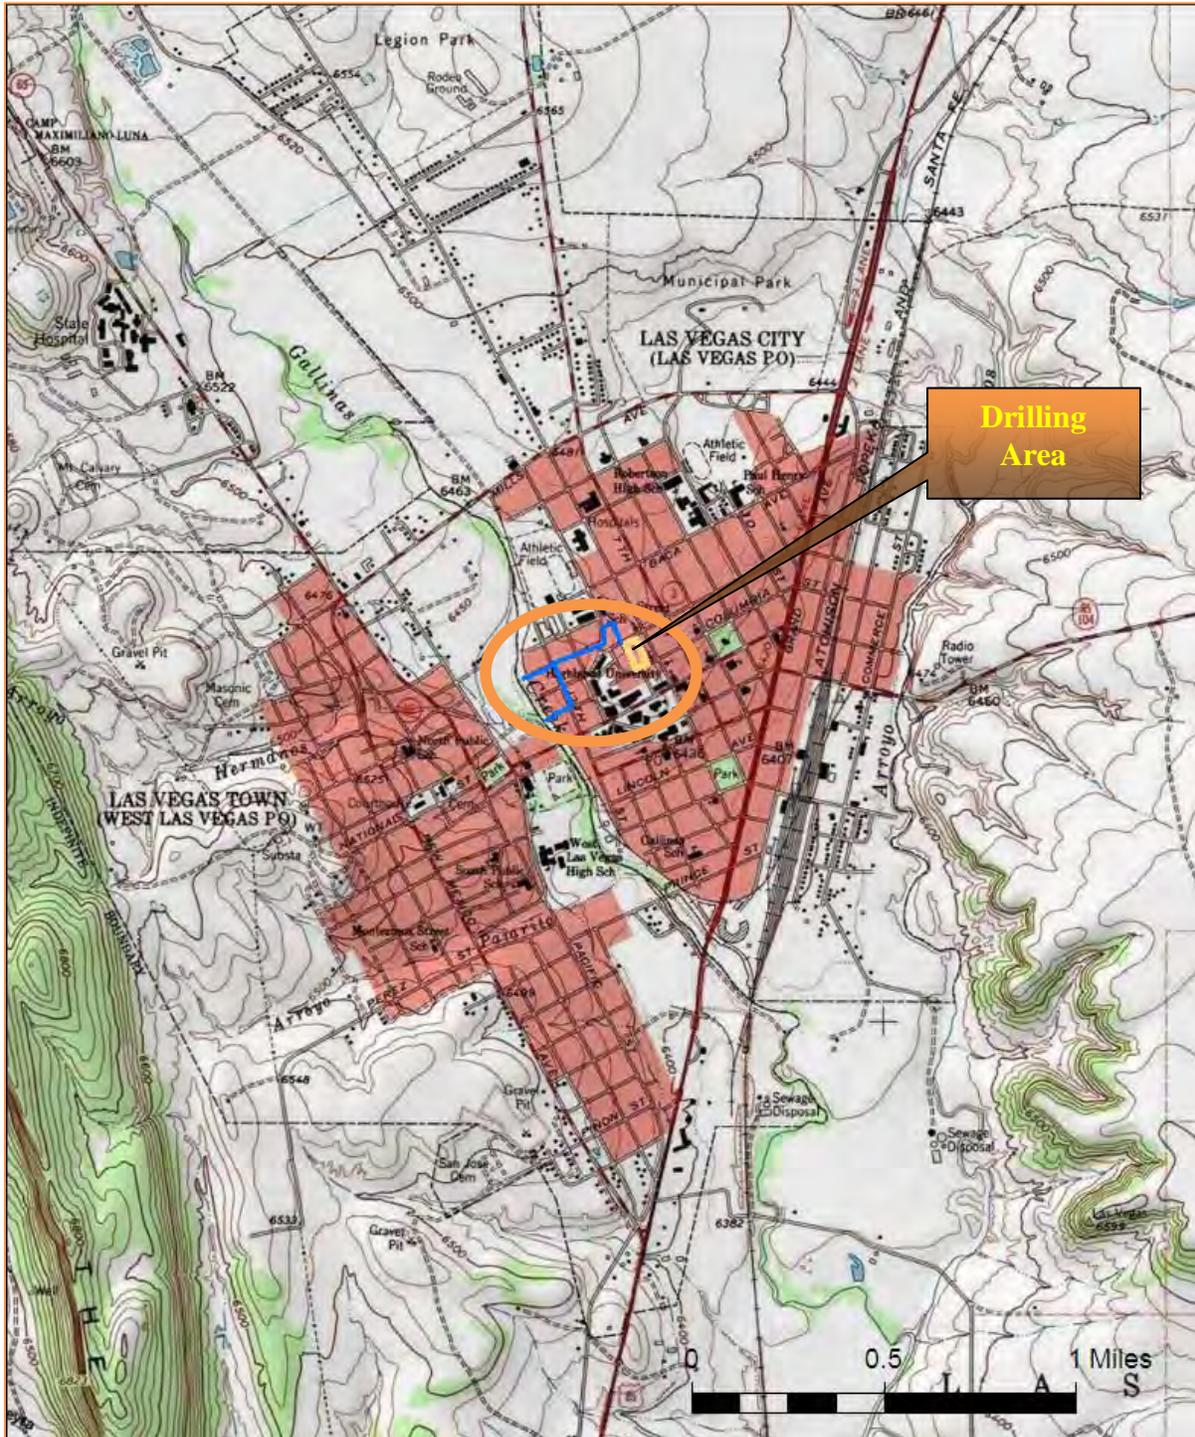
NMED/SWQB
Site Map

An NPDES permit was not obtained for the discharge of pollutants in process waters to Gallinas Creek on June 8. Groundwater was encountered during drilling of Well No. 4 and runoff is noted in NMHU news dated June 7. No additional contingency measures (e.g., a lined pit or other type of containment for process waters) were utilized prior to drilling Well No. 5 on June 8.

Created by: Erin S. Trujillo		
City/County: Las Vegas / San Miguel	State: New Mexico	
Location: New Mexico Highlands University Student Union Geothermal Well Drilling Area		
Subject: Approximate flow path of discharge to Gallinas Creek.
