SITE ID: 3997

FACILITY ID: 27959

SUBMITTAL DATE: 25-Oct-02

CONCLUSIONS AND RECOMMENDATIONS

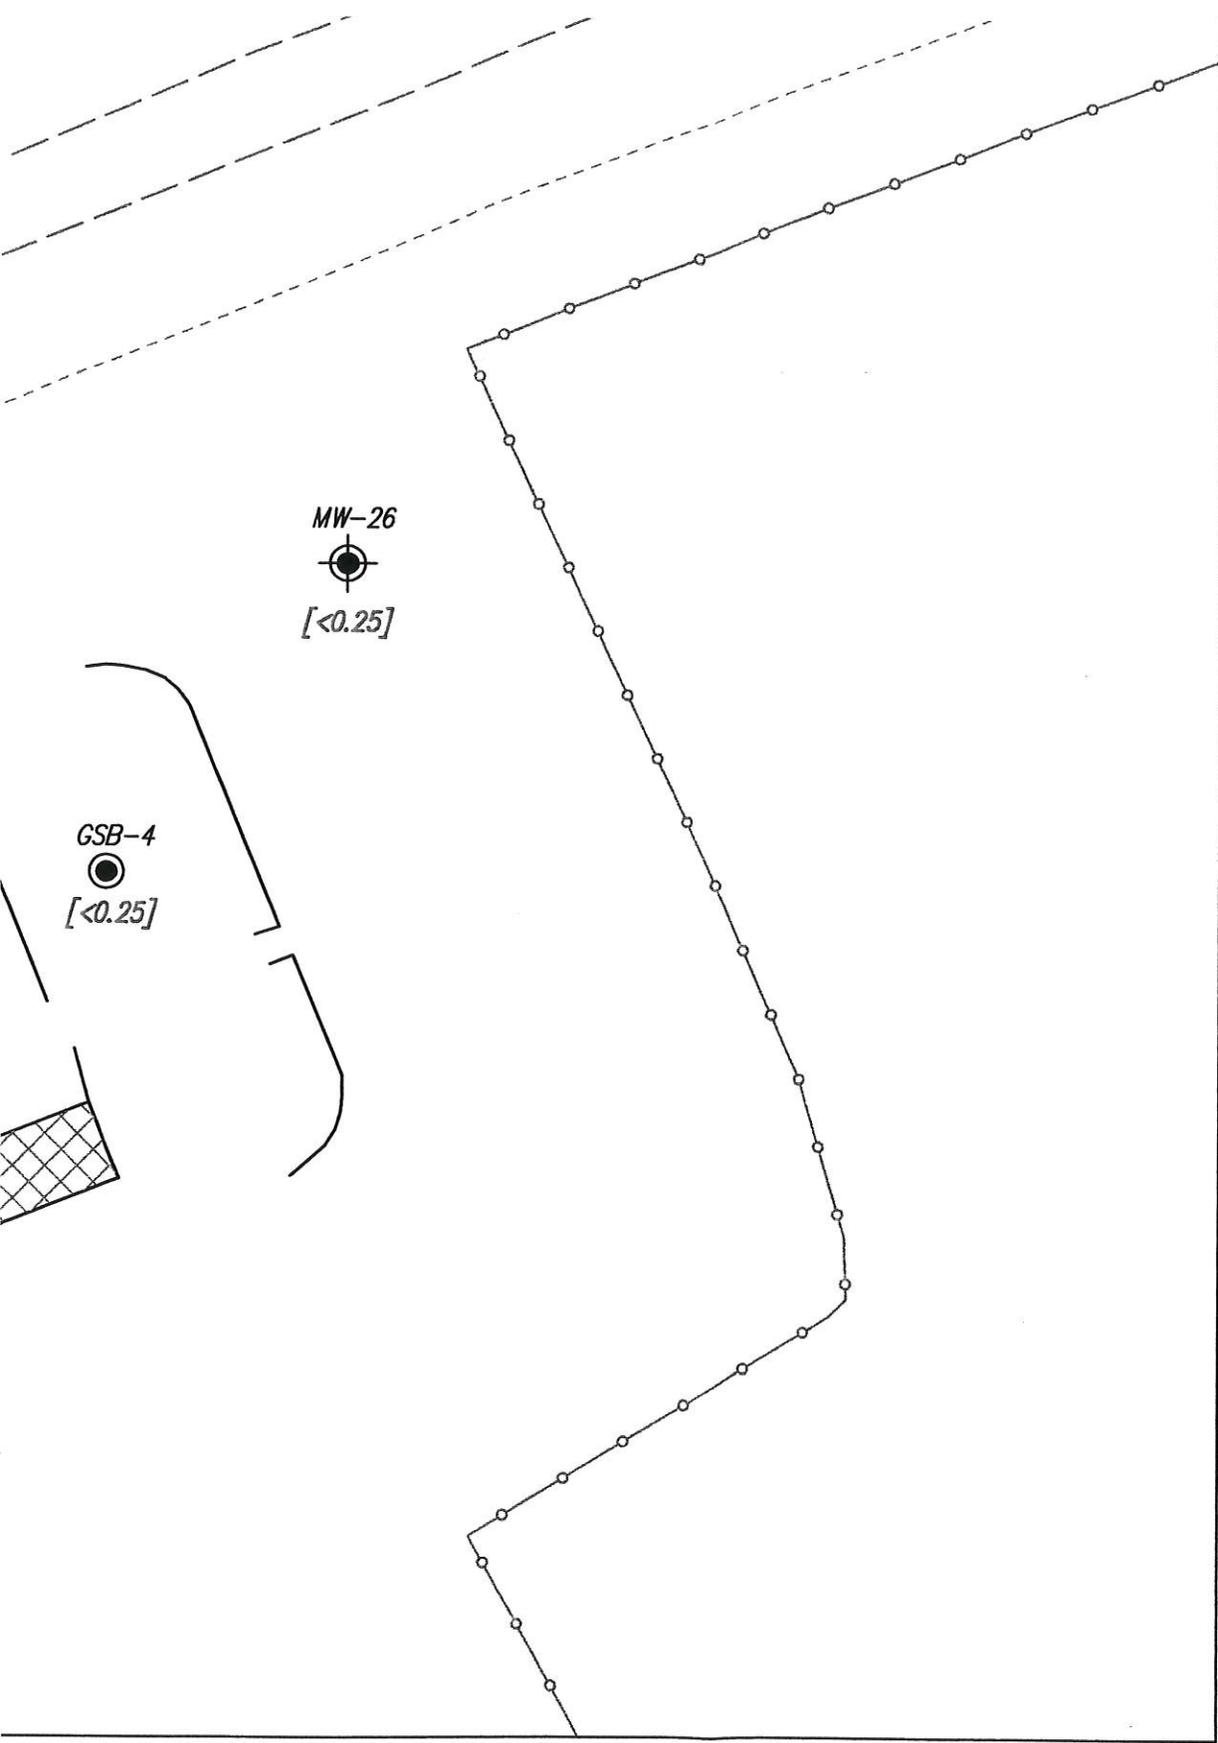
10.	<i>Other relevant information</i>
	<i>There is extensive smear zone soil contamination at the site. No near-surface soil contamination was found in the former tank pit or anywhere else. The lack of identified shallow soil contamination as well as the distribution of soil contamination at the site suggests the release point may have been the piping and/or dispensers.</i>

**SOIL CONTAMINANT CONCENTRATION MAP - TOTAL
FORMER FAIRACRES POST OFFICE
FAIRACRES, NEW MEXICO**

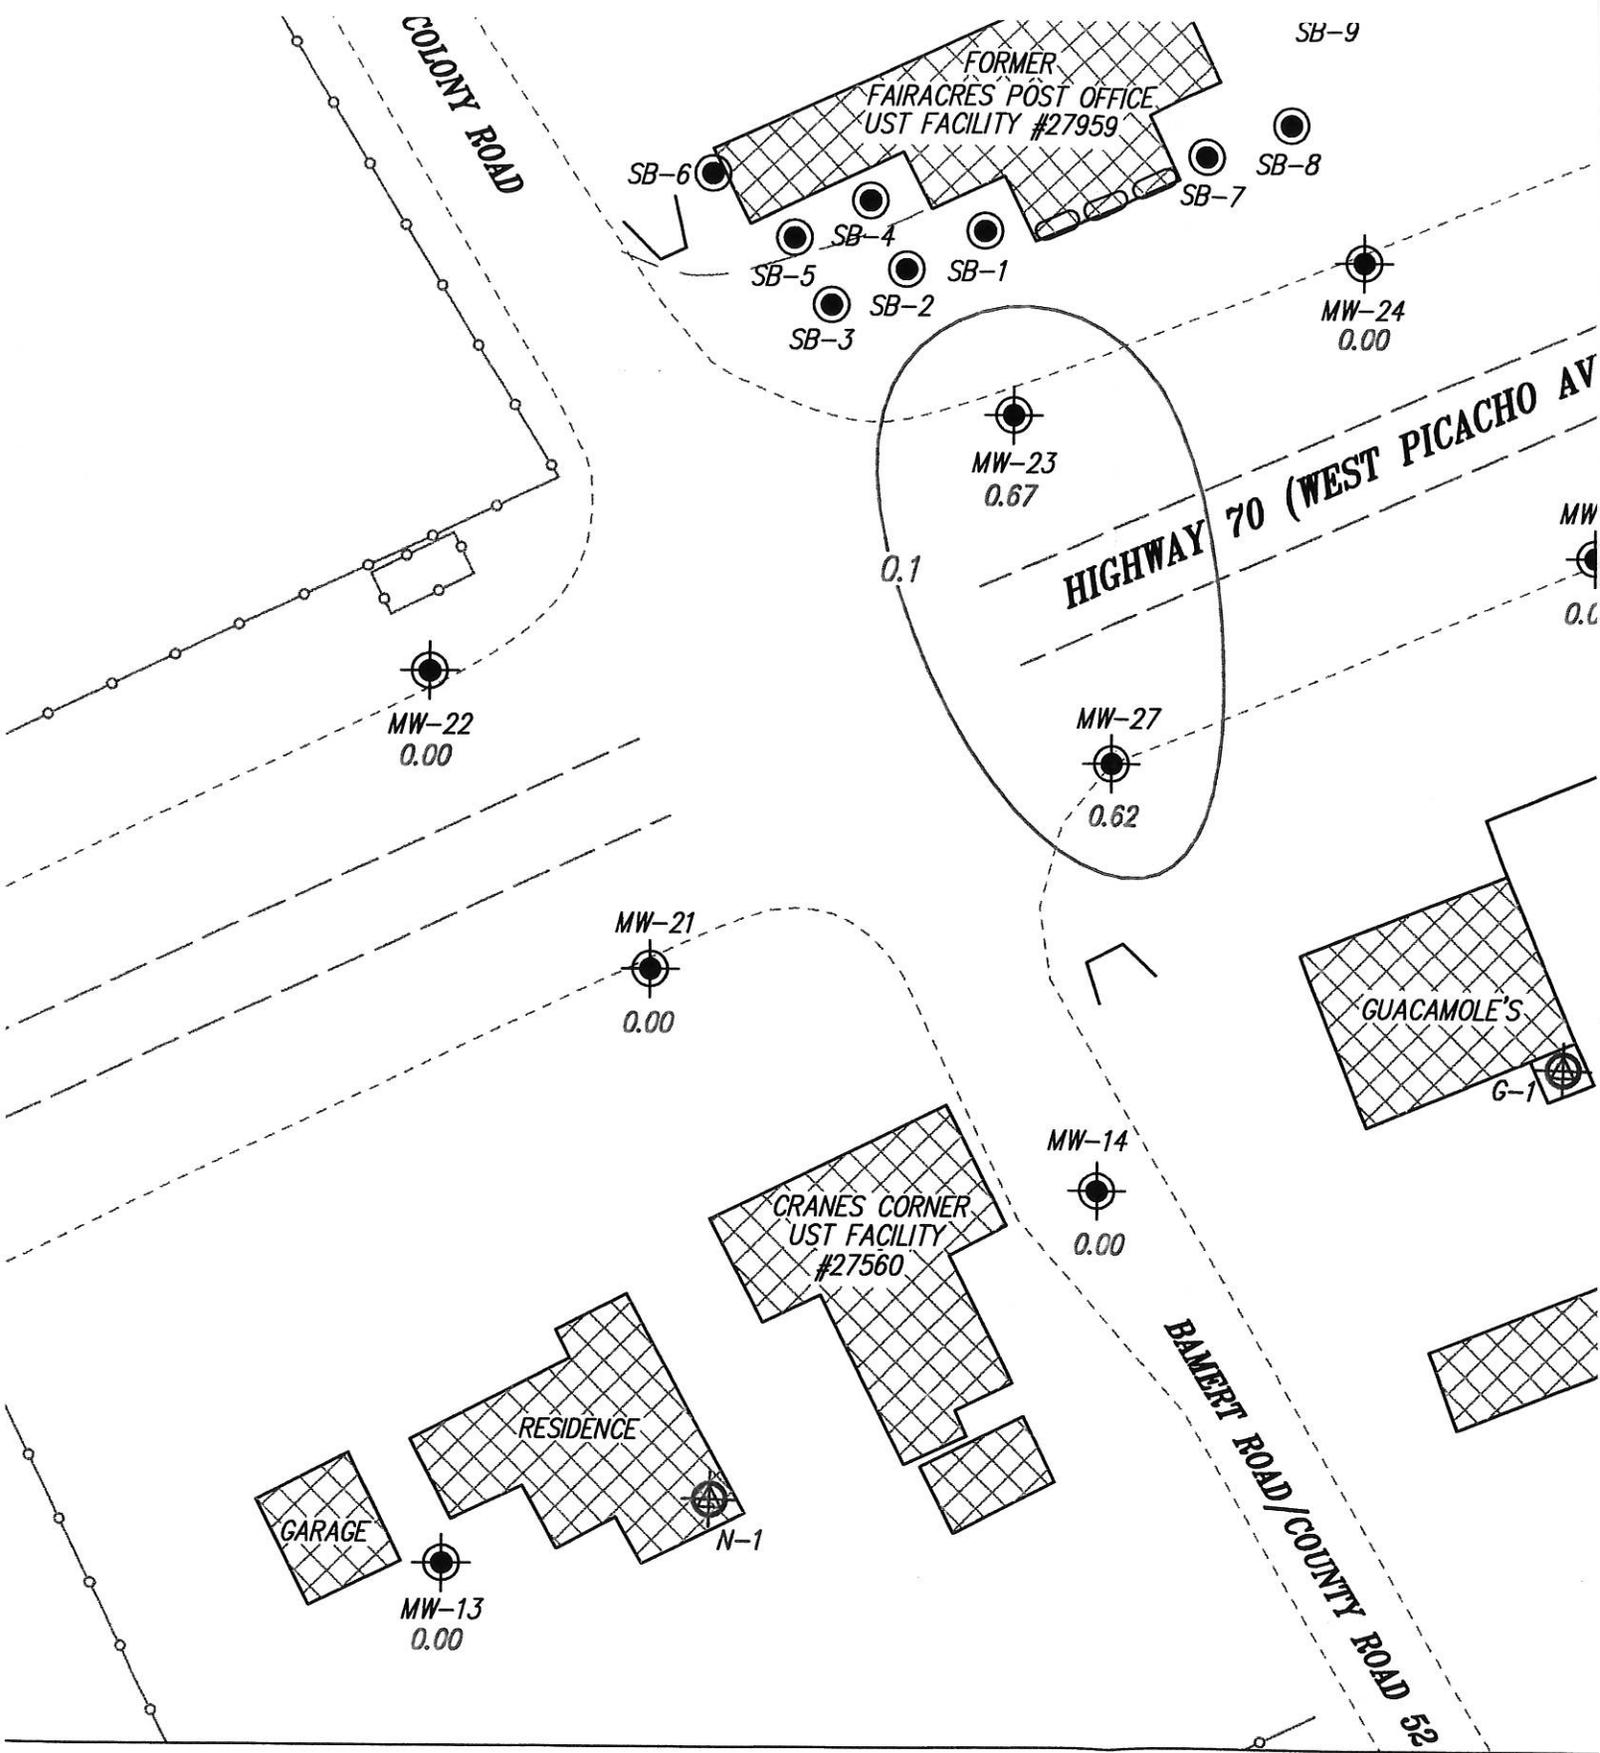
NAPL has been found in monitoring wells MW-23 and MW-27. Although no NAPL recovery program is in place, NAPL has been recovered from these wells during periodic sampling events and water level measurements associated with a neighboring release site.

12.	<i>Is groundwater monitoring recommended?</i>
	<i>Groundwater monitoring is recommended following definition of the extent of the contaminant plume. In addition, NAPL recovery is recommended given the continued presence of NAPL at the site.</i>
