Cimarron Watershed-Based Plan

***Prepared by
Joanne Hilton, P.G. in cooperation with
the Cimarron Watershed Alliance
and the Quivira Coalition***

December 2012

Stream Survey of Cieneguilla Creek

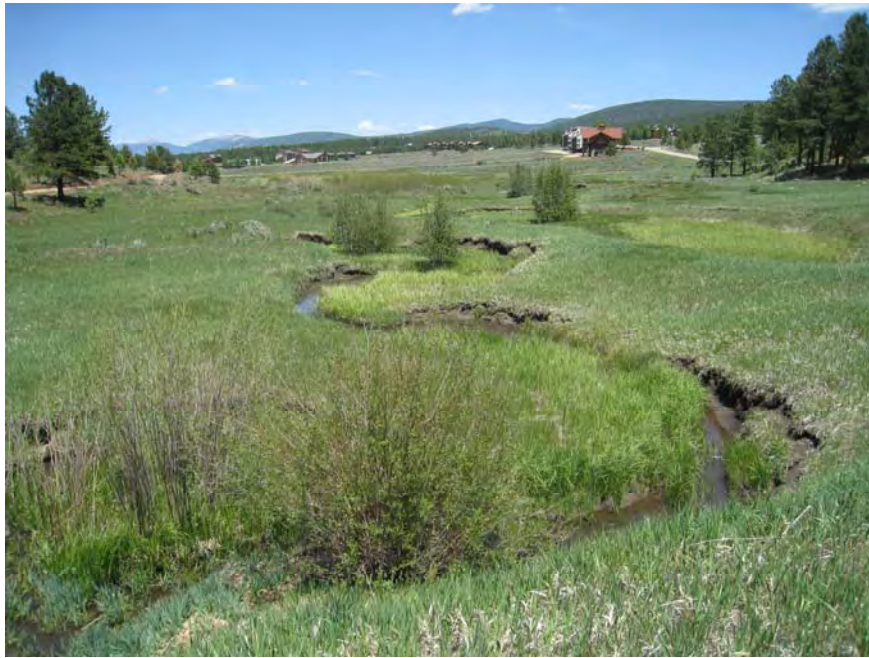
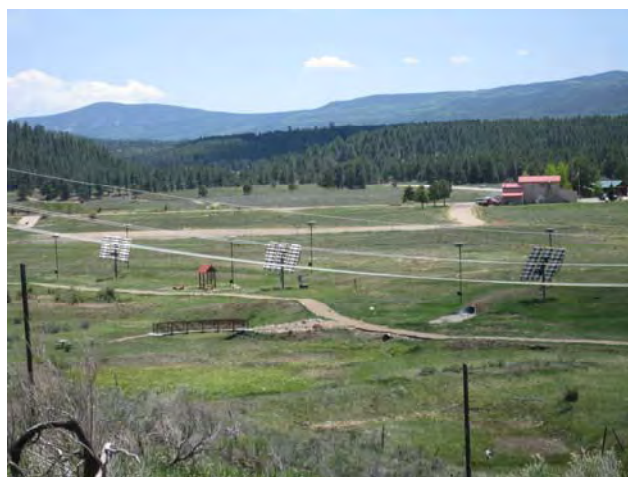
There are 1-2ft cut banks along meanders immediately below the road.

These photos are looking at the stream from Halo Pines terrace looking east

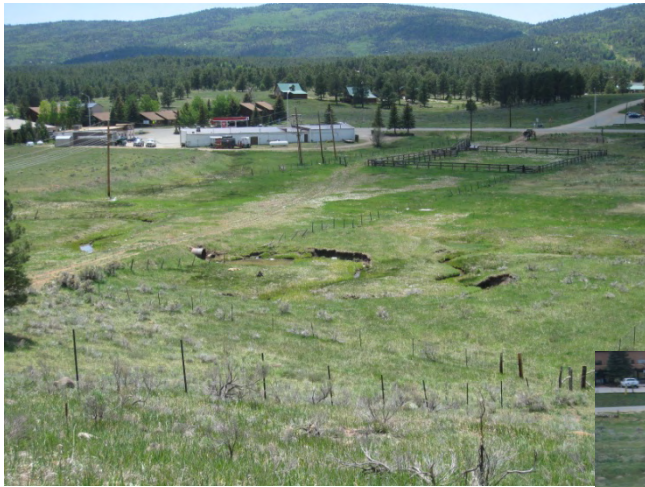
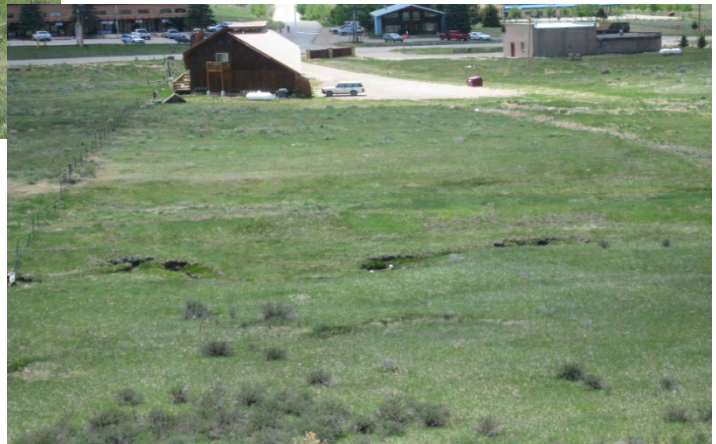
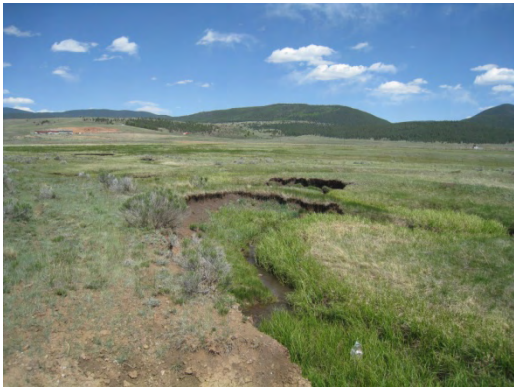
Waypoint 63 is located downstream of El Camino Grande, taking the first left heading toward ranch properties, N36.41708 W105.28721.

At waypoint 64, N36.42305 W10528458 there is an old road crossing that needs to be removed. The stream is cleaner and less silty with a more stable bottom. This photo shows old meander.

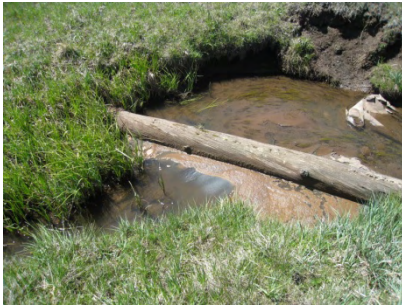
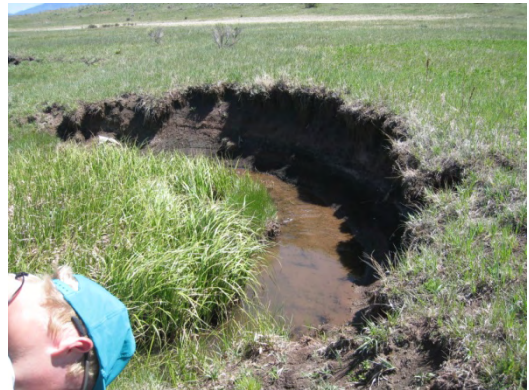
6. Waypoint 59 is 320ft farther downstream. Vegetation is protecting the bank when the flow is moderate, however, at high flows it is completely exposed. The BEHI index is 35, giving it a high rating. 150ft beyond Waypoint 59 there is a 10ft long undercut bank that is between high and

very high on

the BEHI. 60ft farther there is an almost identical bank. Another 130ft downstream there is an outside meander, and very high on the BEHI. The flow is better and less obstructed by trash and vegetation in the stream
