Lee Ranch Mine Use Attainability Analysis

May 2018

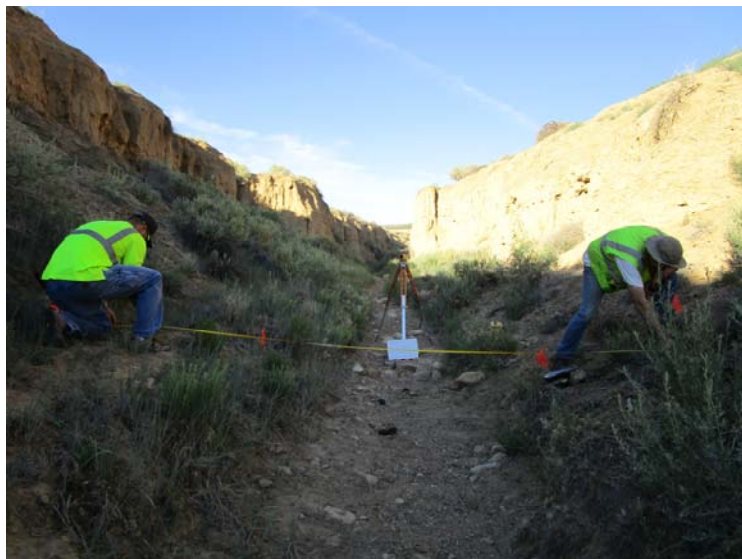
16 – measuring HP14 flood plain width
