RE: KAFB draft Permit  
Public Notice Number 07-03  
EPA ID No. NM9570024423

Please accept the following comments on the subject Draft Hazardous Waste Permit. Our comments relate to the proposed treatment of the existing 21-inch Tijeras Phase II Interceptor (Interceptor) that crosses KAFB Landfill 2 (LF-002). Paragraph 5.2.4 of the Draft Facility Operating Permit dated April 16, 2007 states "The sanitary sewer line that passes through LF-002 shall be removed in accordance with the Department's instructions (letters from NMED to Carl Lanz: July 16, 2004; September 13, 2004; and March 10, 2005). The NMED approval letter dated September 13, 2004 for the Corrective Measures Design and Implementation Work Plan states "The Tijeras Sewer Interceptor shall be rerouted such that no active portion of the pipeline remains within or is located within 100 (one hundred) feet of the landfill. The abandoned portion of the Tijeras Sewer Interceptor shall be drained; its contents disposed of in a manner that meets all applicable laws and regulations."

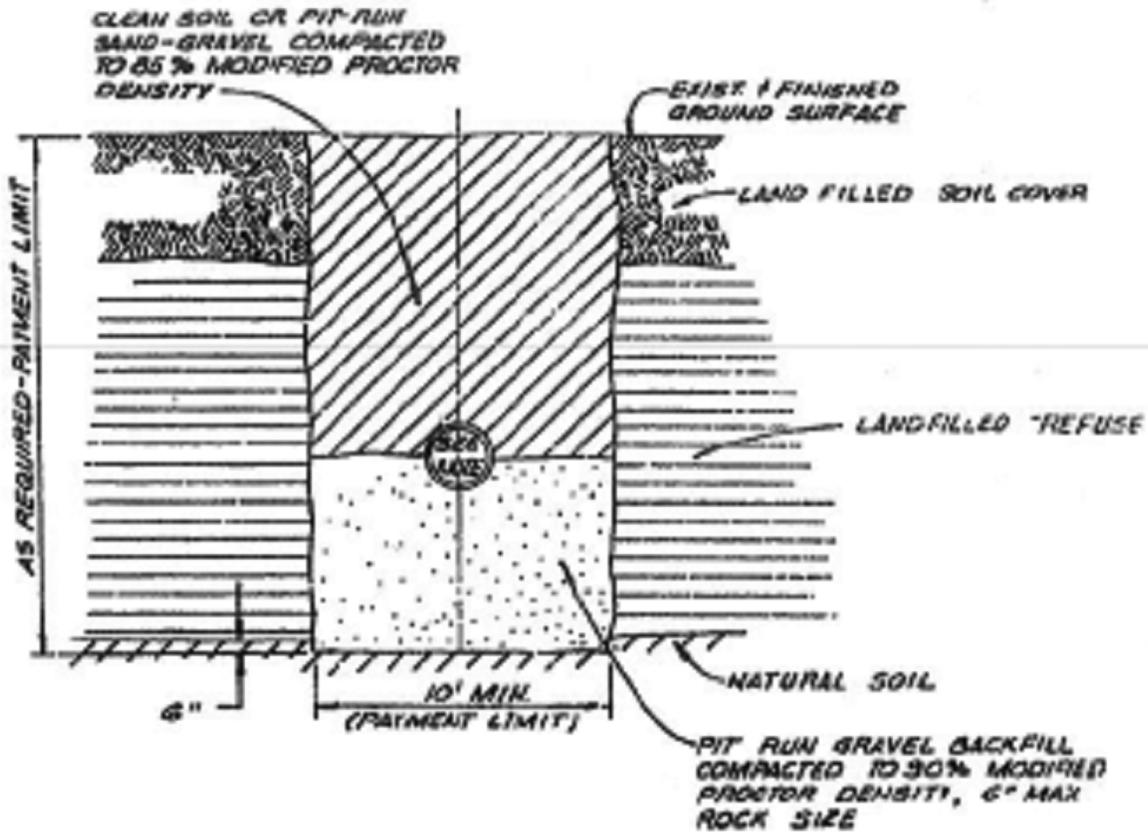
# EXCERPT FROM RECORD DRAWINGS

**DESCRIPTION:**

REMOVE AND DISPOSE OF ALL SOIL COVER AND LANDFILLED REFUSE TO THE NATURAL SOIL LEVEL. PLACE AND MANNER OF DISPOSAL MUST BE APPROVED BY THE OWNER. THE CONTRACTOR SHALL FURNISH ALL BACKFILL MATERIAL AS SHOWN
