**Document title:**      **Mixed Waste Landfill Quarterly Progress Report  
Evapotranspirative Cover Construction Project,  
May – July 2009.**

**Attachment A**  
**Photographic Log of ET Cover Construction Activities**  
**May – July 2009**

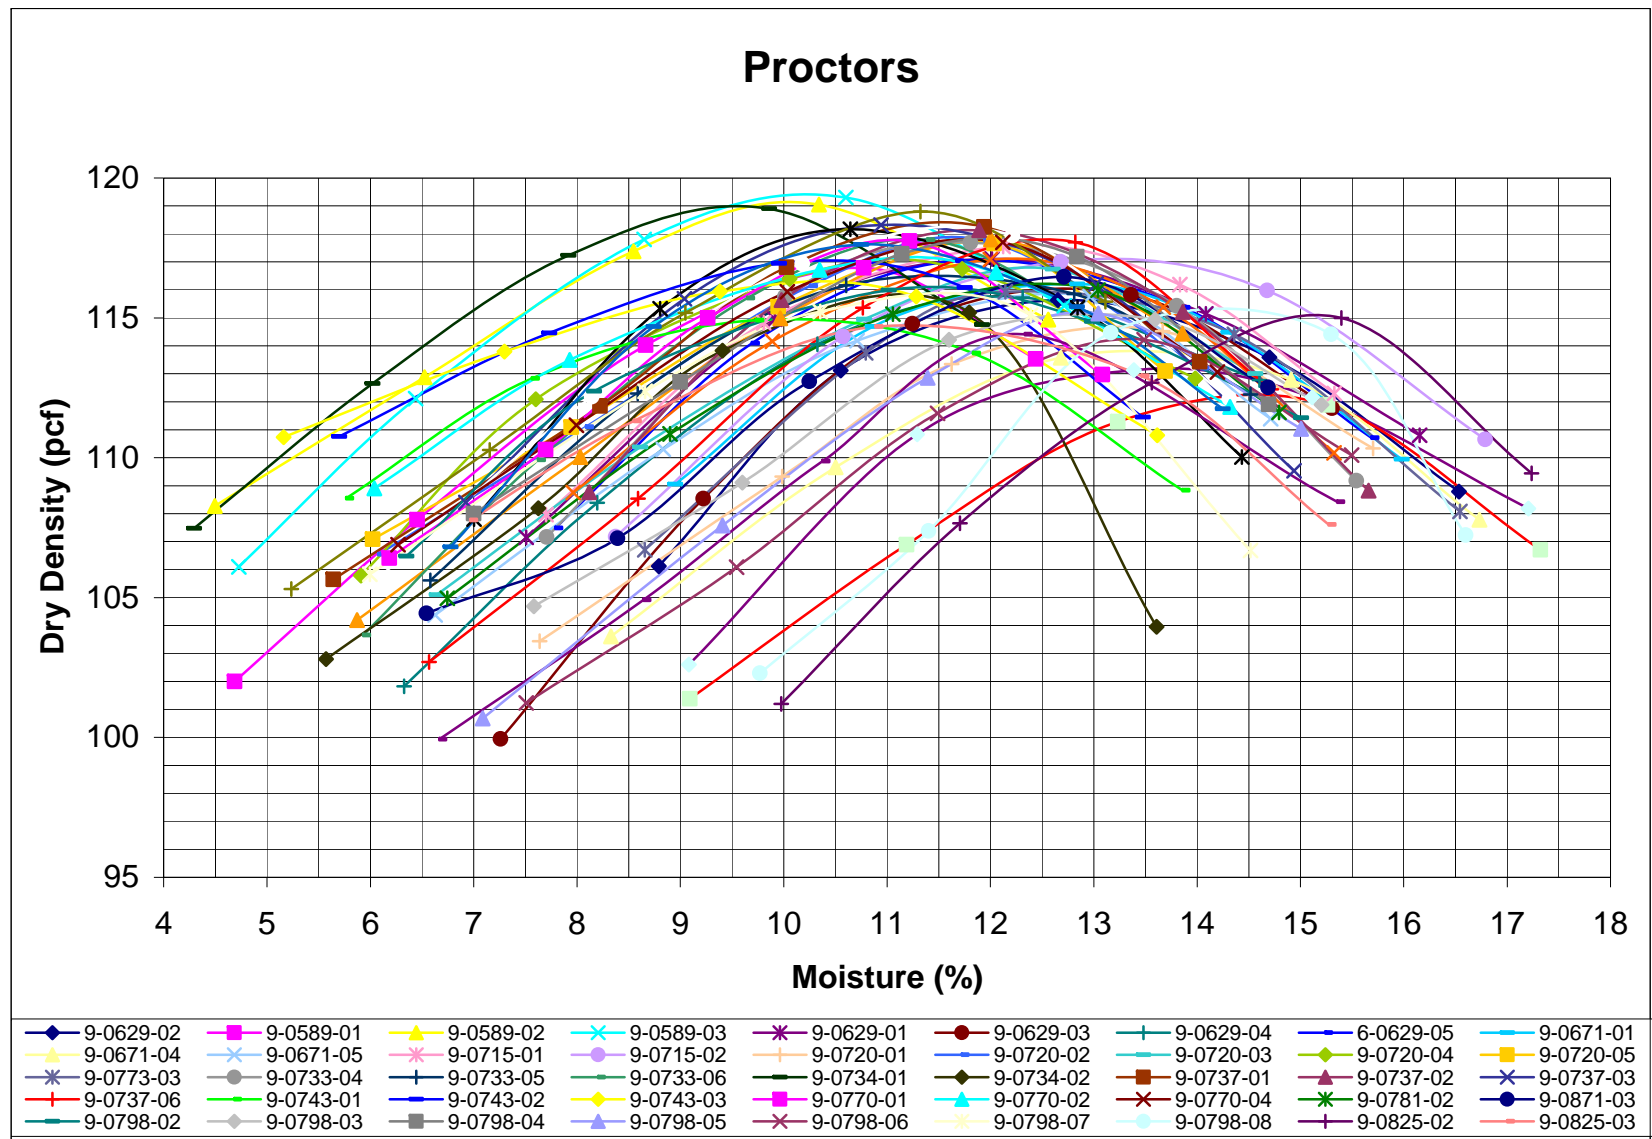
**Figure 4 Graphical Representation of all MWL ET Cover Standard Proctor Results**

All Standard Proctor test results are presented in Table 3, and shown graphically in Figure 4. The results demonstrate the general consistency of the soil fill material with regards to maximum dry density and optimum moisture. All field moisture and density results for the reporting period are shown in Table 4 for the top of the Subgrade Layer and each individual Native Soil Layer lift. Gradation and Classification soil testing results for the Native Soil and Top Soil Layer fill materials are provided in Tables 5 and 6, respectively. Table 7 presents K-SAT results for the Native Soil Layer soil samples.

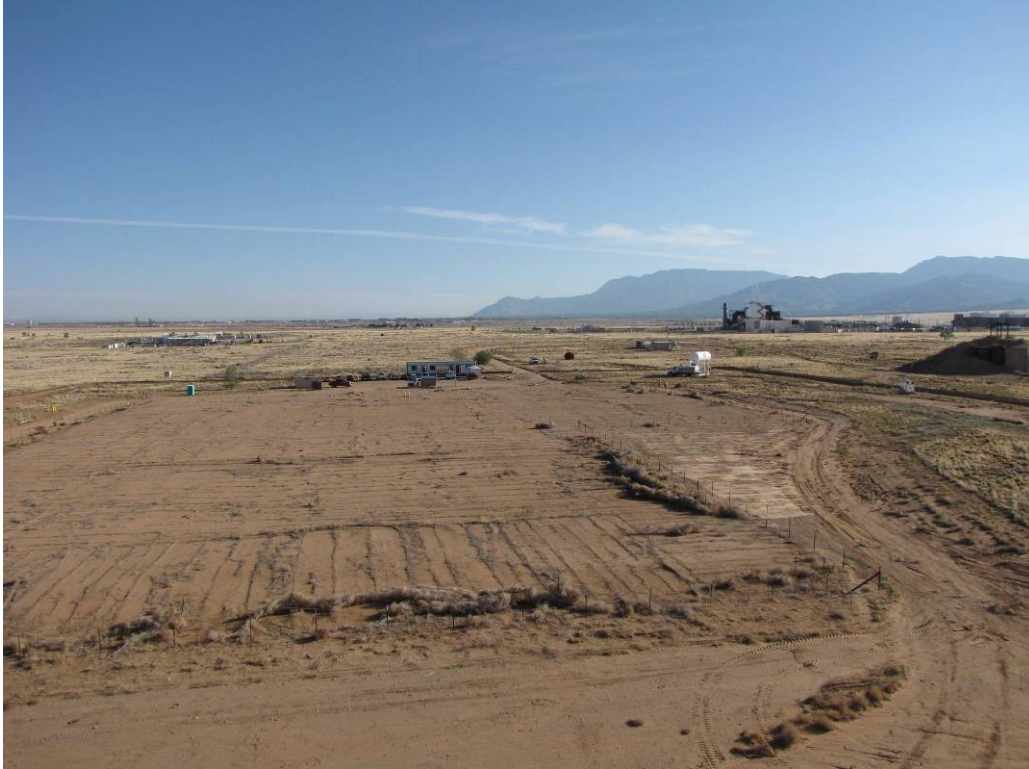
Subgrade Layer surface before the start of 2009 cover construction.  
View to the north of the south end of MWL - May 20, 2009.

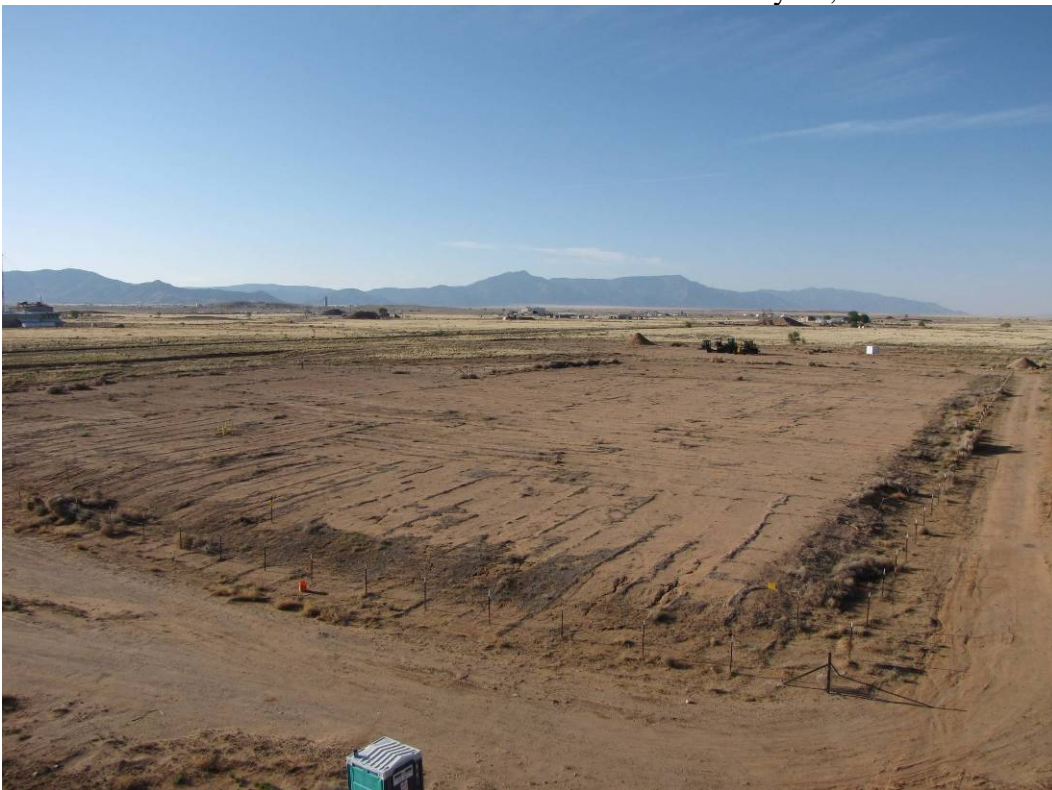
Subgrade Layer surface before the start of cover construction.  
View to the south of the north end of MWL - May 20, 2009.

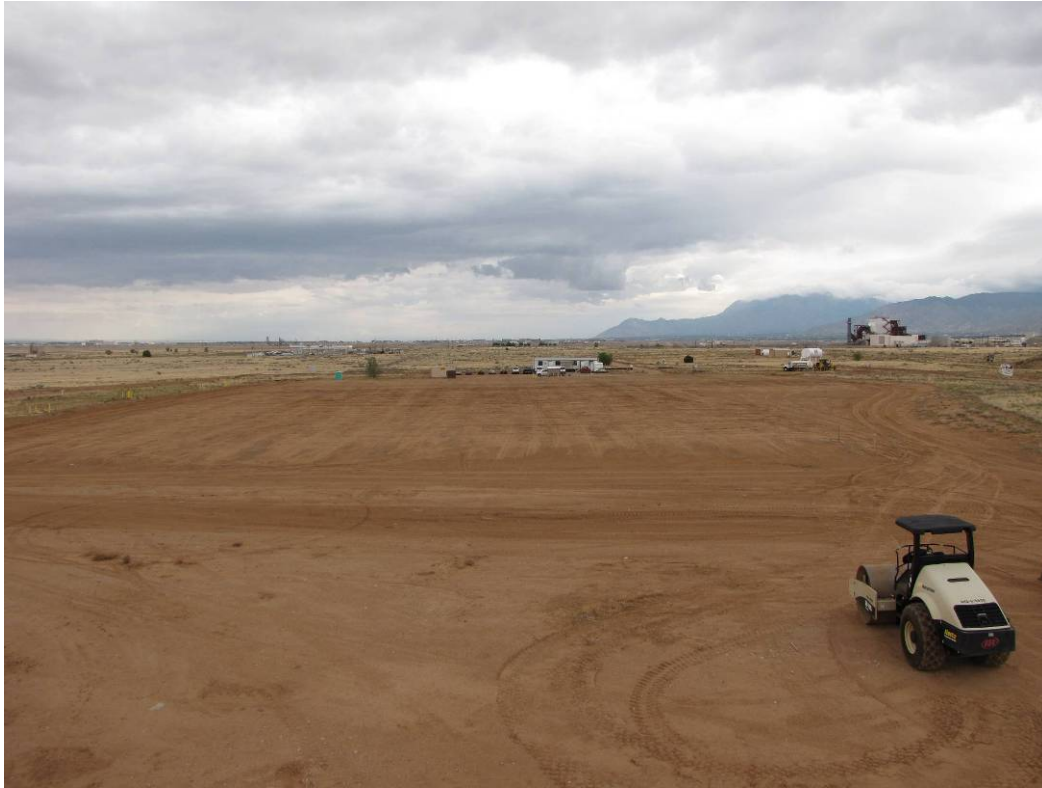
Subgrade Layer surface cleared, watered and rolled/compacted.  
View to the north from the south end of the MWL - May 26, 2009.

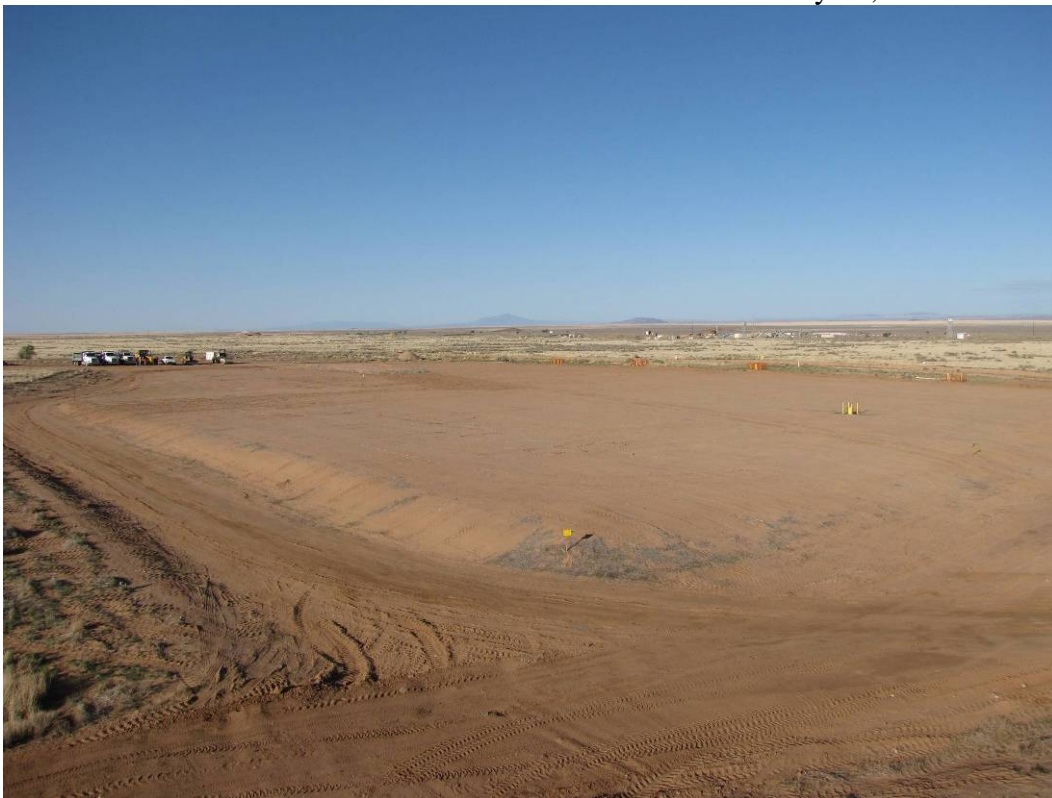
Subgrade Layer surface on May 27, 2009. View to the Southeast.

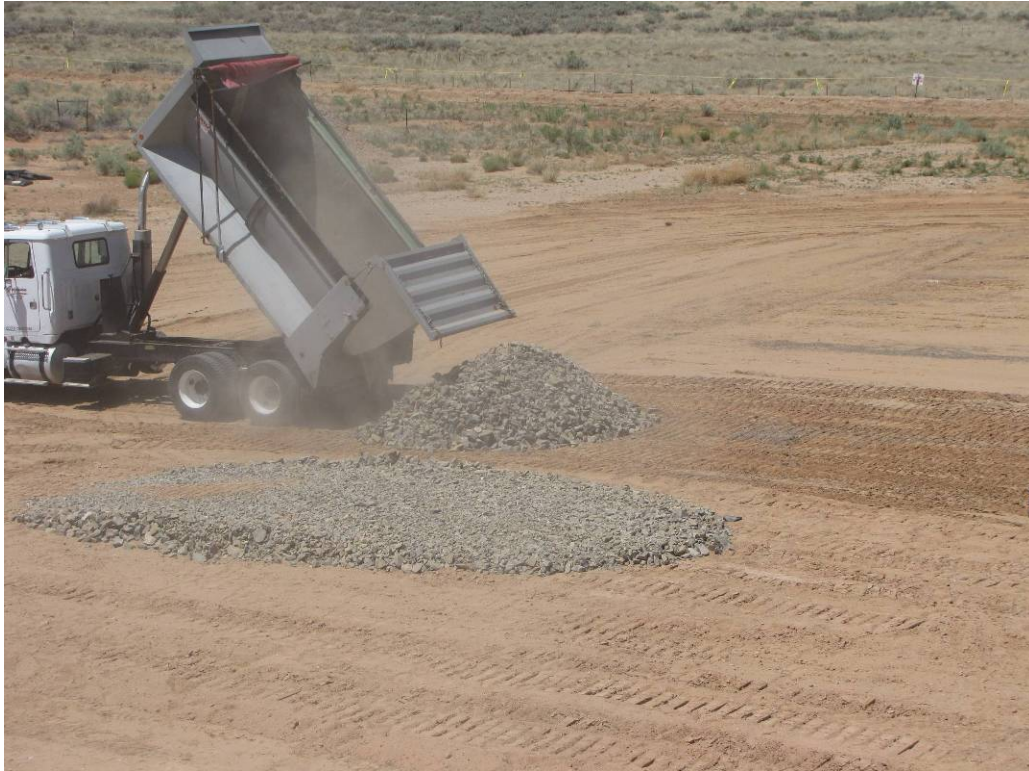
Start of Bio-intrusion Layer test at the south end of landfill.  
View to southwest on May 28, 2009.

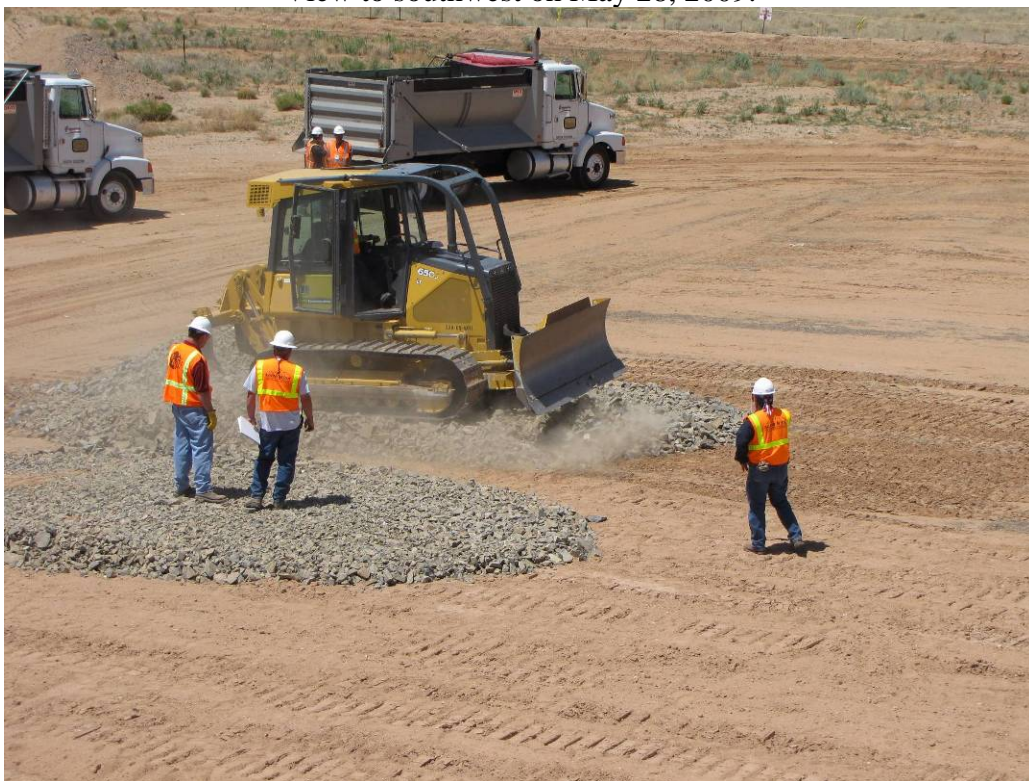
Spreading rock with bulldozer for Bio-intrusion Layer test.  
View to southwest on May 28, 2009.

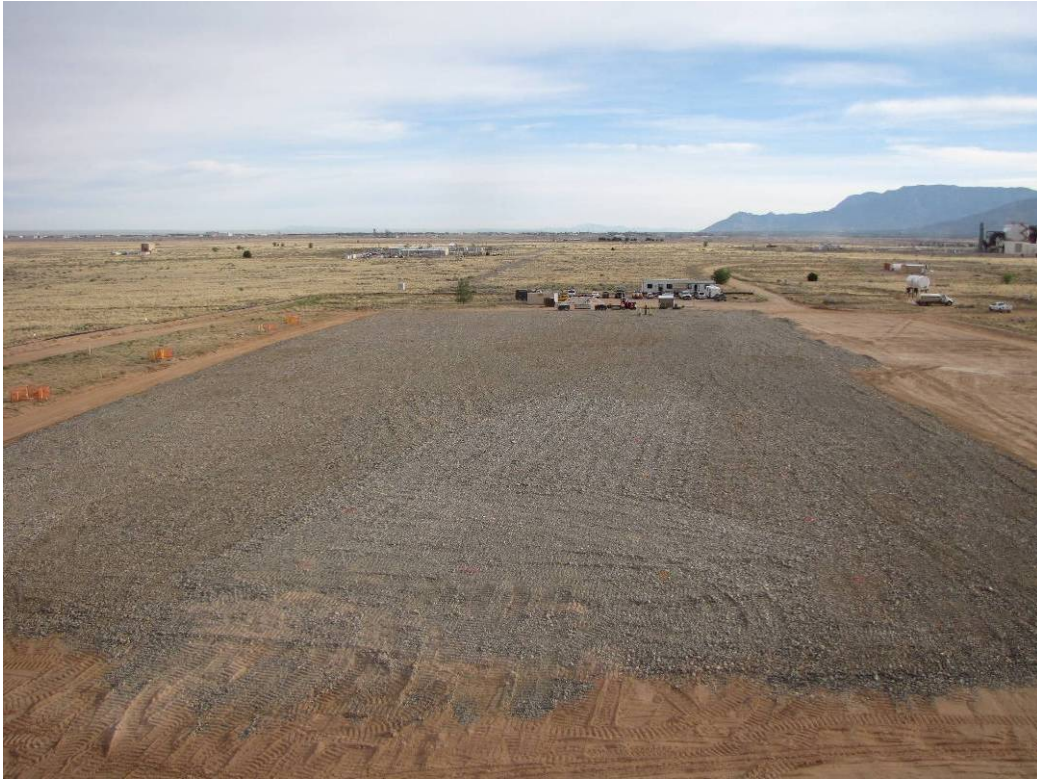
Bio-intrusion Rock Layer on June 8, 2009. View to north from the south end of the MWL.

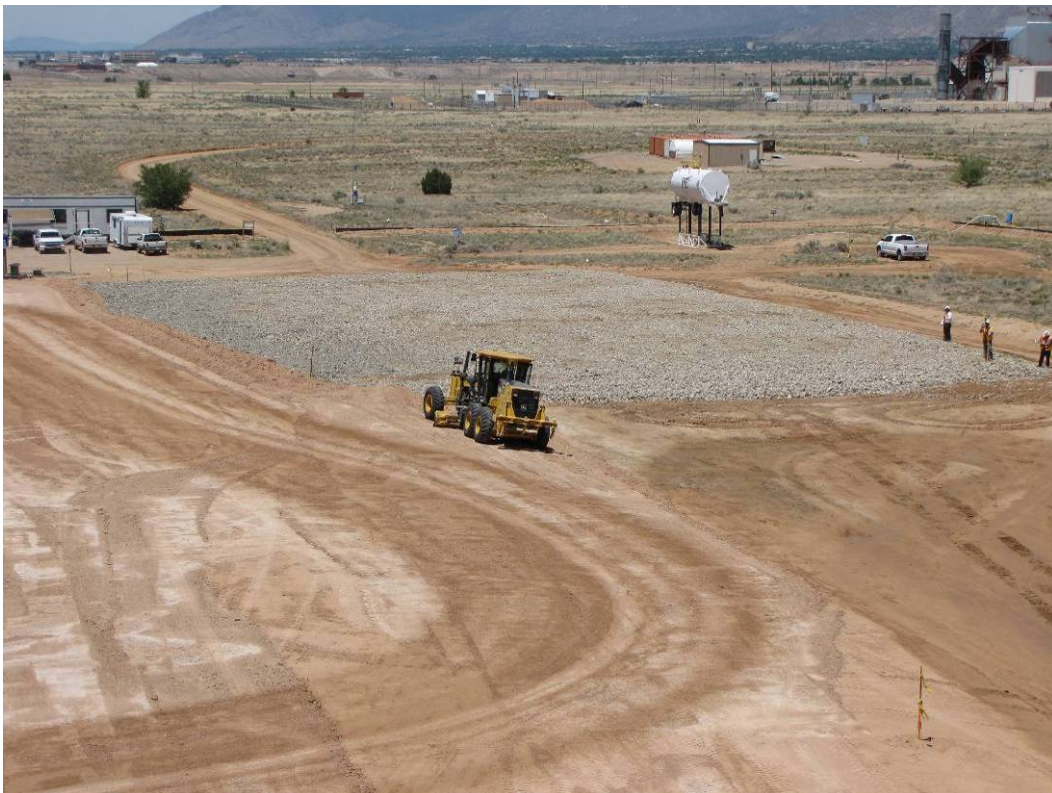
Completion of the Bio-intrusion Layer over the Classified Area – northeast end of MWL. View to north on June 12, 2009.

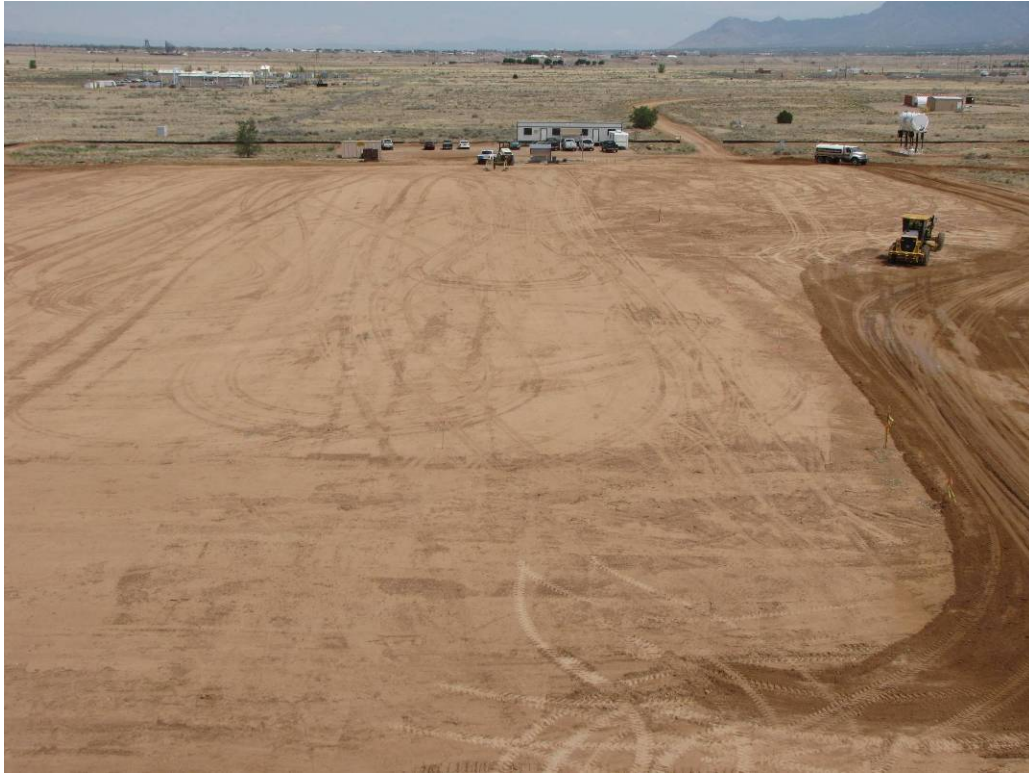
Soil Meniscus Layer (~3 inches thick) covering Bio-intrusion Rock Layer and slope work on east side of the MWL. View to north on June 18, 2009.

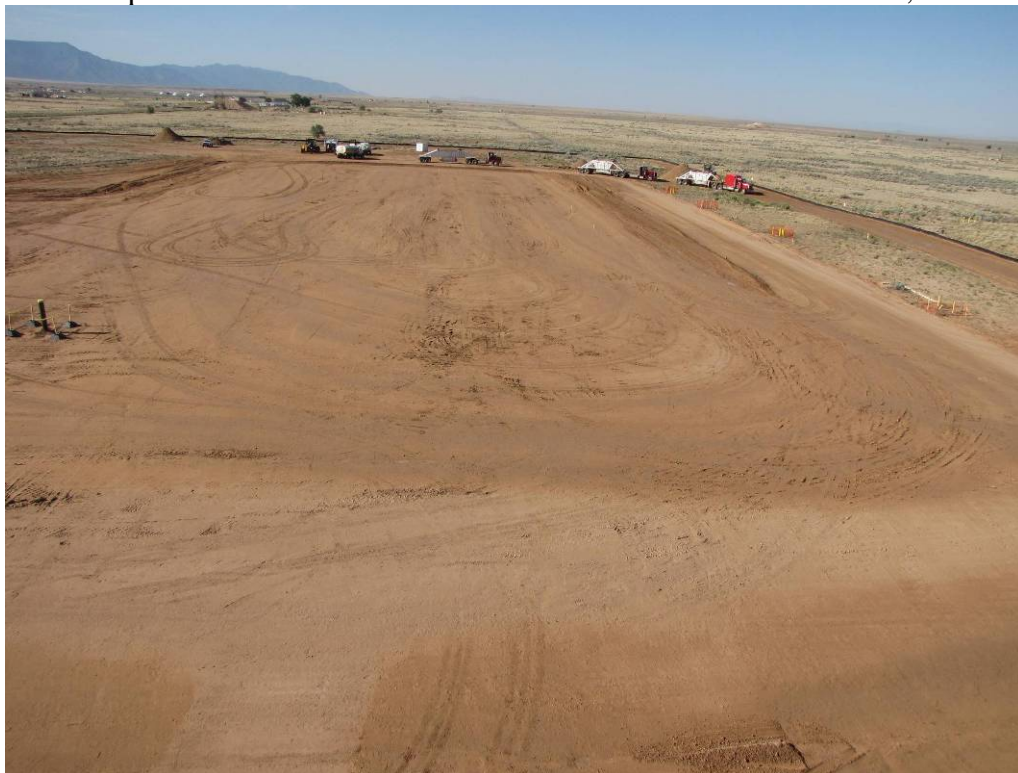
North slope completed to 6 to 1 slope and first 2 wedge lifts completed on east side. Lift #3 of Native Soil Layer in progress. View to the south on June 22, 2009.

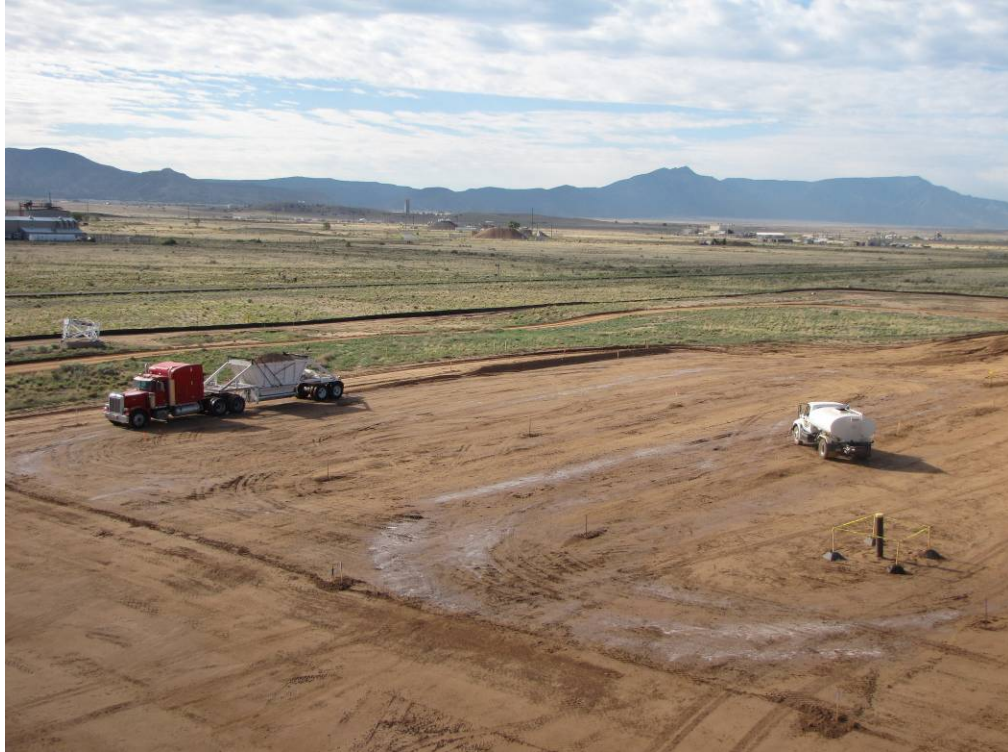
Bottom dump haul truck placing soil for Lift # 5 at northeast side of the MWL.  
View to southeast on June 30, 2009.

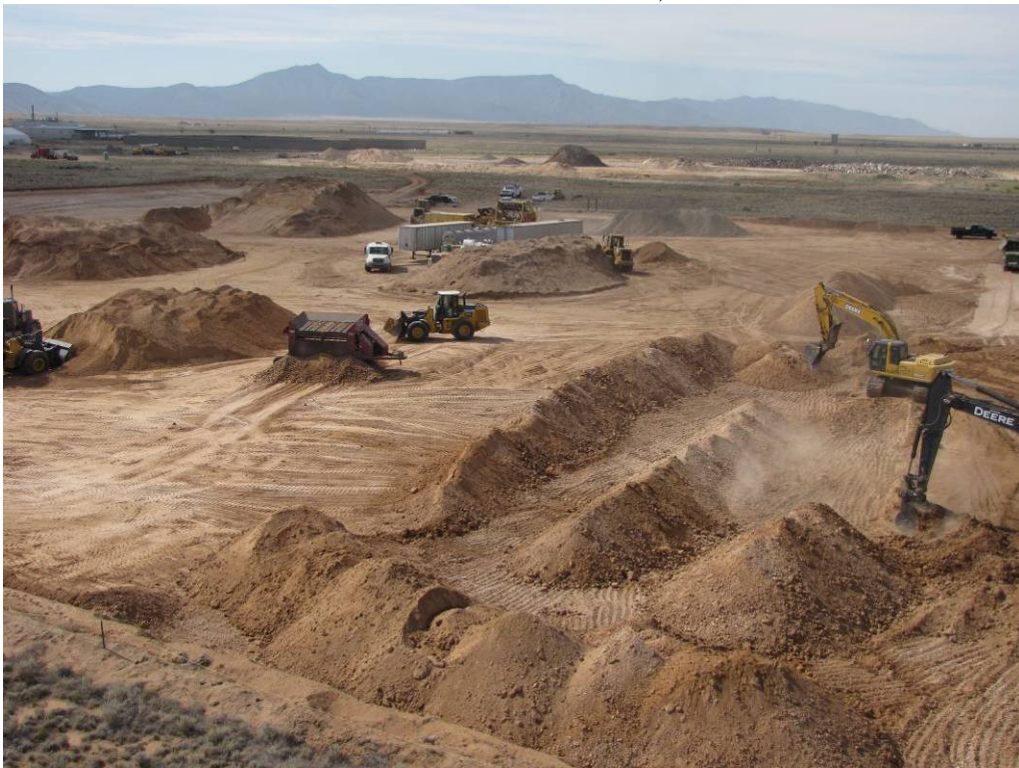
Borrow Pit Area activities on July 15, 2009. Pug Mill (background) and soil excavation and screening (foreground) operations. View to the south.

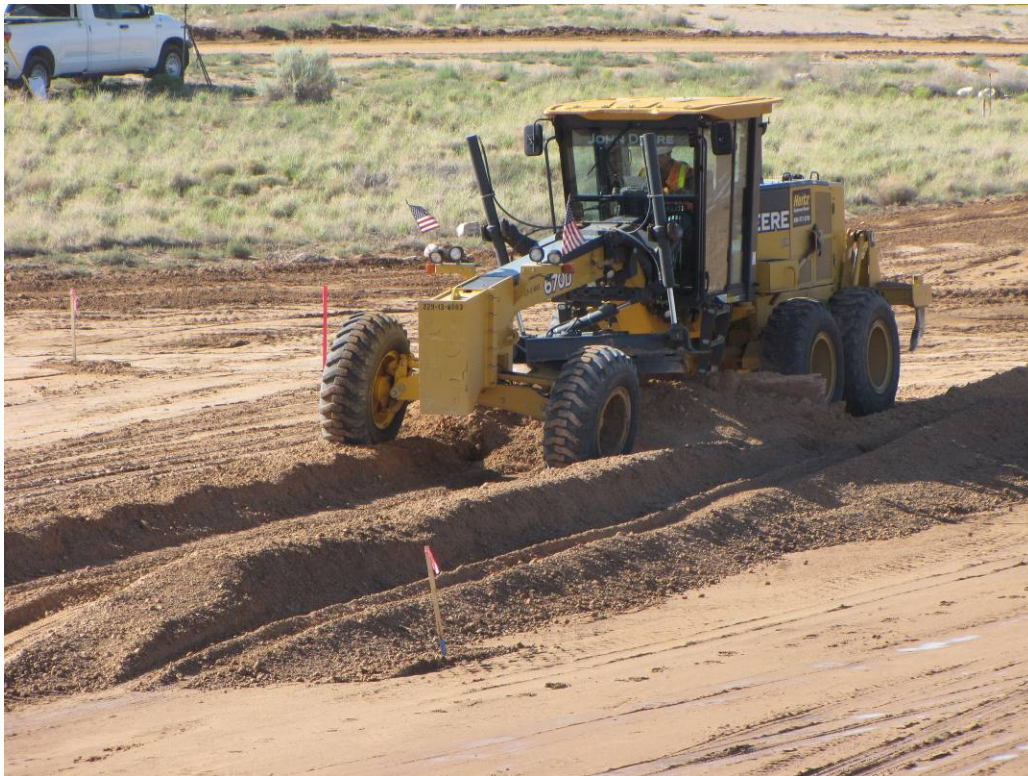
Motor grader spreading soil in dog leg area of MWL for Lift # 8.  
View to the southwest on July 23, 2009.

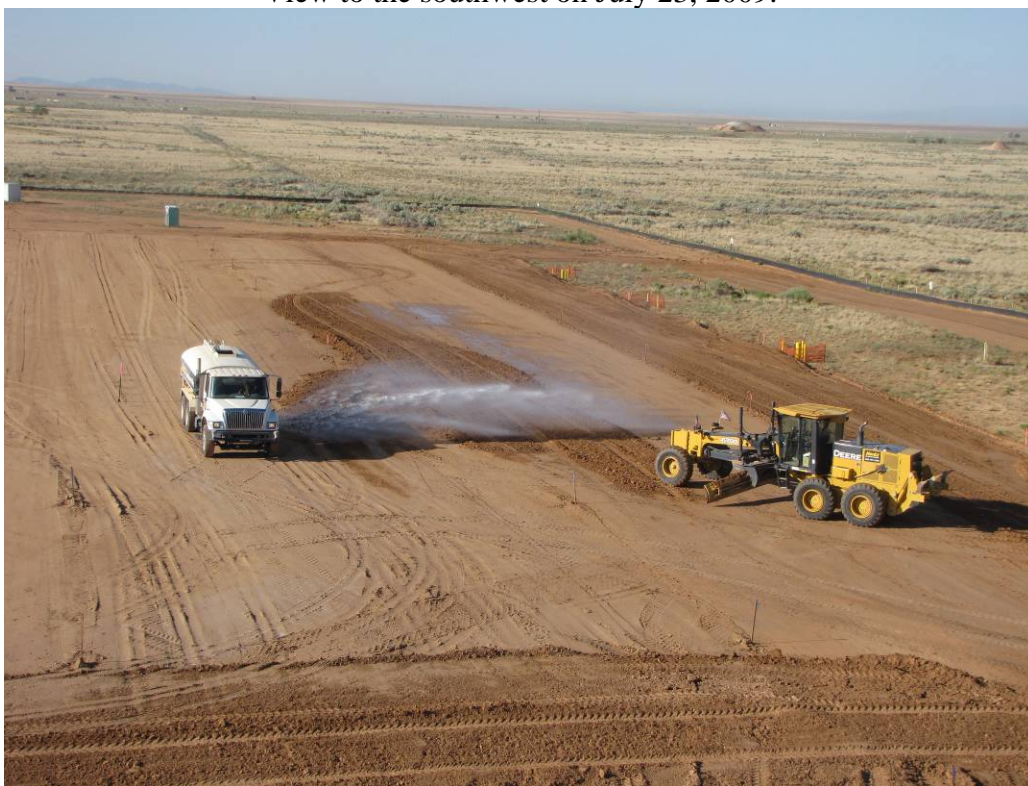
Soil being placed to adjust the Native Soil Layer thickness at specific grid points on the west side of the MWL after verification surveys. View to the south on July 31, 2009.
