From: Elaine Cimino [mailto:ecimino10@gmail.com]
Sent: Tuesday, January 25, 2011 3:08 PM
To: Martin, David, NMENV; Bearzi, James, NMENV
Subject: Re: CES's CMI Report Letter to be added to the Public Comments

RE: Sandia National Laboratory Corrective Measures Implementation Report (CMI)
for the Mixed Waste Landfill.

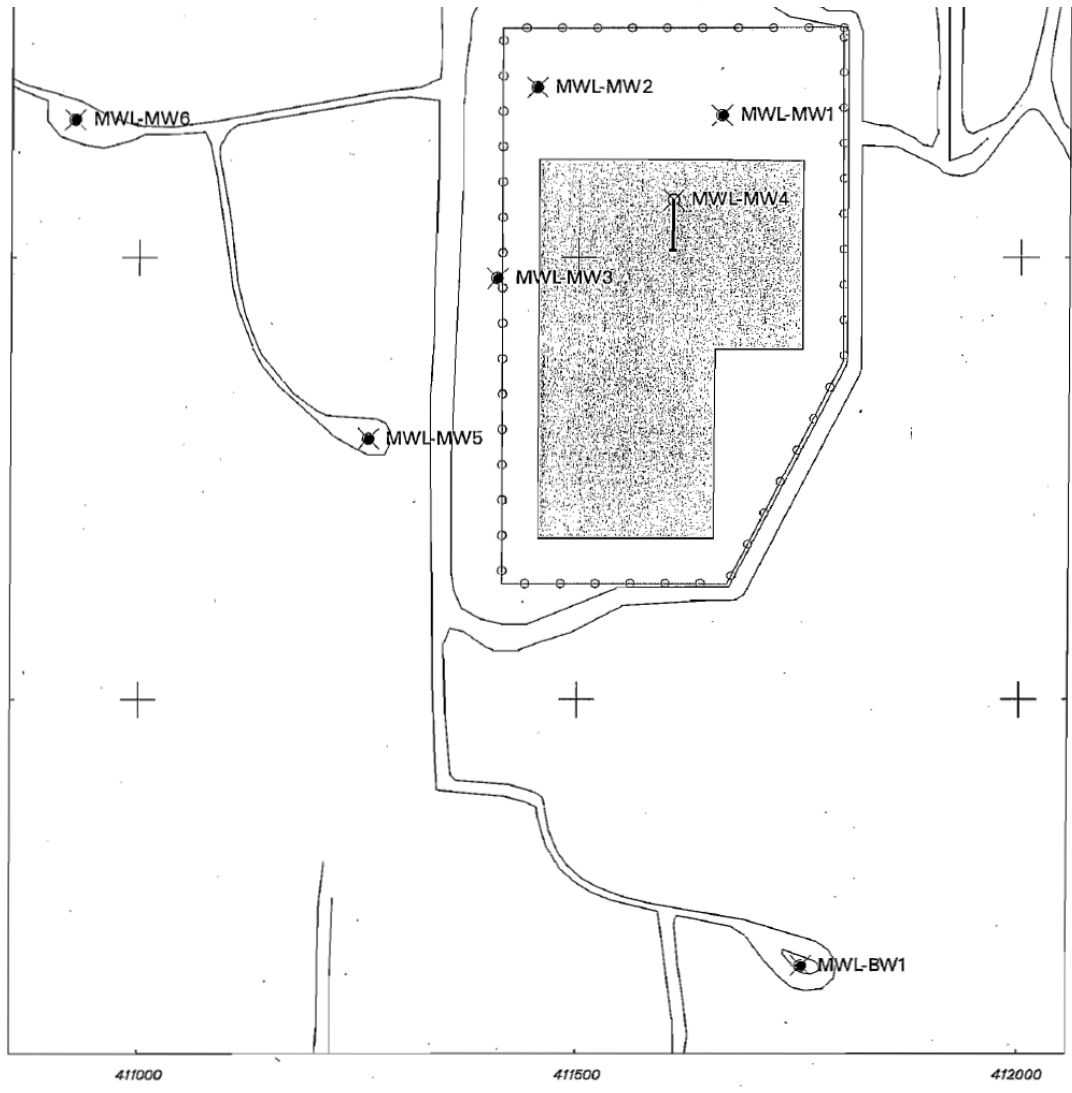
Figure 1. Map of the Sandia Mixed Waste Landfill (Sandia MWL dump) showing the monitoring well network in 2007 of the six monitoring wells MW1 to MW6 and the background water quality well BW1 500 feet south of the dump.

**Figure 1-2
Mixed Waste Landfill
Groundwater Monitoring Wells**

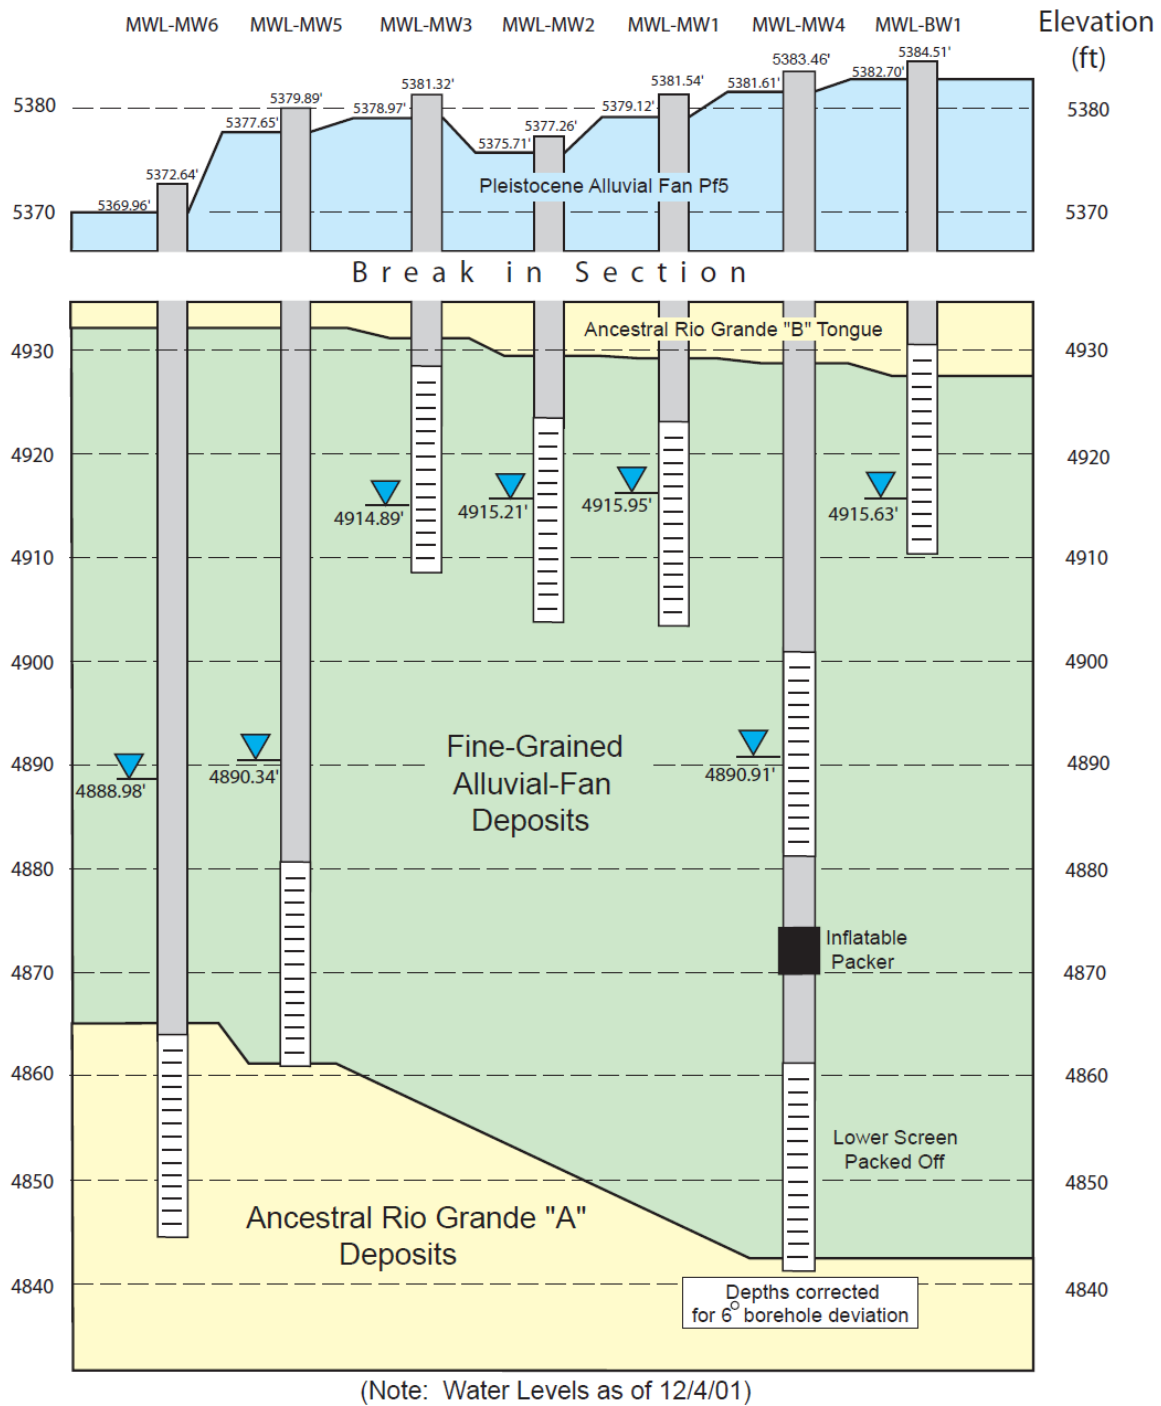
Figure 2. Schematic of the Monitoring Wells and the Hydrogeologic Setting at the Sandia MWL dump. The permeable sands and gravels in the Ancestral Rio Grande "A" Deposits (ARG deposits) are the valuable groundwater resource for Albuquerque and the surrounding region.

- There are two zones of saturation below the Sandia MWL dump that require networks of monitoring wells. A reliable network of monitoring wells was not installed in either of the two zones. Figure 2 (see attached) is a geologic cross section that shows
