Document title: **Mixed Waste Landfill Quarterly Progress Report
Evapotranspirative Cover Construction Project,
August - October 2009.**

Document author: **Mike Mitchell, Department 06765**

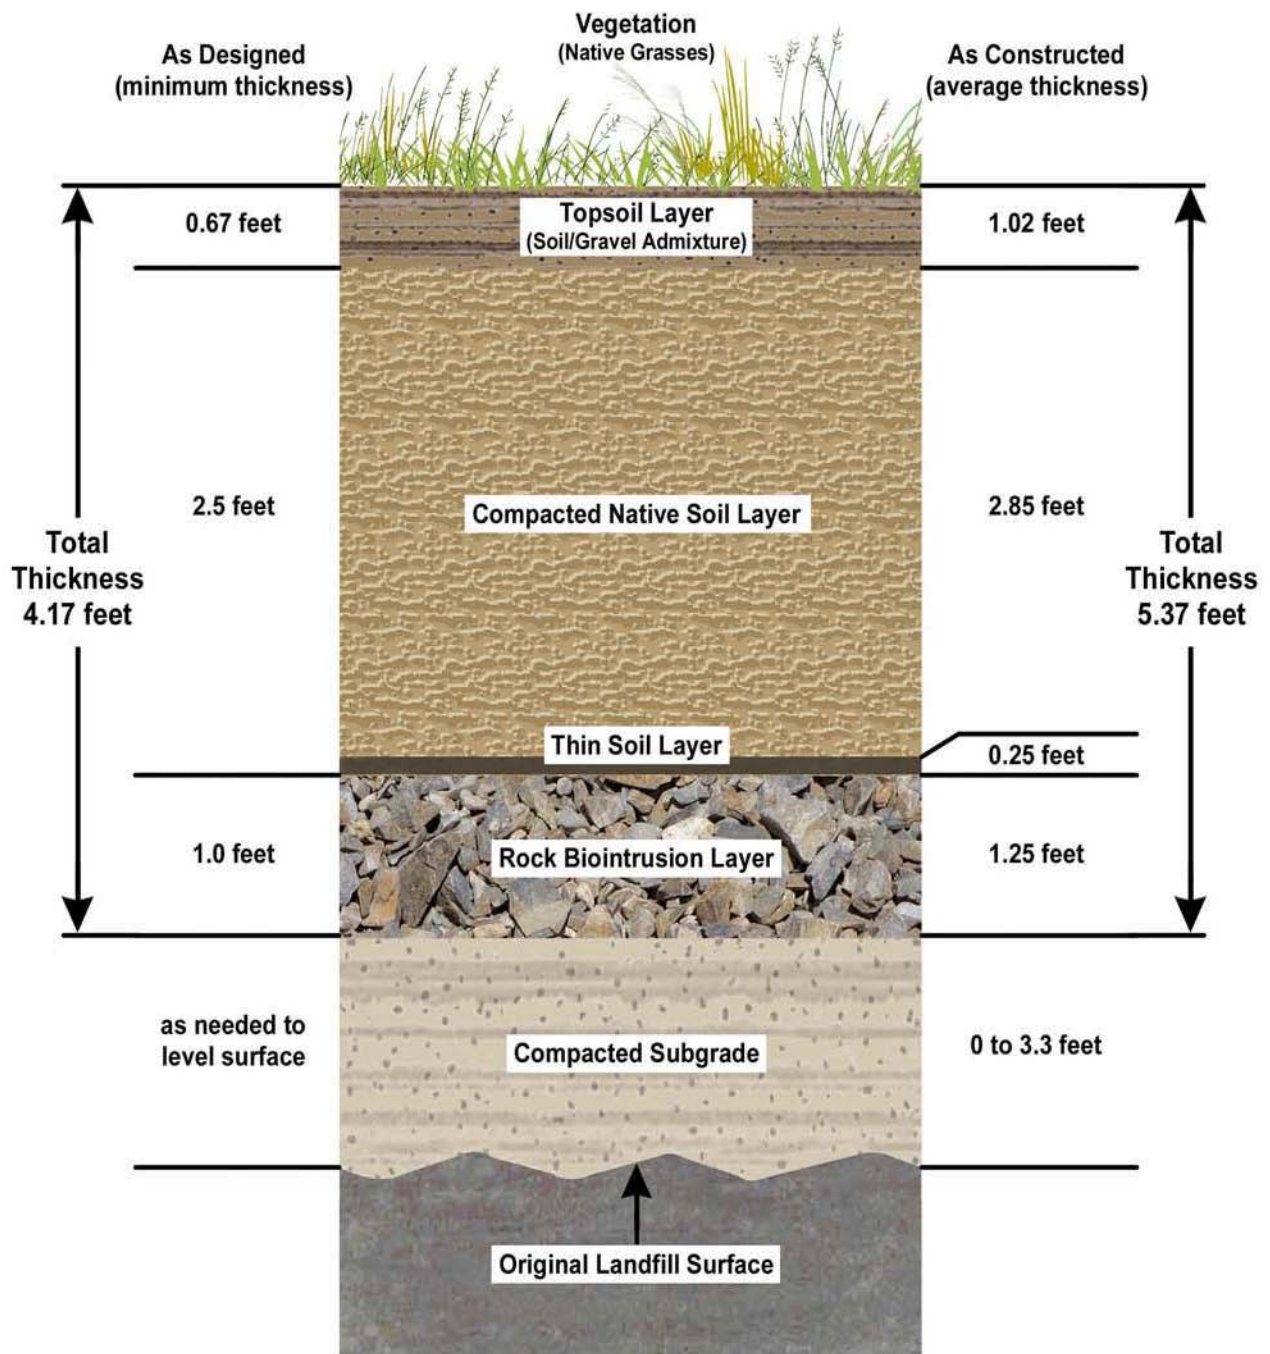
Figure 2
Schematic Diagram of the Mixed Waste Landfill Alternative Evapotranspirative Cover

This is graphically summarized in Figure 2, which shows the average thickness of the as-constructed cover is 1.2 feet greater than the minimum thickness in the CMIP. The thicker as-constructed ET Cover is the result of each cover layer being constructed with at thickness exceeding the minimum specification. Although this required more biointrusion rock and soil fill material than estimated in the CMIP, the final result was achievable within the estimated project budget and schedule. The as-designed versus as-constructed soil and rock volumes for each cover layer are provided in Table 2 along with a brief summary of the main reasons additional materials were needed. In summary, the increase in soil and rock material volumes resulted in a thicker, larger, more protective ET Cover that was achieved within budget and schedule.
