Black Canyon Creek

**Watershed/Aquatic Habitat Enhancement
Basis of Design Report**

**New Mexico Environment Department
Grant County, New Mexico**

May 2019

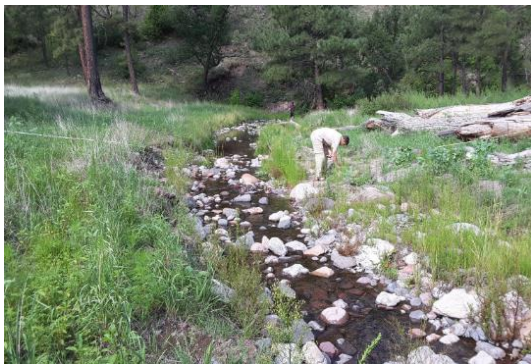
Figure 4: XS 16 with 8% vegetation cover.
Grass on banks with few ponderosa pines.

A typical red (0-25%) and orange (25-50%) section appear like Figures 4 and 5 below, respectively. The red areas with 0-25% vegetative cover are typically open and grassy, with few surrounding ponderosa pines. The orange areas with 25-50% vegetative cover are similar, but have more ponderosa pines closer to the banks of the creek. Some of the orange areas also have willows and oaks, but those are not mature enough to produce significant shade for the creek.

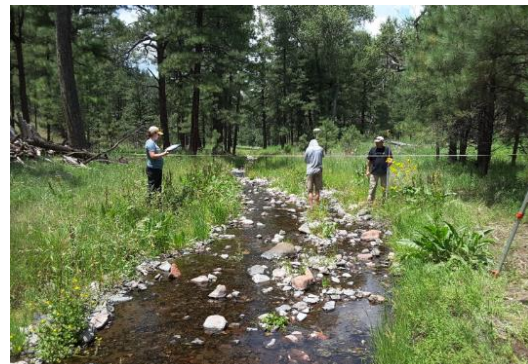
Figure 5: XS 5 with 34% vegetation cover.
Grasses and other riparian shrubbery with ponderosa pines near the channel banks

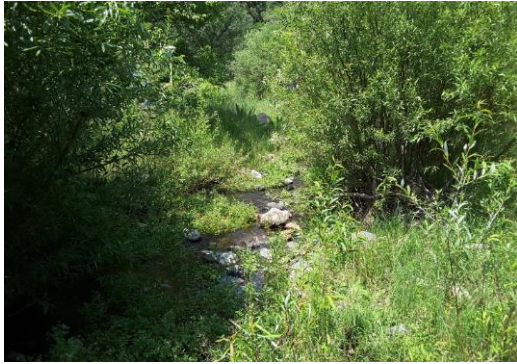
Figure 6: XS 11 with 54% vegetative cover.
Large willow population with breaks.

pine. Green (75-100%) areas are typically shaded with both dense willows and/or ponderosa pine, and examples are shown in Figures 6 and 7.

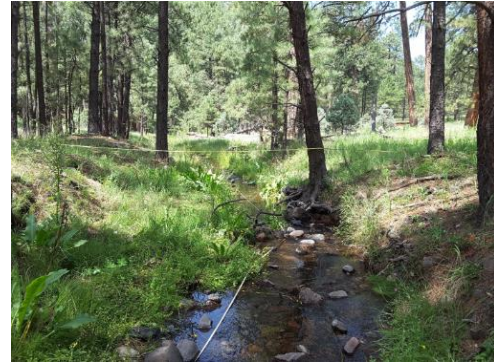
Figure 7: XS 1 with 58% vegetative cover.
Many ponderosa pines on bank and in floodplain providing good canopy cover.

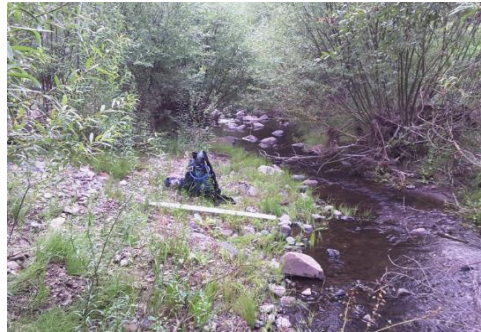
Figure 8: XS 19 with 97% vegetative cover.
Dense willow and oak population with little to no breaks

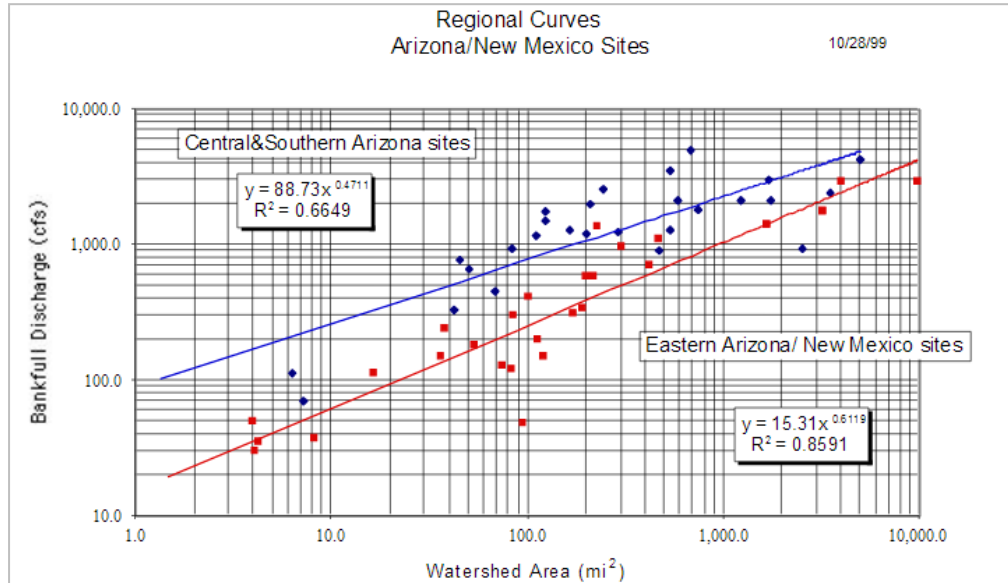
Figure 10: Bankfull Discharge Regional Curves for Arizona and New Mexico Sites (Moody 2003)

To gain an understanding of the flows in Black Canyon Creek, base flow, bankfull flow and storm flows were calculated. Base flows were determined by the Natural Resource Conservation Service (NRCS) Cross Sections Analyzer using water surface elevations obtained during the August 2018 survey. The bankfull flow was derived by comparing cross section, profile, and watershed information with data from the eastern Arizona/New Mexico sites regional discharge curve developed by Moody et al (2003) - see Figure 10.

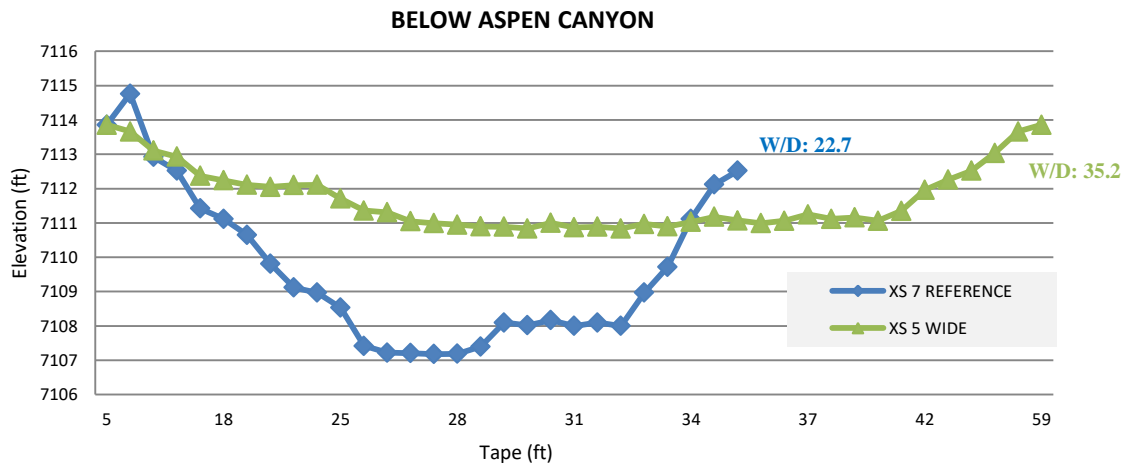
Figure 12: Cross sections below Aspen Canyon. XS5 elevations were altered to overlay.

A number of small split flow/abandoned channels and disconnected pools suggest that the Black Canyon Creek has migrated slightly over the valley floor within recent history. The creek also shows many segments of over widening throughout; with several width to depth (W/D) ratios exceeding the reference W/D ratios. Over wide cross sections overlaid with their respective reference cross sections are shown in Figures 12 and 13 below. The widening likely occurred as post-fire, high flow events impacted the creeks watershed, producing high sediment loads. The sediment was then deposited in the creek allowing the redistribution of shear stress to induce bank erosion and create a wider channel. In the three areas where vegetation density is high (75-100% cover) the width to depth ratios are less than 20. The vegetation in these areas likely increased the creek’s stream bank stability and kept it from widening.

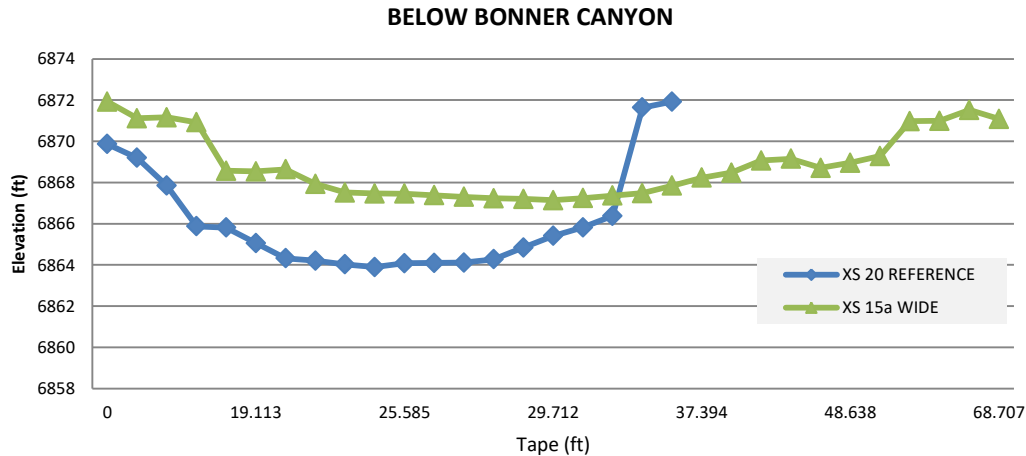
Figure 13: Cross sections below Aspen Canyon. XS15a elevations were altered to overlay.

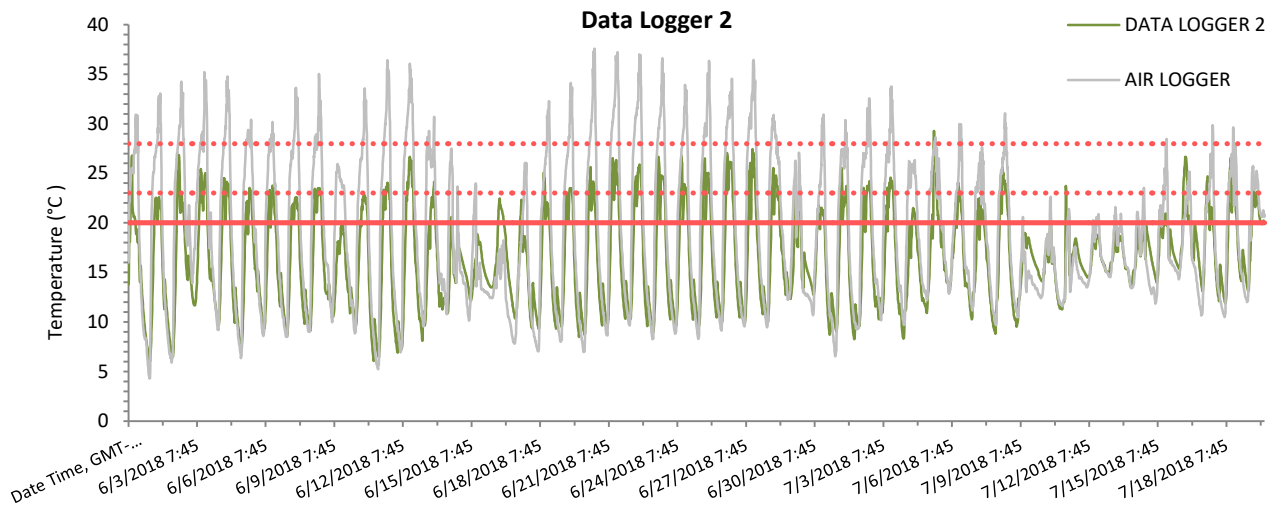
Figure 18: Data Logger 2 and Air Logger Temperatures

Each data logger recorded temperatures for approximately 50 days taking a reading every 15 minutes, for a total of 4768 samples. Sampling started on May 31st and ended on July 19th, which is generally within the hottest time of the year. The vegetative cover at each logger determined by the densiometer is provided in Table 9. The maximum, minimum and average temperatures recorded and the time spent at high temperatures for each logger is provided in Table 10. A graph of each temperature log is provided in Figures 18–21 with the ambient air temperature overlaid. The solid red line in each graph represents the NM Environment Department target temperature for cool water streams (20C max for < 4 hrs on 3 consecutive days). The NM Environment Department maximum temperature (23C max) and a maximum temperature threshold for Gila trout (27C for < 2 hours) are shown as dotted red lines.

Temperature data logger data for the summer of 2018 suggest that none of the reaches in Black Canyon obtained the water quality targets for temperature reaching lethal temperatures and the farthest downstream reach may be reaching lethal temperatures for Gila trout. The coolest temperatures were logged by Data Logger 3, with the maximum temperature reaching 24.7°C. The likely reason for the cool temperatures is that water emerges after being subterranean 0.24 miles upstream from that logger. When surveyed, the water emerged at 12.7°C. The minimum temperature in this area was 11°C and the standard deviation 2.6, showing that the temperatures at this location are relatively stable. The data indicate that this reach comes closest to maintaining temperature standards and has the highest quality water for trout habitat.

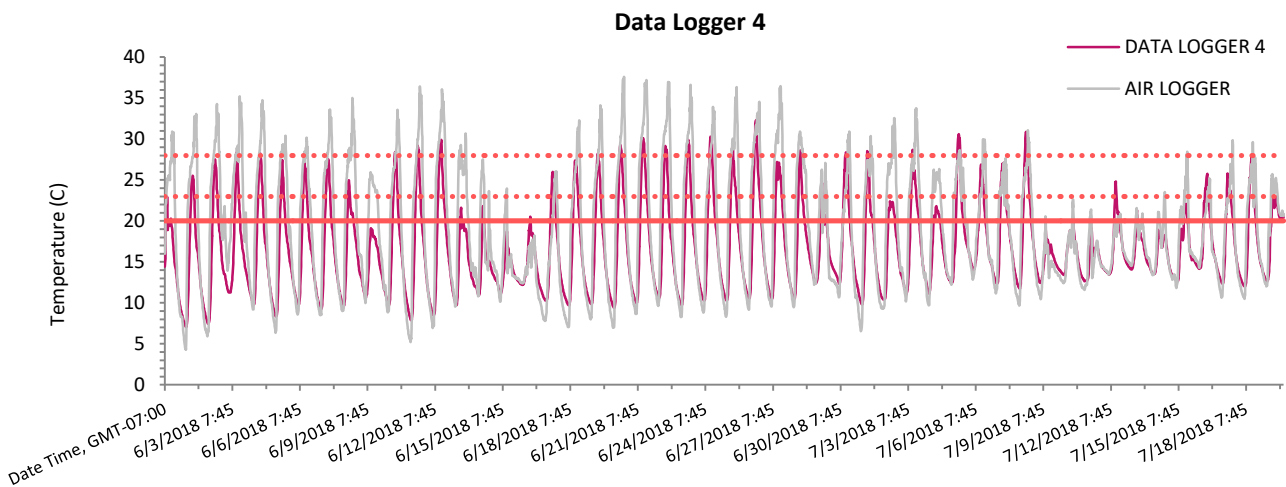
Figure 20: Data Logger 4 and Air Logger Temperatures

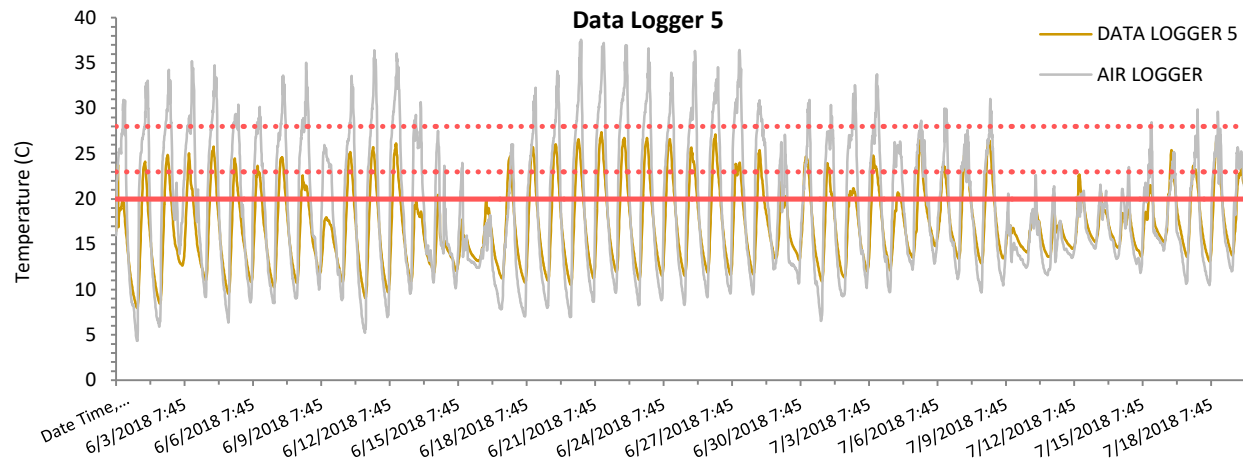
**Figure 21: Data Logger 5 and Air Logger Temperatures**

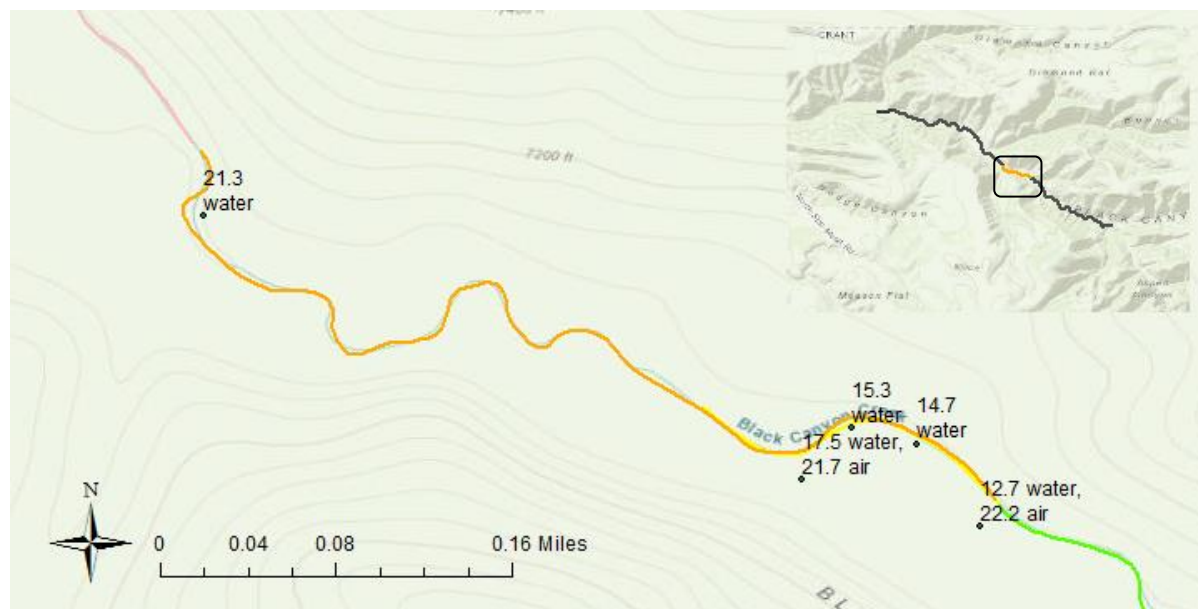
Figure 24: Location of Reach 7 and the August temperature readings

The solar load under current conditions was determined to be $187.55 \text{ (j/m}^2\text{/s)}$ in August and $226.68 \text{ (j/m}^2\text{/s)}$ in June. The corresponding maximum temperatures are 20.6° C and 24° C respectively. By increasing the vegetation density to 80% on both banks of the creek and decreasing the vegetation offset to 2 ft. the solar load conditions were lowered by 54.2%. Specific solar loads were determined to be $84.95 \text{ (j/m}^2\text{/s)}$ in August and $104.96 \text{ (j/m}^2\text{/s)}$ in June, with resulting temperatures of 16.8° C and 19.4° C . The temperature reduction would meet the 20° C water quality standard in both August and June.

The average segment azimuth is -32° offset from the West, which is a potential leading cause in the lower temperatures of the segment. The water also enters the segment at a cool temperature of 12.7° C , as it had been subterranean for roughly .45 miles. Planting vegetation in this reach should be prioritized.

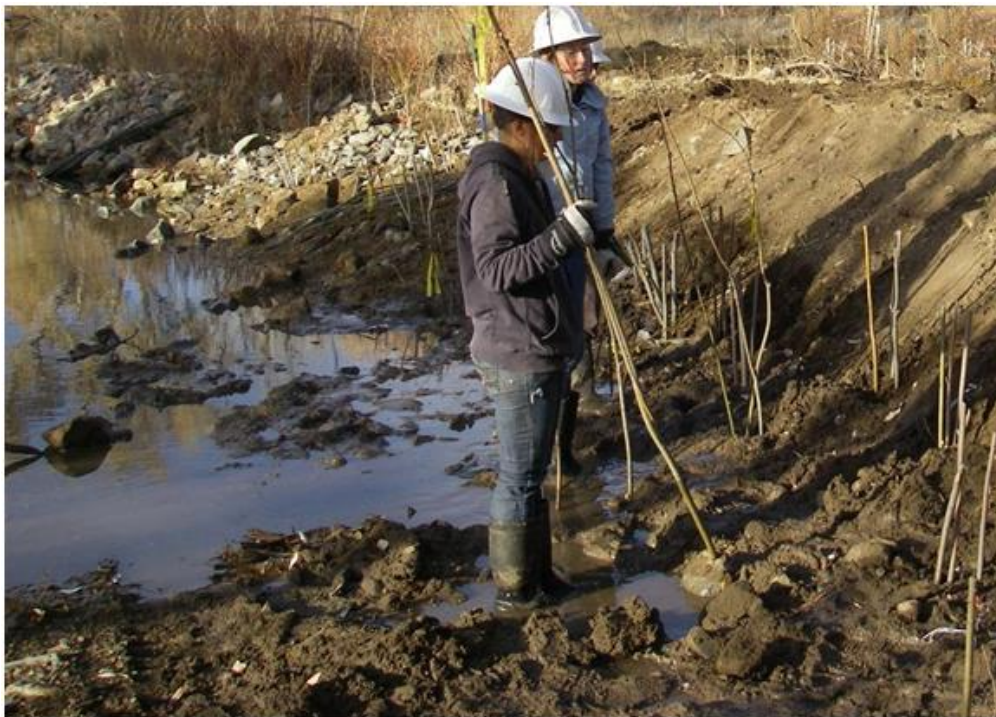
Willow pole plantings use cuttings from willow (*Salix* spp) shrubs that are used to revegetate shallow, eroding streambanks, providing protection against erosion and ultimately shading the stream. Hand tools are used to collect willow poles (½ inch diameter or larger) from the project site. Holes are dug along the toe of the bank using hand tools such as a digging bar, and are deep enough to encounter permanent water. One to three willow poles are placed into the holes, ensuring the butt ends are in water. Holes are then back filled with a mud slurry to eliminate air pockets. The tops of the poles are cut off approximately one foot above soil level. Poles are typically planted in a staggered pattern on banks on two to four foot spacing. Planters must ensure that the base of the poles are below the annual low elevation of ground saturation and the upper part of the stem is in good contact with soil that is relatively well drained for much of the year.

Figure 26: Willow pole plantings at stream bank as part of stream/habitat restoration

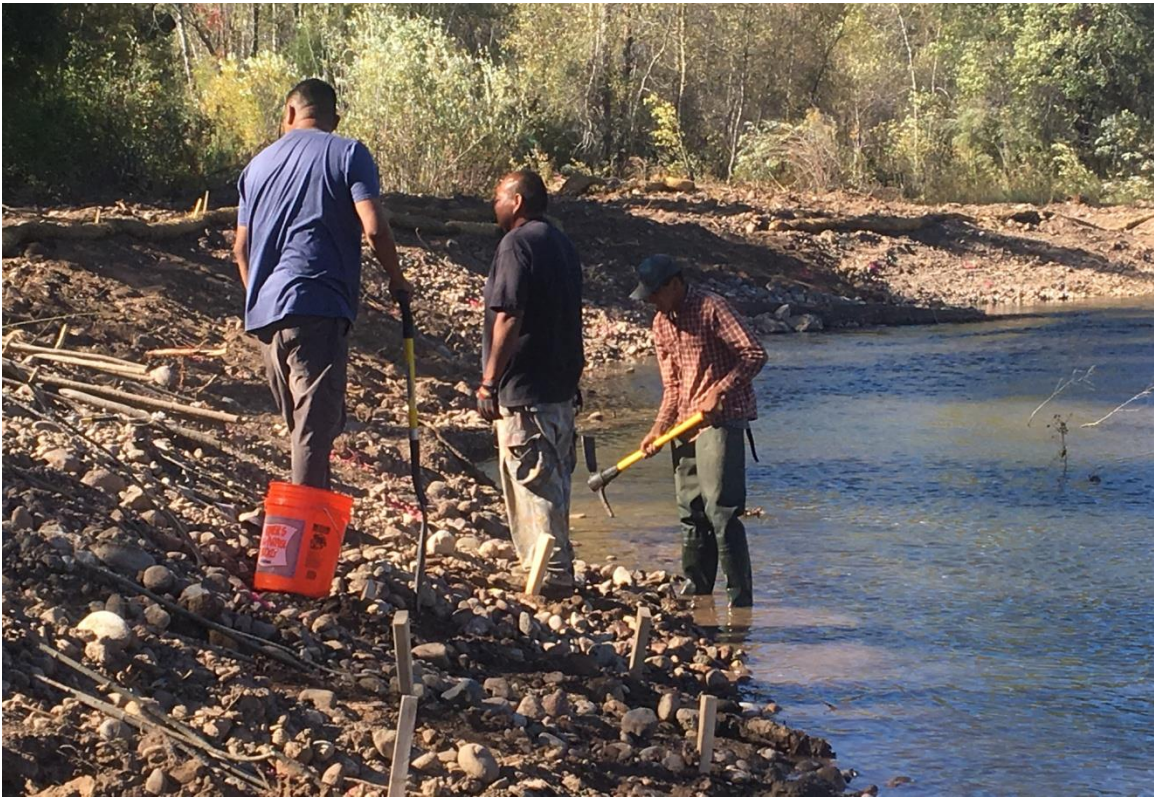
Vertical willow bundles are used to plant and establish willow vegetation that will stabilize eroding banks and provide shade to streams. This practice allows for planting and establishing willows on taller banks than with pole plantings. Willow bundles use 3-5 willow cuttings (minimum ½ inch diameter by 6 ft long) harvested by hand from native willows growing at the site which are tied together with coir twine. Hand tools are used to dig a shallow, 3-4 inch deep vertical trench on a bank down to water permanent water level. The bases of the stems are placed into water, while the rest of the stems are buried along their length, leaving approximately one foot exposed at the top. Wooden stakes are used to secure the bundle to the bank. The willow poles will take root along the buried portion, establishing a dense matrix of roots which will spread over the bank. The stems will sprout along their length, resulting in willow cover up the bank, providing protection against erosion and ultimately shading the stream channel. Trenches are placed approximately every 4-8 feet along an eroding bank.

Figure 27: Willow bundles being installed on a river bank

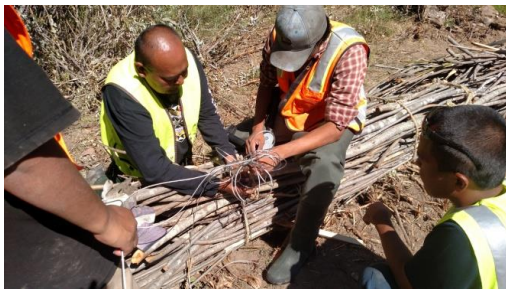
Logs barbs are constructed out of straight, sound logs (either green or dead), 12 to 24 inches in diameter and 15 to 20 feet in length. Willow barbs are assembled from dead and live willow stems that are formed by overlapping and compressing the stems into 8-10 inch diameter bundles, 15 to 20 feet in length. Bundles are tied together with $\frac{1}{4}$ inch jute or coir rope, or other natural material every four feet. To create a “log”, three to four bundles are then tied together with natural material rope or with $\frac{1}{8}$ inch wire rope.

The wood or willow logs are buried into the bank at bankfull height and are ballasted with large boulders or earth anchors. They are positioned into the channel pointing upstream, and sloped down, towards the rivers bed. The in stream end of the barb is placed approximately $\frac{1}{3}$ channel width away from the bank and is buried into the channel down to bed level. The end is held in place with earth anchors or rock bolsters. After installation, the upstream side of the barb can be backfilled with large cobbles or boulders to prevent water from flowing under the structure.

Figure 29: Willow Barb

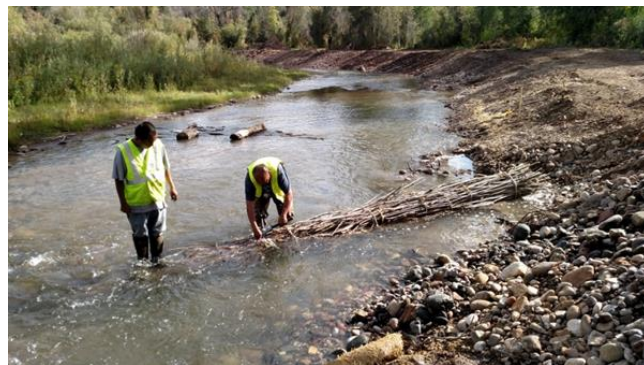
Figure 28: Willow Barb

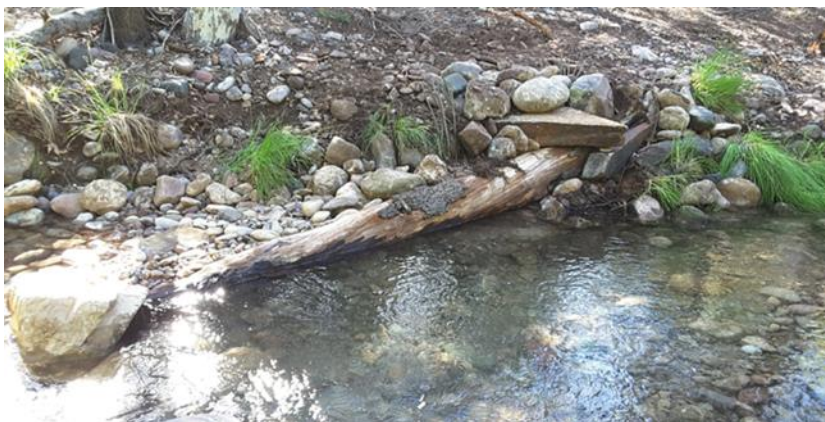
Figure 30: Log Barb

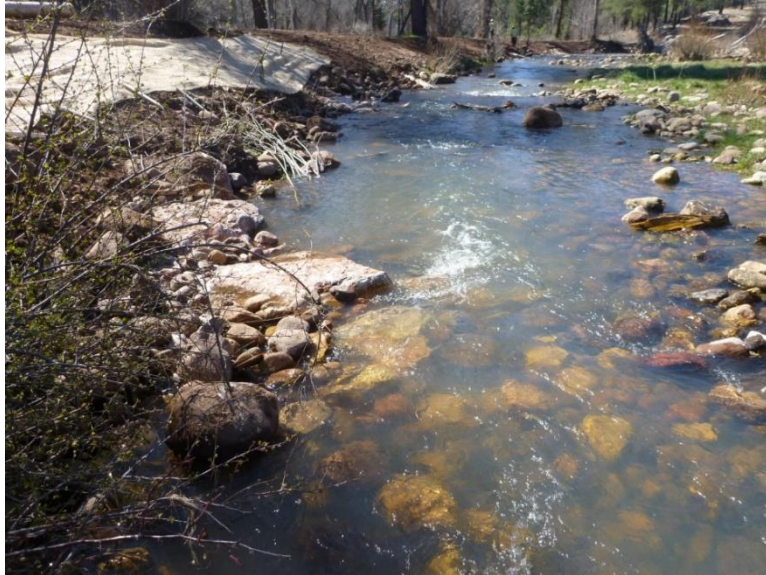
Rock barbs serve the same function as the log barbs but are built out of larger boulders or graded rock. The structure is placed at bankfull elevation where it ties to the bank. It angles upstream, away from the bank at 20-30 degrees, and down to bed elevation. The rocks should fit tightly together so water is forced over the top of the structure. A scour pool can be excavated on the downstream side to enhance habitat. Willow poles are planted around the end of the structure along the bank to provide additional shading and bank stabilization.

Figure 31: Rock Barb extending from left side into the base flow channel

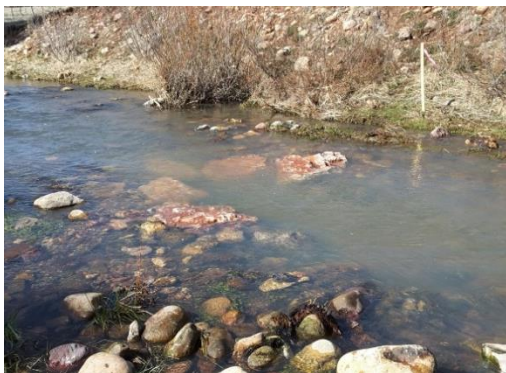
The mini weir is a rock structure that creates small pockets of streambed scour and provides vertical cover in midstream areas. These structures are created with larger boulders (small enough to move by hand) and extend no higher than bankfull elevation above the bed. Rocks are placed into a chevron configuration with the point facing upstream. The bed is dug out enough to place footer rocks which anchor the top rocks in place, and a scour hole is left on the downstream side. Mini weirs are used to establish ‘pocket habitat’ in riffles. They will slow high flow velocities by creating additional roughness but should not be considered as grade control.

Figure: Mini weir in mid-channel

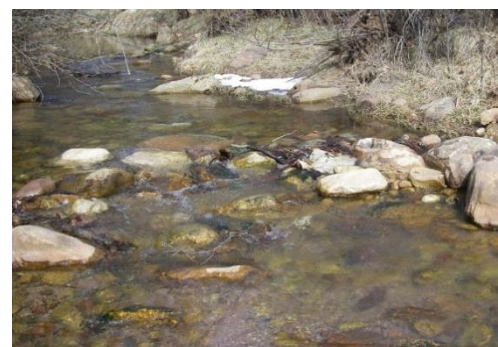
Figure 32: Mini weir mid-channel

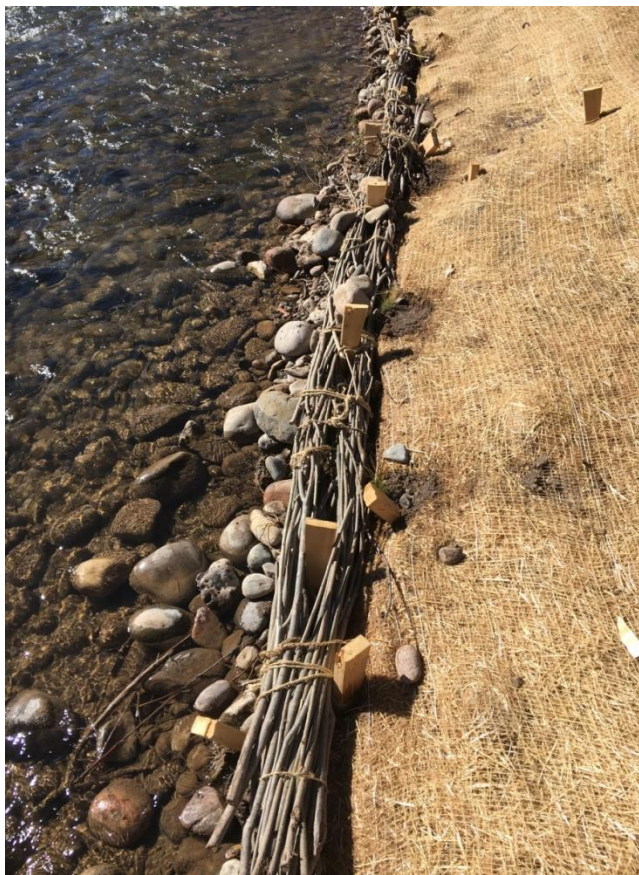
A willow fascine is a bioengineering technique that protects the toe of a bank from scour and is also used to secure erosion control fabric along the base of a bank. Fascines comprised of live and dead willow stems that are bundled and compressed together in an overlapping fashion to create an 8 to 10 inch diameter “log” of the desired length. The fascines are tied with jute or coir rope and are installed along the toe of a bank and partially buried. Tapered wood stakes are used to secure the fascine to the bed.

The advantage of using live willow stems is that they can take root and sprout, adding additional woody bank vegetation that protects against erosion and provides shade over the stream channel. Willows are harvested from the project site and hand tools are used for installation. If sprouting and establishment of willows at the site is desired, soil should be covering the stems with good soil to stem contact or roots will not establish.

Figure 33: Willow Fascine

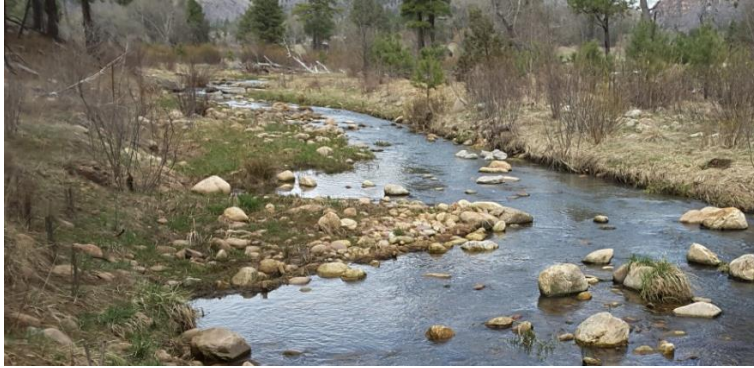
The purpose of a rock or log deflector is to constrict flows and form a low flow channel in an overwide section of stream which can improve fish habitat and reduce thermal gain. These low structures are installed on the bed of the channel, forming a triangle extending out at approximate 45 degree angle from the bank to the center of the channel. The height of the “point” of the triangle is the elevation of the base flow water surface. If the channel has an appropriate width/depth ratio, the structure can remain flat as it progresses towards the bank. If modifications to the bankfull width/depth ratio are needed, the structures can rise as you move towards the bank up to bankfull elevation. Wetland vegetation can be planted in the fill portion.

The structure can be constructed out of appropriately sized rock if available, or a frame can be constructed out of 12 inch or larger logs which are buried in the bank, and infilled with smaller materials (rock, gravel, brush). Structures are placed in straight channel reaches, typically on alternating banks to create a sinuous low flow channel, or can be placed across from each other to create a narrow channel in the center.

Figure 34: Low deflector built at Canyon Creek, Az.

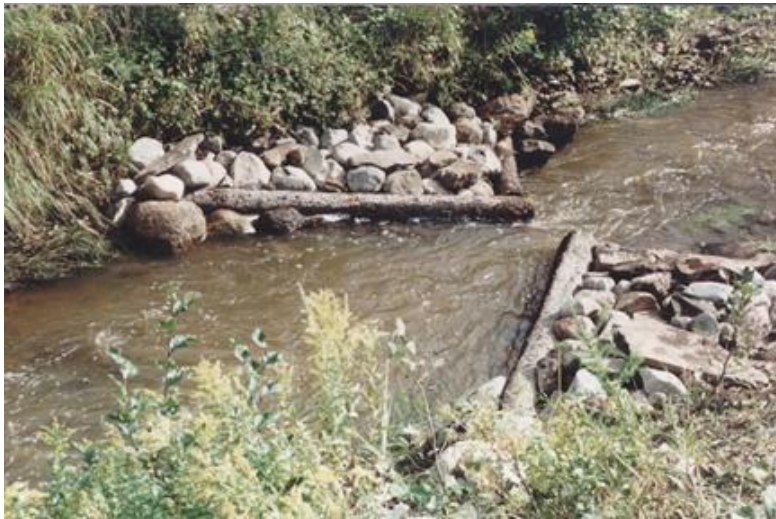
Figure 35: Log deflectors from both banks
Image from afterwildfirenm.org

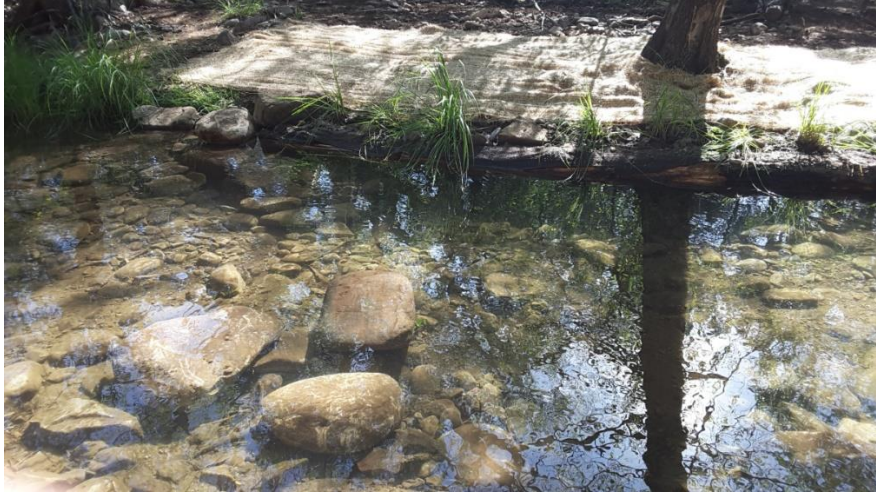
Log overhangs are installed on the outside of meander bends and provide overhanging cover and shade for fish. These structures are constructed against the bank, with a log set on footers and anchored with earth anchors or rock bolsters. The bottom the log is set at an elevation that provides a swimming depth for fish at base flow. The top of the log should not extend above the bankfull elevation. Voids between the bank and log are filled with ballast rock and can be covered with soil and planted with wetland vegetation or willows. Stream currents at the meander help to keep the opening under the log free of sediment. Boulder clusters at the exterior of the structure can be placed to ensure that some stream current is directed towards the structure.

Figure 36: Log Overhang

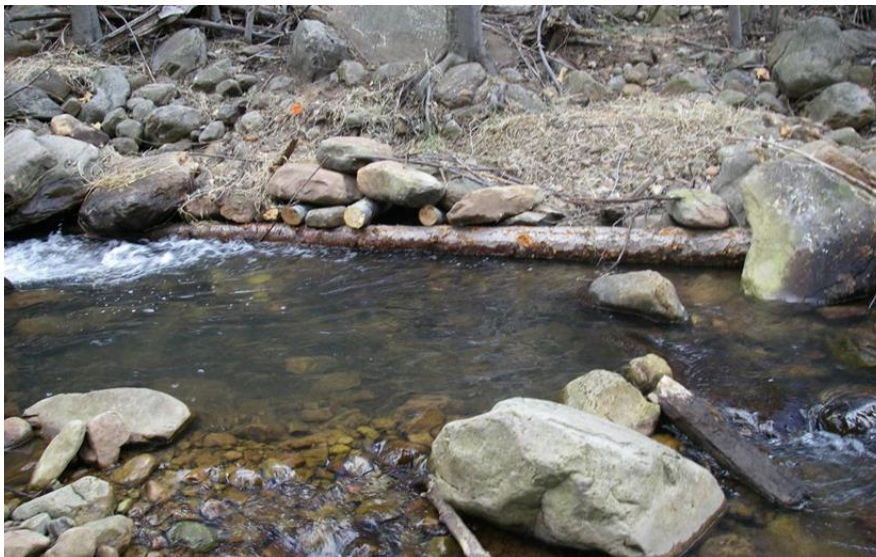
Figure 37: Log Overhang

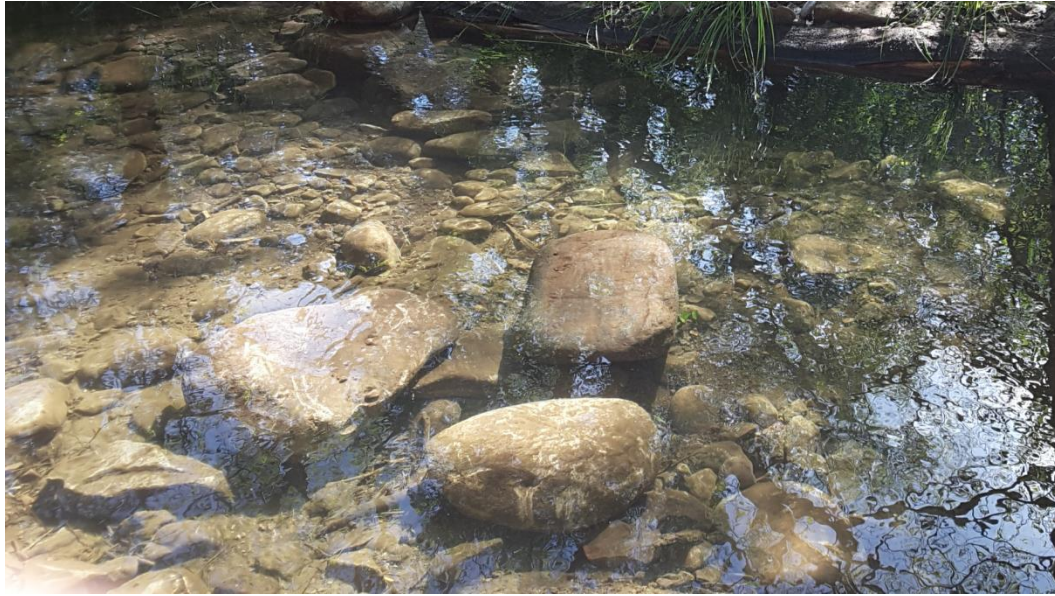
Boulder clusters are composed of three to four larger sized boulders (18-20 inch) placed into a stable section of stream channel, in riffles, glides, or pools, wherever cover for fish is desired. The rocks provide side and overhead cover; create scour pockets around the boulders and builds quiet water resting areas in riffles. Boulders are placed in a triangular or diamond shaped pattern with spaces between boulders ranging from 6 inches to a foot. The tops of boulders should be below bankfull elevation.

Figure 38: Boulder Cluster

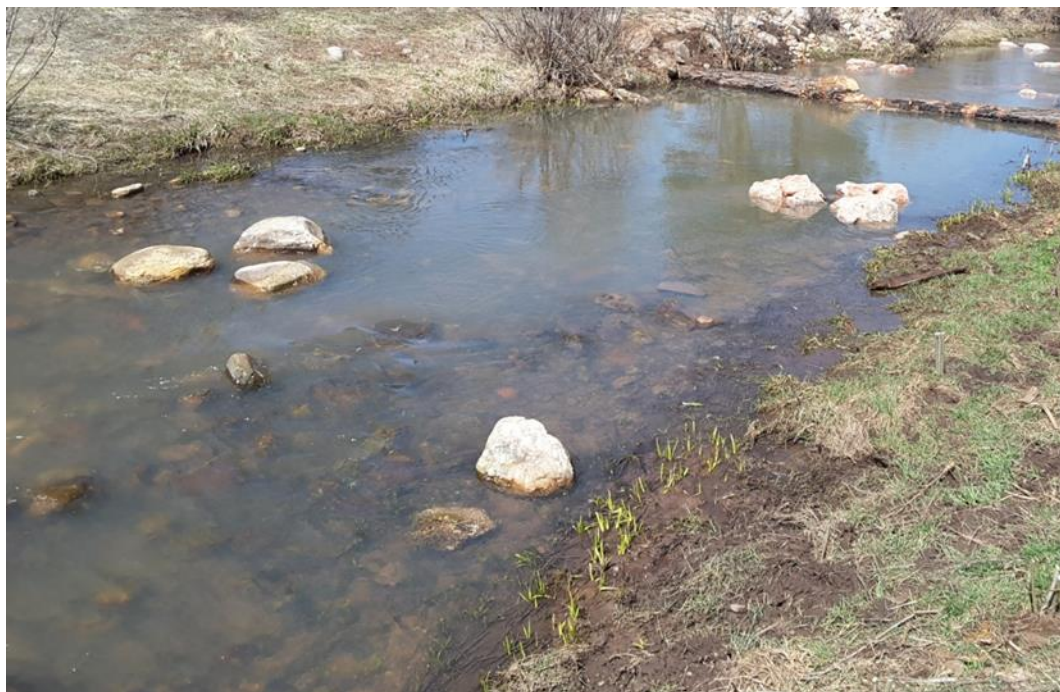
Figure 39: Boulder Clusters

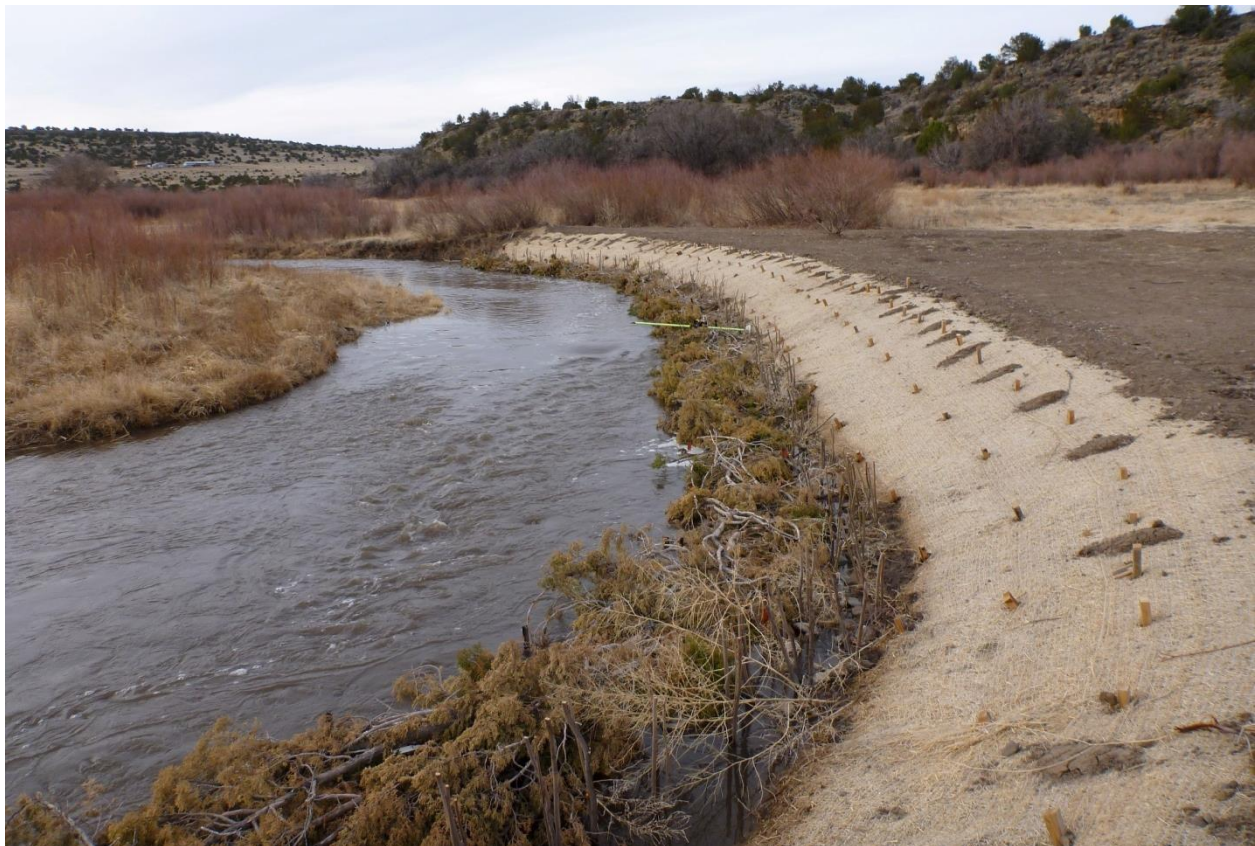
This practice provides temporary, physical protection to the toe of a bank while acting as a sediment catch to build out the toe of the bank. The revetment is made of live, branchy trees or brush (2-6 inch diameter, juniper or fir with needles on work well) which are placed along the toe of an eroding bank. The top of the revetment should be placed near the bankfull elevation. Trees are shingled along the bank starting at the downstream end, with each subsequent tree overlapping by 1/3 of its length. Trees are wired together with 12-gauge galvanized wire. The revetment needs to withstand the force of the flowing water. Revetments need to be staked to the bank with earth anchors, rock bolsters or t-posts (if t-posts are utilized, they should be removed in 2-3 years). Anchor points include each end of the revetment and at each overlap section at a minimum. Willows should be planted behind the revetment to provide permanent cover and a dense root mat. Flood flows will be slowed by the dense woody barrier and sediment will accumulate. Wetland plants will colonize the fresh sediment bench. The long-term effect will be to reduce stress on the outside of meanders and reduce stream width.

Figure 41: Brush Revetment

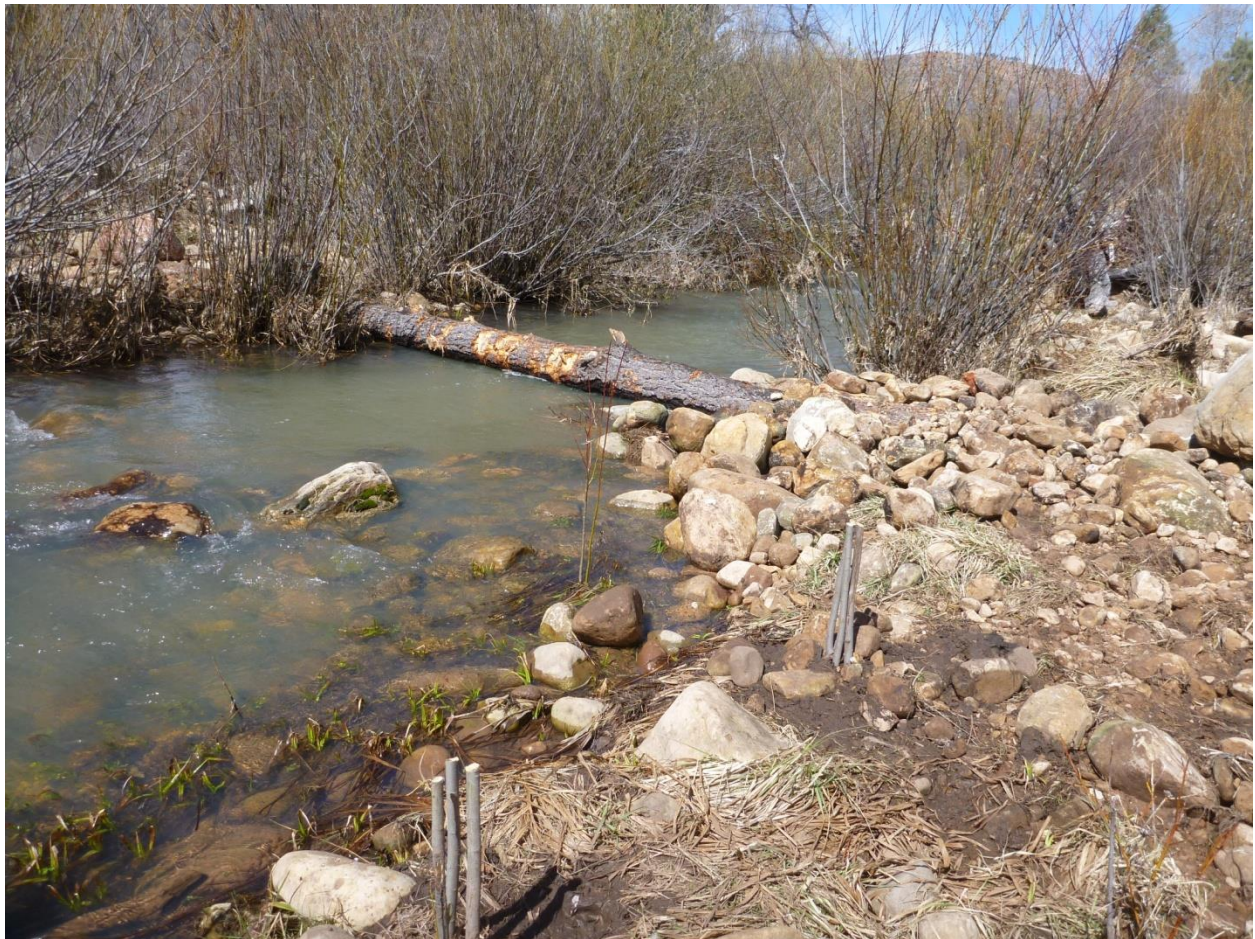
Cross over logs provide overhead cover and shade and help the stream create a relatively deep scour pool beneath to provide fish habitat. The 12 to 24 inch diameter log is felled perpendicular to the stream flow and spans the entire width of the bankfull channel. The log is placed so the bottom of the log is just above bankfull elevation. Bolster or ballast rock is placed on either end of smaller logs to provide anchorage. However, anchorage should be minimal since permanently anchored logs or logs placed too low relative to bankfull will likely cause the stream to erode around the end of the log. Willow poles can be planted around either end of the log to provide additional shade. Flows in excess of bankfull will be deflected vertically and scour the pool. If the log is placed in a meander or at proper pool to pool spacing the pool will persist even after the log has been dislodged and moved. This practice can be expected to cause some bank erosion and should not be placed where a loose log or debris could cause an issue for downstream infrastructure.

Figure 42: Crossover Log
