**PETITION FOR ALTERNATIVE
ABATEMENT STANDARDS
FORMER PRICE'S VALLEY GOLD NORTH DAIRY
BERNALILLO, SANDOVAL COUNTY, NEW MEXICO**

Prepared for:
D&GP
Bernalillo, Sandoval County, New Mexico

Prepared by:
EA Engineering, Science,
and Technology, Inc., PBC
320 Gold Avenue SW, Suite 1300
Albuquerque, New Mexico 87102

April 2016

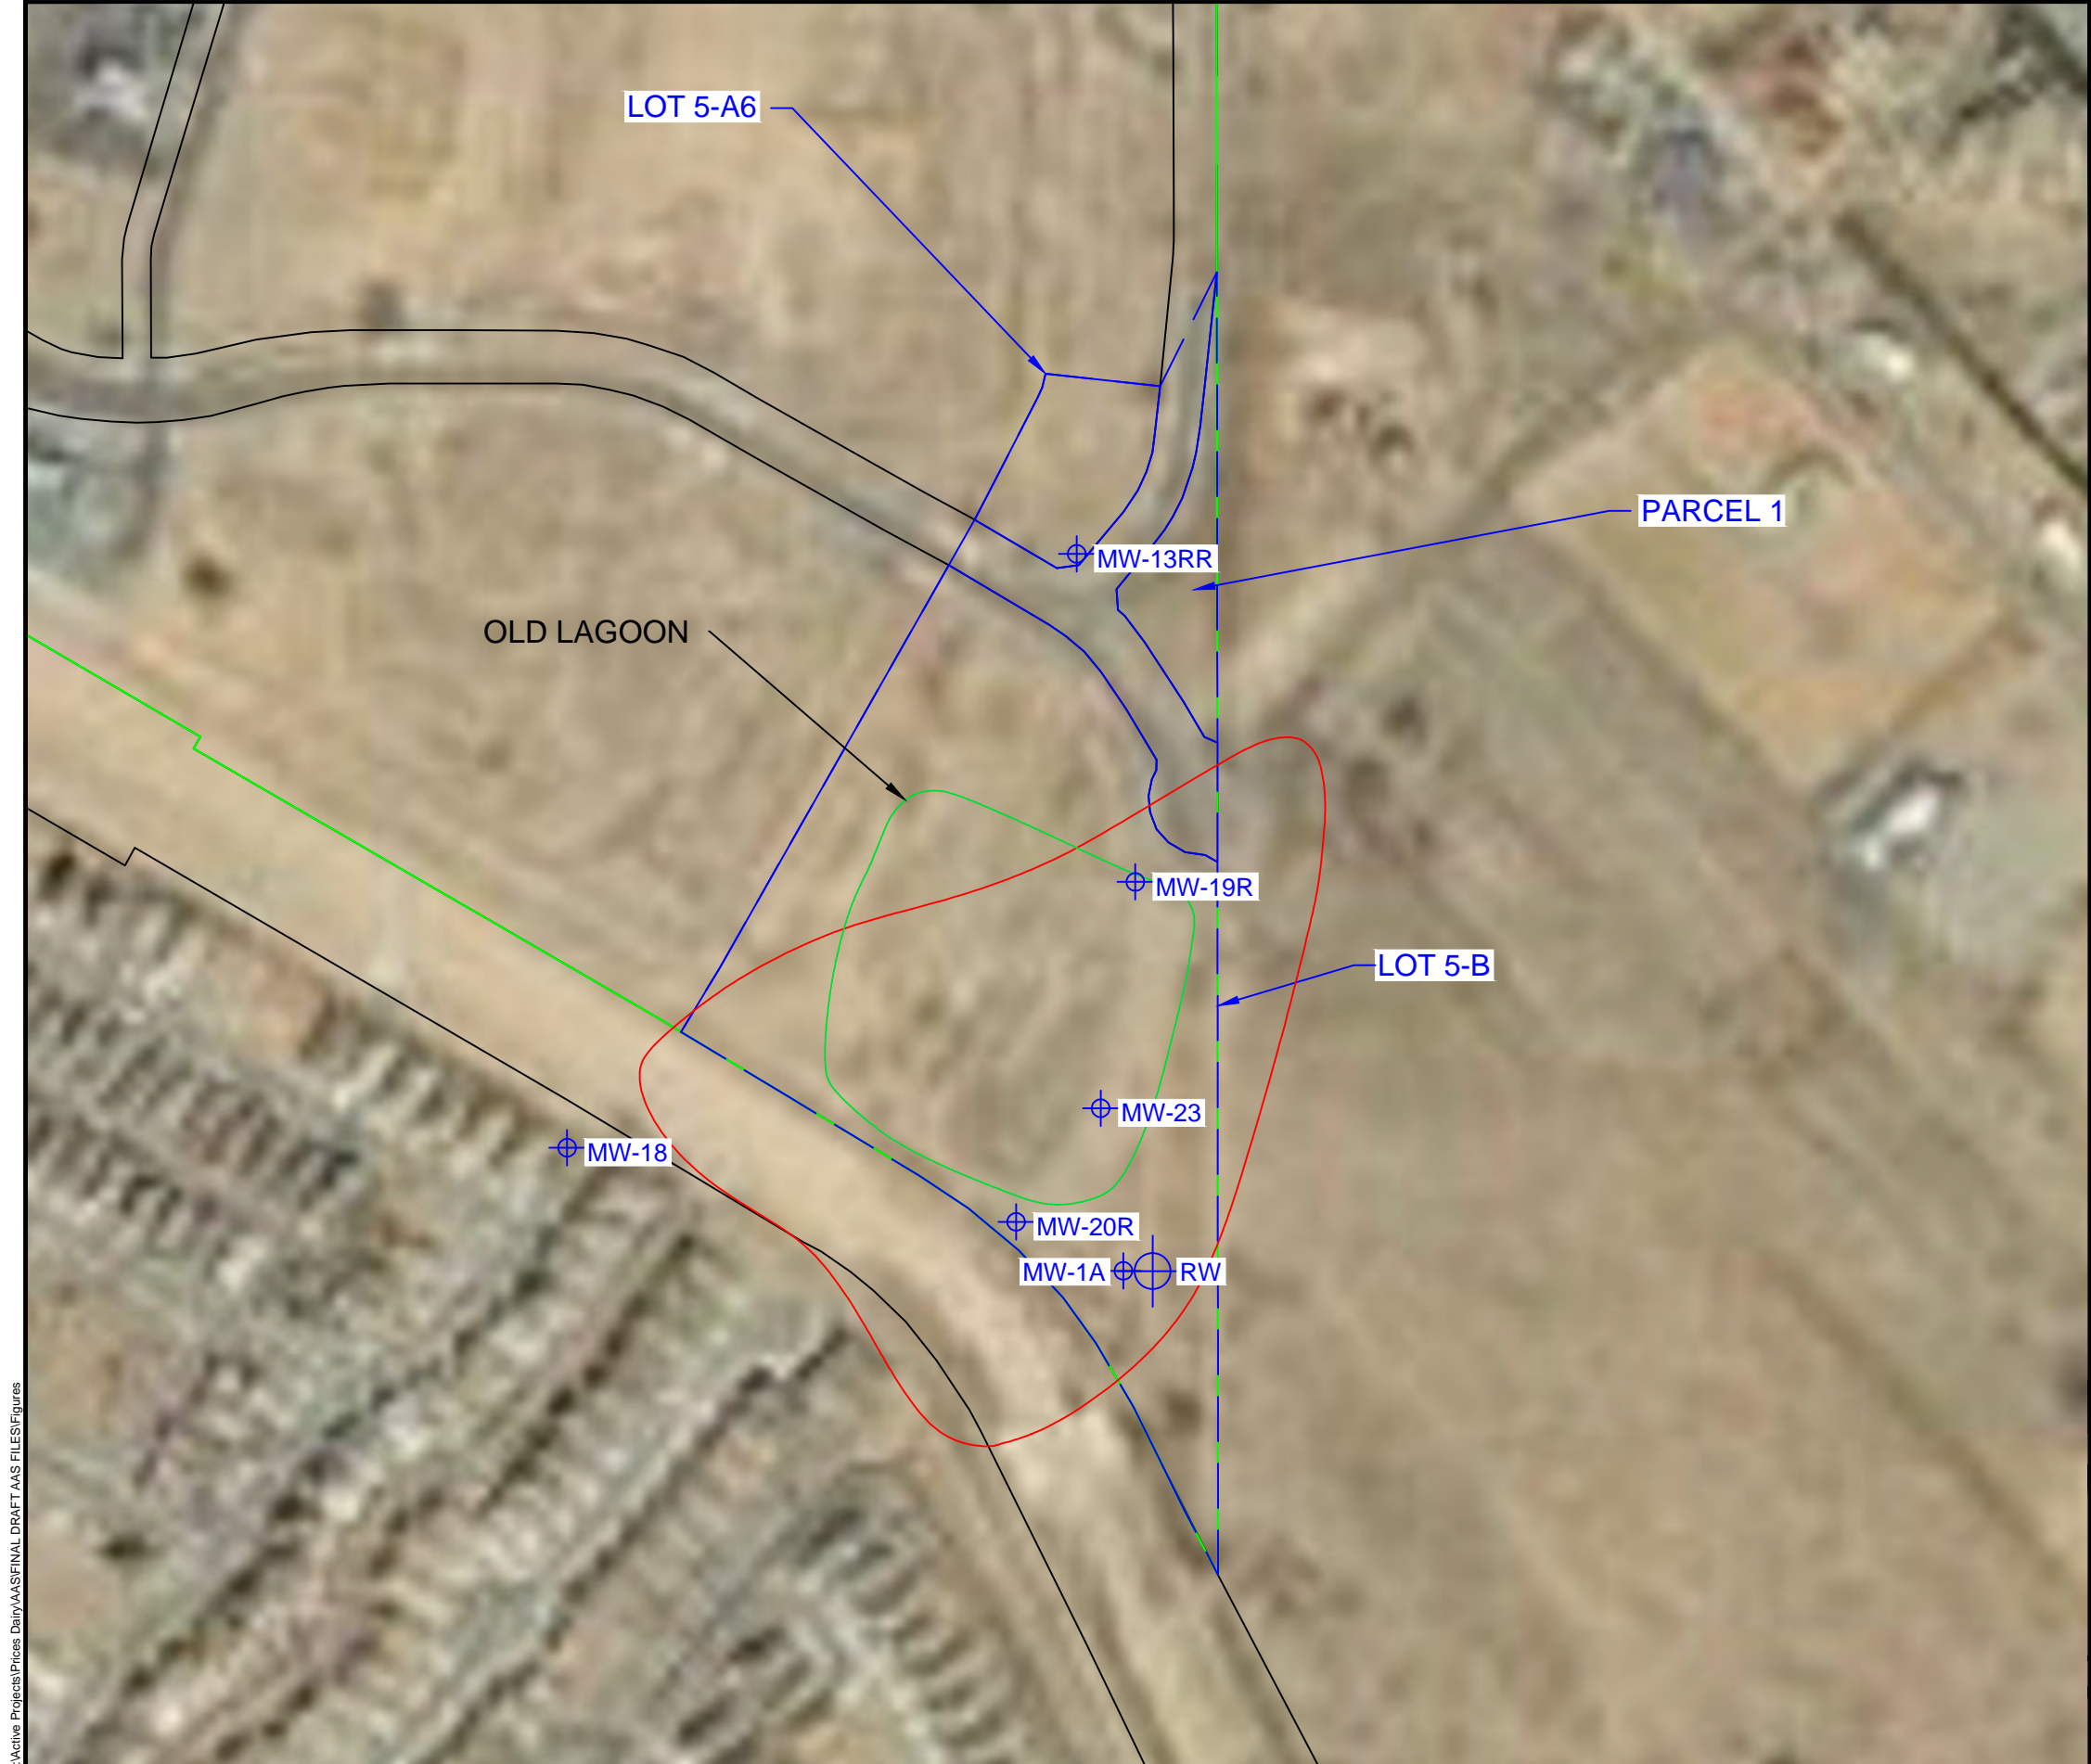
**FIGURE 2.
AREA SUBJECT TO VFA
ALTERNATIVE ABATEMENT
STANDARD**

- SITE BOUNDARY
- REPLATTING BOUNDARY
- VFA NO₃ PLUME
- OLD LAGOON
- ⊕ VALLEY FILL MONITORING WELLS

Replatted lots shown relative to original DP-437 Plat.

NO₃ plume and monitoring well locations shown from Amended Stage 2 Abatement Plan by Metric Corporation dated October, 2010.
