**WATER-QUALITY CHANGE DUE
TO THE CERRO GRANDE FIRE,
AND ITS POTENTIAL USE AS A
RECHARGE TRACER**

**Presented at 13th DOE Annual Technical Information Exchange
Workshop, November 13-15, 2001, Albuquerque, New Mexico**

PURPOSE/OBJECTIVE

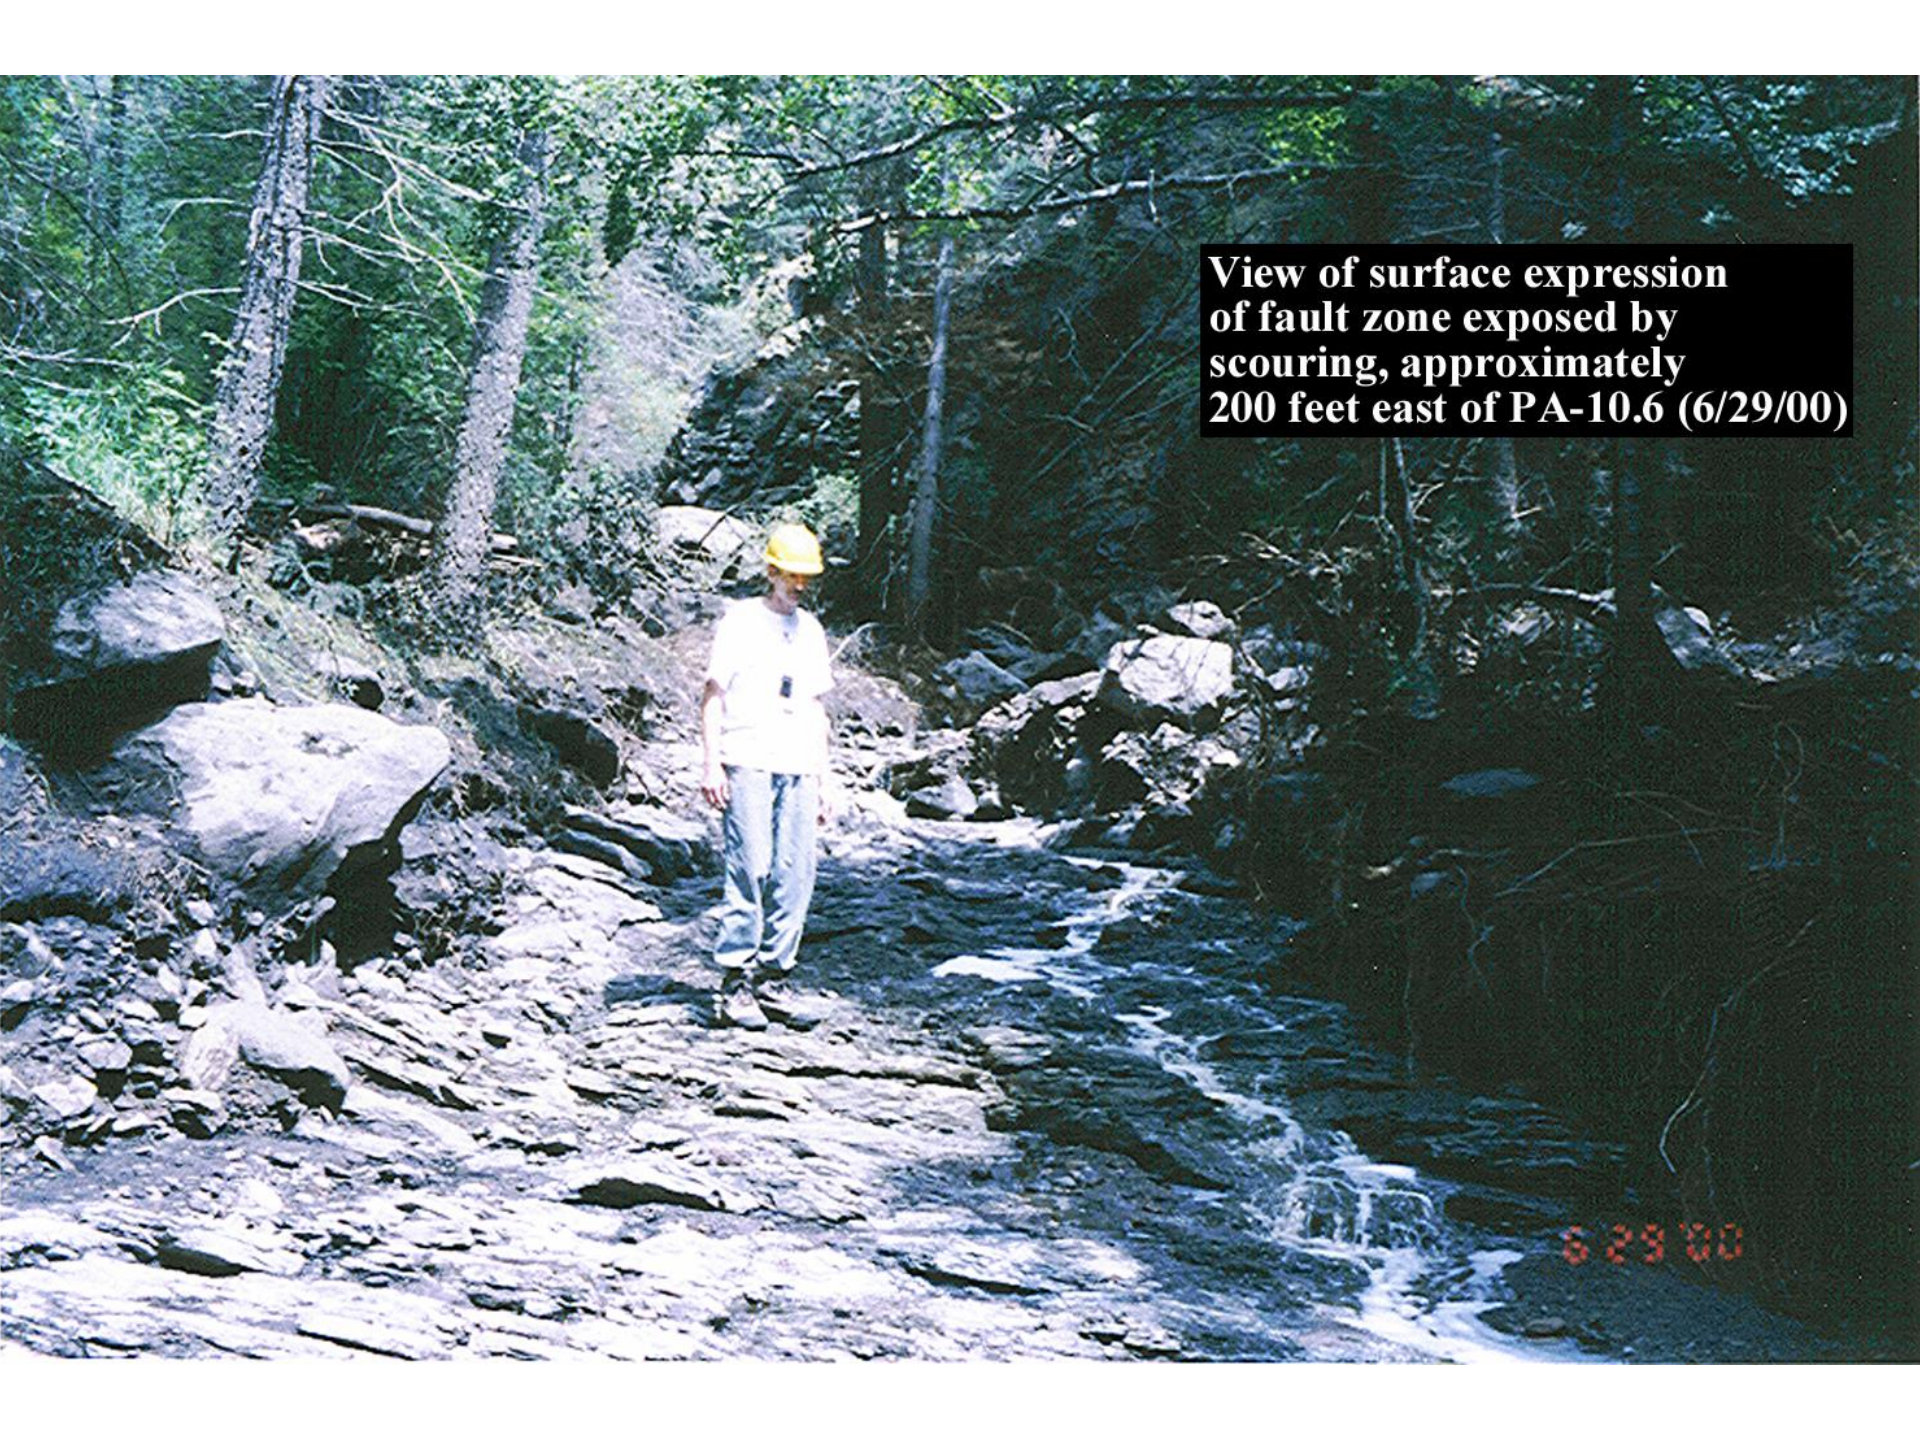
**View of surface expression
of fault zone exposed by
scouring, approximately
200 feet east of PA-10.6 (6/29/00)**

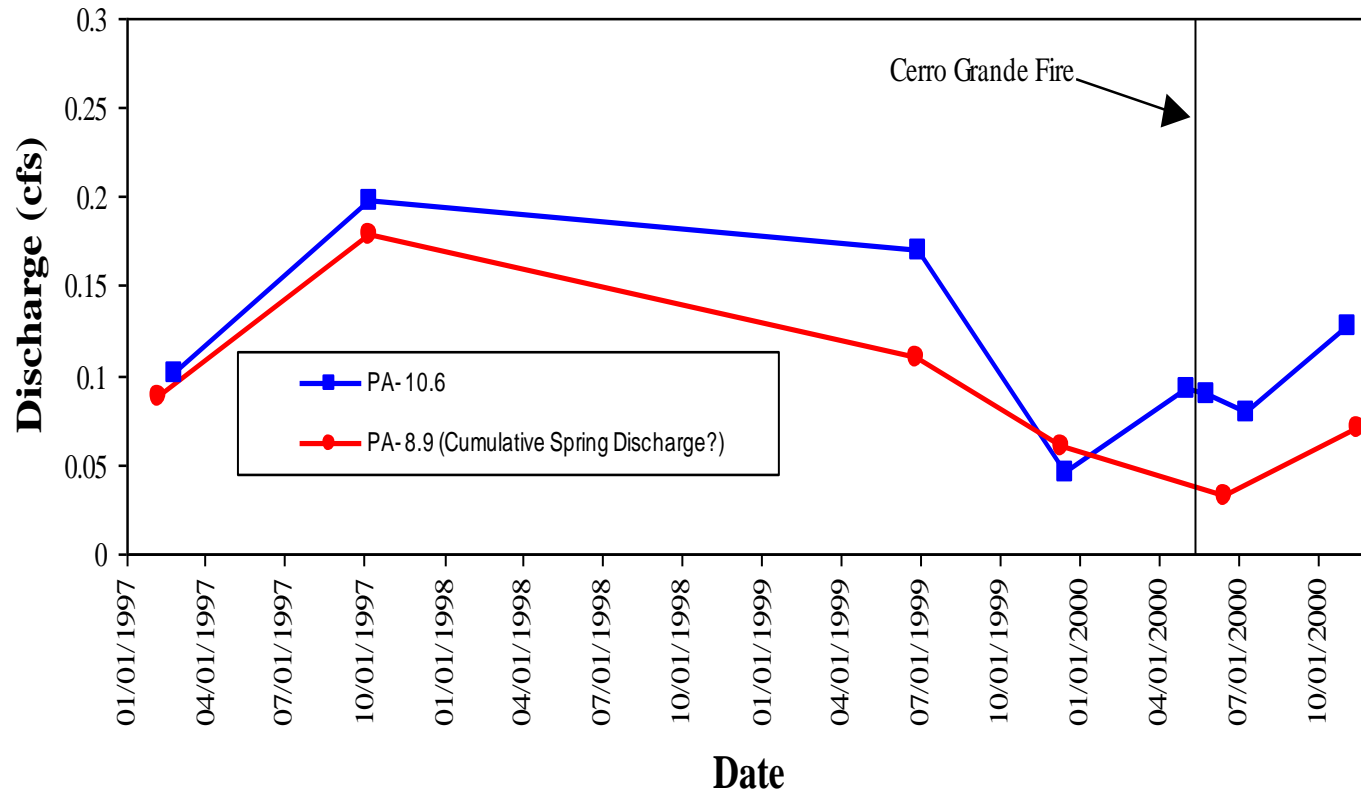
Comparison of Discharge Rates Through Time for Surface-Water Stations PA-10.6 and PA-8.9 (Cumulative Spring Discharge?)

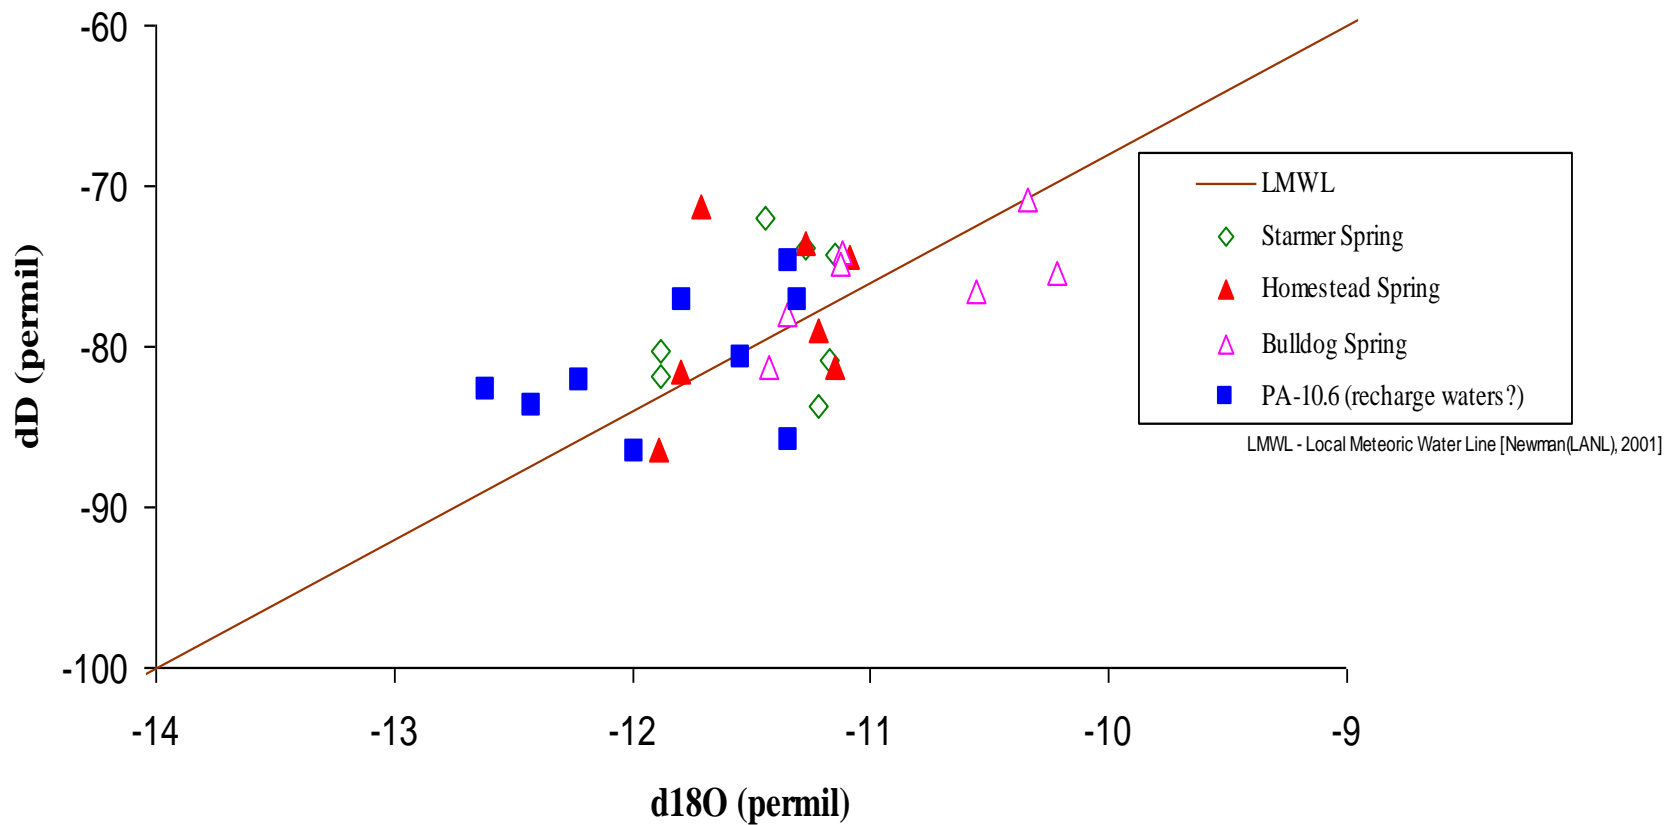
Plot of the Stable Isotopes Deuterium Versus Oxygen-18 for Springs and Surface-Water Station PA-10.6

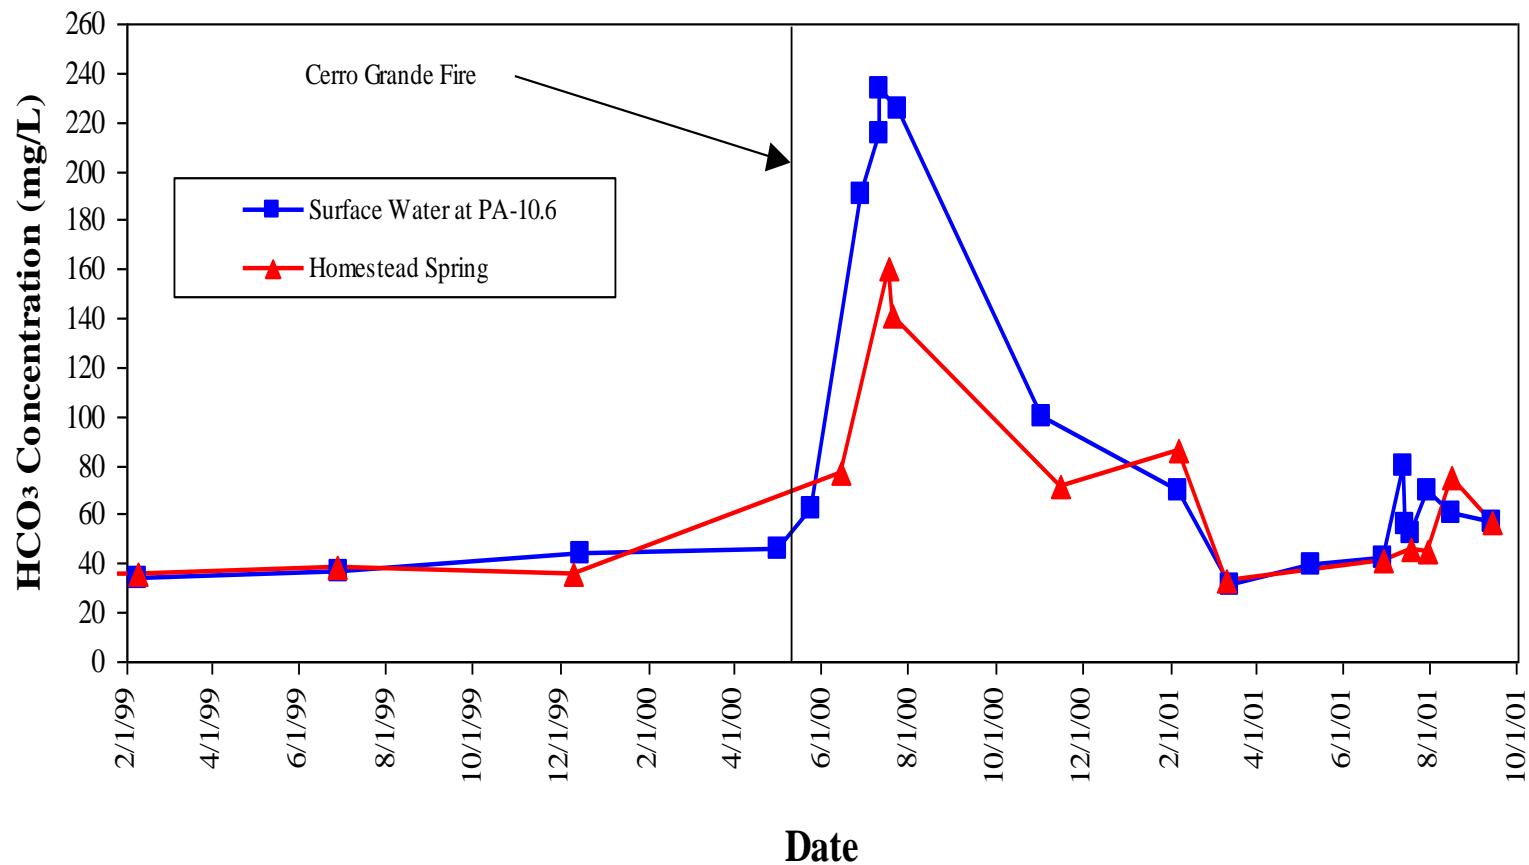
Bicarbonate Concentrations Through Time at Homestead Spring and Surface-Water Station PA-10.6

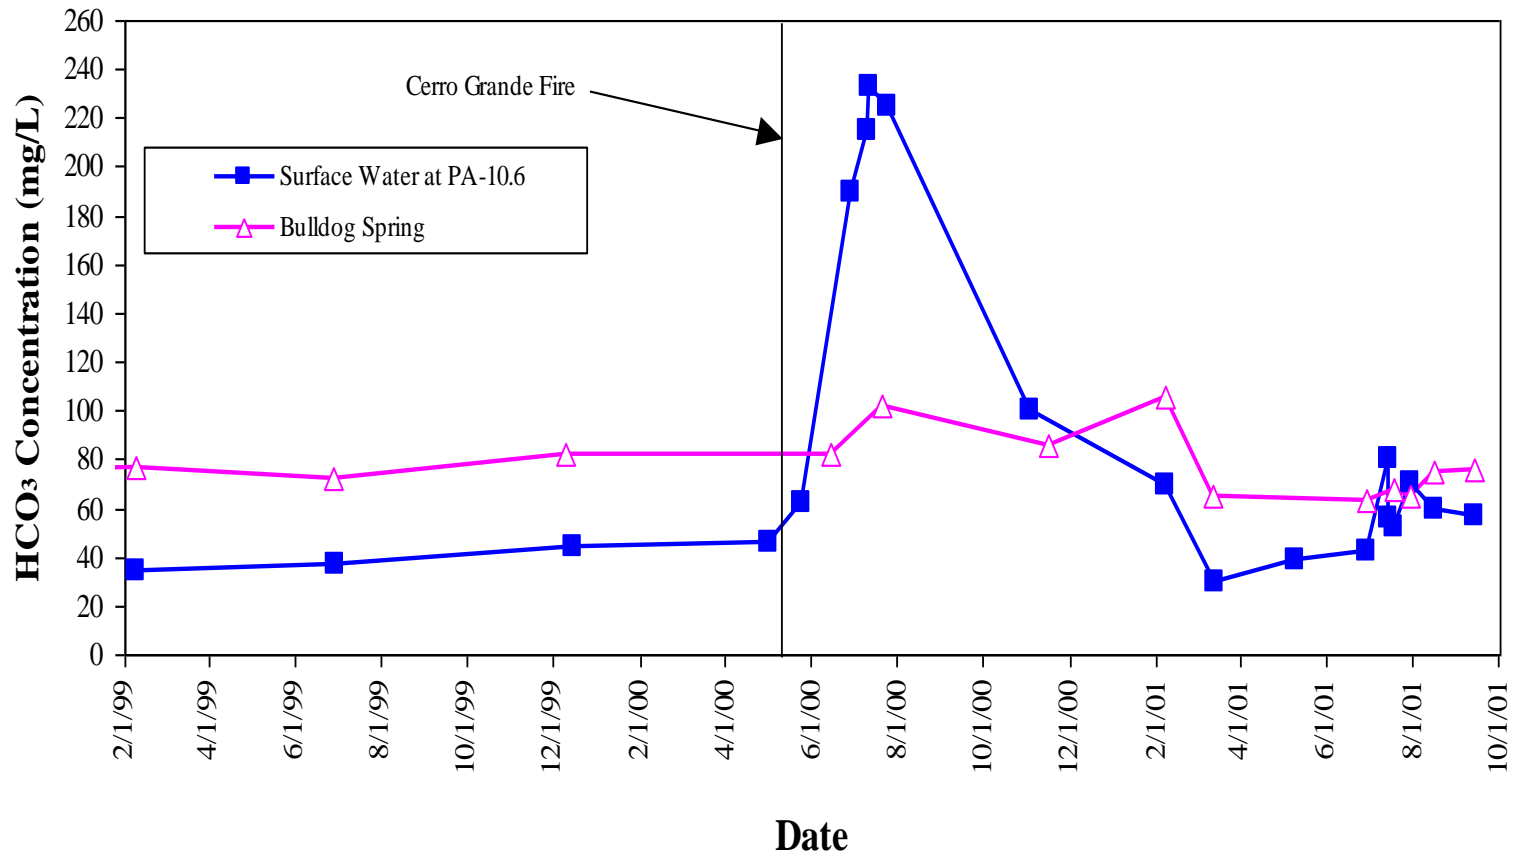
Bicarbonate Concentrations Through Time at Bulldog Spring and Surface-Water Station PA-10.6
