LEAD TESTING IN SCHOOLS AND CHILDCARE FACILITIES UNDERSTANDING THE PROCESS AND RESULTS

The only way to know if there is lead in your drinking water is to TEST. Lead is colorless, odorless- and harmful to human health. NMED's Lead Testing in Schools and Childcare Facilities program is a voluntary program for schools and childcare facilities to receive assistance in reducing lead in their drinking water to maintain a healthy learning environment for New Mexico's students.

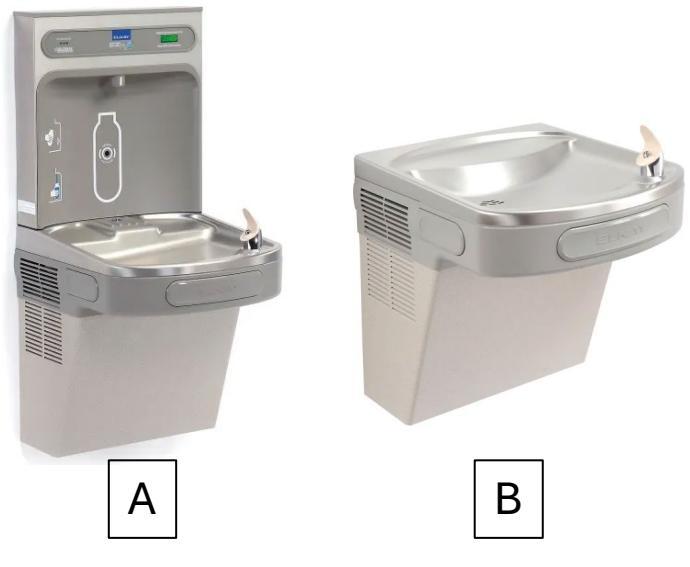
NMED has created codes for types of drinking water outlets often encountered in schools.

Examples: Outlet A would be recorded as WC (Water Cooler) Outlet B would be recorded as WF (Water Fountain)

Outlet Type Codes

BF – Bathroom Faucet CF – Classroom Faucet IM – Ice Machine KF – Kitchen Faucet NS – Nurse's Office Sink OF – Outdoor Faucet WC – Water Cooler WF –Water Fountain
