## State of New Mexico NONPOINT SOURCE MANAGEMENT PROGRAM

## 2014 Annual Report

New Mexico Environment Department Surface Water Quality Bureau Watershed Protection Section

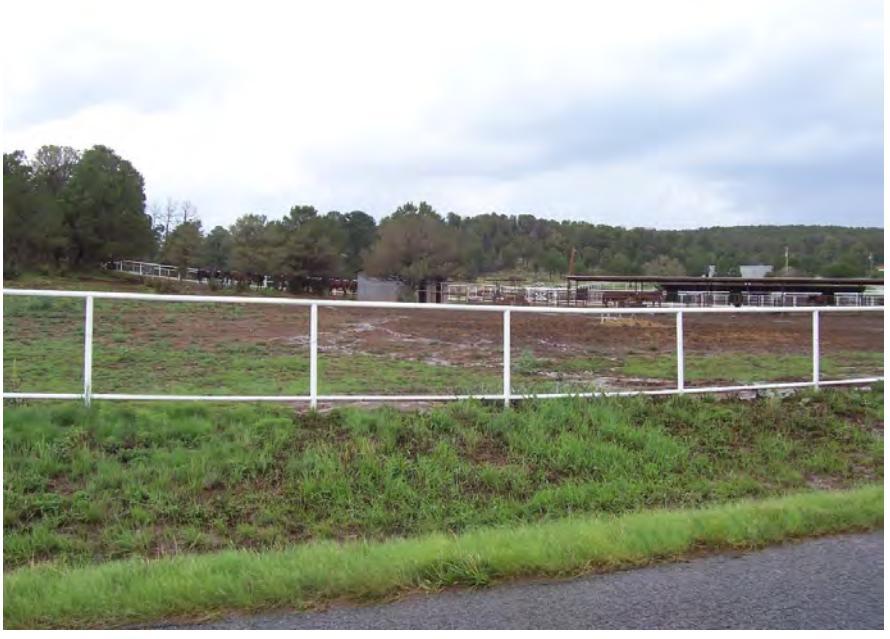
Stormwater runoff carrying NPS pollutants from a horse corral entering a bar ditch that drains to Little Creek in the Sacramento Mountains.

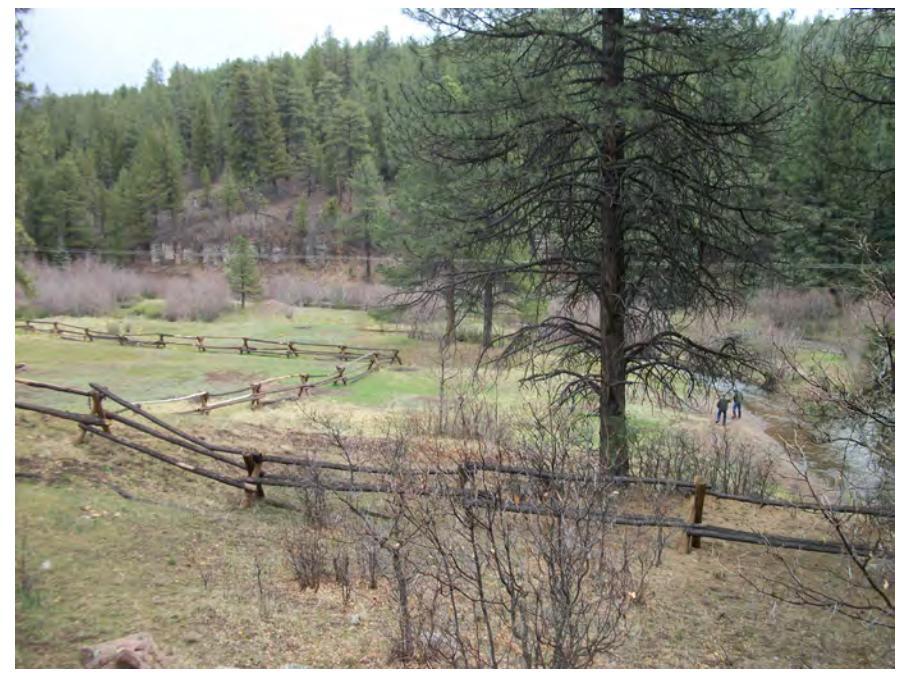
Buck and rail fencing provides an aesthetic alternative to direct cattle away from sensitive riparian areas along the Rio de Las Vacas.

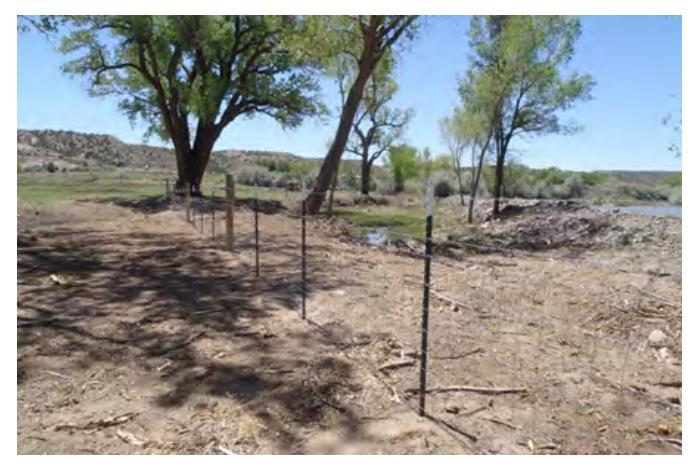
Riparian fence on the Blancett farm along the Animas River on 5/22/13 right after Russian olive removal and fence installation.

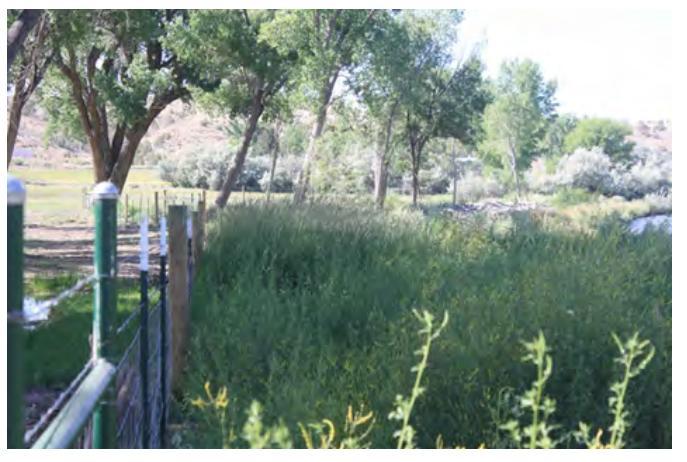
Same fence on the Blancett farm one year later on 6/25/2014 showing an increase in vegetation after livestock were excluded.

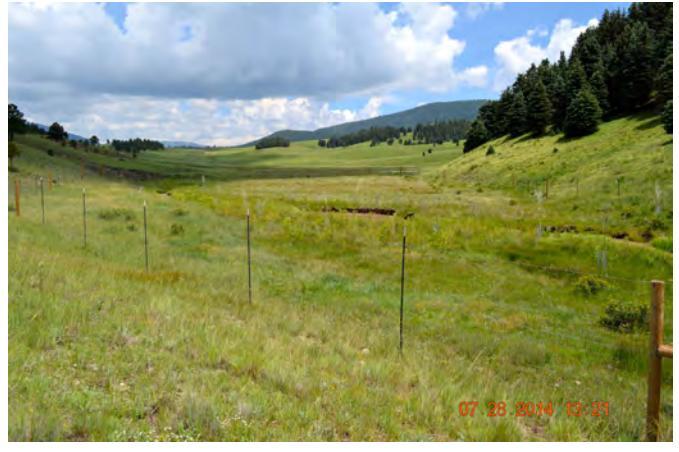
San Antonio Creek exclosure after planting small cottonwood poles, July 2014.

Several sections of Redondo Creek and San Antonio Creek and their floodplains were fenced to exclude domestic livestock and elk. Woody vegetation was planted to provide shade and stream bank stability for the riparian systems. The Redondo Creek meadow was restored to a wetter condition (with expected increases in base flow and reduction in sediment loading) by realigning a section of Redondo Creek to its

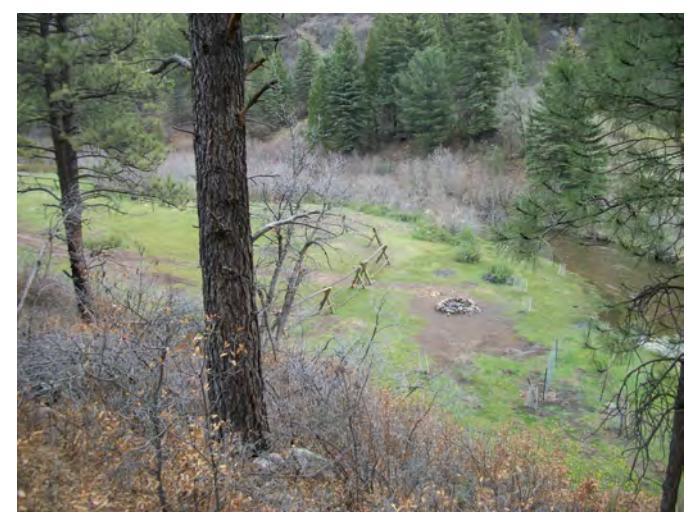
Buck and rail fencing in combination with wire fencing protecting sensitive riparian plantings reduce impact to the riparian area from cattle and elk.

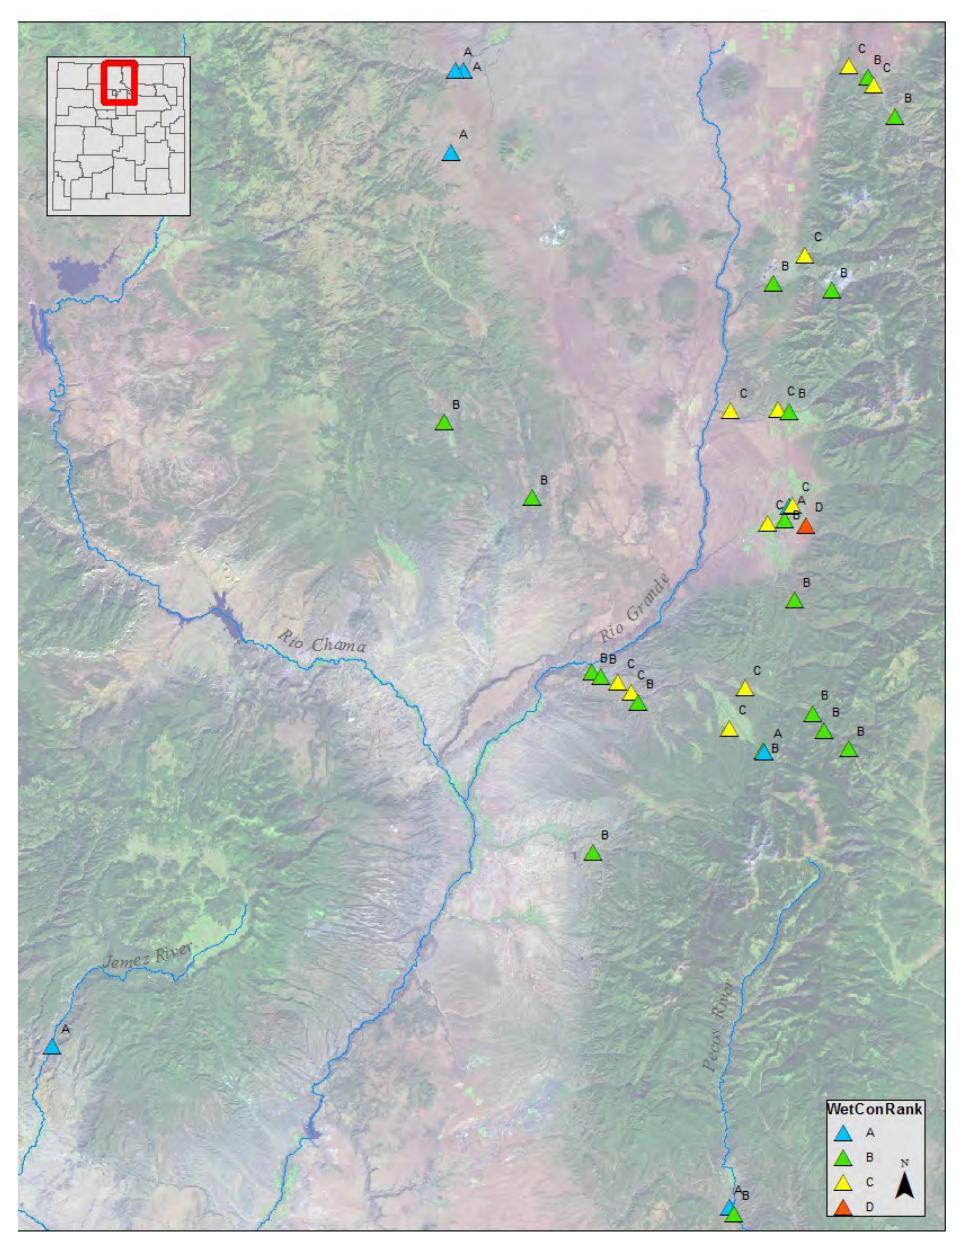
Map of NMRAM assessment areas (AAs) in the Upper Rio Grande Reference Domain including six additional outlier sites where the NMRAM was tested to determine the geographical limits of the method. Initial rankings after NMRAM data collection are also given.

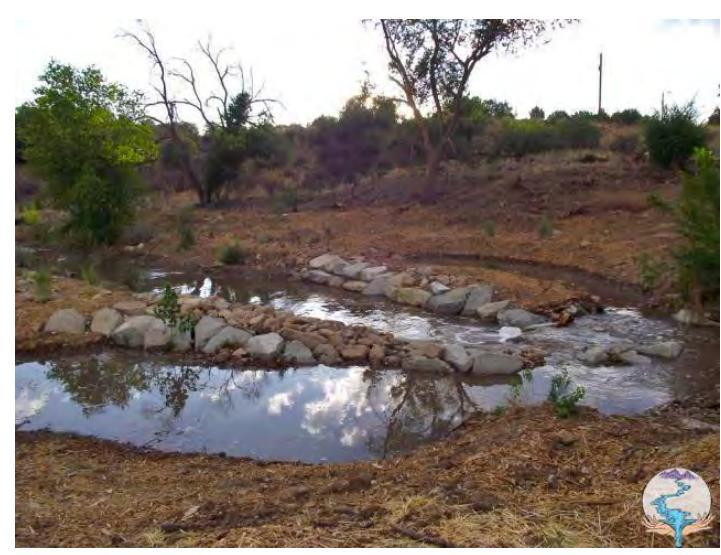
A new cross-vane shown during a moderate flood event. The cross-vane prevents erosion down to a sewer line that had been damaged by prior flooding.

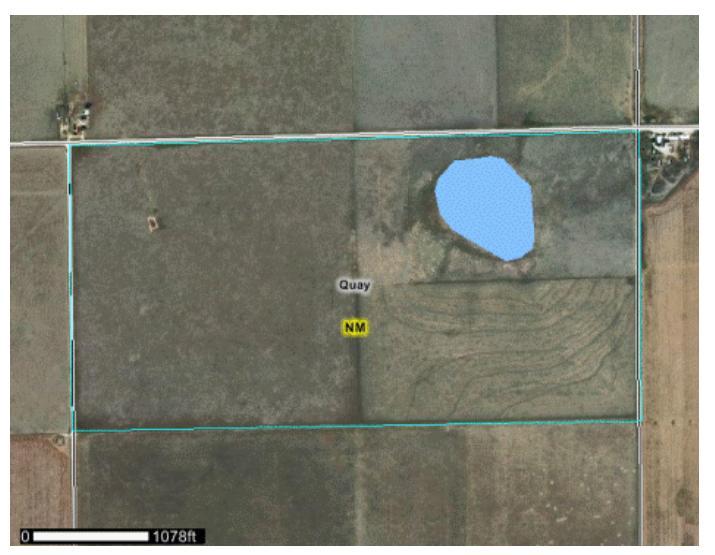
Mackechnie Playa – Quay County. A small pit on the south end was restored with local soils previously side cast. The Conservation Plan includes grazing deferral for the playa and buffer, fencing, and alternative water source improvements.

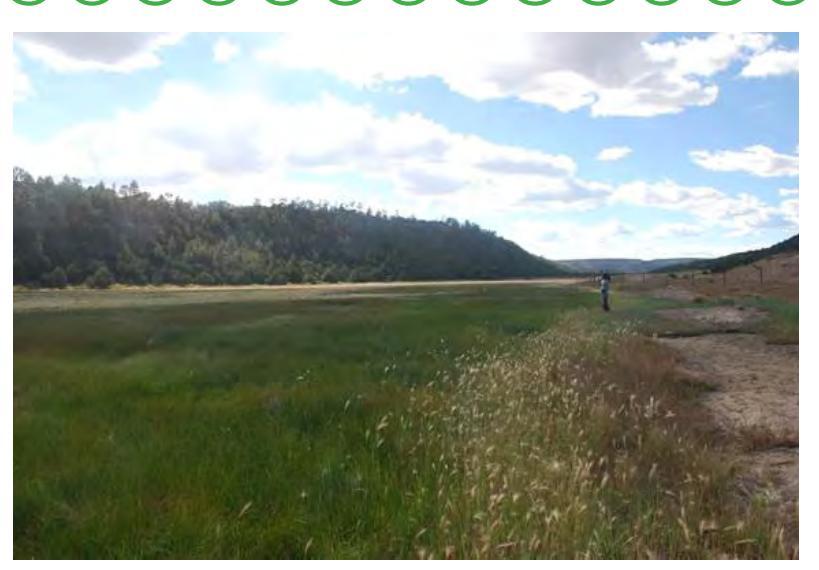
September 2014 view of the Cebolla Canyon Wetlands after implementation of project restoration structures, grazing cattle removed from the area, and the 2014 monsoon season.

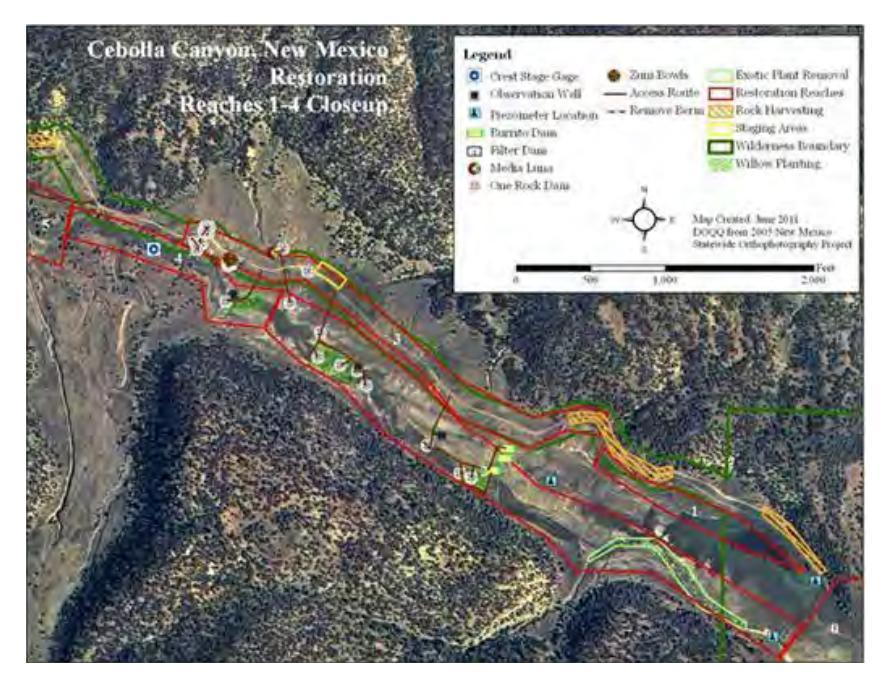
Restoration design for reaches 1-4 of the "Restoring and Protecting Wetlands in Cebolla Canyon Closed Basin" project.

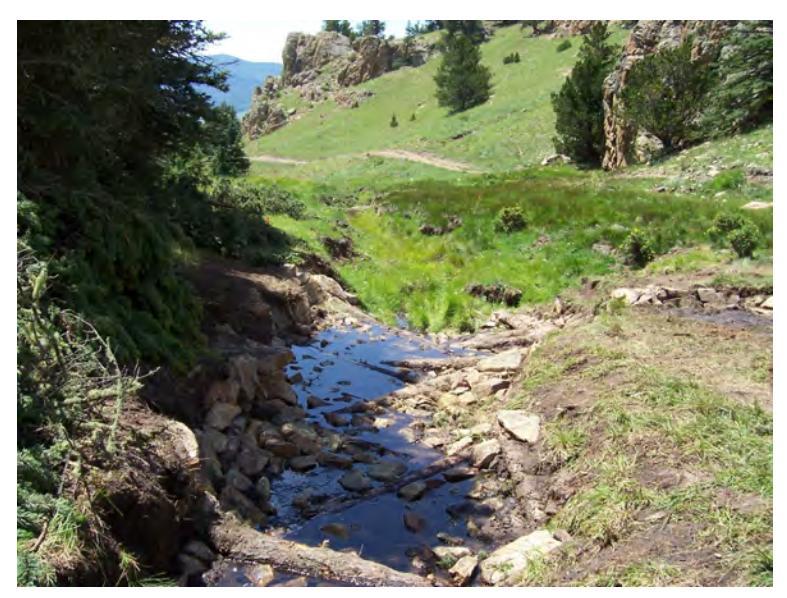
Head cut in lower Grassy Creek, Valle Vidal after treatment with a machine built log and rock rundown structure. This structure will hold the grade and help prevent the de-watering of upstream slope wetlands.

The Quivira Coalition utilized sub-contractors with heavy equipment to build large structures, and recruited 42 volunteers to handbuild dozens of smaller structures from locally available materials such as logs, brush, rocks, sod and soil. In total, 1,362 hours of volunteer work were donated to the project. A variety of structure types were built including: log flow splitters, lateral worm ditches, sod flow splitters, jackstraw fences, sod plugs, log mats, zuni bowls, one-rock dams, log step falls, and log and rock rundowns. The result of the work was to restore 33 acres of wetlands, stabilize 2.8 miles of stream channel by halting head-cuts, stabilize eroding banks, and develop new wetlands.

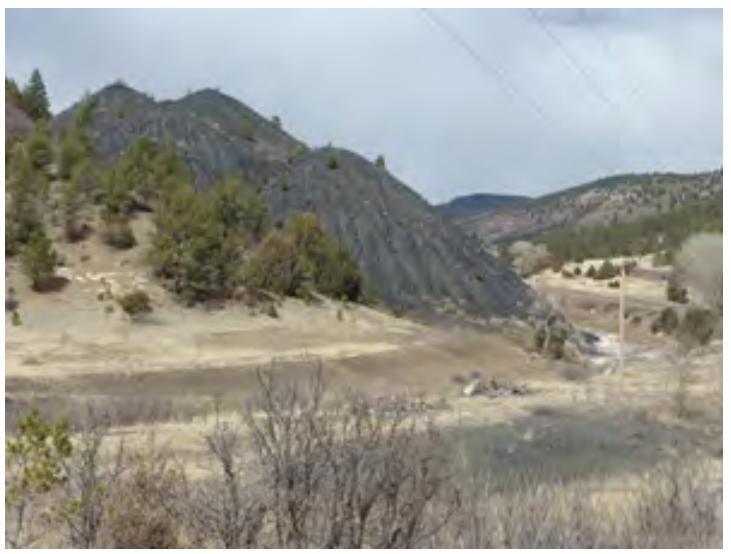
Steep-sided coal mine gob piles at Swastika Mine.

The NM Abandoned Mine Land Program with EMNRD completed the project to restore degraded environment at the Swastika Mine and Dutchman Canyon sites. Specifically, the project addressed the issues of stream turbidity, sedimentation, channel degradation, low pH mine runoff, and riparian vegetation. At Swastika Mine, the stream channel had been re-located and straightened, and steep gob piles were eroding, depositing sediment with low pH and high sodium into the stream. At Dutchman Canyon, historic mine adits were seeping low pH water and the infrastructure that had been created to capture this water was creating erosion problems. The \$125,000 in state funding was used directly on construction, wetlands restoration, and riparian planting, and helped leverage \$4.1 million in federal funding that was used to re-shape the gob piles

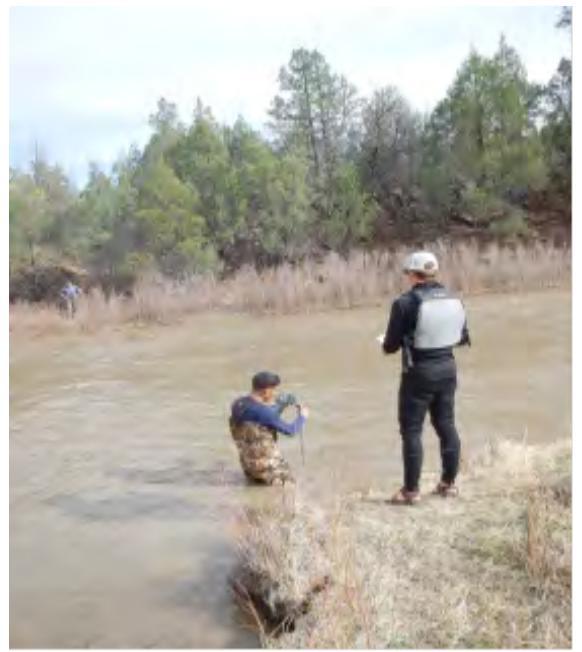
*Rio Chama Flow Optimization Project team members measured velocity and sediment loading at a flow rate of 2,000 cfs in the Chama River, April 2014.*

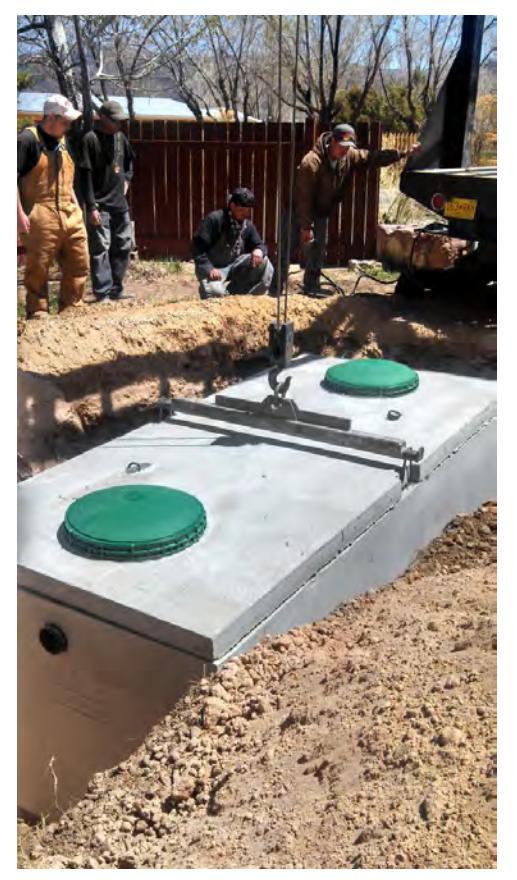
Installation of a new septic tank permitted by the GWQB at Pagosa Hills Mobile Home Park.

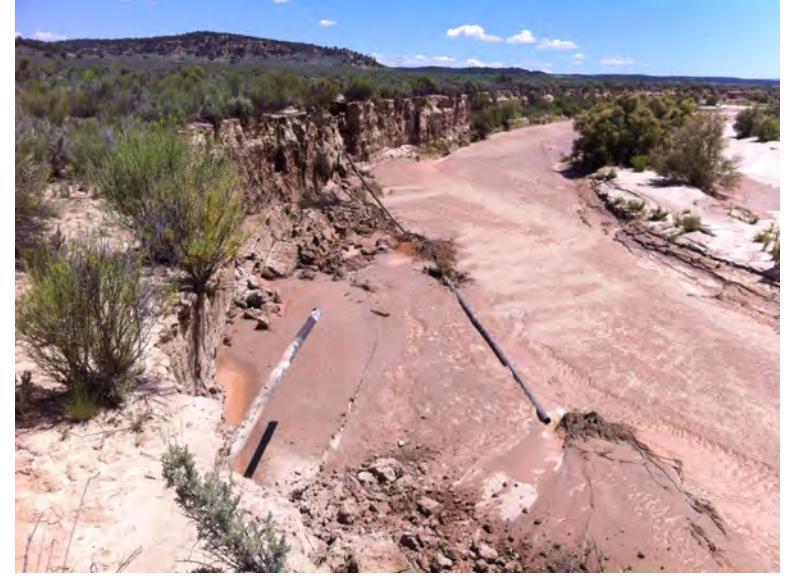
A broken natural gas pipeline in Largo Wash following a thunderstorm in August, 2014. Subsequent repair and bank stabilization was authorized under the Section 404 Regional General Permit for Activities in Emergency Situations.

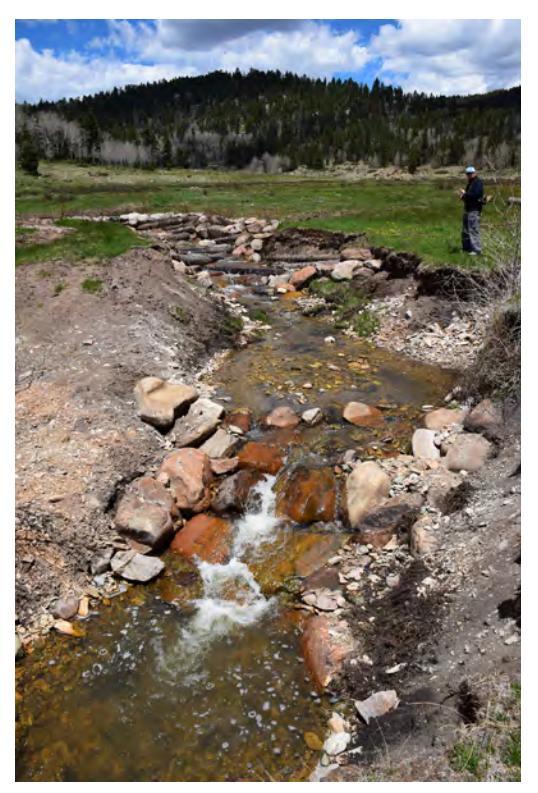
A series of grade control structures were installed to reduce erosion and halt headcut migration into the meadow on Placer Creek.

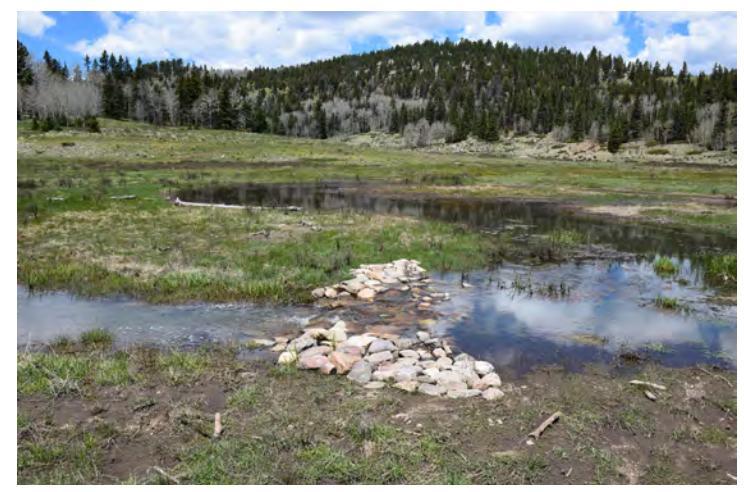
A flow splitter was installed that inundates the meadow during higher flows reducing erosion, storing water and improving habitat.

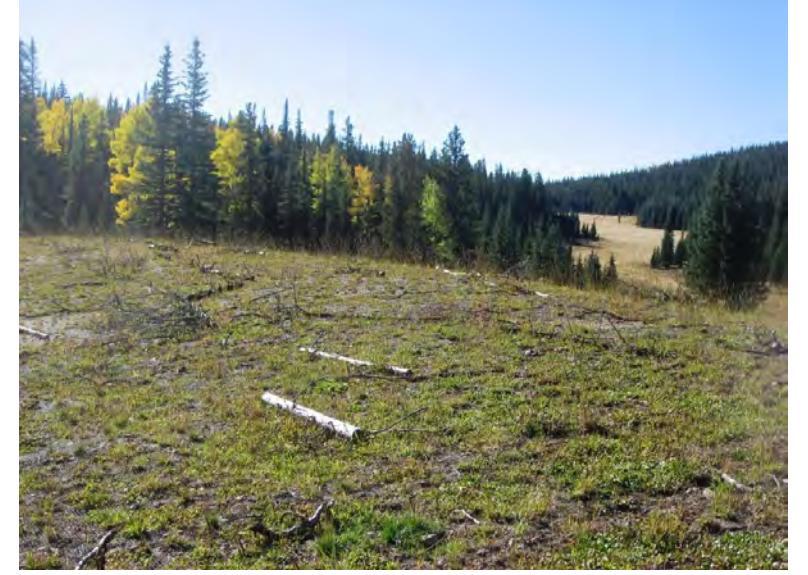
Midnight Mine Consolidation Cell (foreground) showing good vegetation in October 2014.

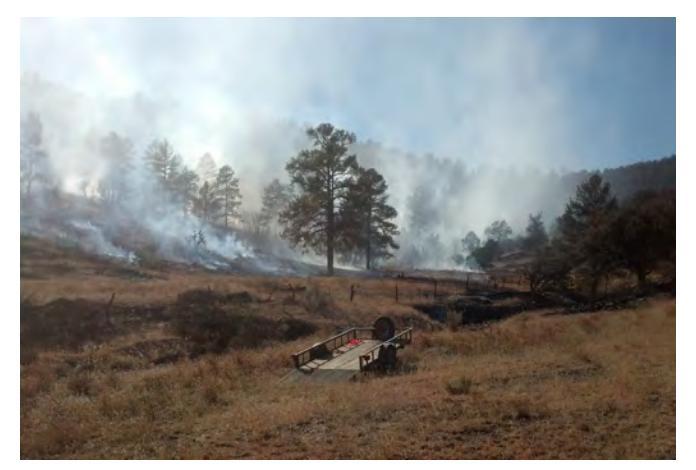
*NM Forestry Division uses prescribed fire after thinning operations to increase groundcover and reduce erosion and the risk of wildfire near Luera Mountains, NM.*
