# Kirtland Air Force Base Fuel Spill Cleanup

October 23, 2014

# Kirtland Air Force Base Bulk Fuel Facility Site

## Site Conditions, Drinking Water Protection, & Soil and Groundwater Cleanup

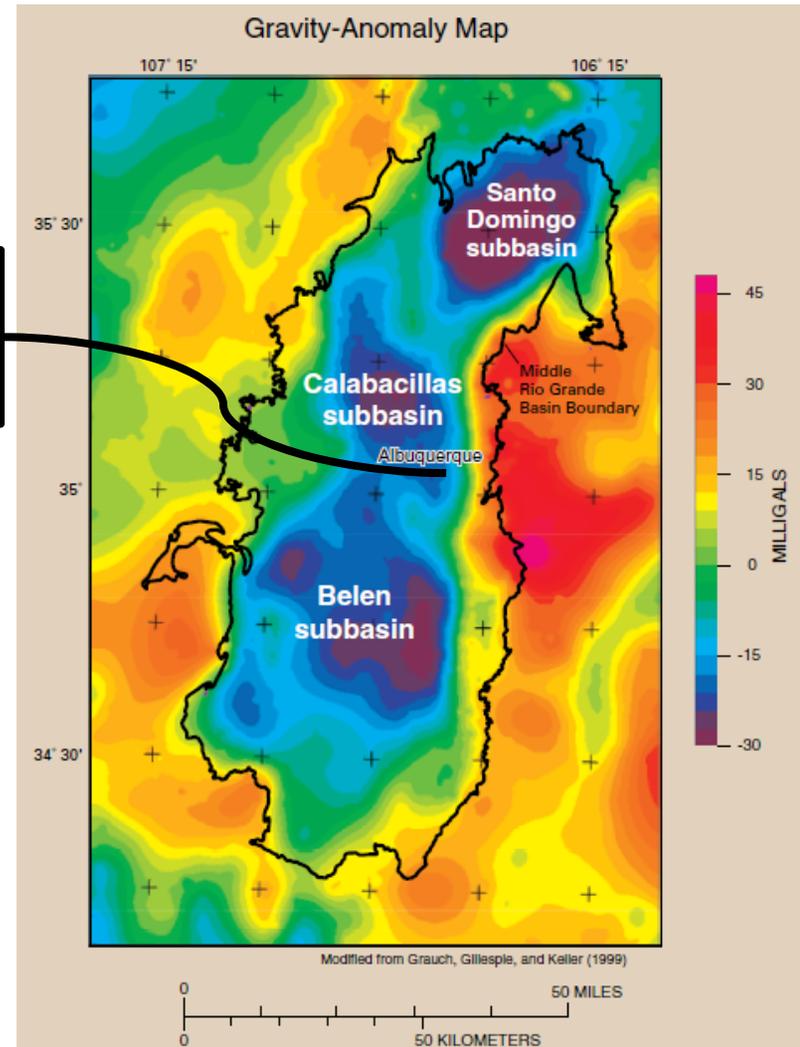
**Figure D.1.**—Gravity data for the entire Middle Rio Grande Basin and surrounding area. The Santa Fe Group has much lower density than the surrounding bedrock, producing low values (shown in blue and purple) on the gravity-anomaly map .

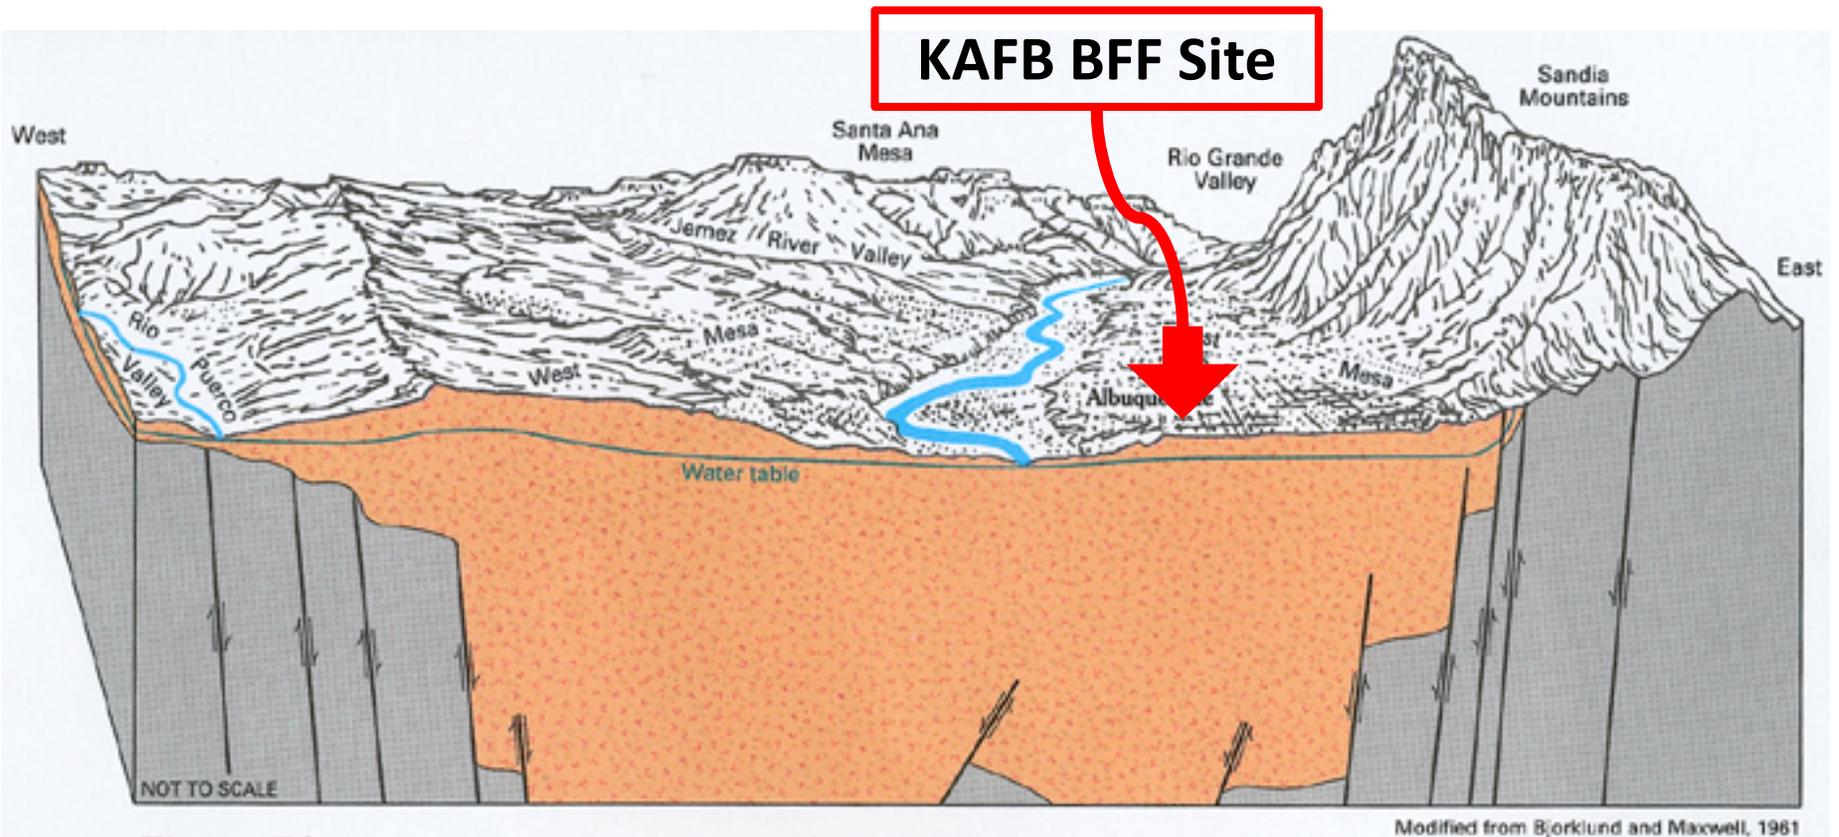
**Figure 56.** This diagram of the area near Albuquerque, N. Mex., shows the configuration of the land surface and its relation to the generalized subsurface geology.

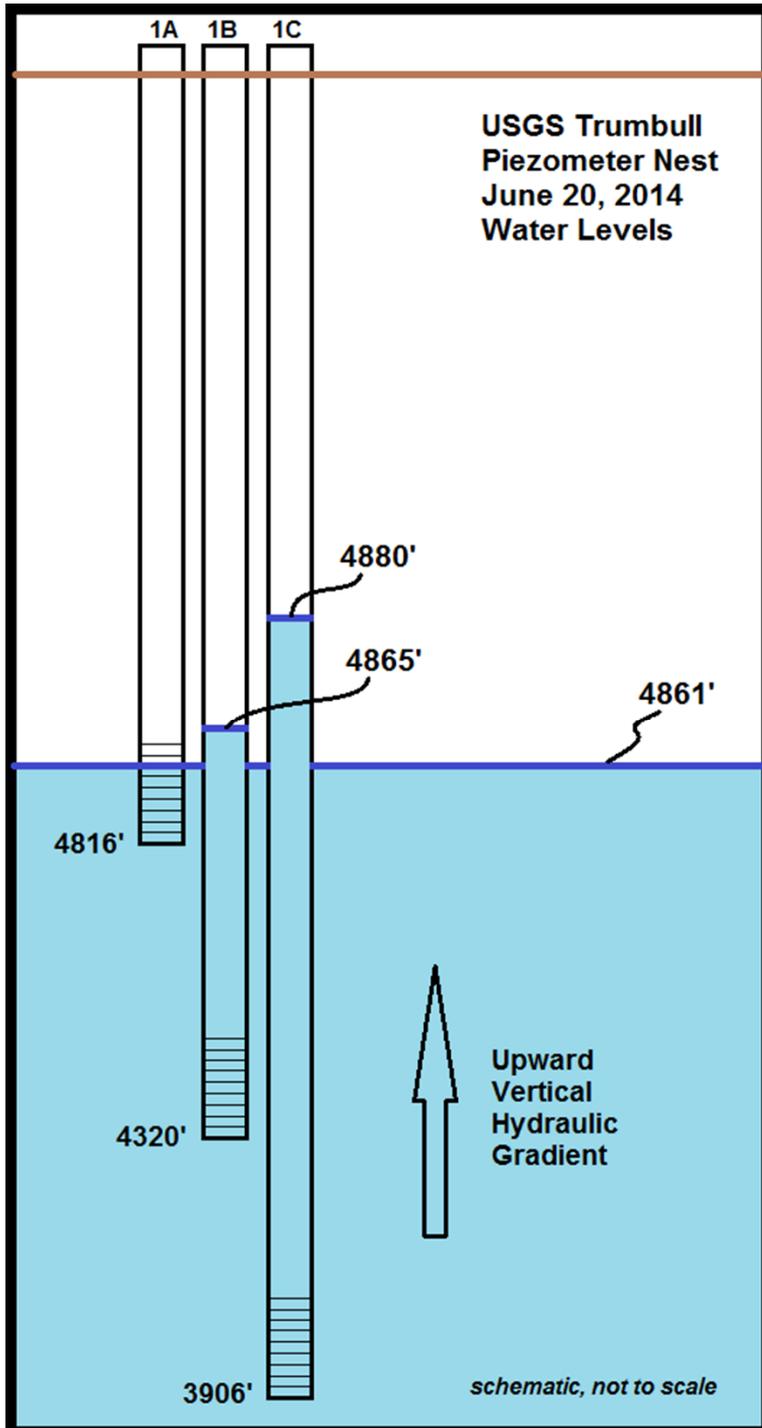
In the area of the fuel spill, groundwater is under artesian pressure at depth

Vertical migration of groundwater and any contaminants will tend to be upward, rather than downward

This upward hydraulic gradient works in favor of protecting deep water supply wells from fuel contamination in the shallow zone

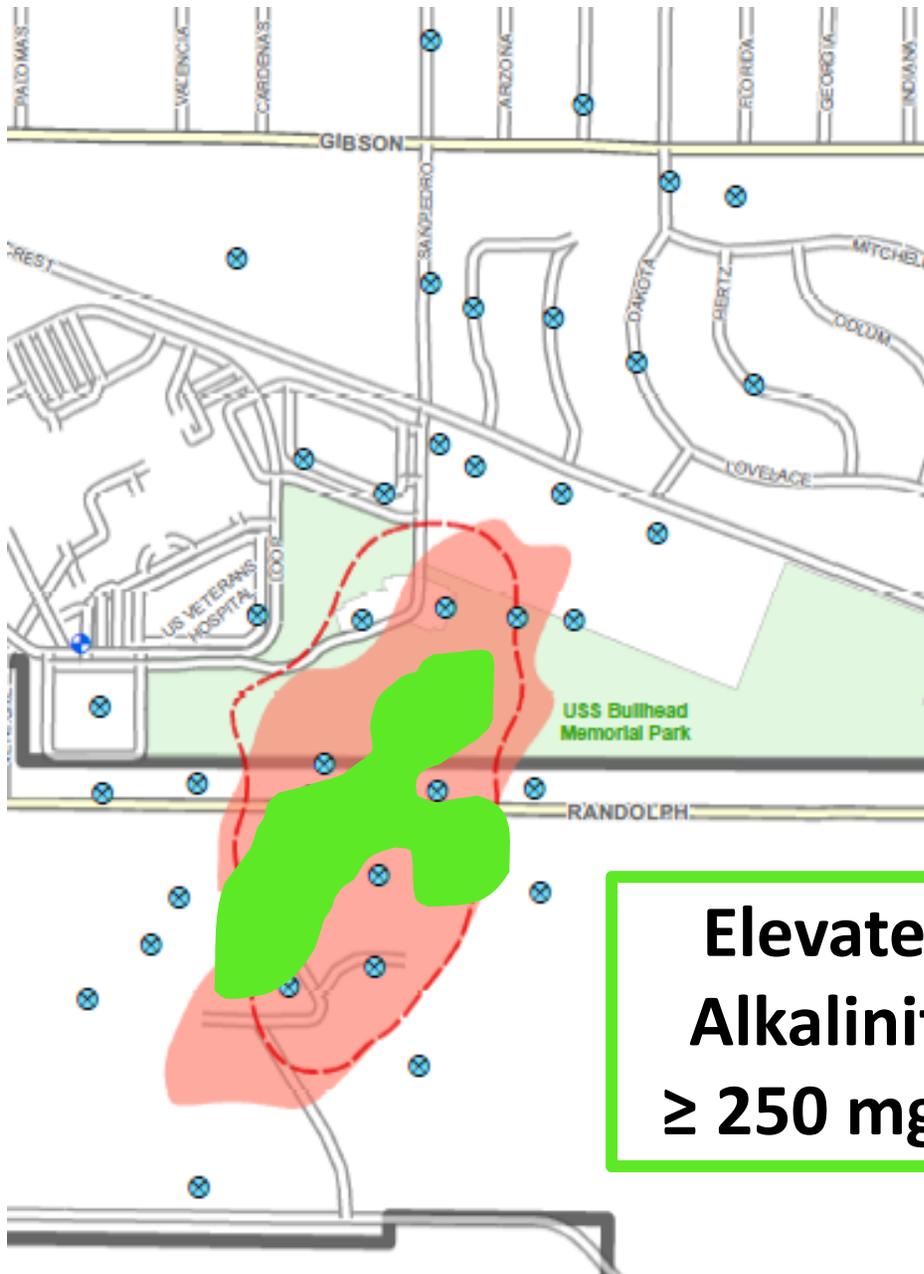
Fuel hydrocarbons  
have undergone  
extensive  
biodegradation  
increasing alkalinity  
in groundwater

**Elevated  
Alkalinity  
≥ 250 mg/L**

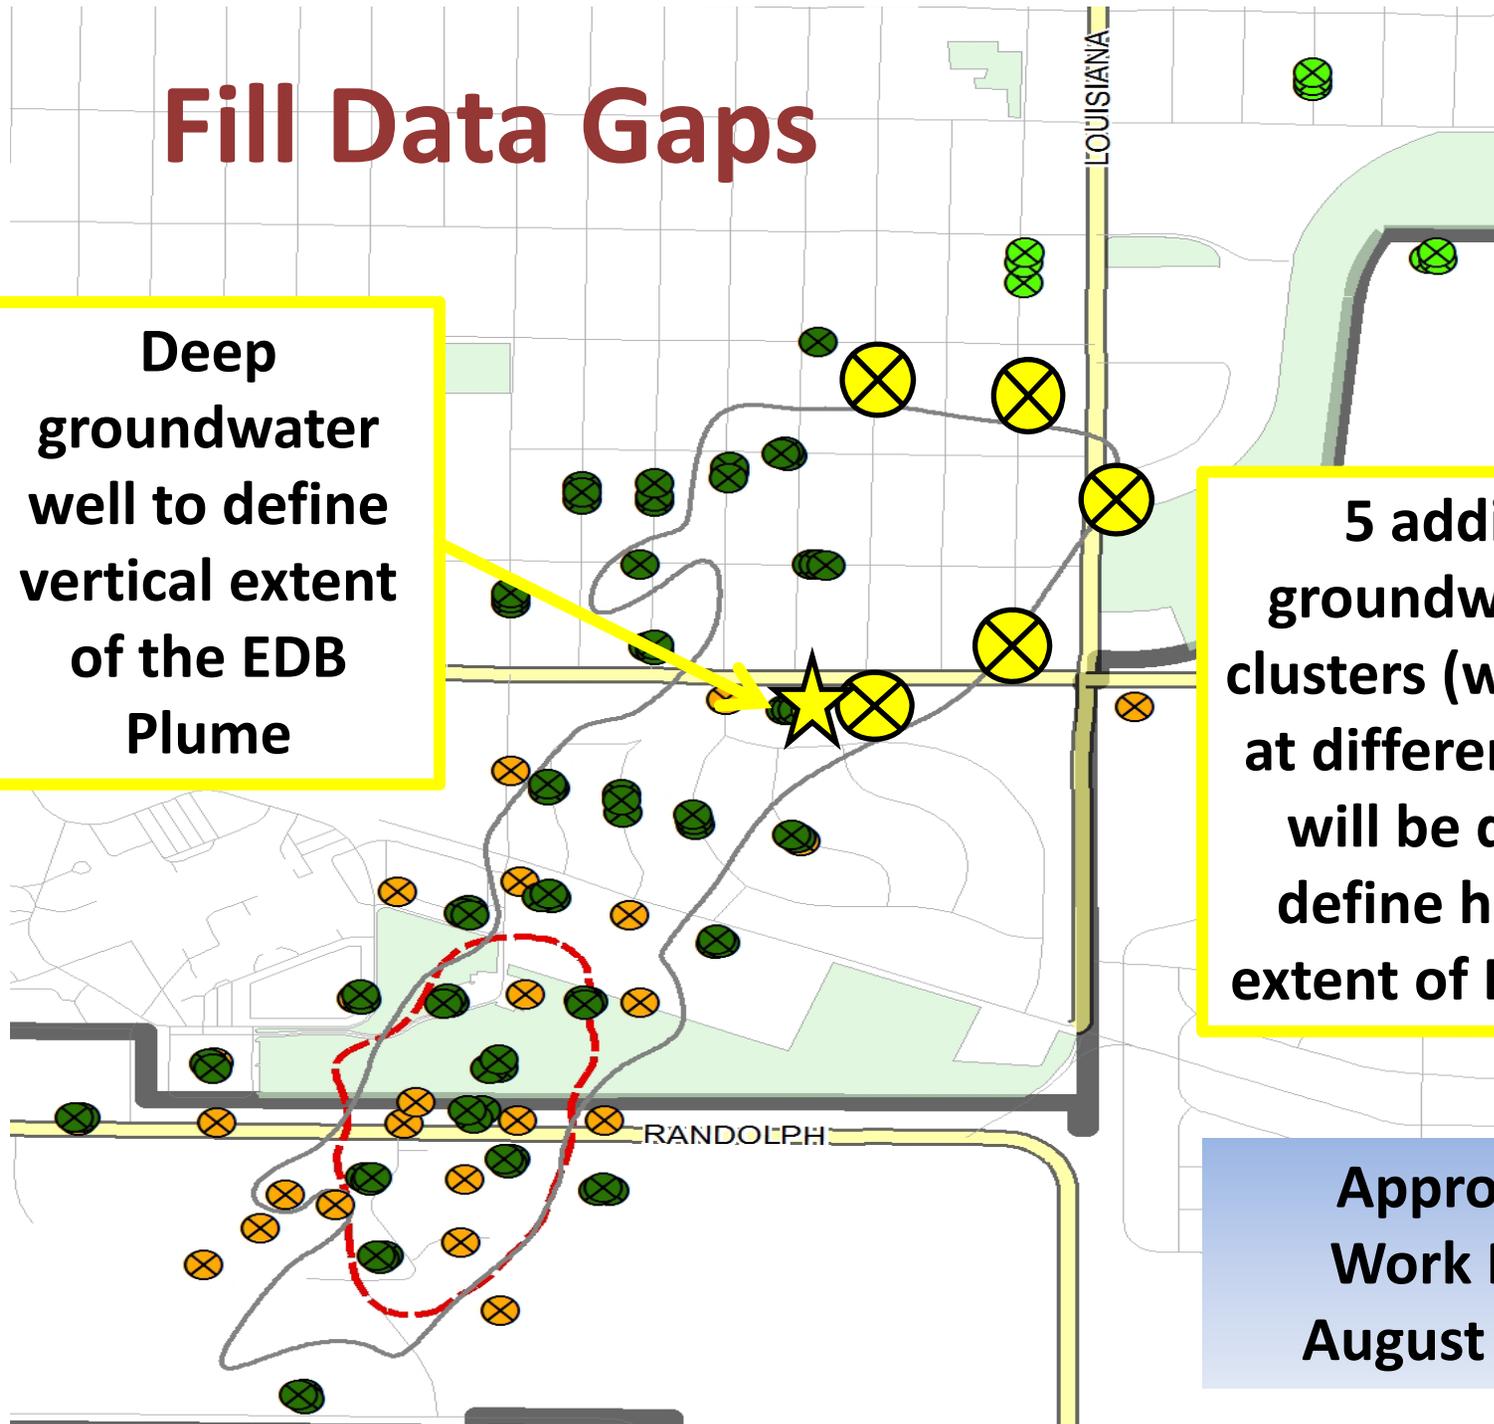
Deep groundwater well to define vertical extent of the EDB Plume

5 additional groundwater well clusters (with 3 wells at different depths) will be drilled to define horizontal extent of EDB plume

Approved Work Plan August 2014

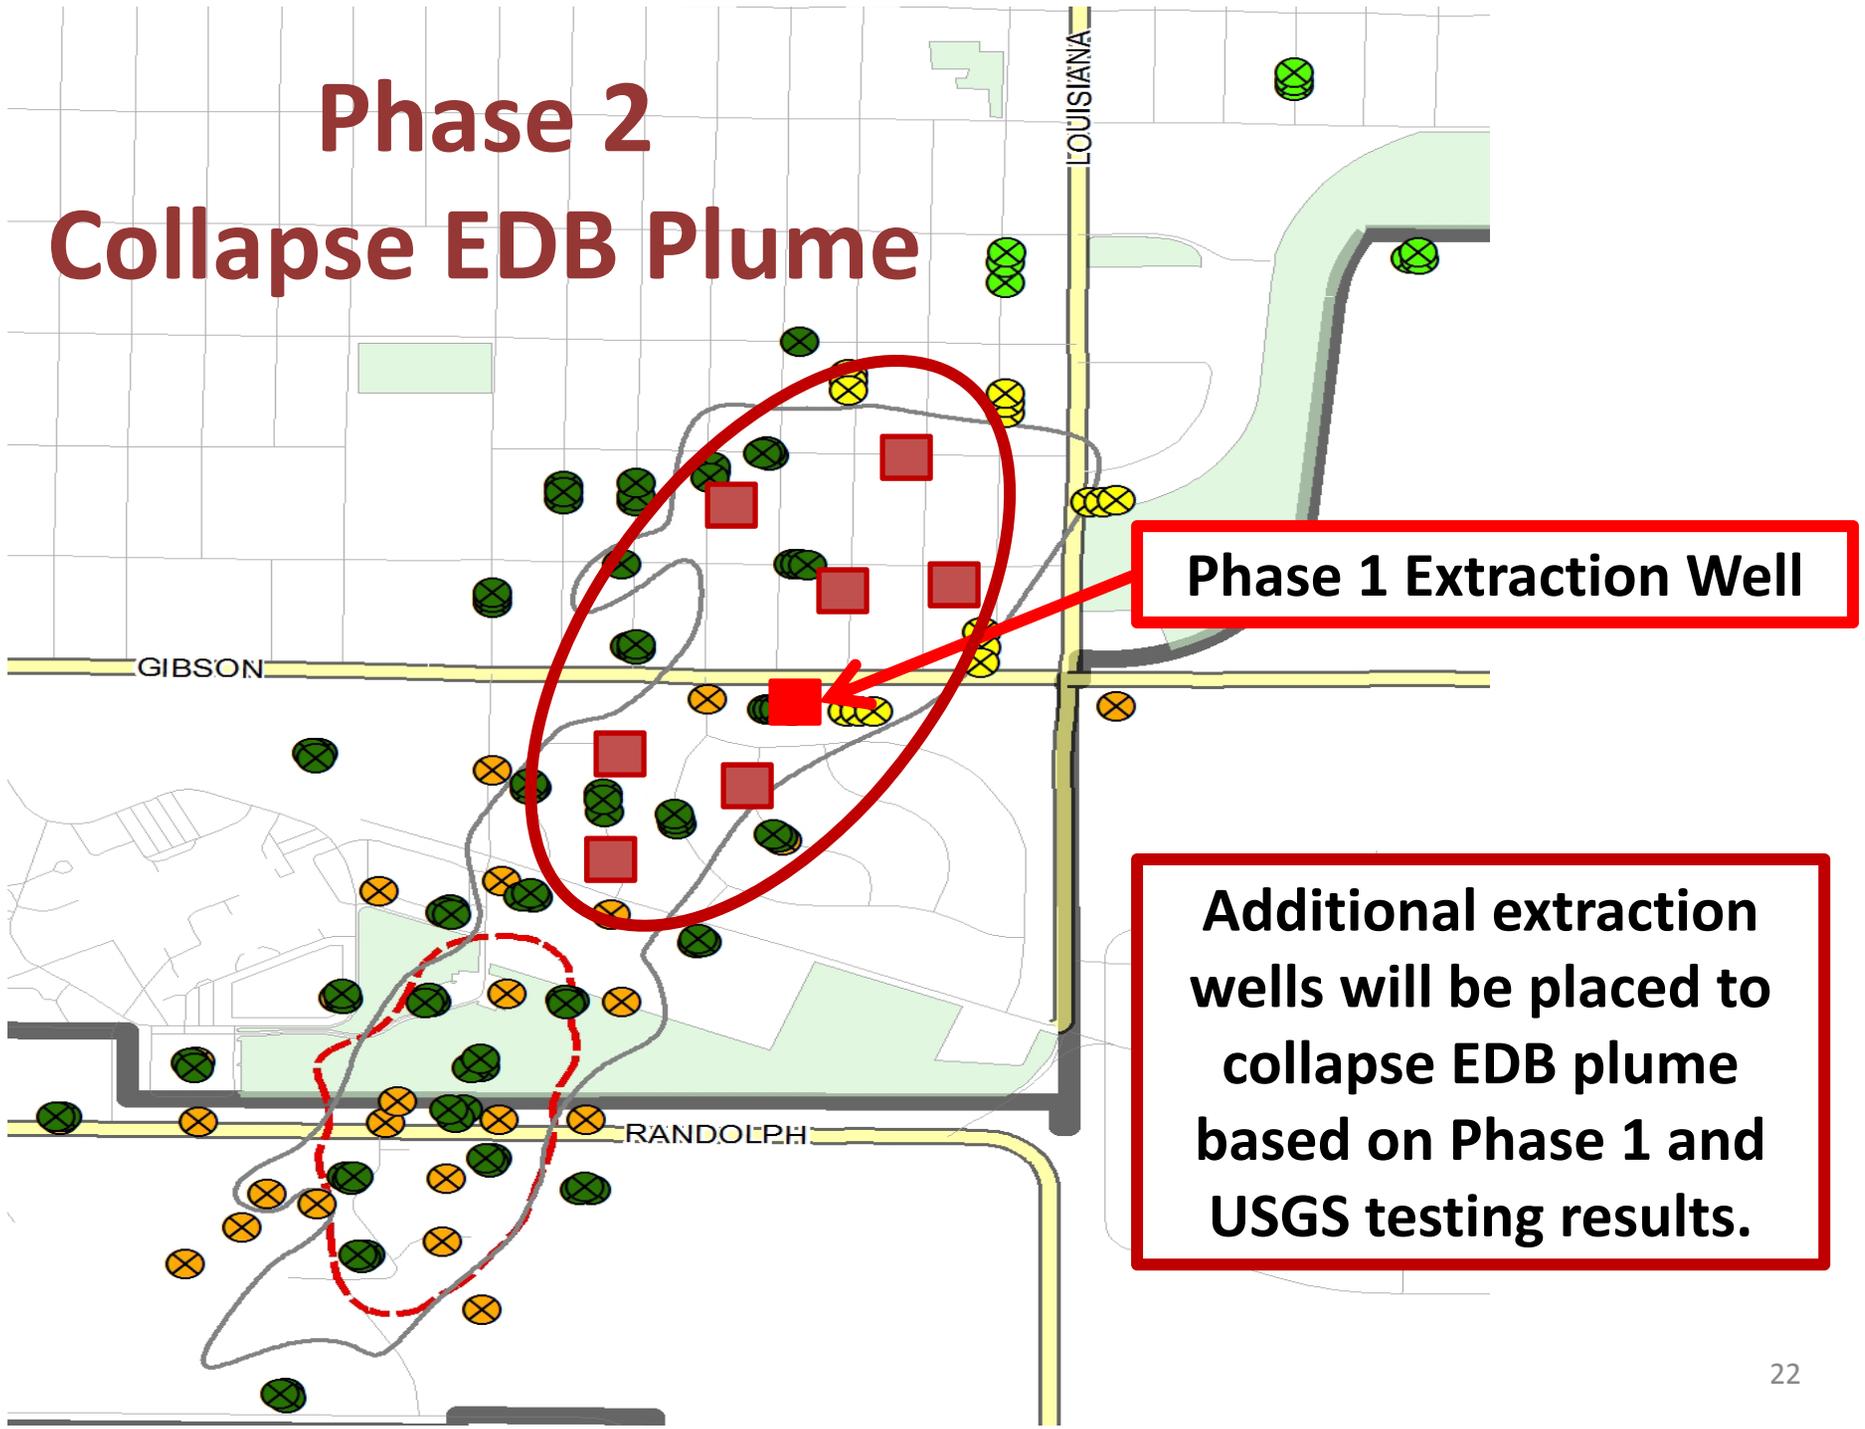
**Phase 1 Extraction Well**

**Additional extraction wells will be placed to collapse EDB plume based on Phase 1 and USGS testing results.**

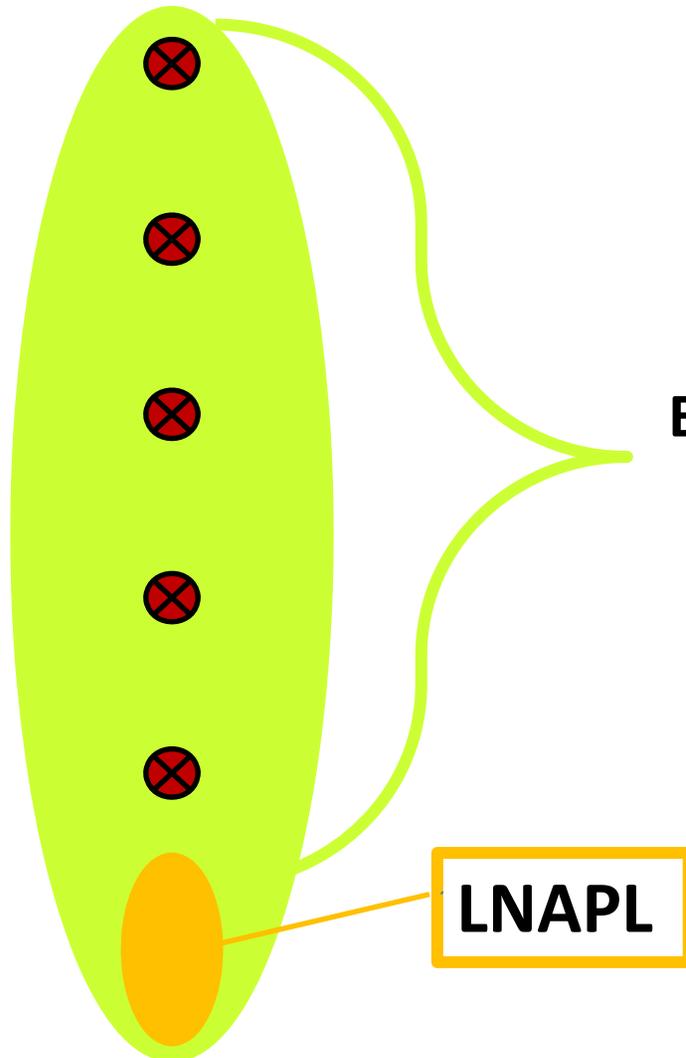
Extraction  
wells

Extracted groundwater  
will be treated to 0.05  
 $\mu\text{g}/\text{L}$  or better, and put  
to beneficial use.

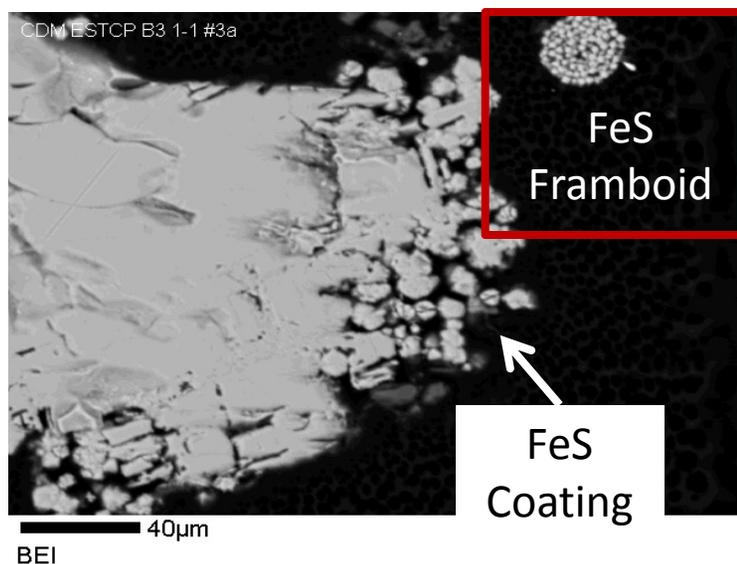
- **Reactive minerals can remove bromide from the EDB**
  - Similar to reductive debromination the result is bromide and ethylene
- **Hydrolysis (i.e., reaction with water)**
  - Half lives can be up to 18 years
  - In the presence of sulfide or at elevated temperatures half lives can be on the order of hours
  - The end product is bromide and ethylene glycol, which degrades readily under aerobic and anaerobic conditions

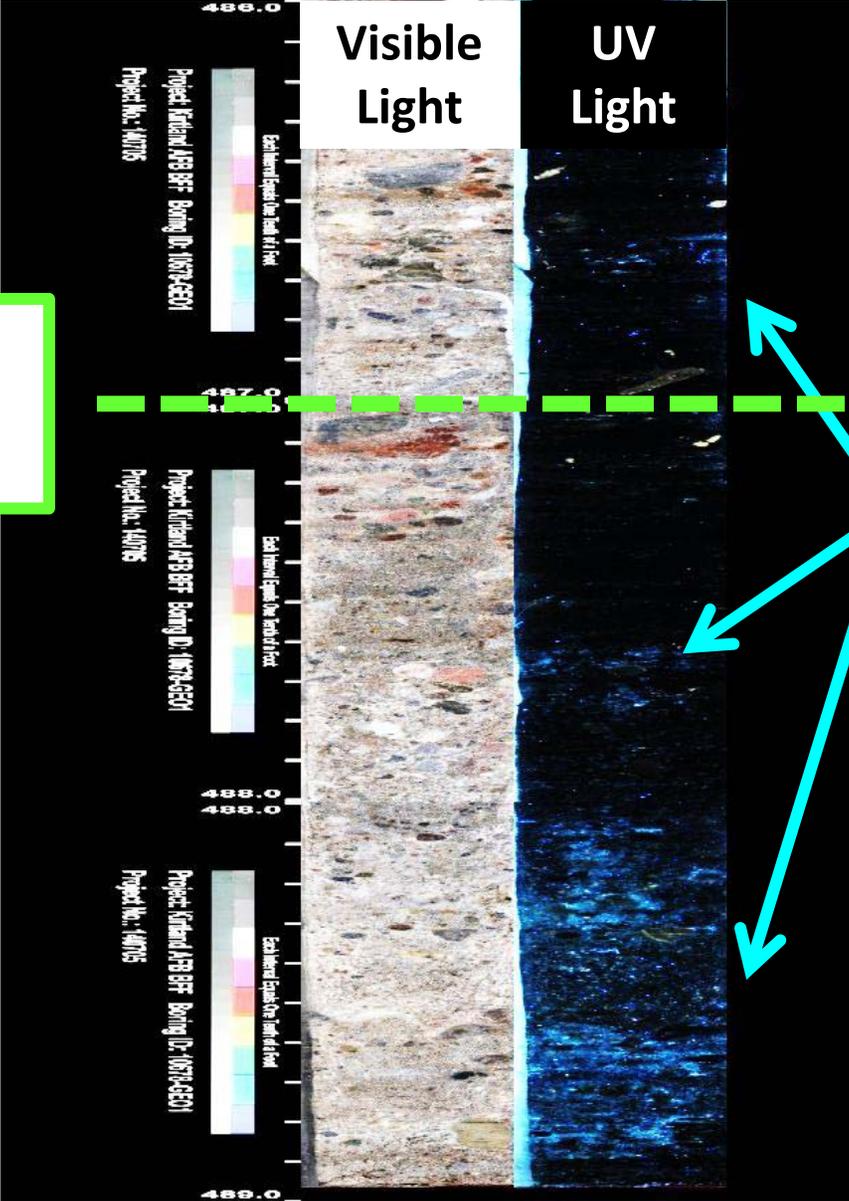
**Groundwater Table**

**LNAPL Under UV Light Fluoresces Blue**

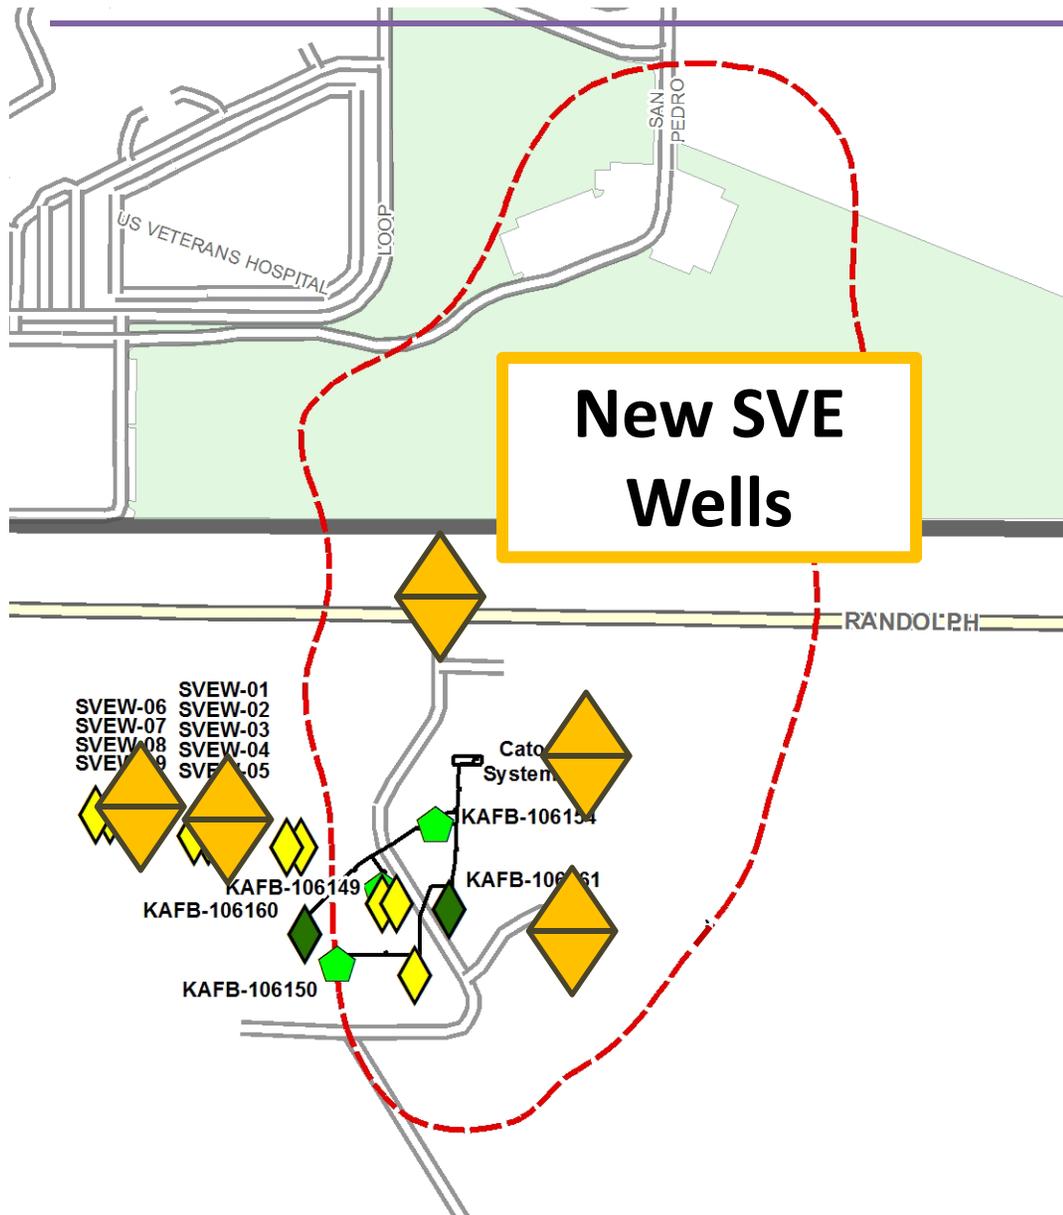
- Expand the SVE footprint by installing 5 SVE well clusters in hot spot areas
- Collect and evaluate SVE soil cores using state of the art techniques
- Perform SVE pilot testing to inform vapor extraction rates and the size of the SVE destruction system
