# New Mexico Occupational Safety & Health

# FATAL FACTS

No. 8775-004

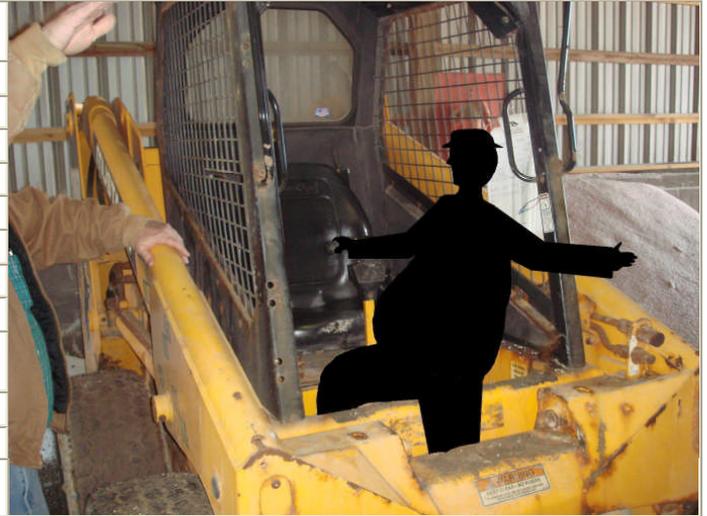
An employee is presumed to have attempted to close a storage bin door in a fertilizer barn by himself. The employee pulled his skid loader into the storage bin and raised the tractor's lift arms using the bucket to support the top hinged door so that he could release the pins which held the door open. When the employee exited the loader, he apparently made contact with the pedal that lowers the bucket causing him to become pinned between the tractor arm and the cab of the tractor.

1. Employers must instruct each employee in the safe and proper guidelines as stated in the operator's manual for the skid loader. Before exiting the skid loader, lower the lift arms, put the attachment flat on the ground.
