The only way to know if there is lead in your drinking water is to have it sampled and analyzed. Lead is colorless, odorless, and harmful to human health. NMED's Get the Lead Out NM (GTLO) program is a voluntary program for schools and childcare facilities to receive assistance in reducing lead in their drinking water to maintain a healthy learning environment for New Mexico's students.

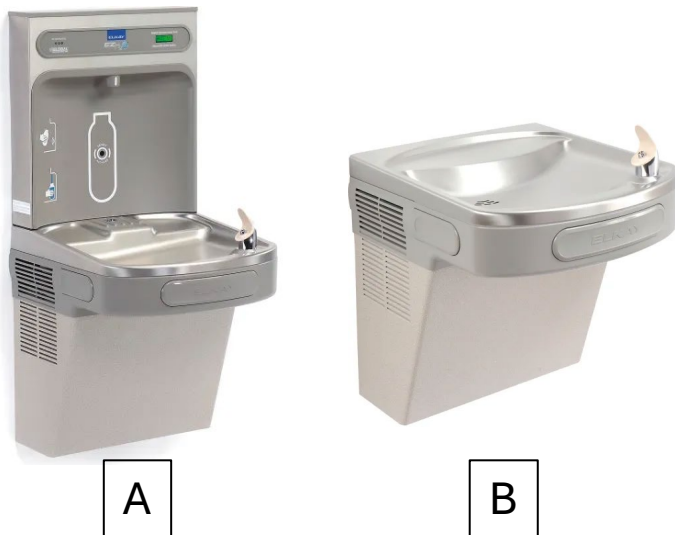
NMED has created codes for types of drinking water outlets often encountered in schools.

Examples: Outlet A would be recorded as WC (Water Cooler)
Outlet B would be recorded as WF (Water Fountain)

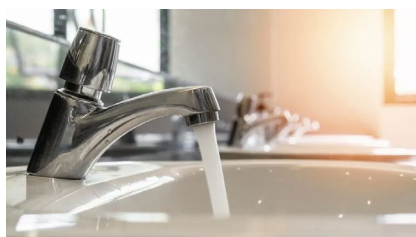
Two (2) samples will be collected at each outlet: a First Draw Sample, and a Flush sample. If lead is found in either sample, the two samples will help us determine the possible sources of contamination (i.e. fixture issue, interior plumbing issue, etc.)

First Draw Sample

Sample collected before school starts after water has sat in pipe for 8-18 hours.

Flush

Water is flushed from fixture continuously for 30 seconds.

Flush Sample

Second sample collected after the water is flushed.

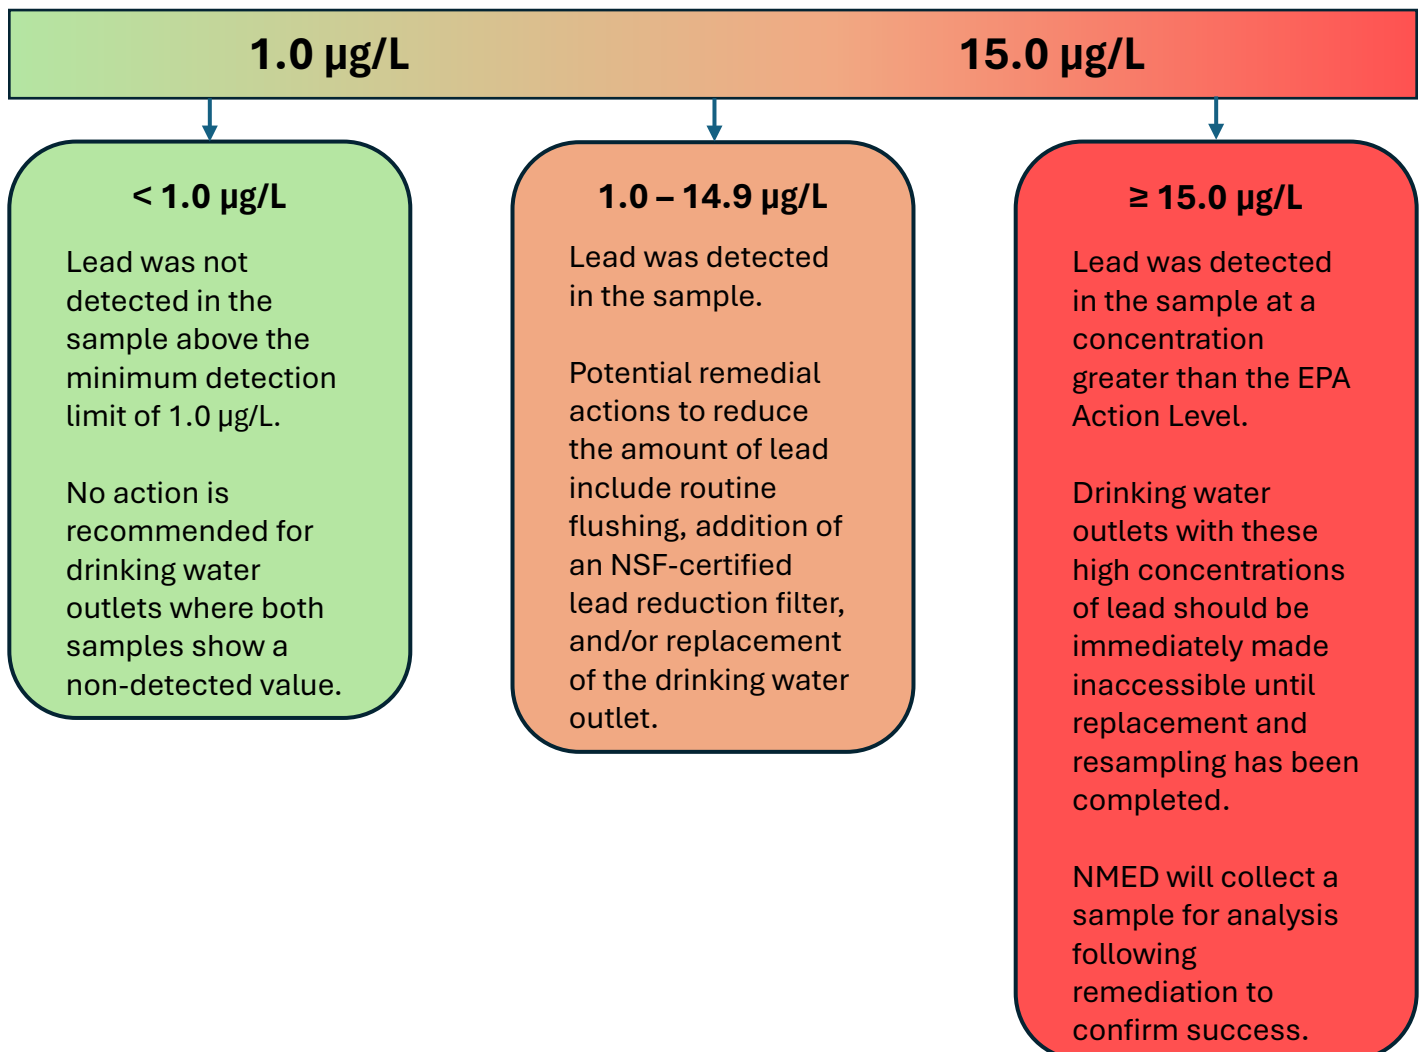
What do these numbers mean?

After receiving the samples, the NM state laboratory analyzes them and generates a report. Our program staff then organizes this report to make the data more digestible. We organize sample results into three categories: Non-Detect (<1.0 µg/L), Low Detection (1.0 – 14.9 µg/L), and High Detection (≥15.0 µg/L).
