PERMIT ATTACHMENT L FIGURES

Appendices with Figures

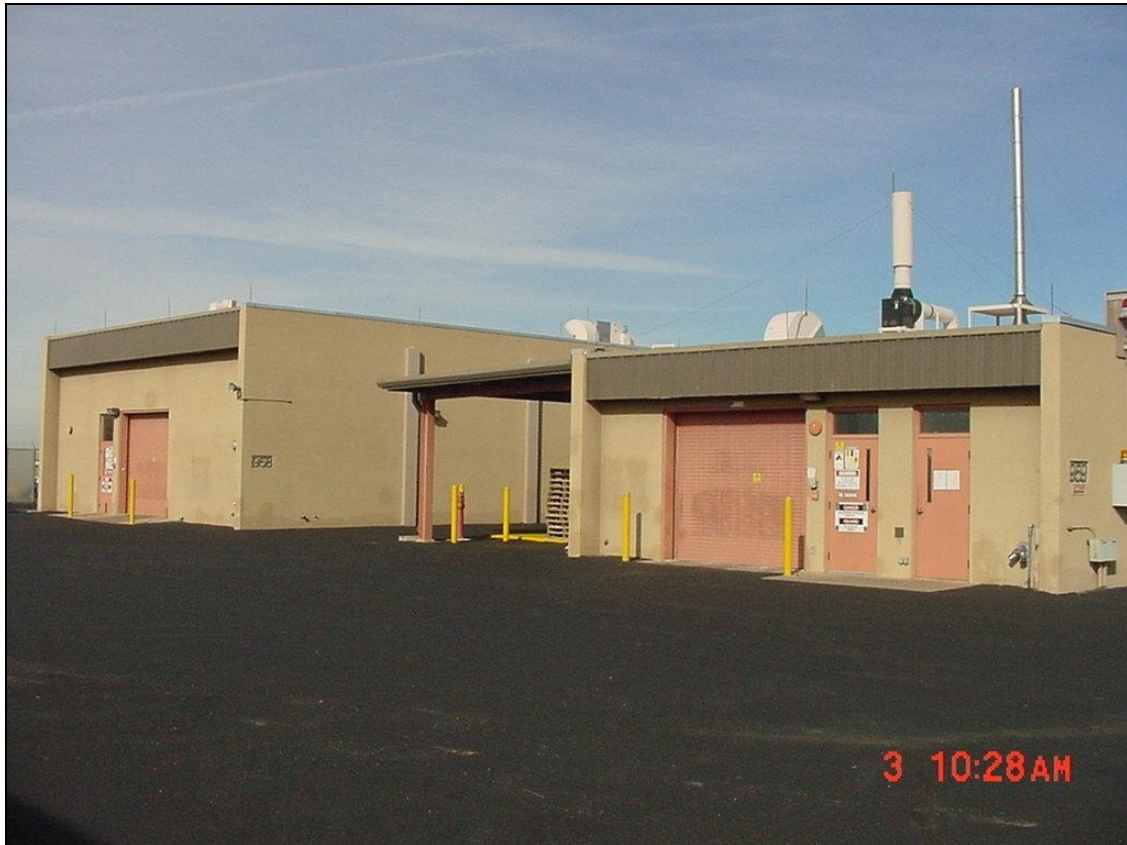
Hazardous Waste Handling Unit, Buildings 958 and 959
Photograph Taken on January 3, 2002
Process Code: S01

Building 958 is on the left, and Building 959 is on the right.

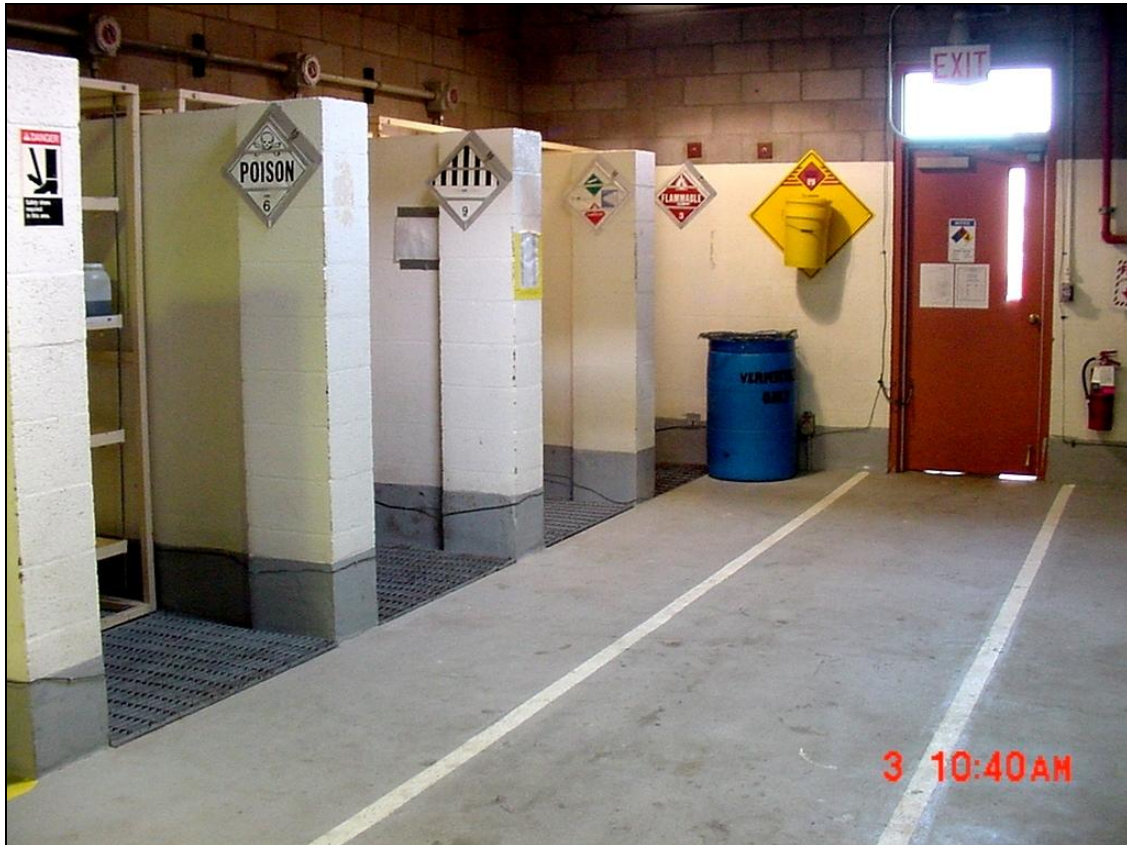
Hazardous Waste Handling Unit, Waste Storage Bays in Building 959

The drum at the far end of the building near the door contains absorbent for spill control. The bucket on the wall above it contains clean up materials.

Containers of RCRA-regulated wastes (solids and liquids) are segregated into the bays by compatibility and are stored on shelves over secondary containment in the bay.

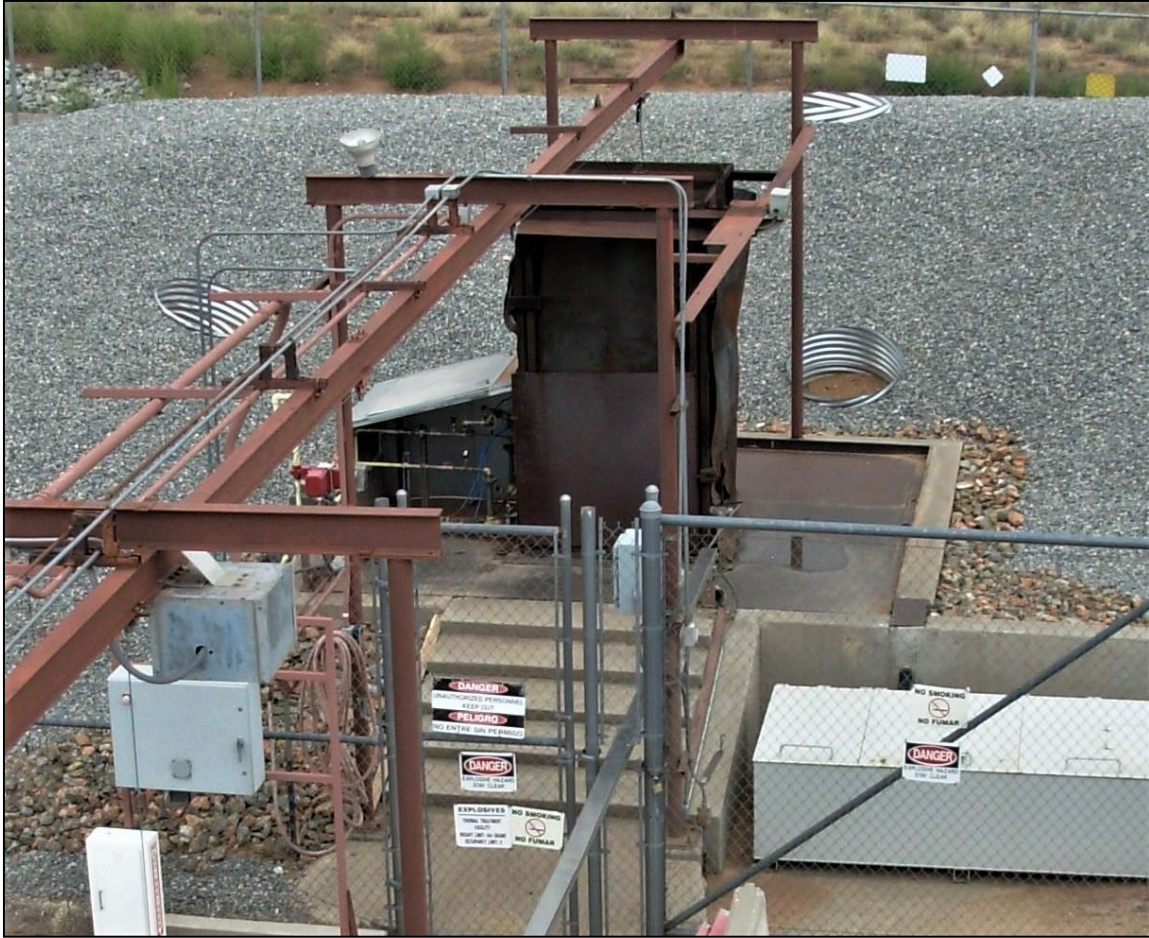
Thermal Treatment Unit
Viewed from Roof of Building 6715
Photograph Taken September 1, 2020
Process Code: X01

The sheet metal housing and propane lines for the propane burners are on the left side of the burn cage. The sheet of steel on the door of the burn cage is attached at the top and provides protection from wind during waste treatment. Another sheet of steel is attached to the back side of the burn cage.

The entire surface of the concrete foundation pad and the inside edge of the concrete pad curb are lined with steel. Runoff water is directed toward the right front corner of the pad, through a filter, and into a covered catchment tank (rectangular white tank) that is visible at the lower right corner of the photograph.

The burn cage and pad are surrounded by an earthen berm that is covered with gravel. The corrugated metal collars surrounding three soil sampling points are visible on the sides and top of the berm.

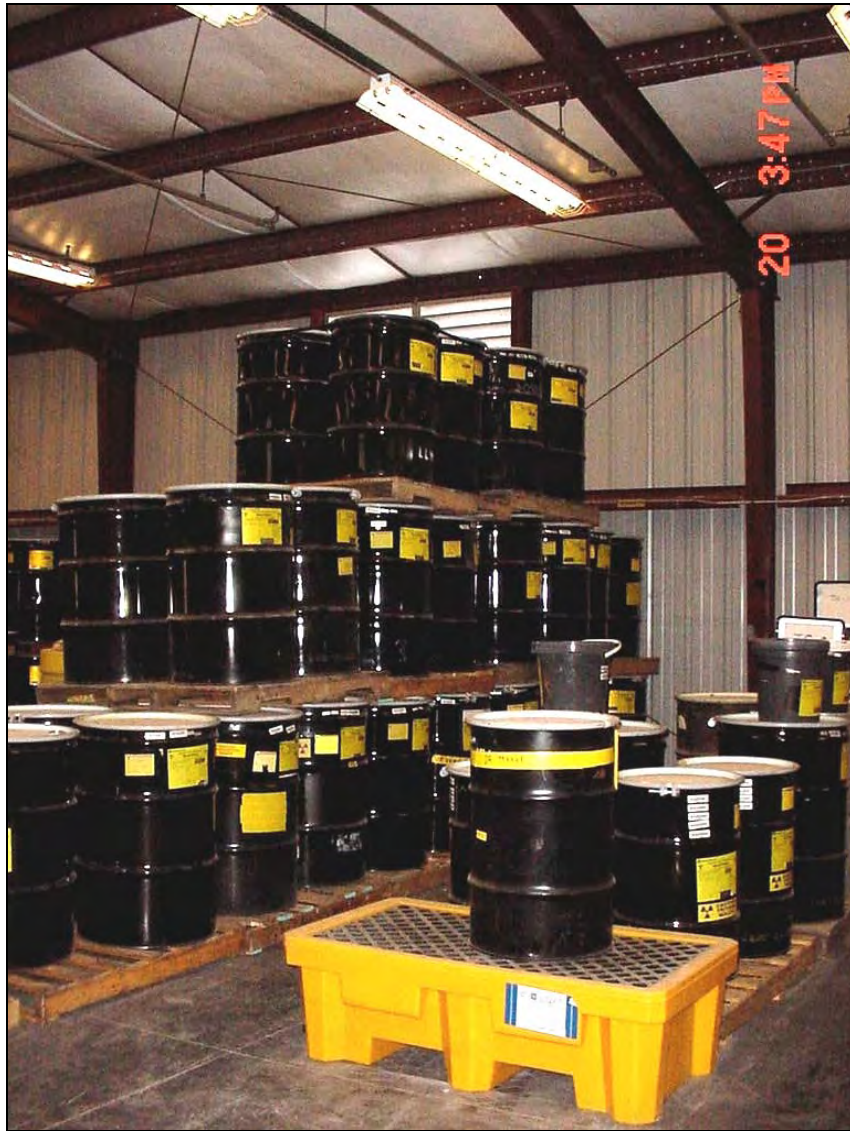
Radioactive and Mixed Waste Management Unit, Building 6925, Interior

The drum in the front of the row on the right contains liquid mixed waste and is stored on a portable spill containment pallet.

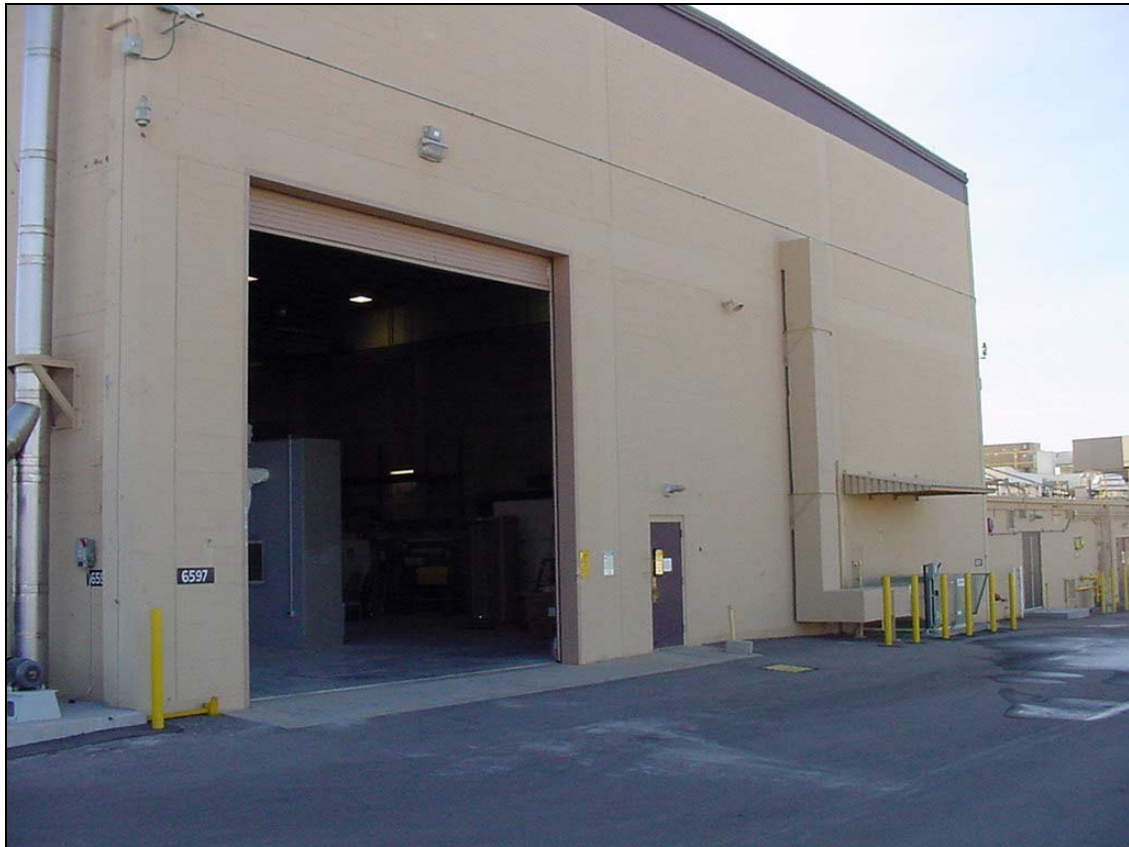
Auxiliary Hot Cell Unit, North Side of Building 6597

The work area and permanent shield wall are visible inside the building.

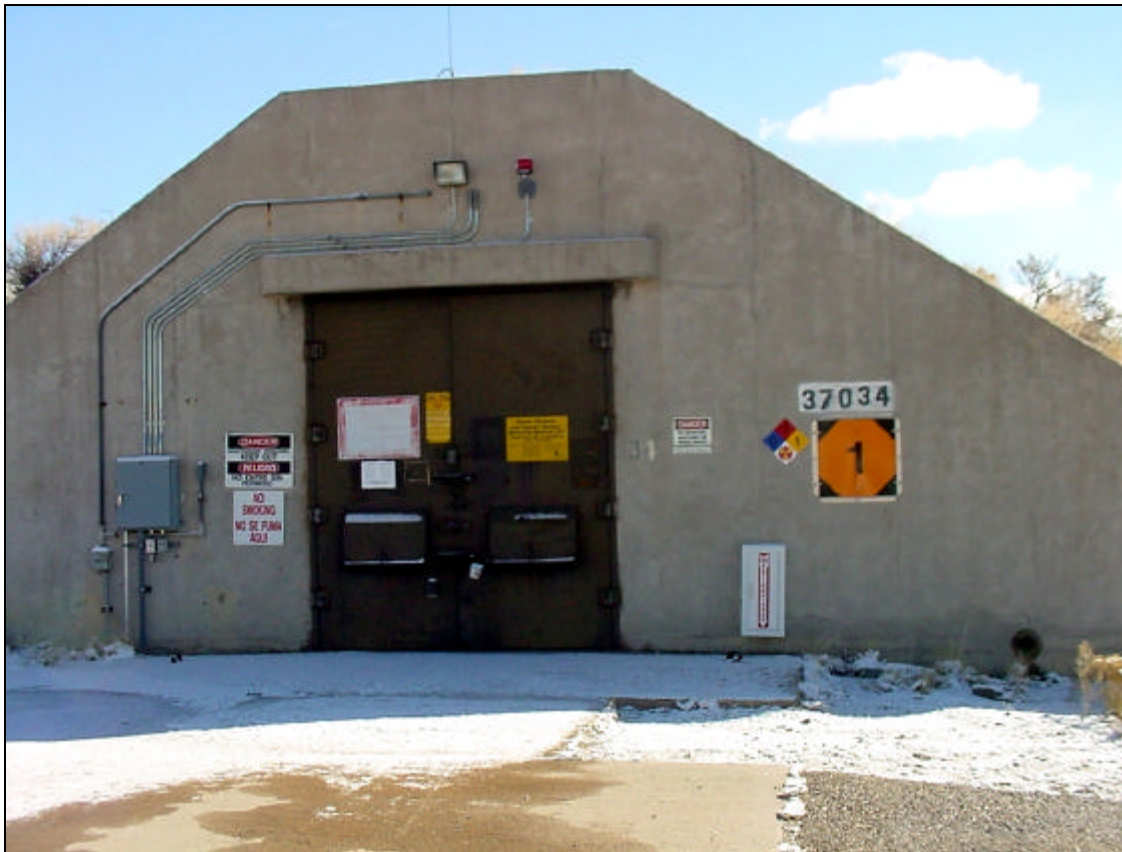
Manzano Storage Bunkers, Type B, Front View of Bunker 37034

The drain shown near the right edge of the picture serves a drain tile on the outside of the bunker, allowing drainage of water (from precipitation) that may accumulate in the soil behind the concrete wall.

The large orange sign indicates that explosive (D003) waste is currently stored in this bunker. The fire extinguisher is located in the white box below and to the left of the orange sign.

The concrete pad in front of the bunker doors is level or slopes slightly away from the bunker, preventing surface water runoff into the bunker.
